Subject: July 2014 WBMWD Pipe Rack Biofouling Test

West Basin Pipe Rack Biofouling Test First Pipe Spool Inspections July 1, 2014

Subject: August 29, 2014 WBMWD Pipe Rack Biofouling Test:
Pipe Spool Inspections

Subject: October 28, 2014 WBMWD Pipe Rack Biofouling Test:
Pipe Spool Inspections

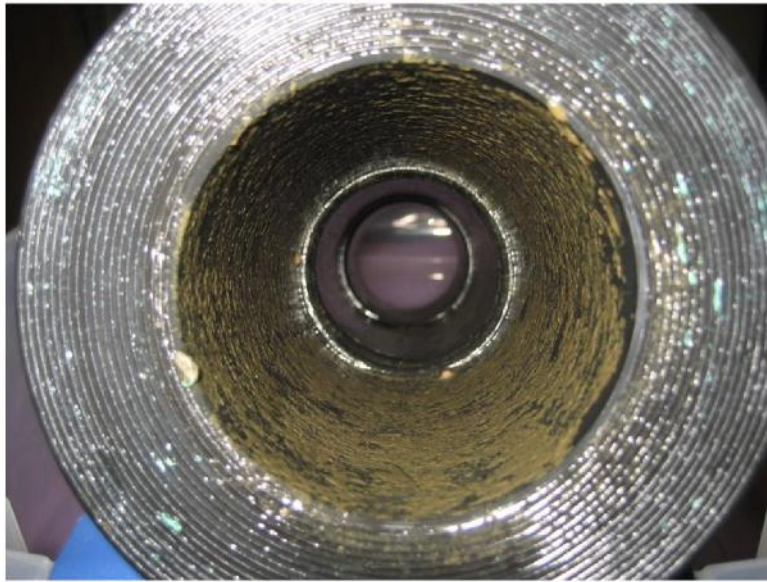
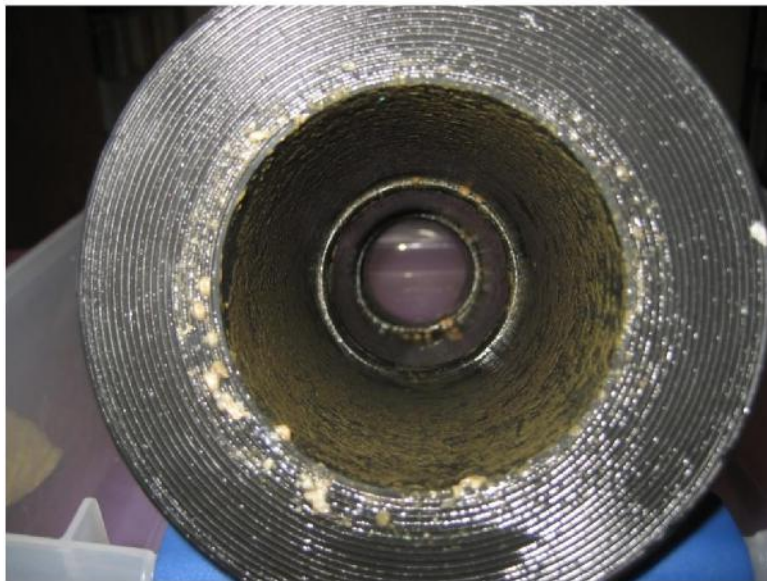
- Photos were taken from inlet and outlet ends (**Figure 1**).
- Pipe surface has a slimy feeling to the touch. Slime layer is visible in the photos with a brownish appearance. Samples were removed and inspected under a dissecting microscope. The samples appeared to be comprised of filamentous material (probably algal filaments) with entrapped detritus (silt, etc.). The layer was not of measureable thickness (less than 0.5 mm) or of a quantity that would allow its removal for a weight determination. Following photographs and inspection, this layer was easily removed from the pipe surface by either a gentle swipe with a finger or soft instrument, or by flushing with water from a hose.

- Inspection with lighted-mirror tools found a total of 18 small acorn barnacles (2 mm to 4 mm basal diameter). The barnacles are located near areas of surface discontinuity or turbulence, such as the inlet to the spool and the ridges that divide the spool into three sections (inlet, middle, and outlet). Barnacles that were large enough to be identified were *Megabalanus californicus*, the others were Balanid barnacles, possibly *Balanus glandula* or *M. californicus*, but it was too early in their development to be sure.

- Six small acorn barnacles (1 mm) were found on the face of the outlet flange – not within the pipe spool (**Figure 1**).
- No other macrofouling was found.

Figure 1. Pipe spool A3 (Control) October 28, 2014. Inlet (top) and Outlet (bottom).

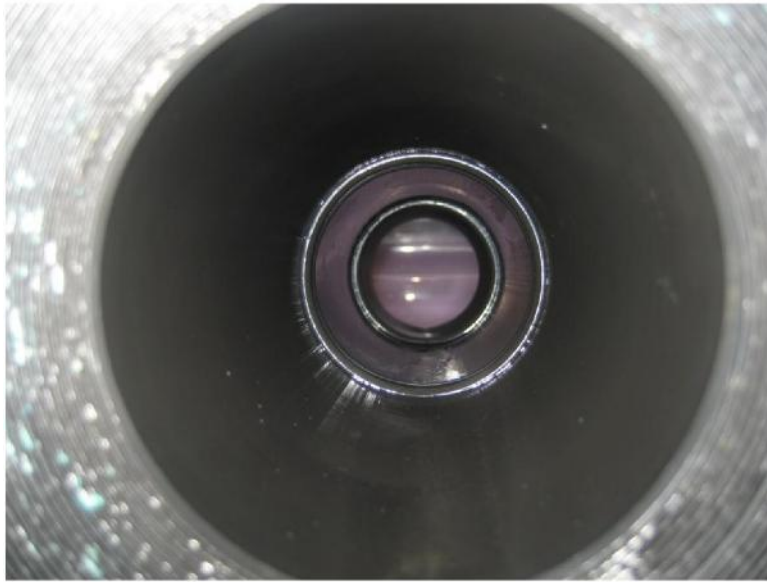
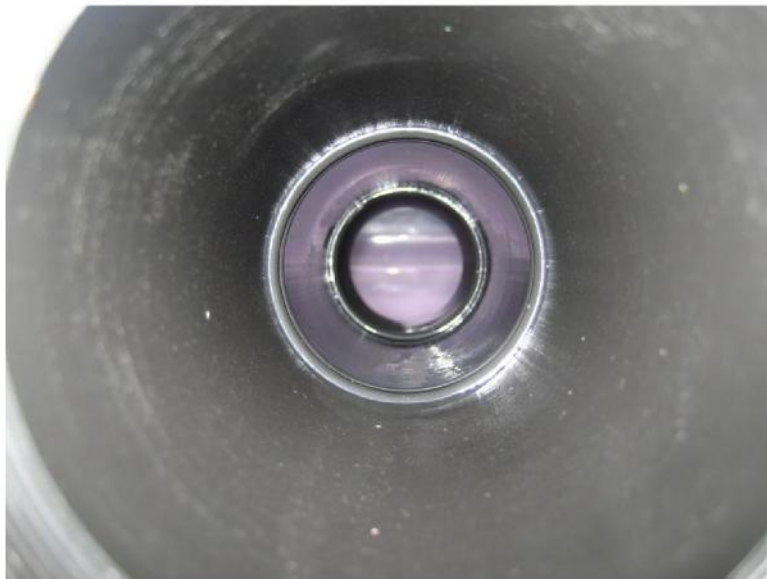
- This is the third pipe spool in spool row B and was treated with continuous injection of a chloramine solution.
- Photos taken from inlet and outlet ends (**Figure 2**).
- No macrofouling organisms were found.
- No slime/diatoms detected by touch or tissue wipe.
- No sand

Figure 2. Pipe spool B3 (Continuous Chloramine Injection) October 28, 2014. Inlet (top) and Outlet (bottom).

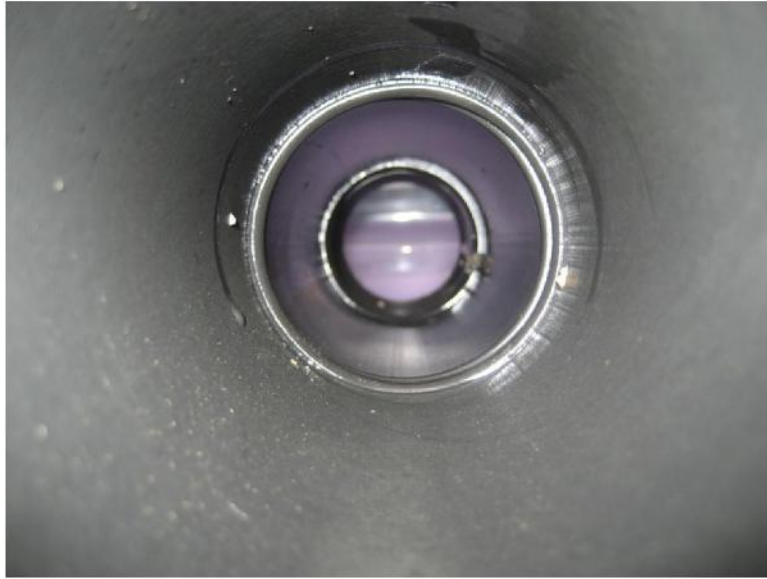
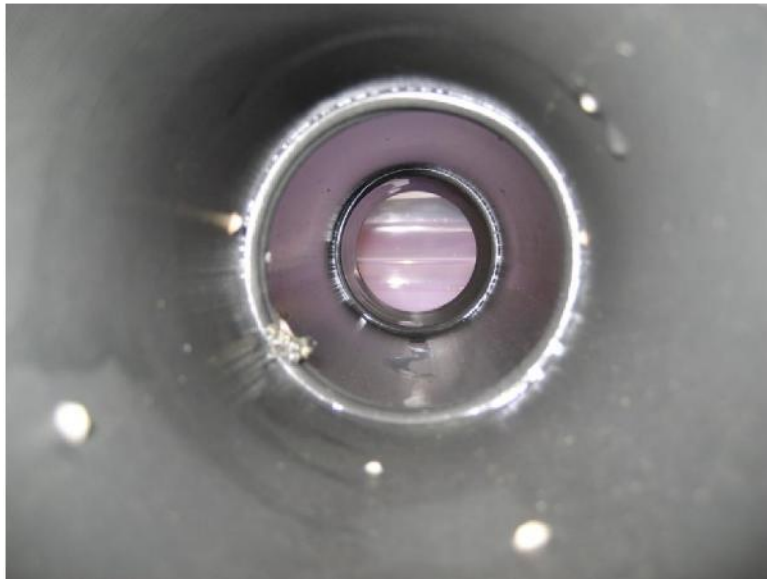
- This is the third pipe spool in spool row C and received a weekly shock treatment with sodium hypochlorite.
- Photos taken from inlet and outlet ends (**Figure 3**).
- The pipe walls have a slight brown tinge, but do not feel slimy to the touch. The material can be easily removed with a tissue wipe. This could be fine silt trapped in a bacteria layer, or a thin layer of diatoms
- 9 small acorn barnacles (Balanidae) were observed; 3 in the inlet section and 6 in the outlet section.
 - Size (basal diameter) ranged from about 1 mm to 3 mm.
 - No barnacles found in the middle section of the spool.
- A small ball of plastic shavings were found at the ring between the middle and outlet section.
- No sand

Figure 3. Pipe spool C3 (Shock Chlorination) October 28, 2014. Inlet (top) and Outlet (bottom).

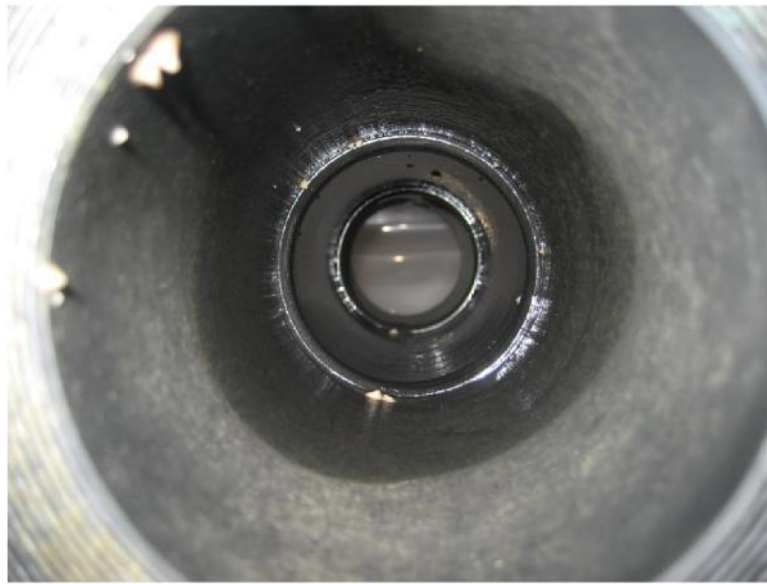
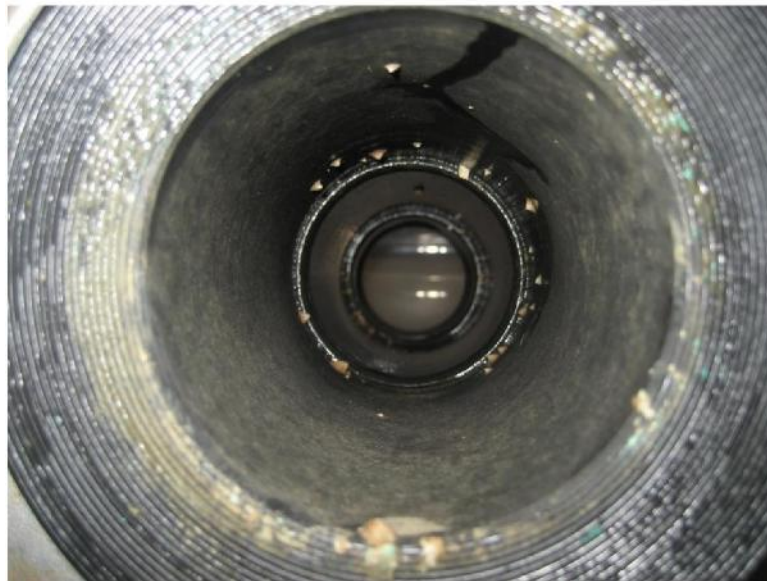
- Photos were taken from inlet and outlet ends (**Figure 1**).
- The pipe surface had a dull brown appearance, but no slimy feeling to the touch as had been detected at the end of October when the last set of spools were inspected. Following photographs and inspection, an attempt was made to remove some of the brown discoloration with a tissue wipe, but no material came off the surface of the pipe.

- Inspection with lighted-mirror tools found a total of 11 small acorn barnacles in the inlet section of the pipe spool, 19 barnacles in the middle section and 25 in the outlet section. The barnacles ranged in size from <1 mm to 4 mm. The barnacles were located near areas of surface discontinuity or turbulence, such as the inlet to the spool and the ridges that divide the spool into three sections (inlet, middle, and outlet). Barnacles that were large enough to be identified were *Megabalanus californicus*, the others were Balanid barnacles, possibly *Balanus glandula* or *M. californicus*, but it was too early in their development to be sure.

- No other macrofouling was found.
- No sand or debris was observed in the spool.

Figure 1. Pipe spool A4 (Control) December 23, 2014. Inlet (top) and Outlet (bottom).

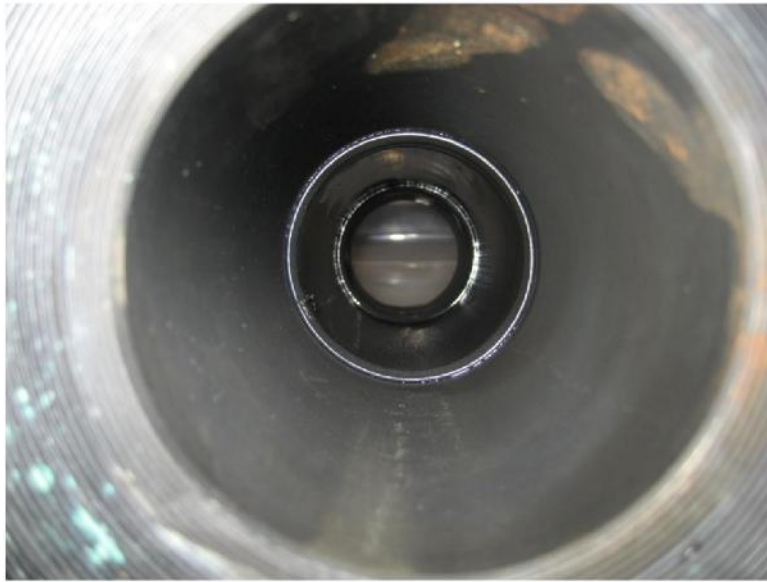
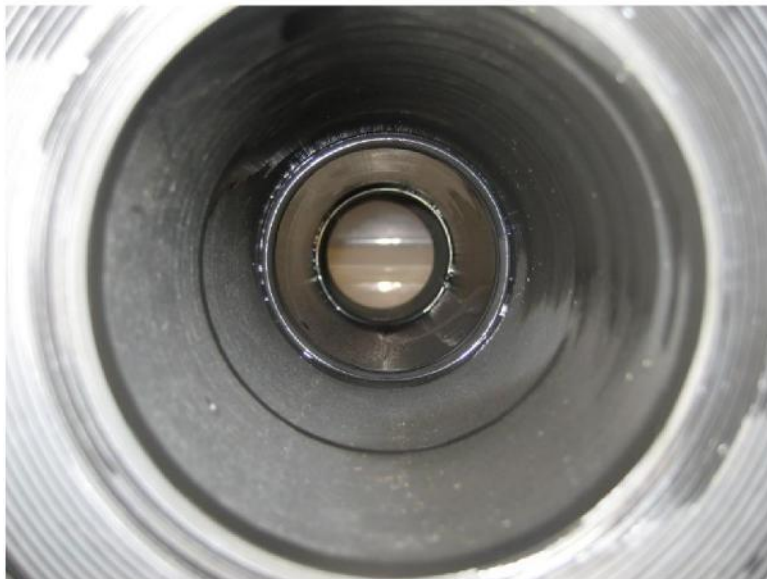
- This is the fourth pipe spool in spool row B and was treated with continuous injection of a chloramine solution.
- Photos taken from inlet and outlet ends (**Figure 2**).
- No macrofouling organisms were found.
- No slime/diatoms detected by touch or tissue wipe.
- No sand or debris, although a rust stain was observed in the inlet section (**Figure 2**).

Figure 2. Pipe spool B4 (Continuous Chloramine Injection) December 23, 2014. Inlet (top) and Outlet (bottom).

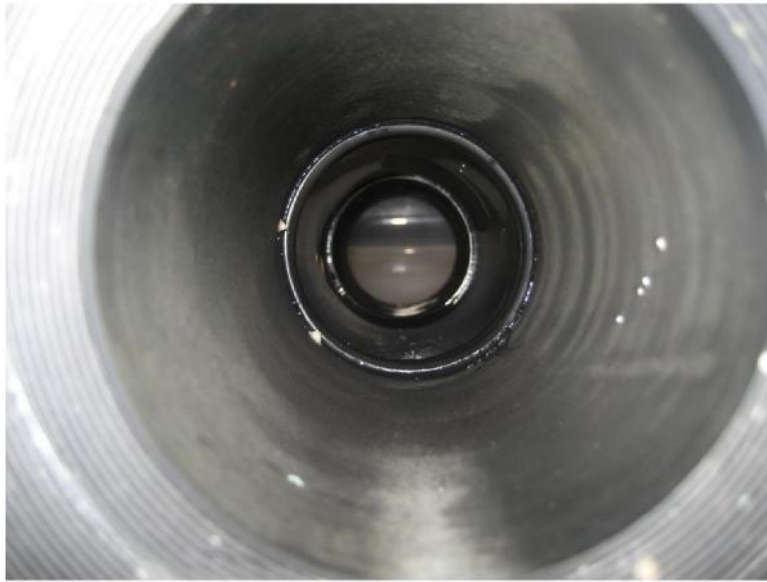
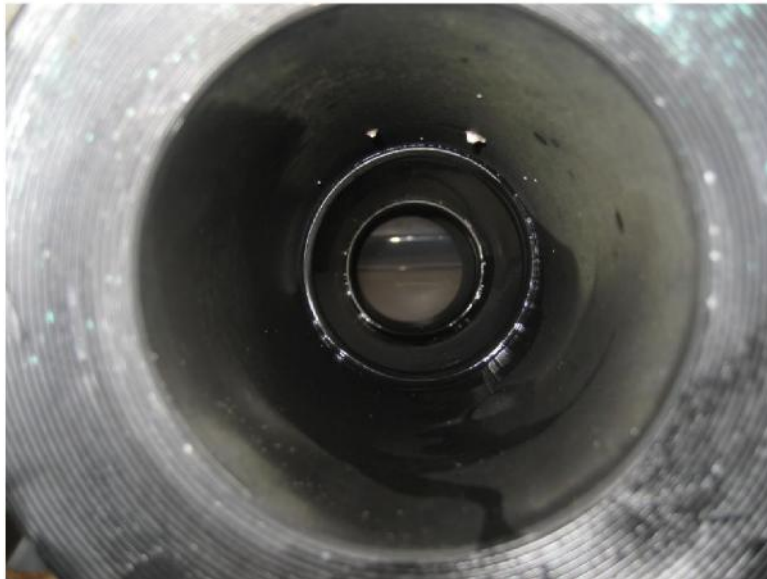
- No slime/diatoms detected by touch or tissue wipe.
- 9 small acorn barnacles (Balanidae) were observed; 5 in the inlet section, 2 in the middle section, and 2 in the outlet section.
 - Size (basal diameter) ranged from about <1 mm to 3 mm.
- No sand or other debris was observed.

Figure 3. Pipe spool C4 (Shock Chlorination) December 23, 2014. Inlet (top) and Outlet (bottom).
