Subject: September 2014 WBMWD Biofouling Test Rack I Inspection

West Basin Intake Biofouling Test Test Rack I September 17, 2014

Duration of Testing: June 17, 2014 – September 16, 2014 (92 days)

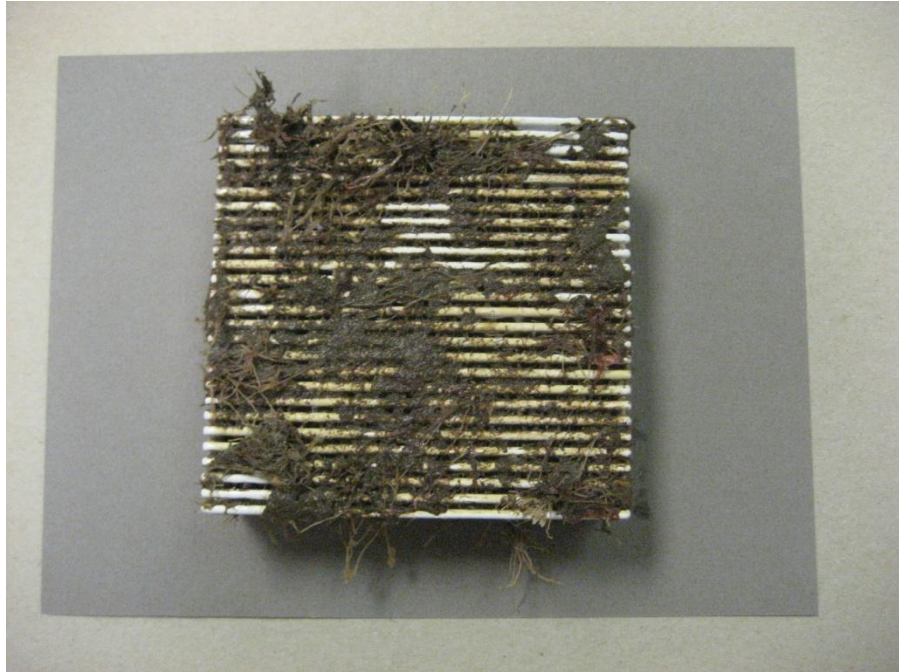
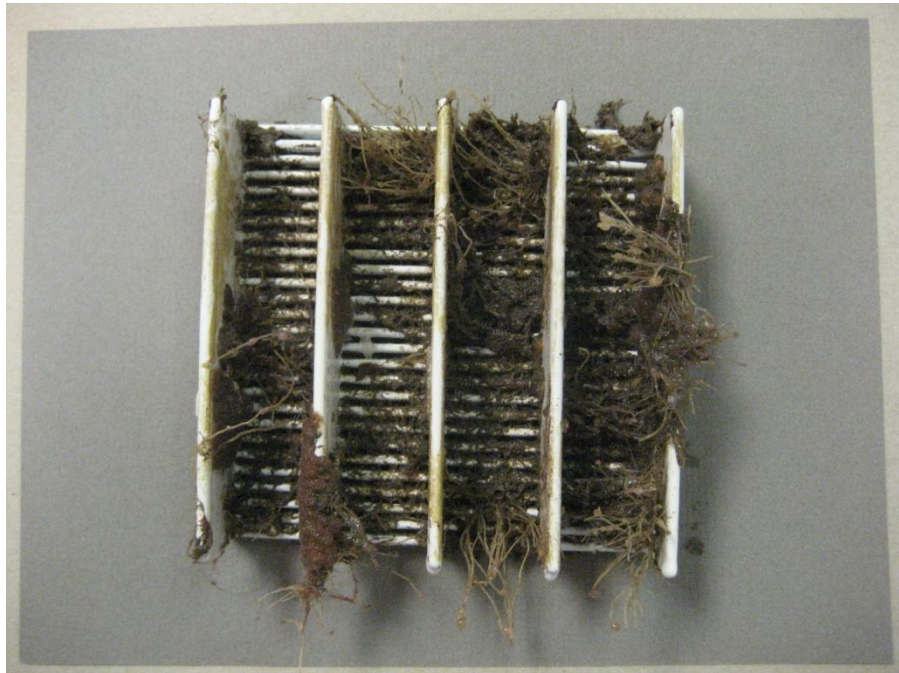
Figure 5. 2205 stainless steel Wedgewire sample with foul release coating, photographed 12/30/14.

- **2205 SS (stainless steel) with antifouling coating wedgewire sample and coupon (IIA3 and IIB3):**
 - Wedgewire sample (IIA3) (**Figure 5**)
 - About 30 to 40 percent of the sample's total surface had hydroids attached to it (up to 3 cm long). About 2 percent of the underside ribs were covered with an encrusting bryozoans and another 5 percent had a filamentous red alga attached to it. 12 half-slipper shells (*Crepipatella lingulata*), similar to limpets, measuring 5 to 20 mm in diameter were found on the reinforcing ribs of the underside of the sample. A single 7 mm white bivalve (*Hiatella?*) was nestled in the hydroids. The foul-release coating was in very good shape and all of the fouling was removed with just a light brushing using a soft nylon brush.

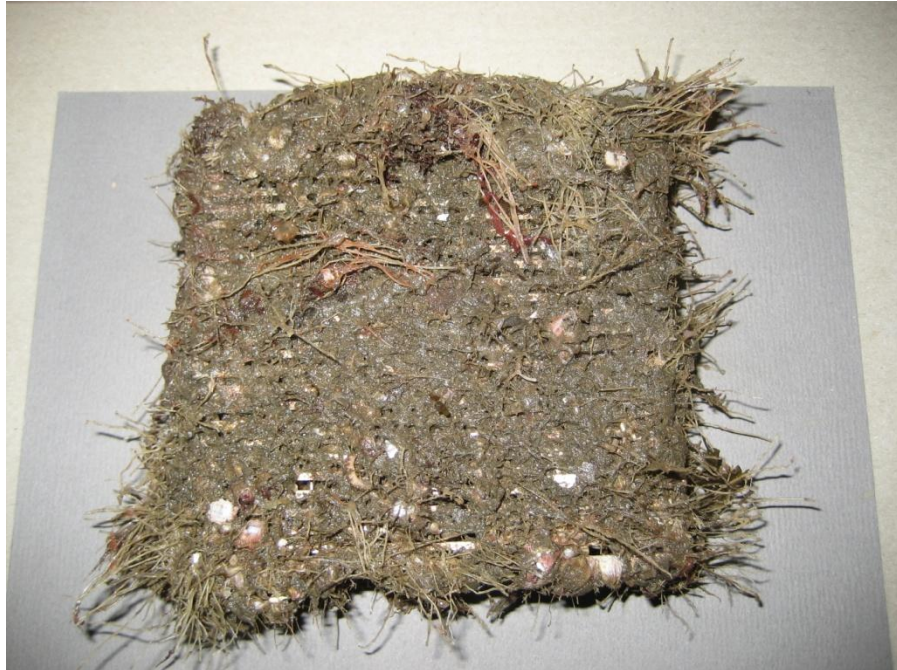
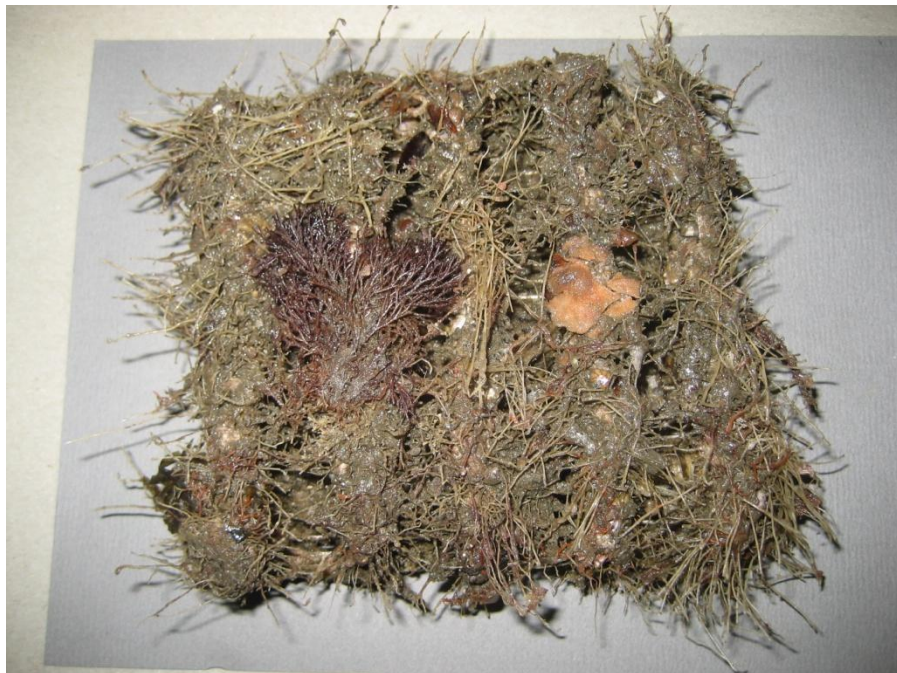
Figure 7. 2205 stainless steel Wedgewire sample, photographed 12/30/14.

- **2205 SS (stainless steel) wedgewire sample and coupon (IIB4 and IIA4):**
 - Wedgewire sample (IIB4) (**Figure 7**)
 - This sample was very heavily fouled with hydroids covering most of the surface. Beneath the hydroids, attached to the sample, were approximately several thousand barnacles (*M. californicus*) ranging from 1 to 10 mm in diameter. Also intermixed with the hydroids were small mussels (*Mytilus*

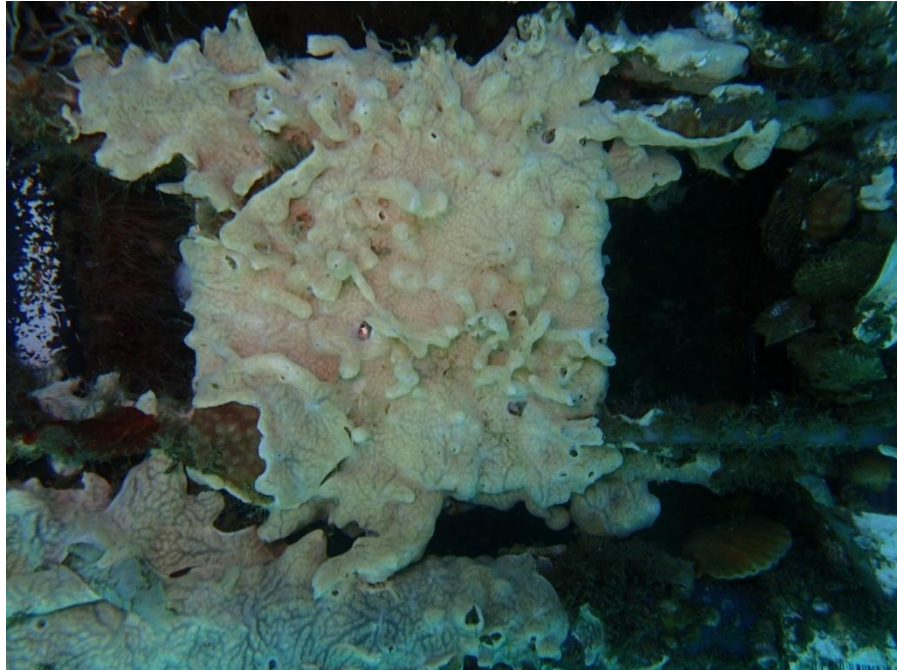
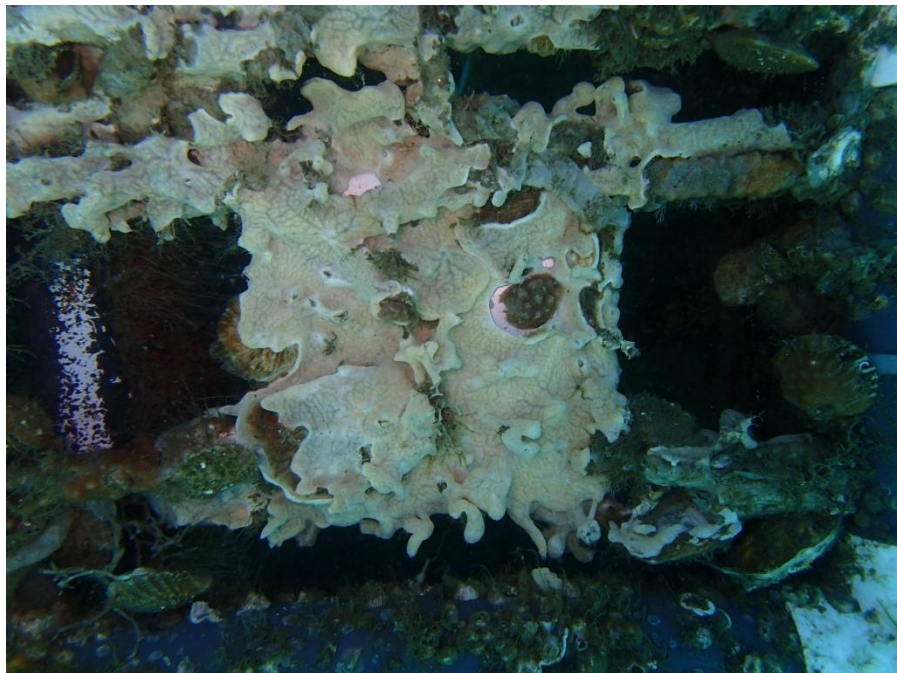
Figure 14. 2205 stainless steel test plate (Test Plate 4), photographed 12/29/14 in situ after removal of its Vexar mesh bag.

- **2205 Stainless Steel (uncoated), Plate 4, (Figure 14)**
 - This plate is almost completely covered with macrofouling, primarily a large, expansive colonial tunicate. Hydroids and bryozoans are also

- As with the other plates, a variety of encrusting invertebrates are attached to the PVC frame and the plastic cable ties that secure the plate to the frame. In this case, there is little to differentiate between the stainless steel plate and the plastic components.

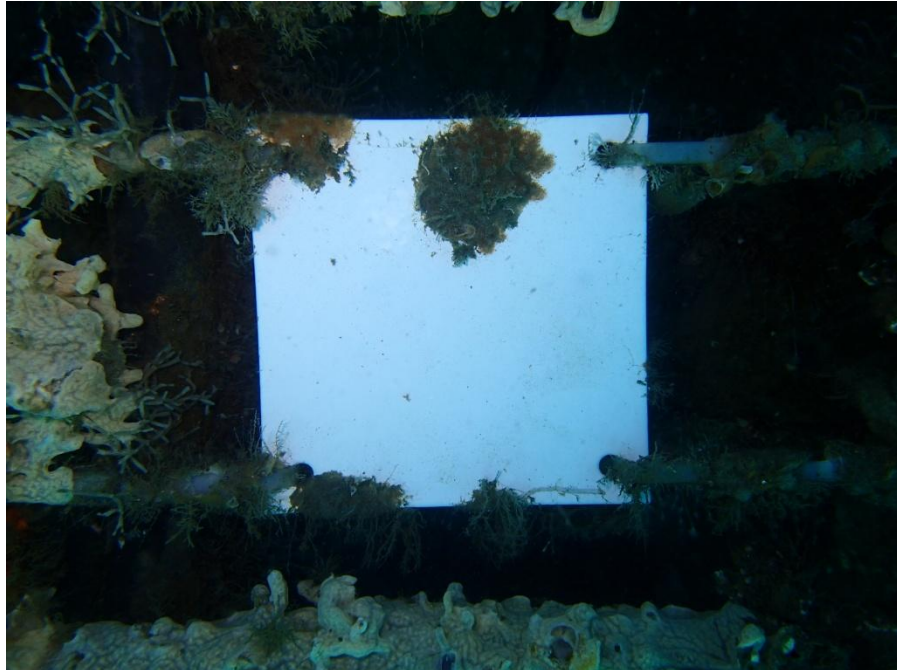
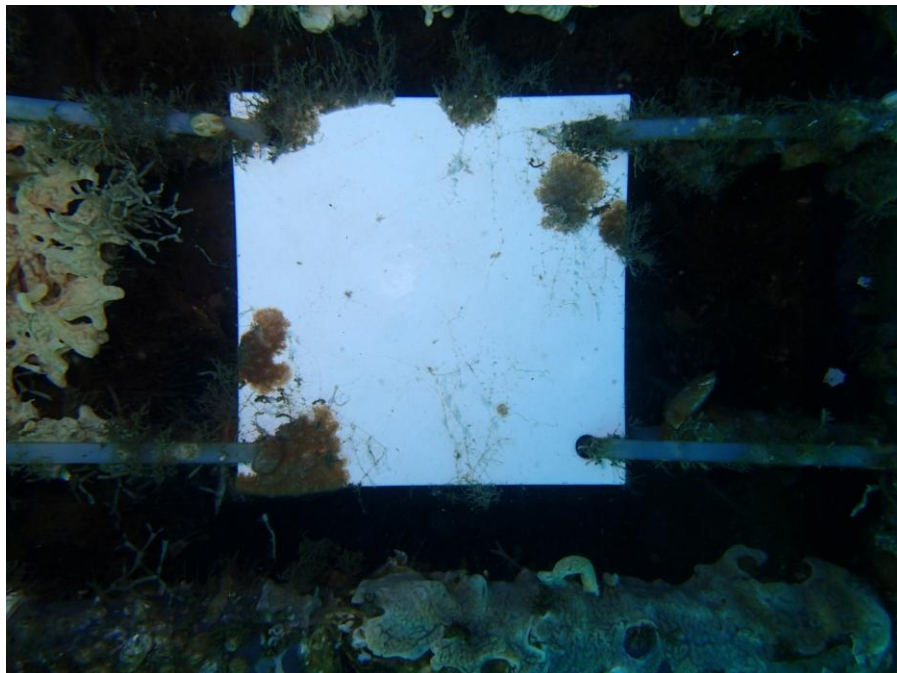
Figure 15. 2205 stainless steel test plate with foul release coating (Test Plate 5), photographed 12/29/14 in situ after removal of its Vexar mesh bag.

- **2205 Stainless Steel with foul release coating, Plate 5, (Figure 15)**
 - This plate is of the same material as Plate 4, but has been coated with a silicone elastomer foul release coating.

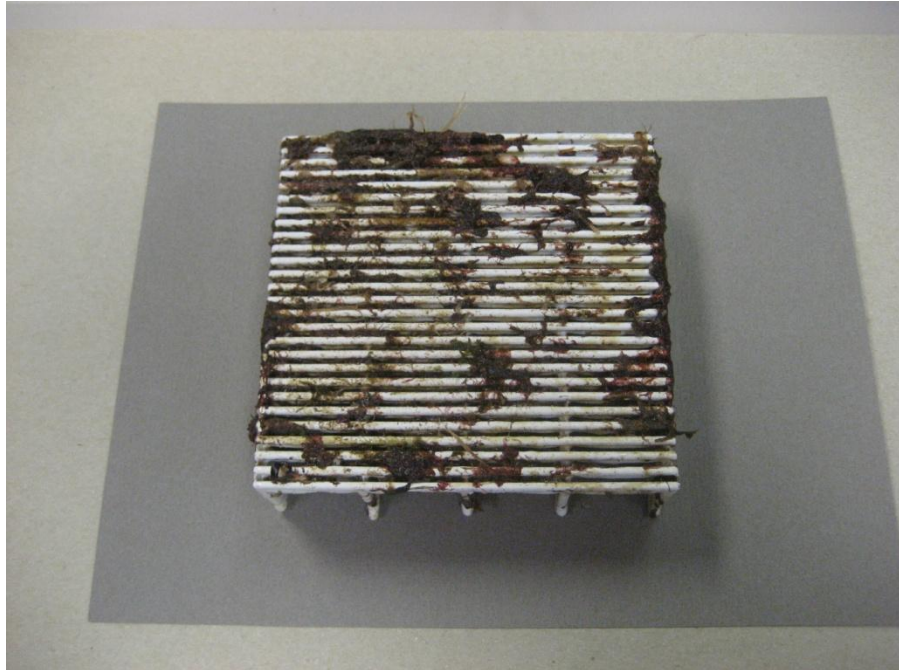
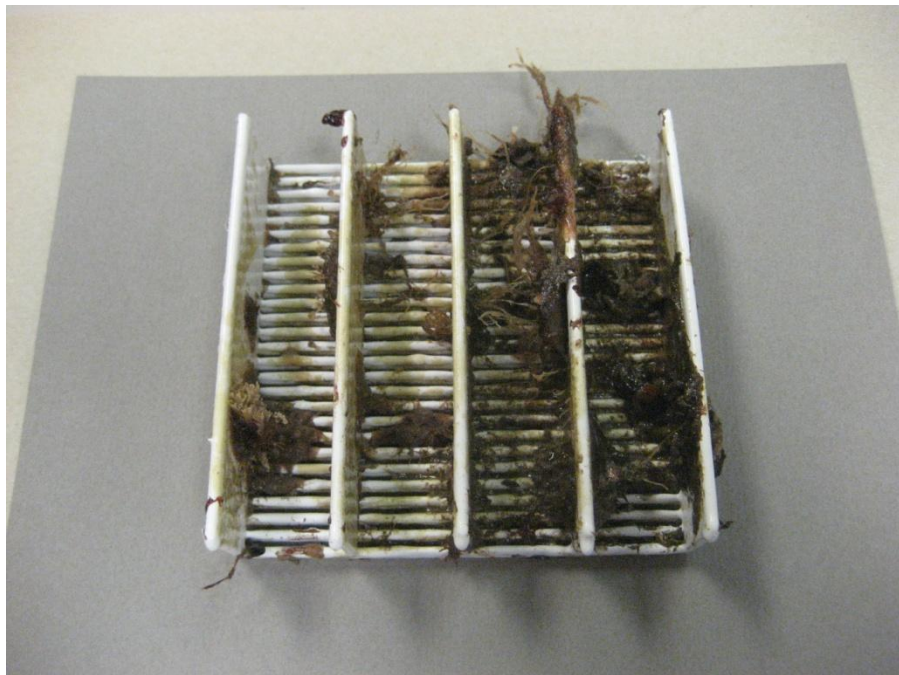
Figure 5. 2205 stainless steel Wedgewire sample with foul release coating, photographed 04/22/15.

- **2205 SS (stainless steel) with antifouling coating; wedgewire sample and coupon (IIIA3 and IIIB3):**
 - **Wedgewire sample (IIIA3) (Figure 5)**
 - About 20 percent of the sample's outer surface had filamentous red algae and some hydroids attached to it (up to 3 cm long). There was also some encrusting bryozoans, a 4 mm mussel (*M. galloprovincialis*) and a single 1 cm barnacle (*M. californicus*) About 50 percent of the underside ribs were clean of fouling. The other 50 percent was covered with encrusting bryozoans, filamentous red algae, hydroids, 9 half-slipper shells, or slipper limpets, measuring 10 to 30 mm in diameter, 6 mussels (all < 4 mm), and some solitary tunicates. The foul-release coating was in very good shape and all of the fouling was removed with just a light brushing using a soft nylon brush, however one of the slipper shells took a small piece (2 mm x 4 mm) of the coating with it when it was removed.

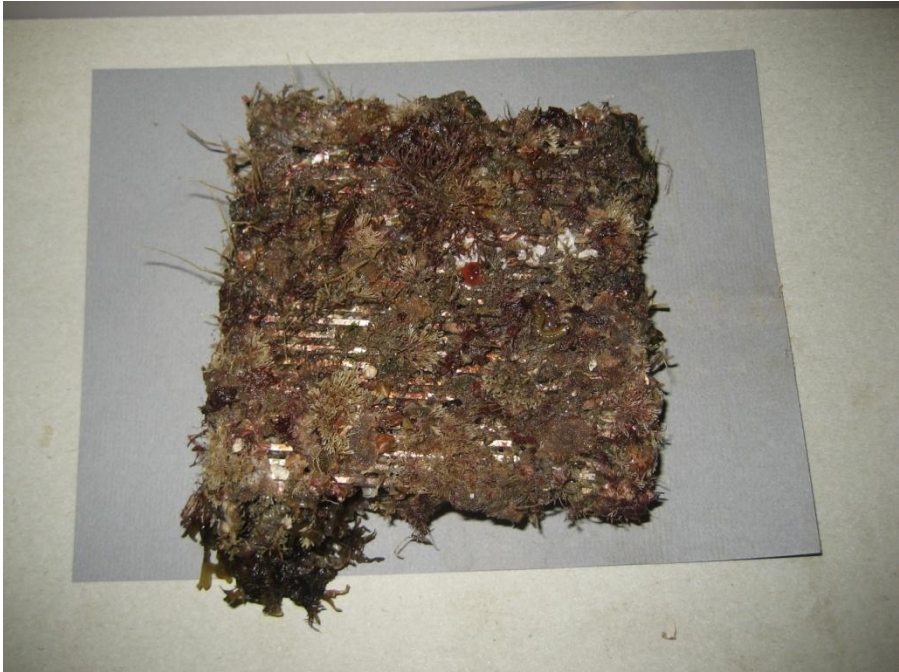
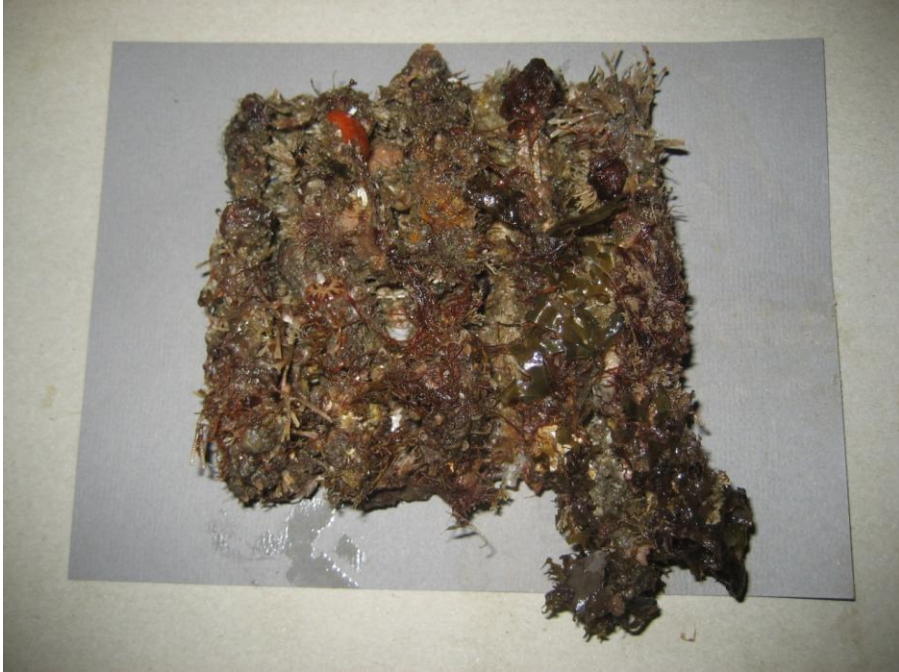
Figure 7. 2205 stainless steel Wedgewire sample, photographed 04/22/15.

- **2205 SS (stainless steel); wedgewire sample and coupon (IIIB4 and IIIA4):**
 - Wedgewire sample (IIIB4) (**Figure 7**)
 - This sample was very heavily fouled with hydroids covering most of the surface. Beneath the hydroids, attached to the sample, were approximately several thousand barnacles (*M. californicus*) ranging from 2 to 15 mm in diameter. Also intermixed with the hydroids were small mussels (*M. galloprovincialis*) up to 5 mm in length, scallops, tube worms, amphipods, crabs, erect and encrusting bryozoans, red algae (filamentous and foliose), slipper limpets, sponges, and probably other small invertebrates. The original weight of the sample was about 312 g and the fouling added about another 276 g. The fouling was firmly attached and was not removed for fear of damaging the sample prior to metal analyses.

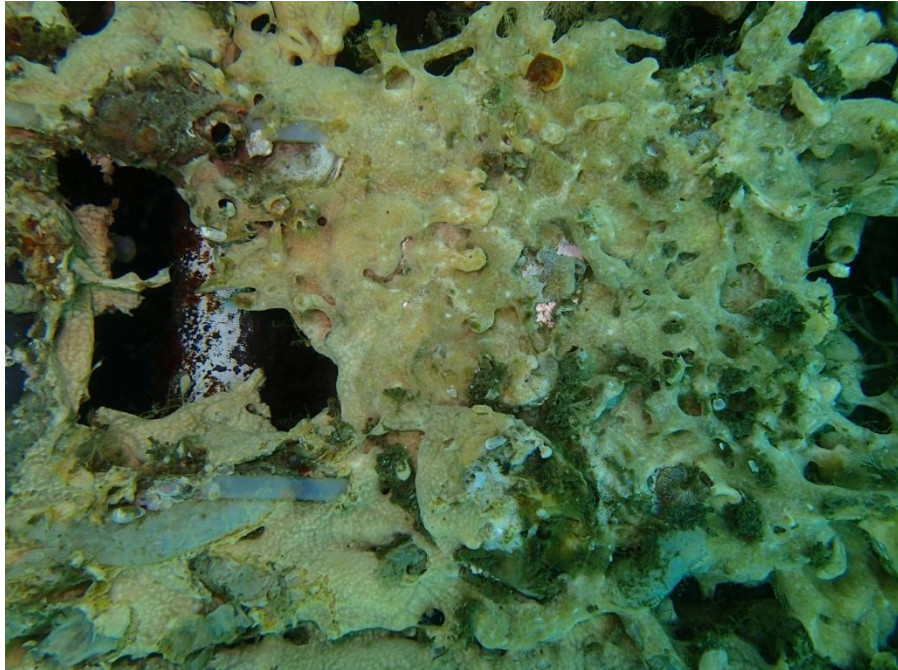
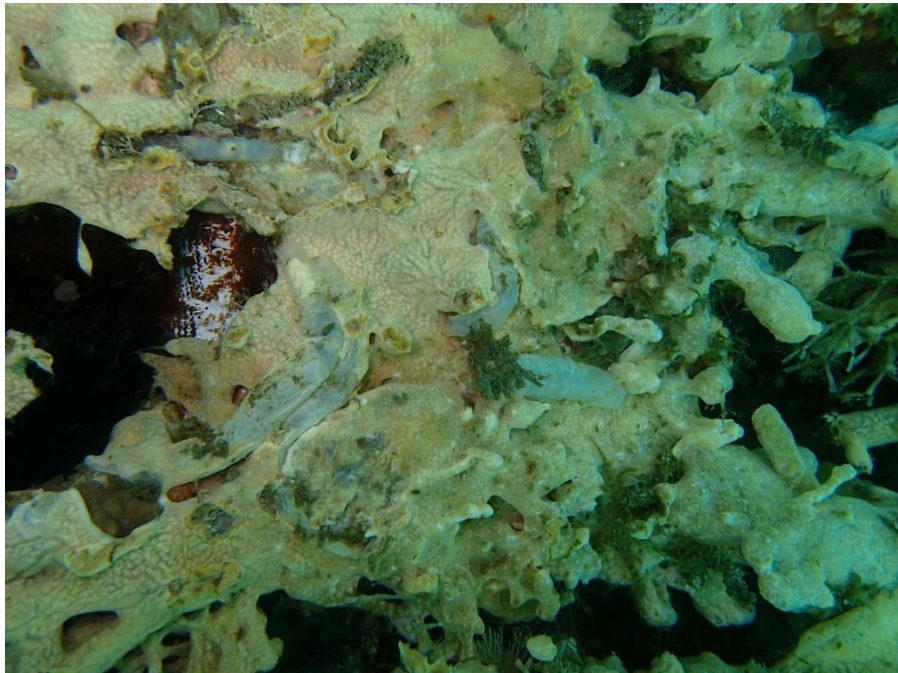
Figure 14. 2205 stainless steel test plate (Test Plate 4), photographed 04/21/15 in situ after removal of its Vexar mesh bag.

- **2205 Stainless Steel (uncoated), Plate 4, (Figure 14)**
 - This plate is almost completely covered with macrofouling, primarily a large, expansive colonial tunicate. Hydroids and bryozoans are also visible. There may be other species underneath the tunicate or, if the tunicate colonized the plate first, it may have excluded settlement by other species. Regardless, this material shows no apparent antifouling characteristics.

- As with the other plates, a variety of encrusting invertebrates are attached to the PVC frame and the plastic cable ties that secure the plate to the frame. In this case, there is little to differentiate between the stainless steel plate and the plastic components.

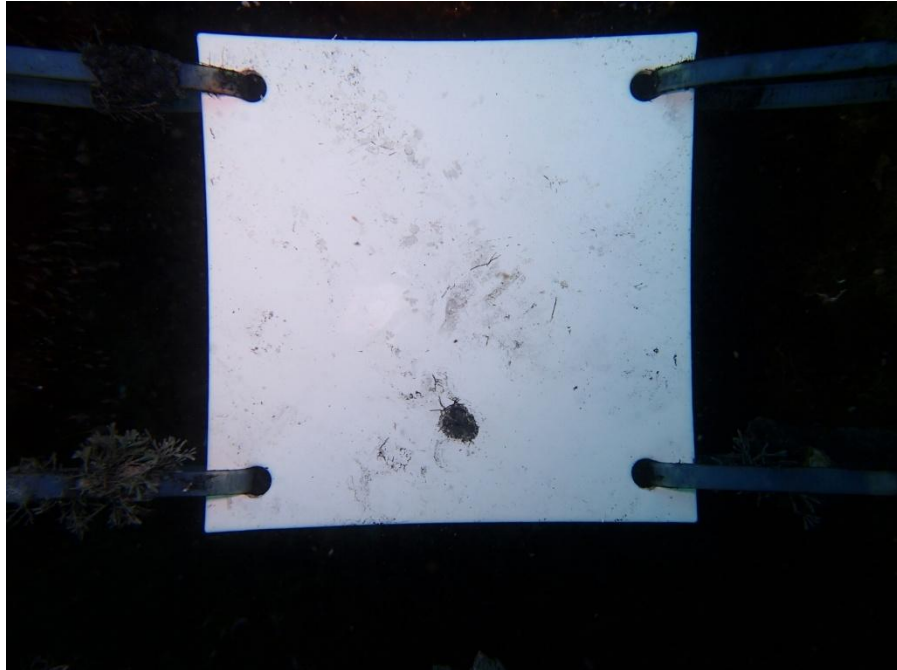
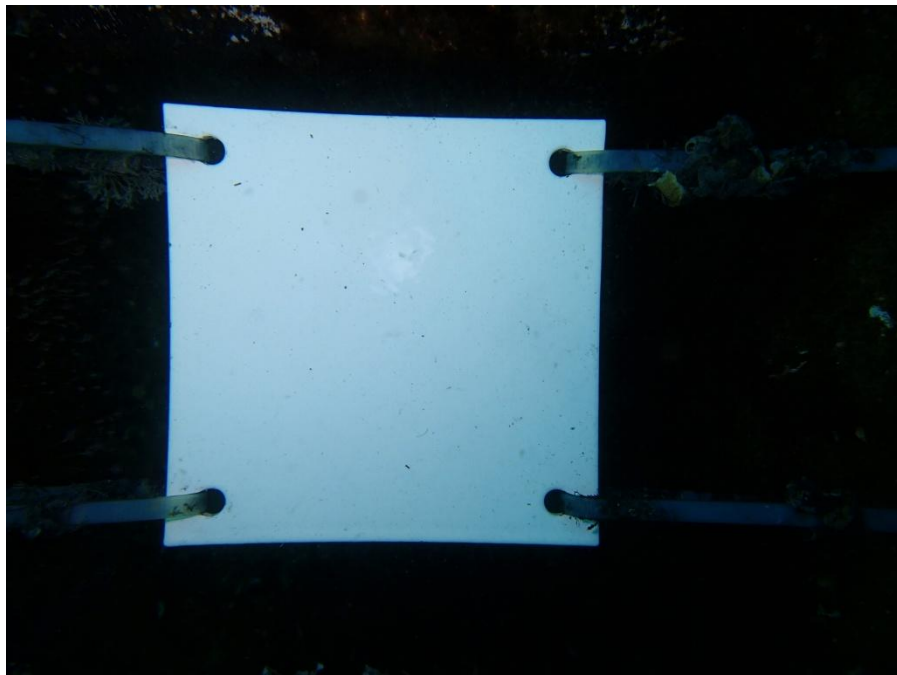
Figure 15. 2205 stainless steel test plate with foul release coating (Test Plate 5), photographed 04/21/15 in situ after removal of its Vexar mesh bag.

- **2205 Stainless Steel with foul release coating, Plate 5, (Figure 15)**
 - As stated earlier, this plate and its frame and bag were missing when the divers arrived at the WB intake. The cords that suspended the frame may have failed, but remained intact on the other four plates. The plate was found lying in the soft sediment and was retrieved from inside the intake by the divers and returned to its original position. The cords were replaced on all five of the plate frames.

- The fouling that was growing on the plate and on the PVC frame is now gone with the exception of some empty barnacle shells on the frame. The soft sediment at the bottom of the intake was probably anaerobic and the fouling probably suffocated, died, and decayed. The black

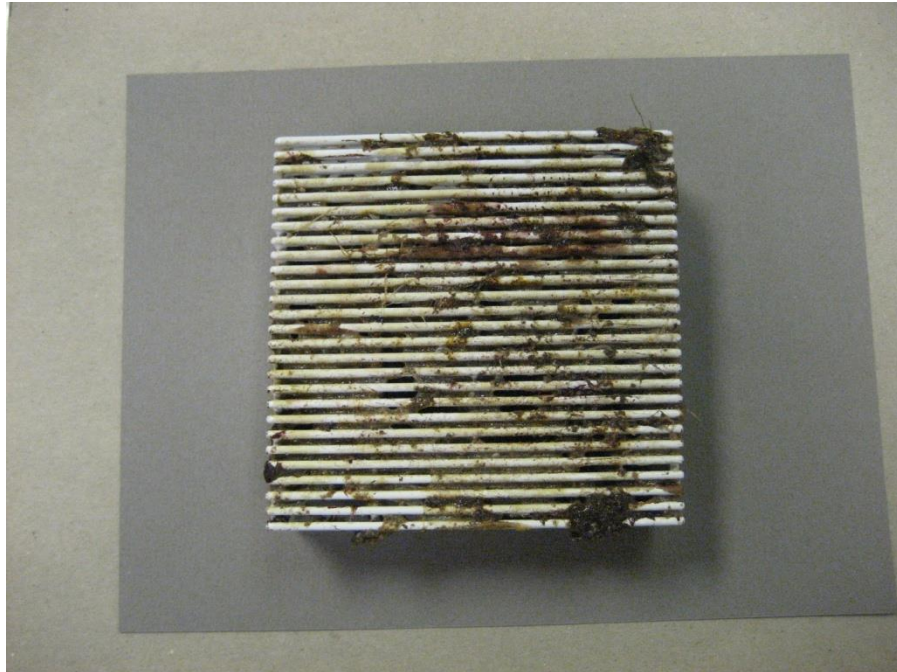
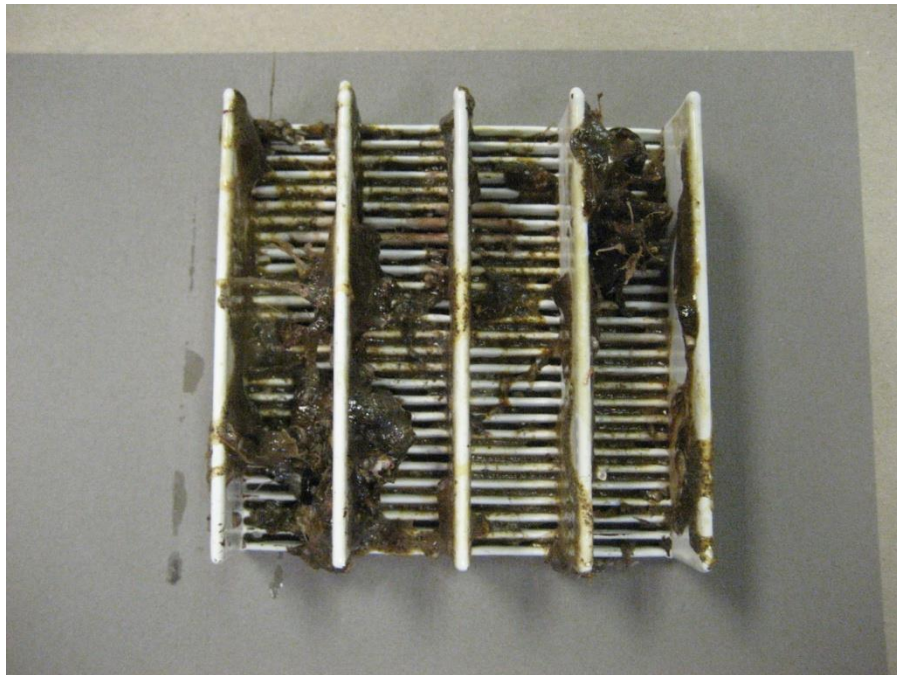
Figure 5. 2205 stainless steel Wedgewire sample with foul release coating, photographed 06/17/15.

- **2205 SS (stainless steel) with antifouling coating; wedgewire sample and coupon (IVA3 and IVB3):**
 - **Wedgewire sample (IVA3) (Figure 5)**
 - About 50 percent of the sample's outer surface had a light covering of diatoms and filamentous red algae. There were also a few individual hydroids at the cable tie sites. Two small (4-5 mm) mussels (*M. galloprovincialis*) at two different cable tie sites.

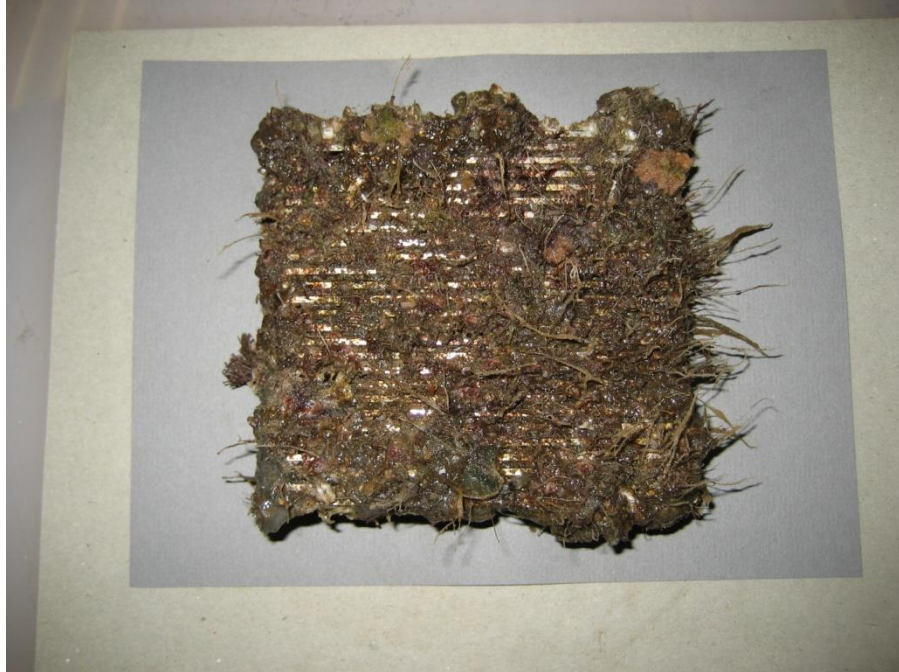
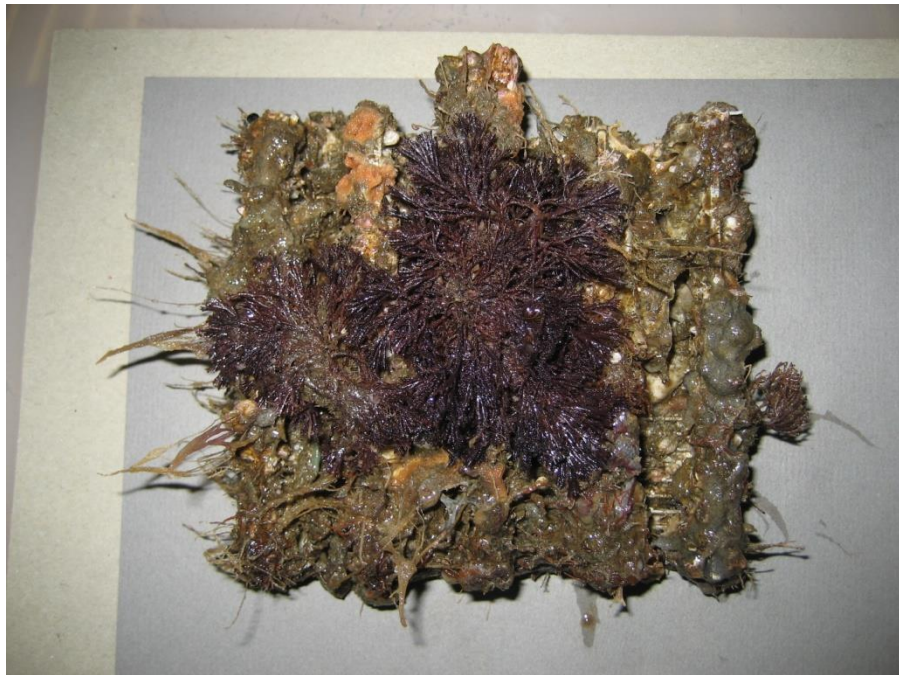
Figure 7. 2205 stainless steel Wedgewire sample, photographed 06/17/15.

- **2205 SS (stainless steel); wedgewire sample and coupon (IVB4 and IVA4):**
 - **Wedgewire sample (IVB4) (Figure 7)**
 - This sample was very heavily fouled with little of the metal visible. Hydroids covered 40 – 50 percent of the surfaces. The density of hydroids has actually declined since earlier photos (December 2014 and April 2015) of the same sample and the PVC rack; this could be seasonality, species succession, or predation (or all three). Beneath the hydroids, attached to the sample, were several thousand barnacles (*M. californicus*) ranging from 1 to 20 mm in diameter. Also intermixed with the hydroids were small mussels (*M. galloprovincialis*) up to 10 mm in length, scallops, white bivalves, tube worms, amphipods,

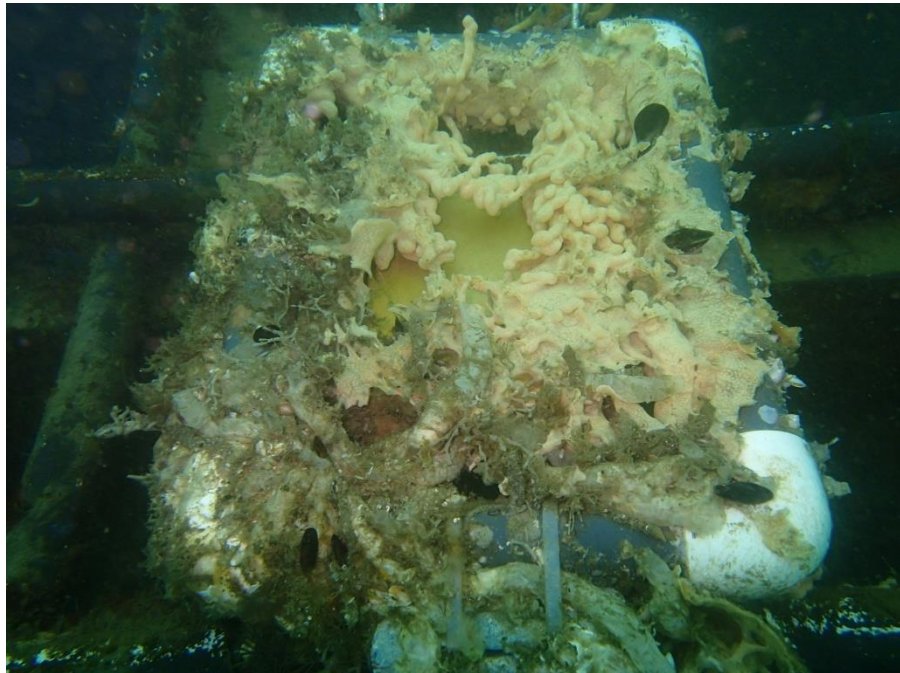
Figure 15. Z-alloy test plate and PVC frame (Test Plate 3), photographed 06/16/15 in situ after removal of its Vexar mesh bag.

- **Z-alloy, Plate 3, (Figures 15 and 16)**
 - The plate is very clean, except for a single 19 mm mussel that had been attached to one of the cable ties. When the cable tie was removed, the mussel remained loosely attached to the plate by three byssal threads.

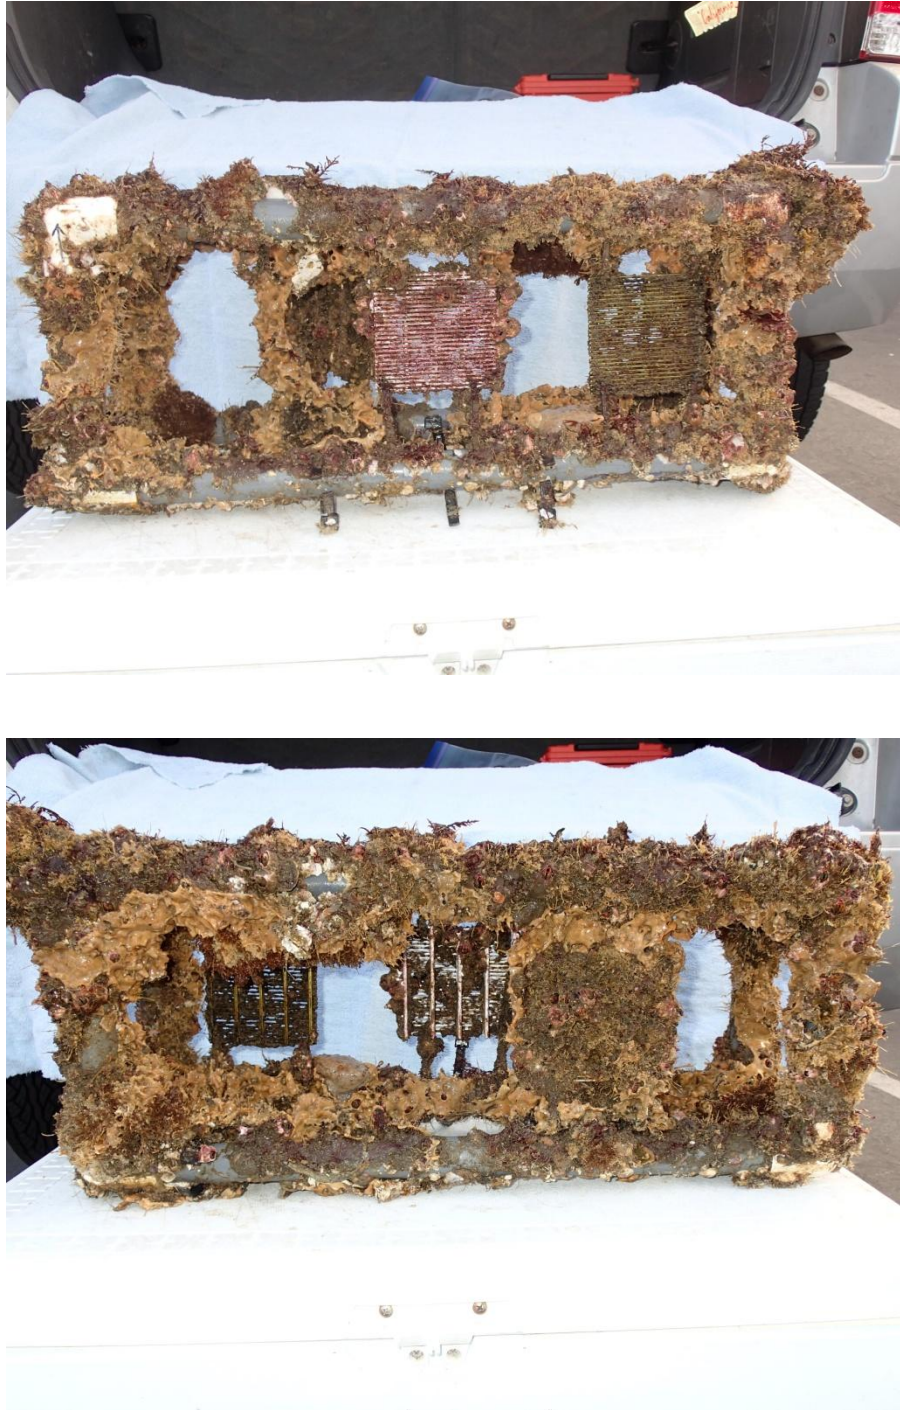
Figure 1. Rack V with three remaining wedgewire samples still attached, photographed 05/23/17.

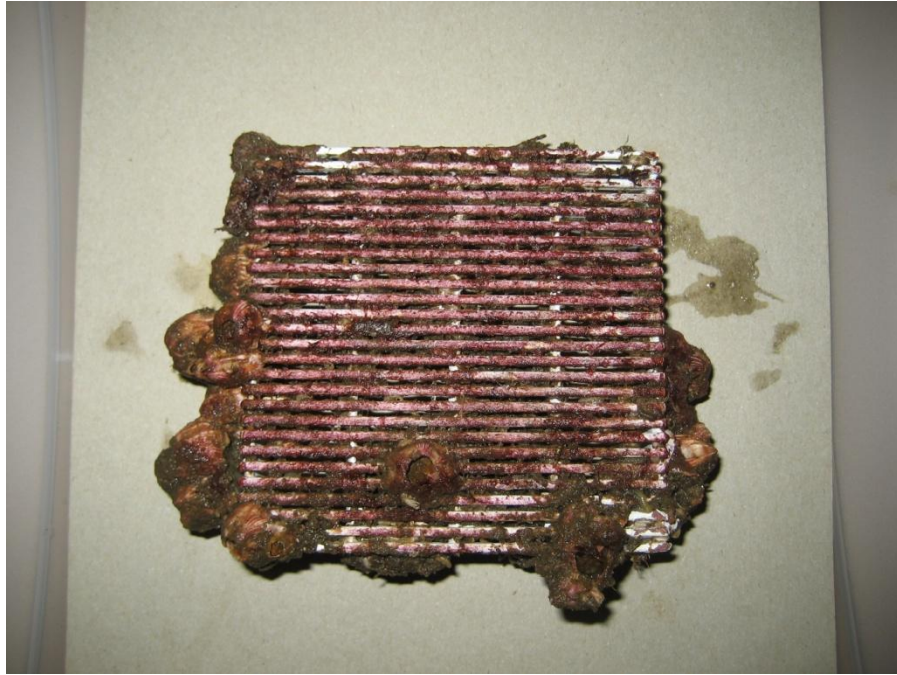
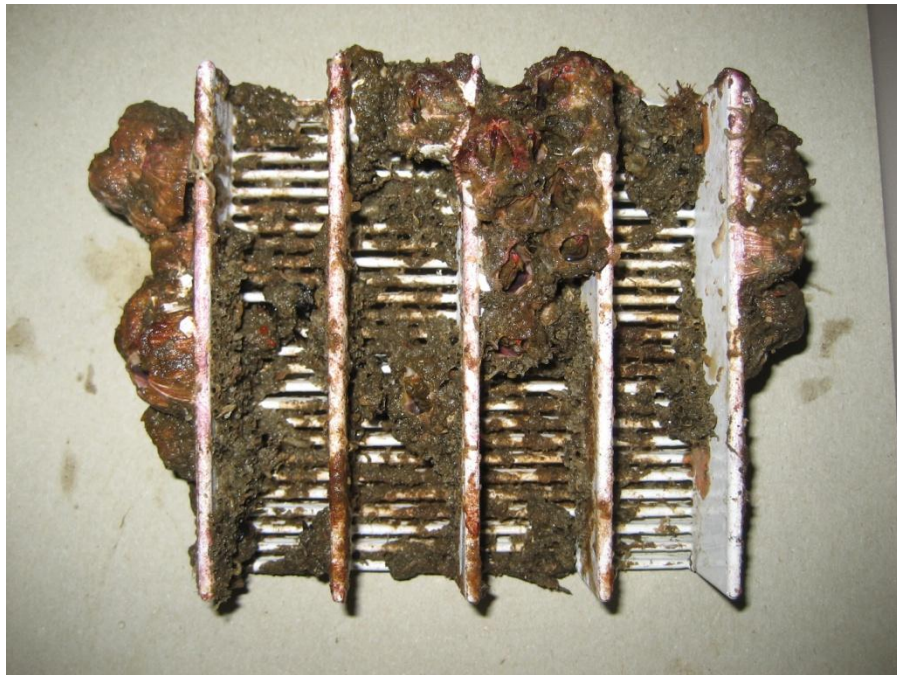
Figure 2. 2205 stainless steel wedgewire sample with foul release coating, photographed 05/24/17.

- The SS sample that was painted with the foul-release coating had considerably less attached fouling than the uncoated SS samples, and was almost as clean as the Cu-Ni sample. The barnacles that were present appear to have initially attached themselves at locations where the coating had detached from the sample or some surface irregularity existed. The foul-release coating is fairly soft and can easily be damaged.

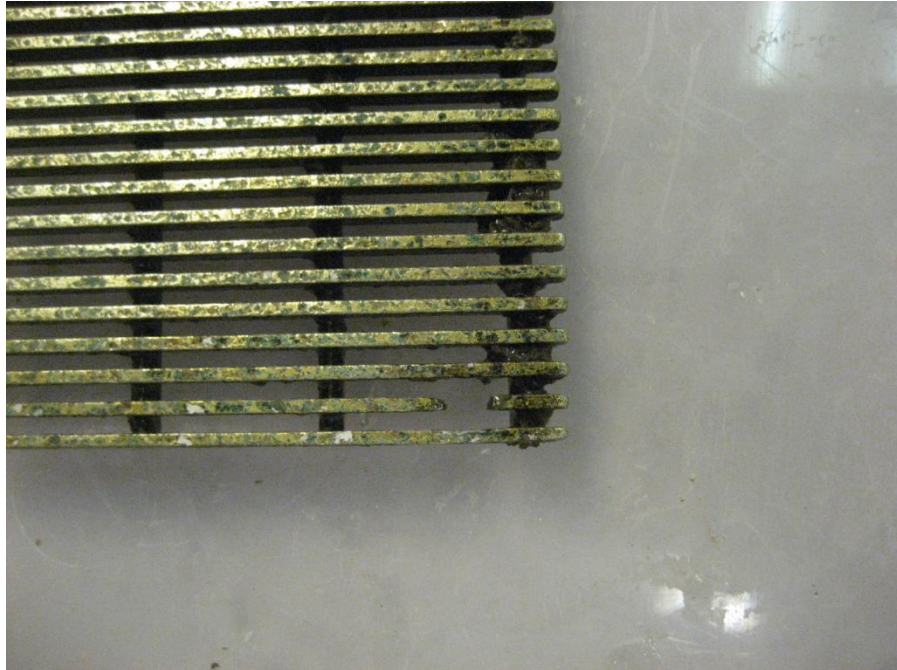
Figure 5. 70-30 Cu-Ni (CDA715) wedgewire sample, photographed 05/25/17, showing erosion/corrosion at one of the four attachment points.
