WEST BASIN MUNICIPAL WATER DISTRICT OCEAN WATER DESALINATION INTAKE CORROSION STUDY

November 2014

V&A Project No.: 13-0376

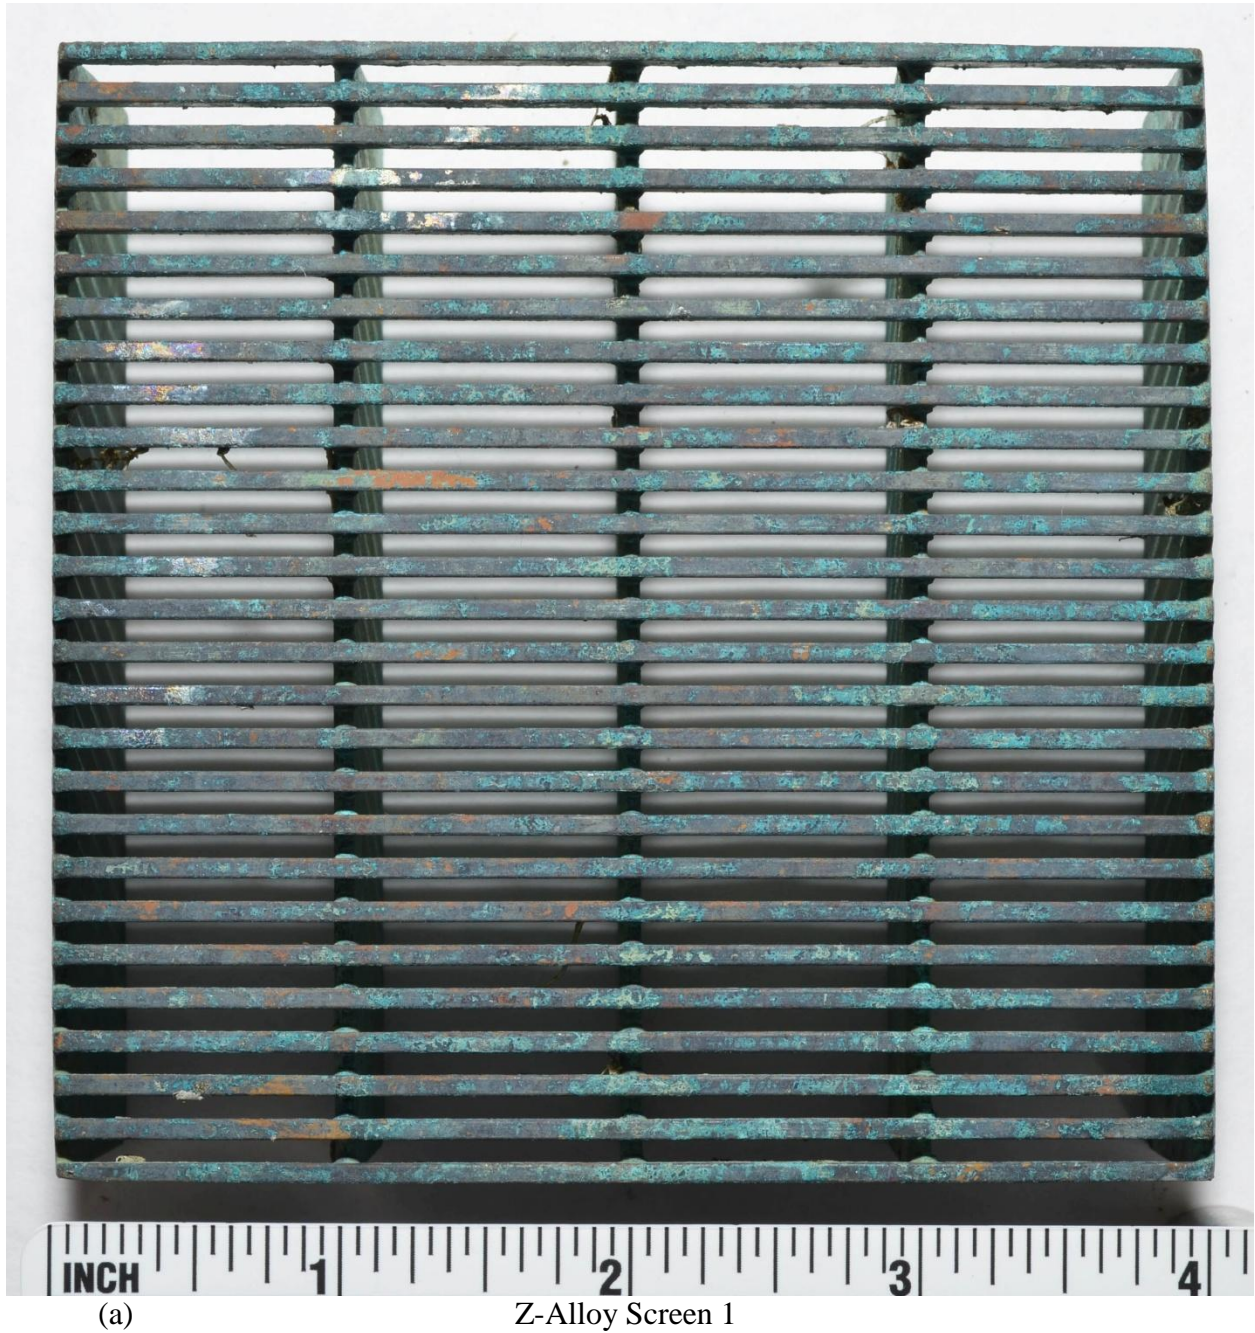
Figure 4 Photograph of Z-Alloy screen 1 after a 3 month corrosion test.

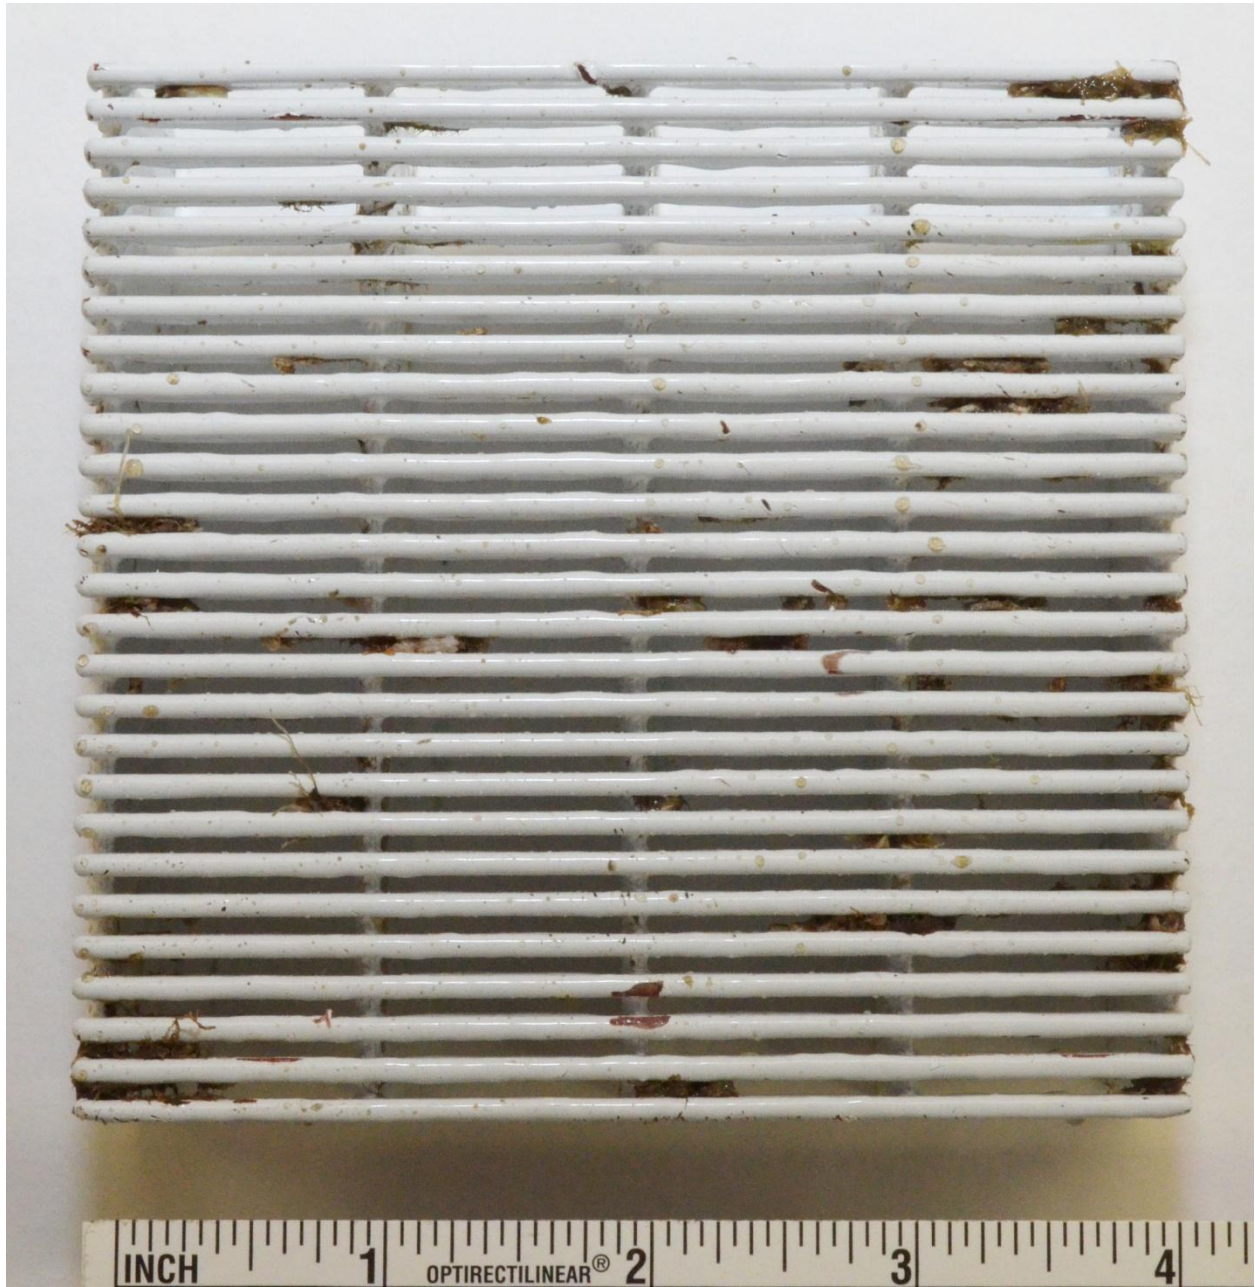
Figure 5 Photograph of duplex 2205 stainless steel with anti-biofouling coating screen 1 after a 3 month corrosion test.

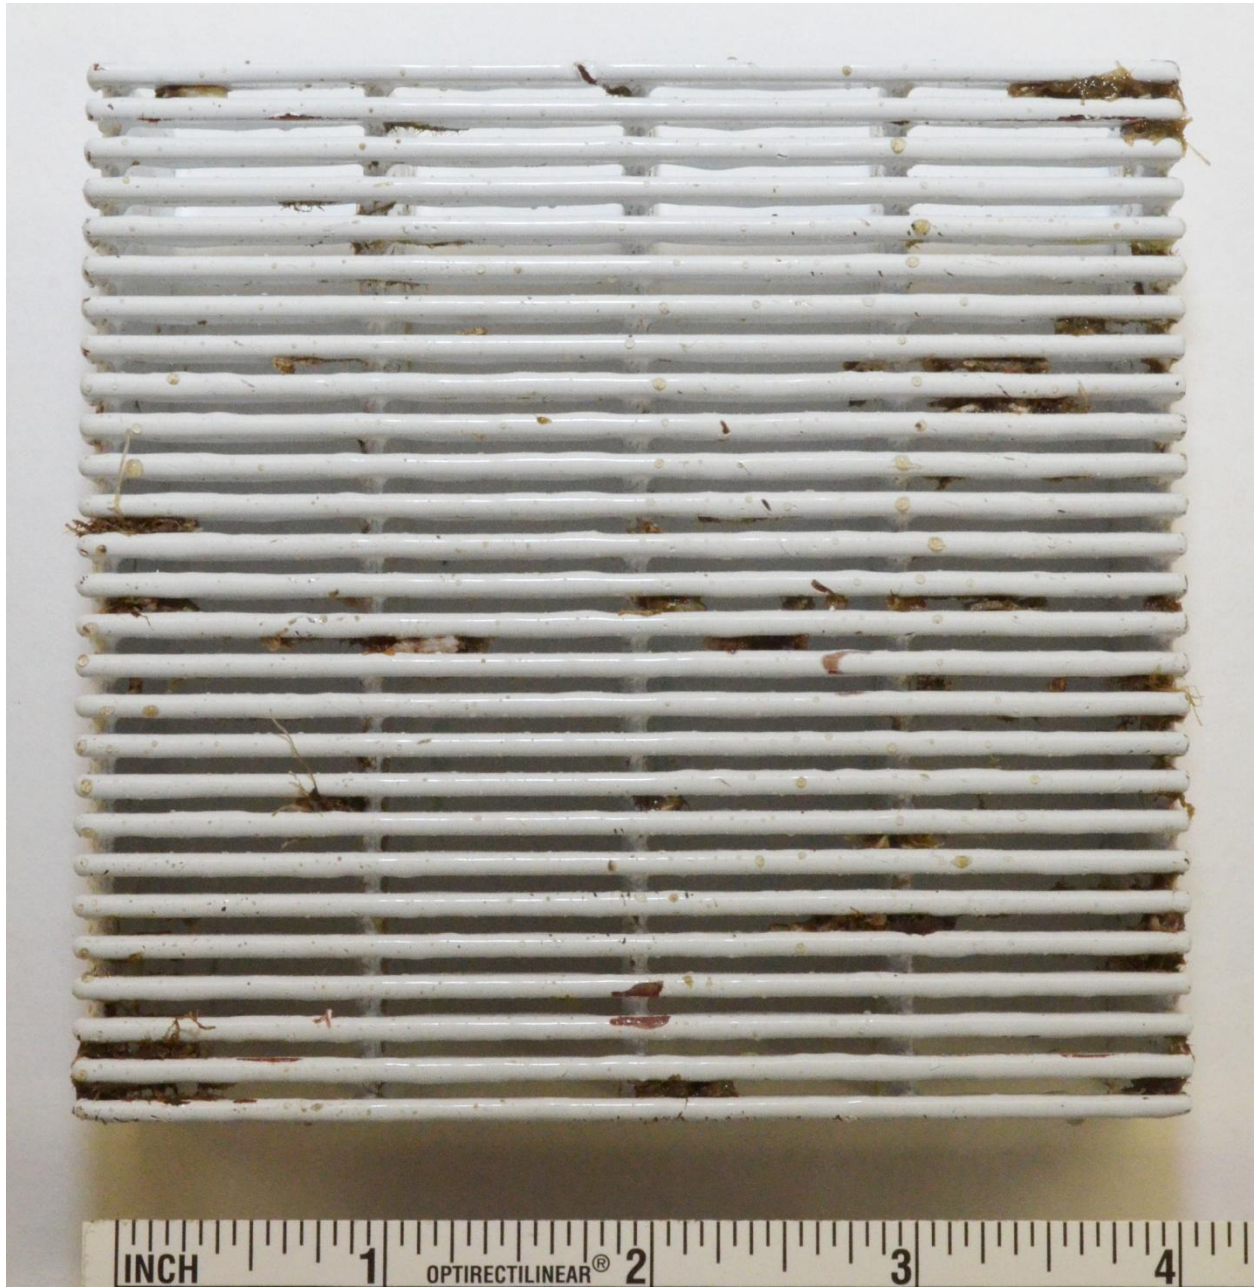
Figure 6 Photograph of duplex 2205 stainless steel with anti-biofouling coating screen 1 after a 3 month corrosion test.

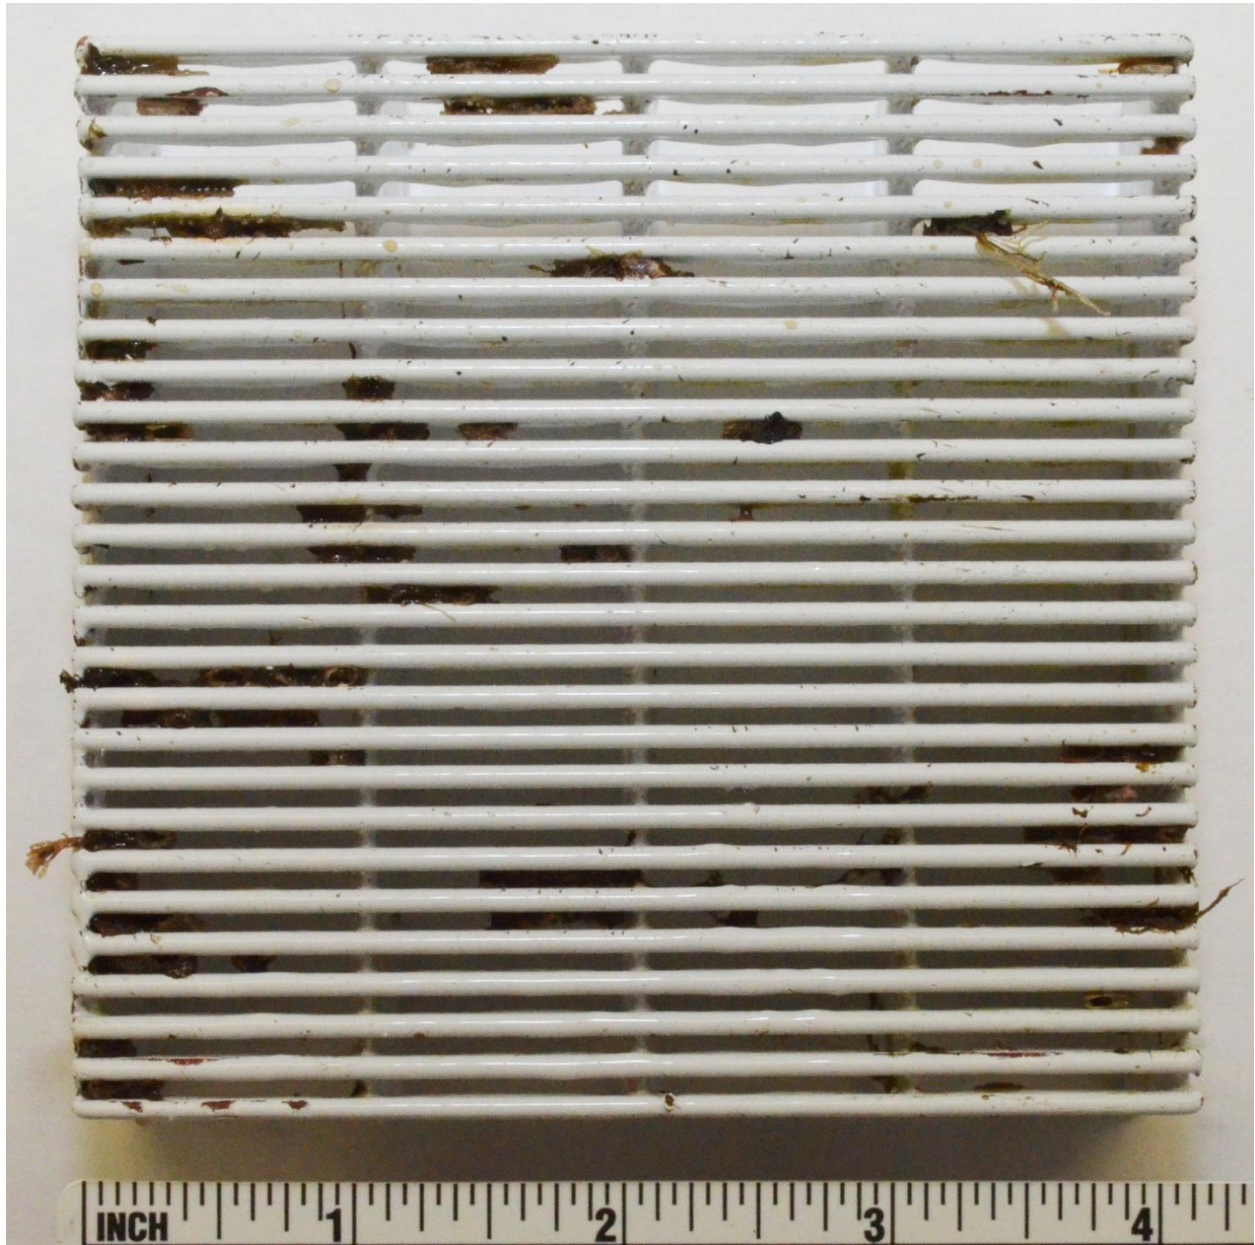
Figure 7 Photograph of duplex 2205 stainless steel with anti-biofouling coating screen 2 after a 6 month corrosion test.

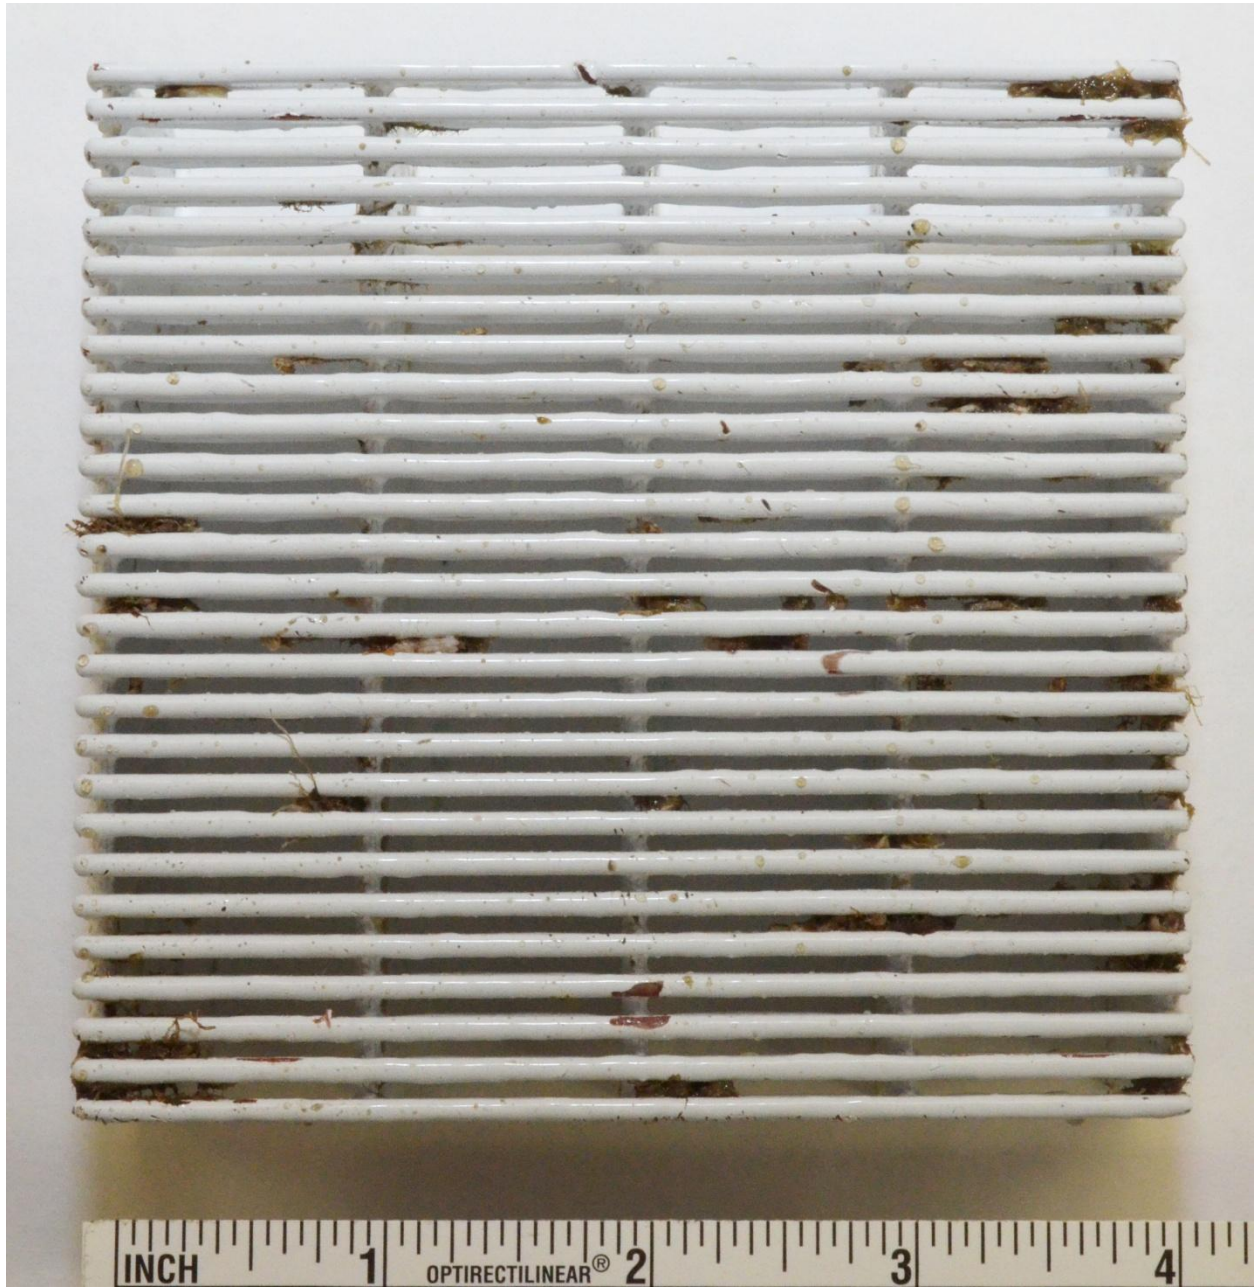
Figure 7 Photograph of duplex 2205 stainless steel with anti-biofouling coating screen 1 after a 3 month corrosion test.

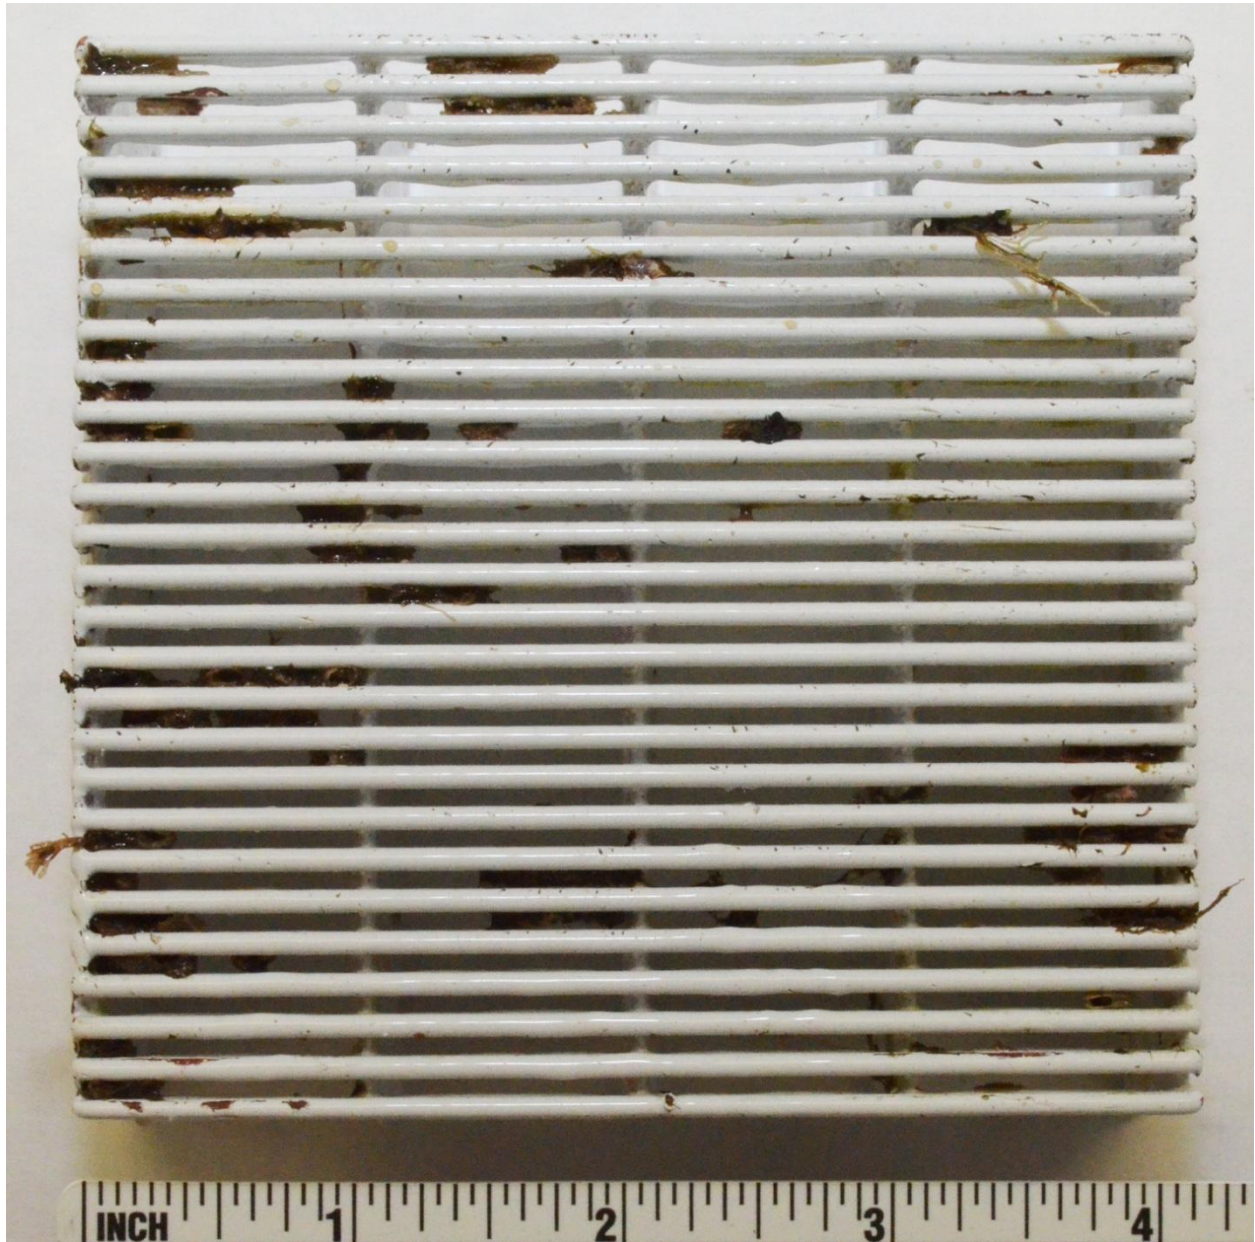
Figure 8 Photograph of duplex 2205 stainless steel with anti-biofouling coating screen 2 after a 6 month corrosion test.

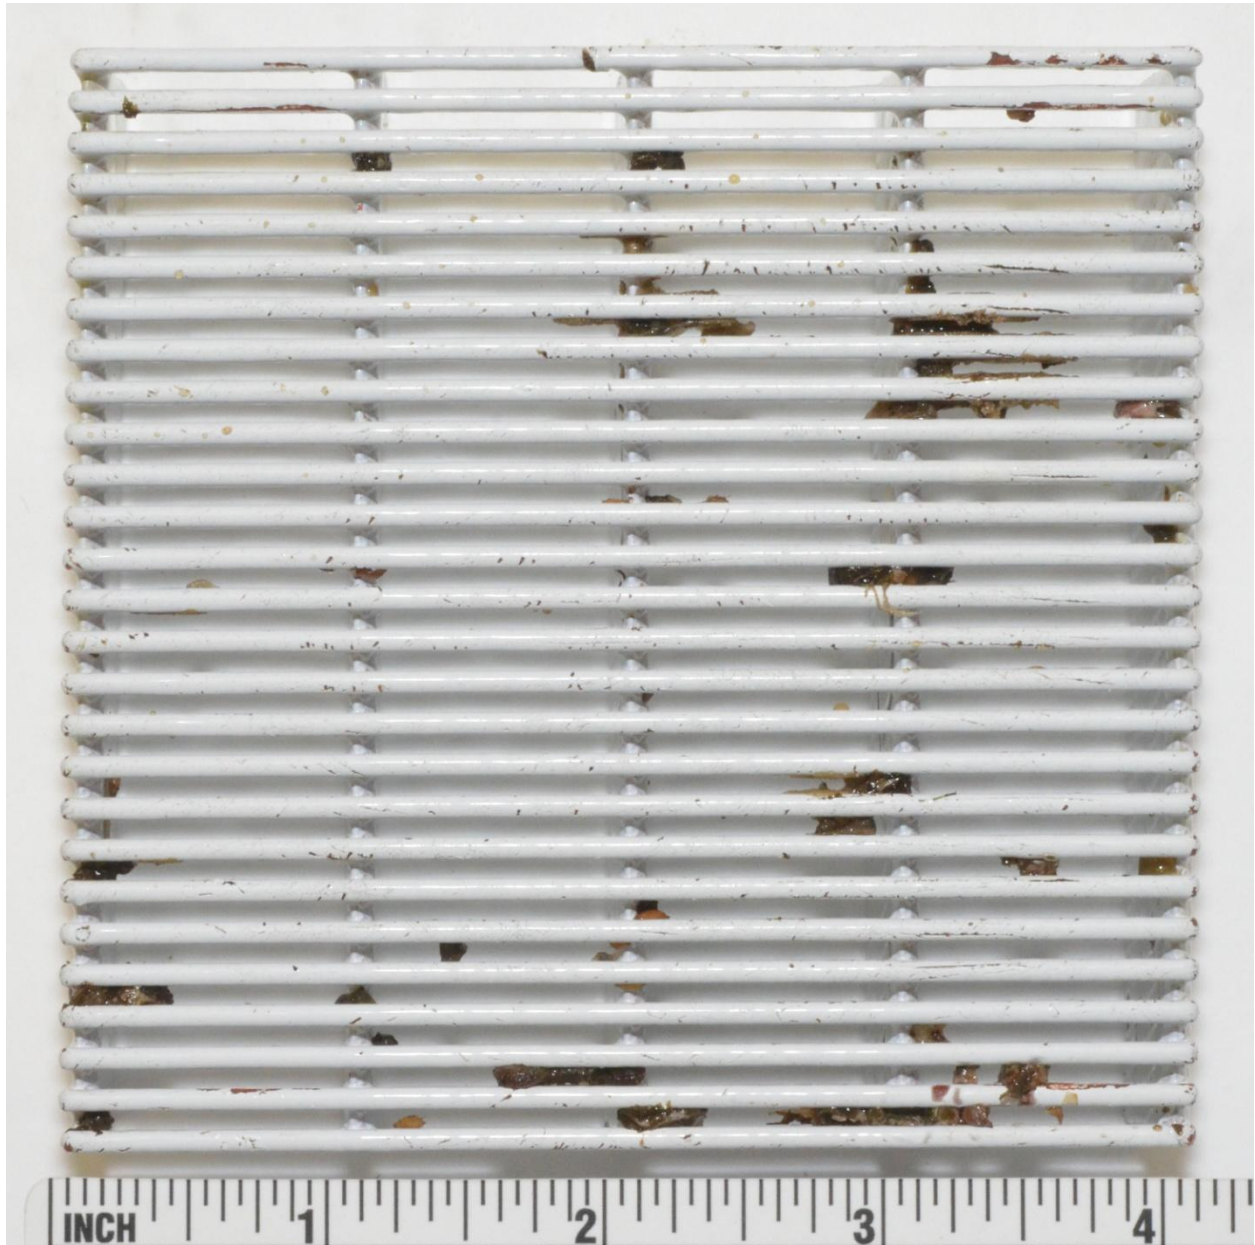
Figure 9 Photograph of duplex 2205 stainless steel with anti-biofouling coating screen 3 after a 10 month corrosion test.

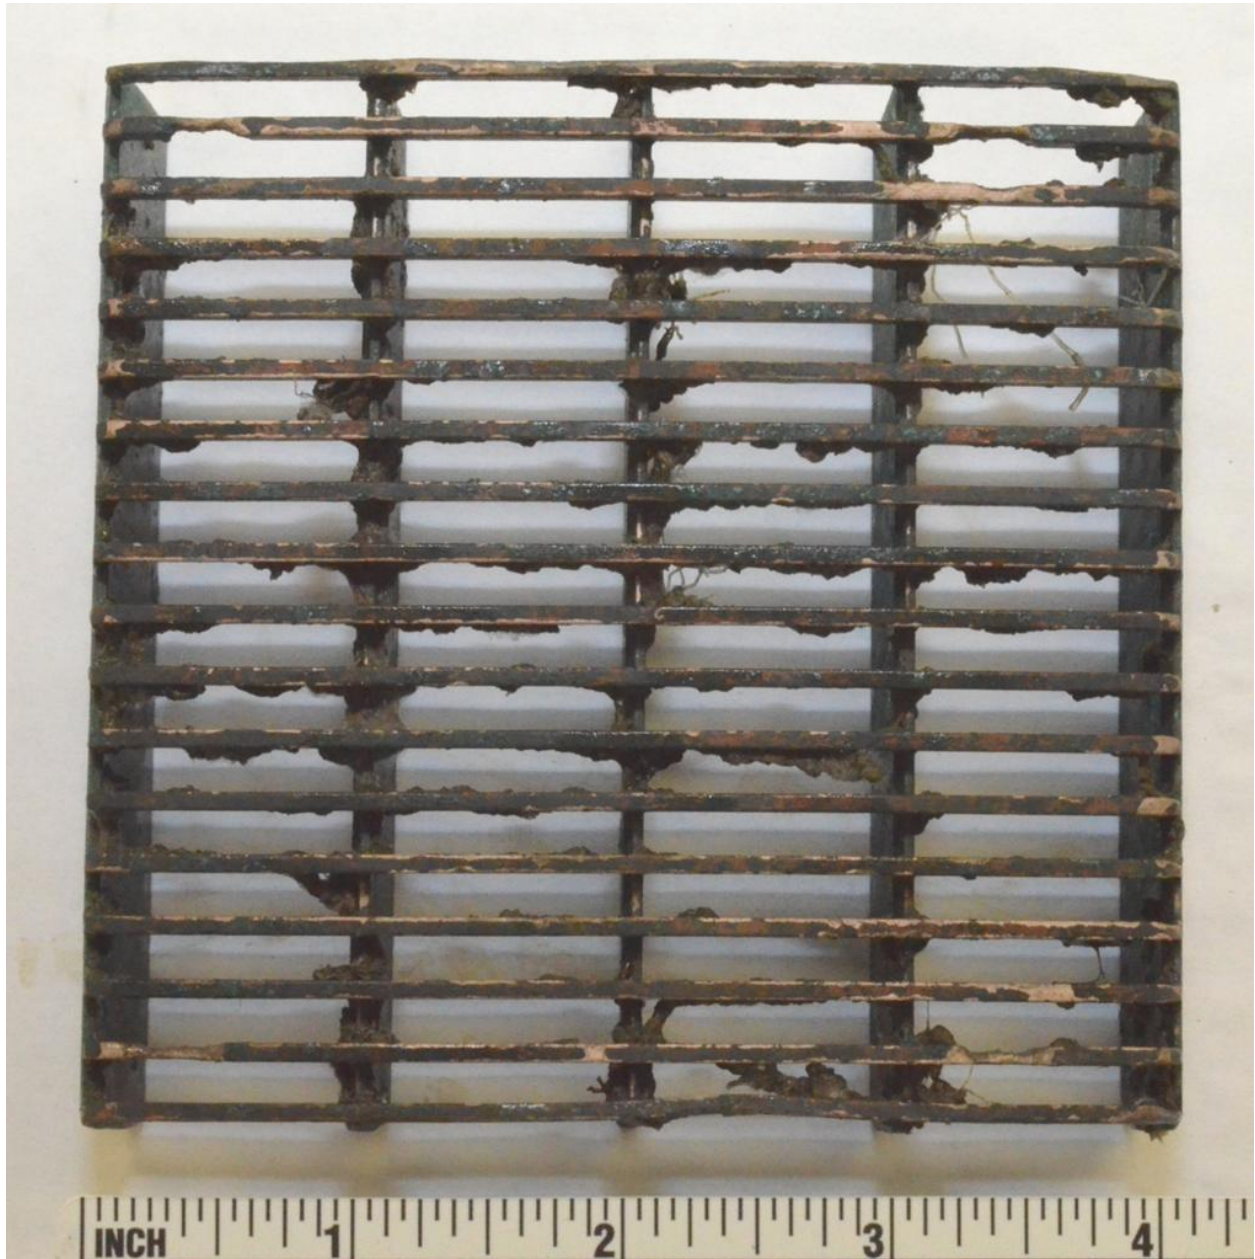
Figure 8 Photograph of CDA 706 screen 2 after a 6 month corrosion test.

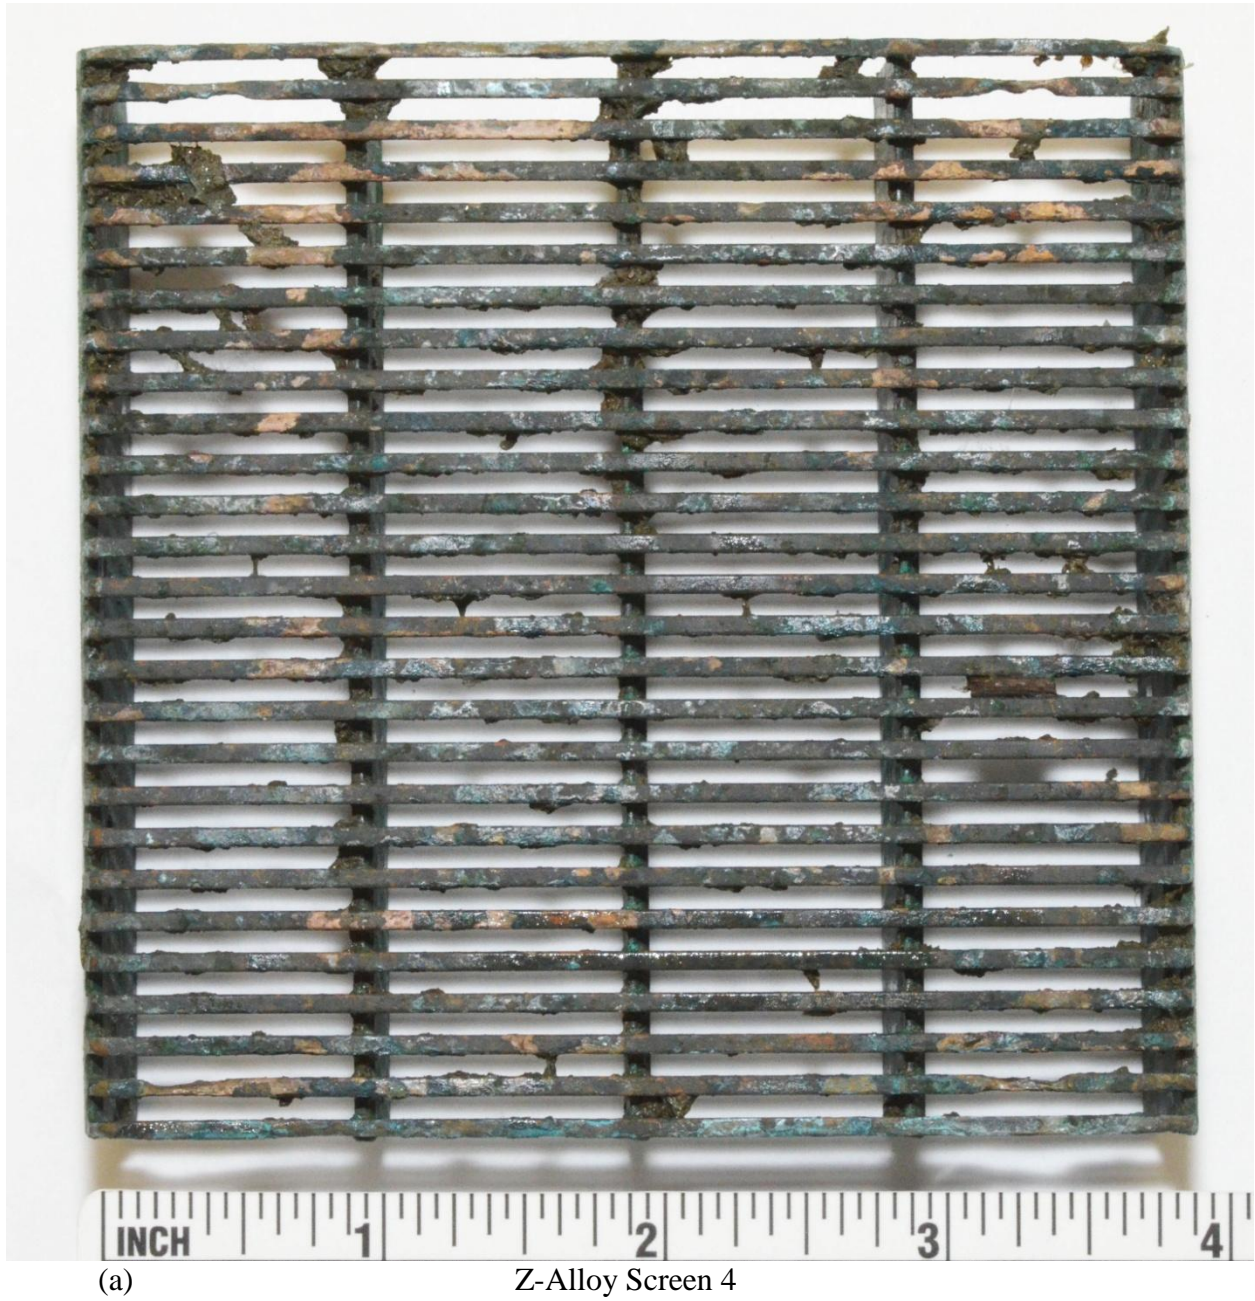
Figure 10 Photograph of Z-Alloy screen 4 after a 12 month corrosion test.
