FINAL  
INTAKE BIOFOULING  
AND CORROSION STUDY  
(UPDATED)

**West Basin Ocean Water Desalination  
Demonstration Facility Intake  
Biofouling and Corrosion Study**

**April 18, 2018**

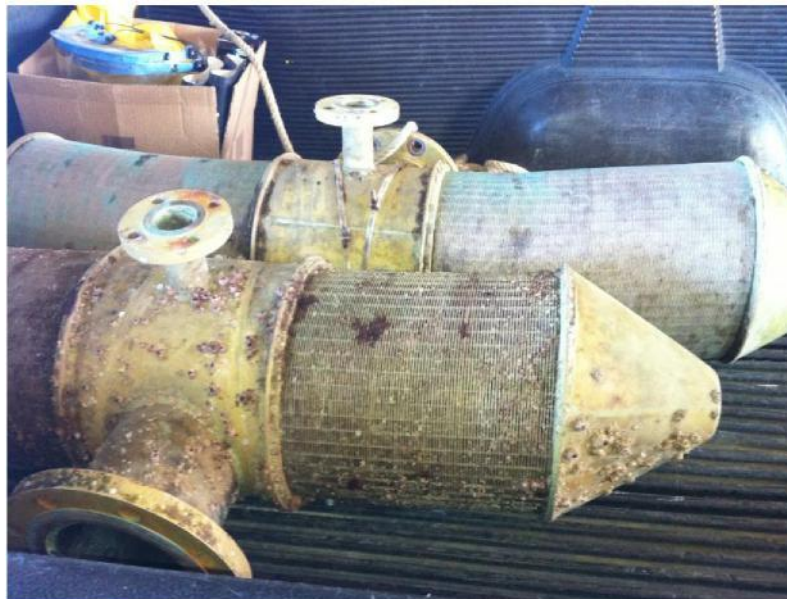
Cook Legacy Screens Removed after Failure

The initial screen installed experienced signs of corrosion within months of installation. After one year of operations mussels were noticed inside the screen. Build-up of mussels, and barnacles inside the screen caused the screens to fail after approximately 15 month of service. Larvae that passed through the screens entered the 6-inch pipelines and caused extensive biofouling, barnacle, and mussel growth. This growth would foul the pipes, become loose, and then damage downstream equipment at the Demonstration Facility.

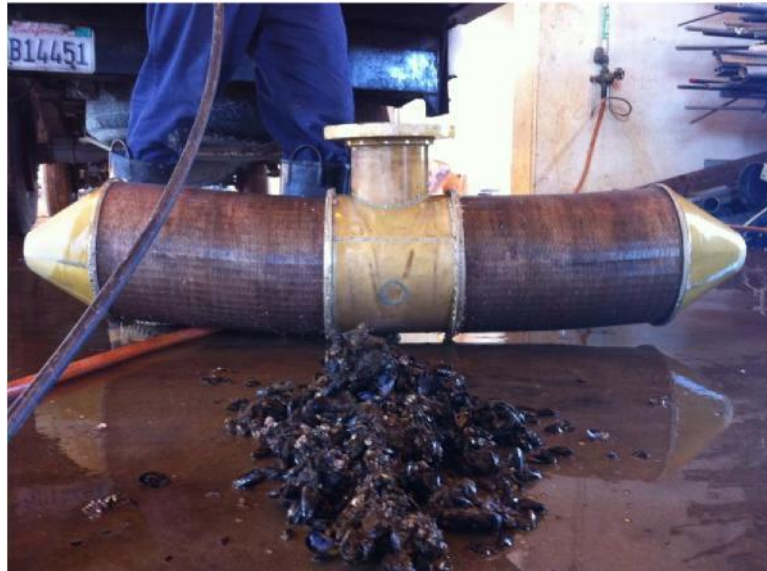
**Mussels Removed from the Cook Legacy Screen after Failure**

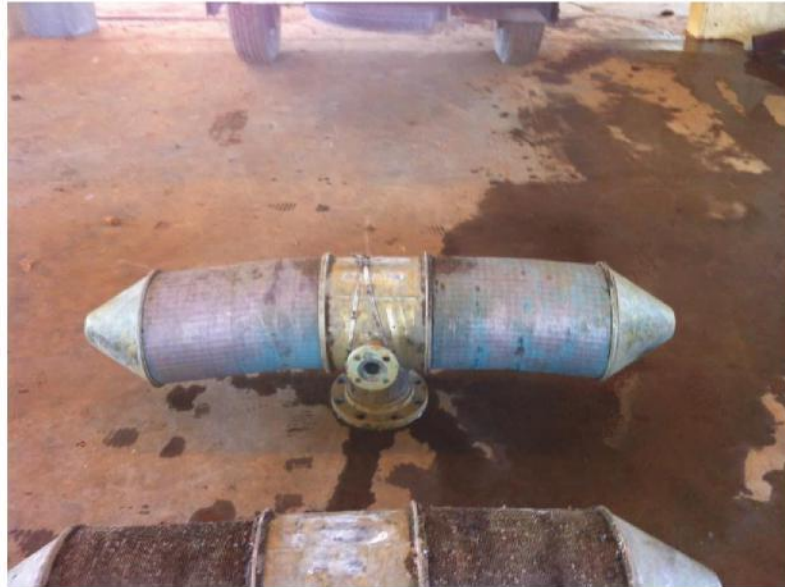
In June 2012, West Basin hired Tetra Tech to investigate the failure of the Cook Legacy screens. A report prepared by Corpro dated August 26, 2012, indicated minor corrosion but not significant enough to cause failure, see copy of Corpro report in Appendix A. However, a structural review of the Cook Legacy screens indicated that the screens likely failed due to bending of the support members connected to the wedgewire. The weight of the solid deflection cone coupled with the weight of the interior biofouling caused the support members to bend and fail.

**Cook Legacy Screen after Structural Failure**

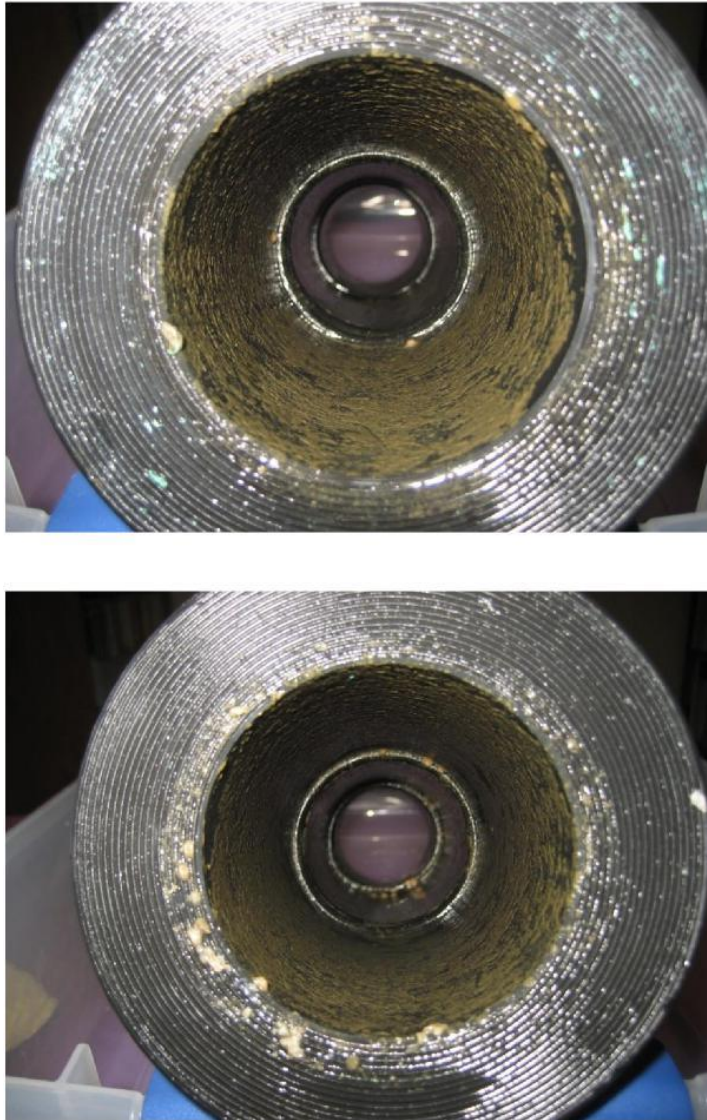
**Figure 3-1. Pipe spool A3 (Control) October 28, 2014. Inlet (top) and Outlet (bottom).**

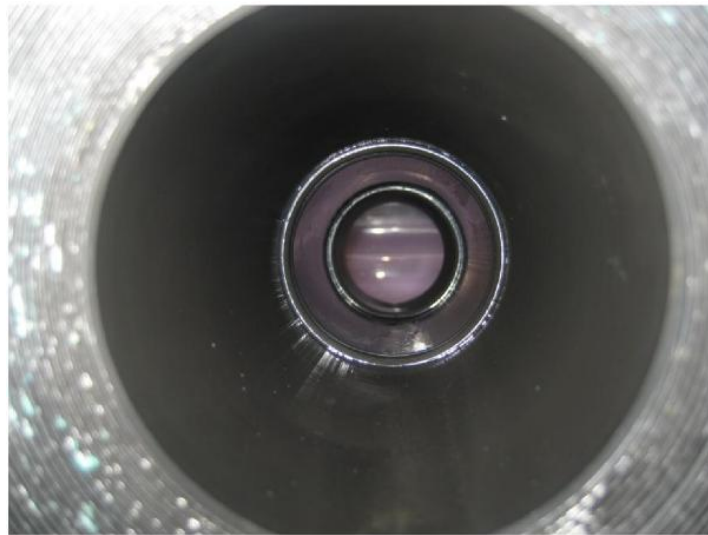
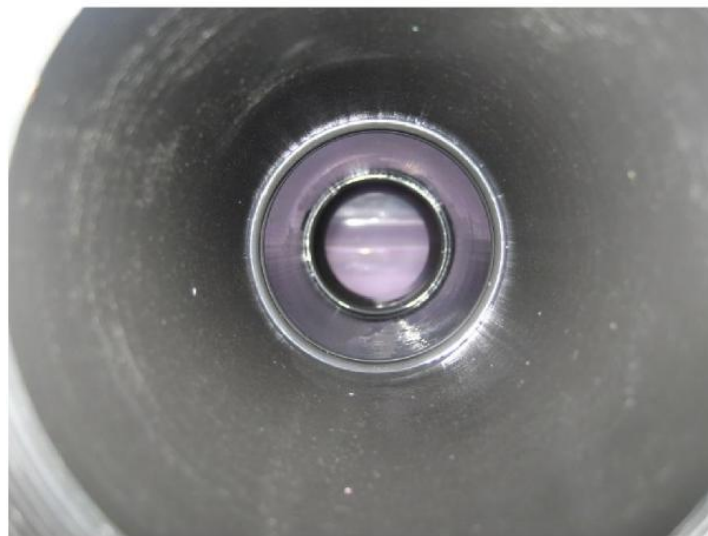
- This is the third pipe spool in spool row B and was treated with continuous injection of a chloramine solution.
- Photos taken from inlet and outlet ends (**Figure 3-2**).
- No macrofouling organisms were found.
- No slime/diatoms detected by touch or tissue wipe.
- No sand

**Figure 3-2. Pipe spool B3 (Continuous Chloramine Injection) October 28, 2014. Inlet (top) and Outlet (bottom).**

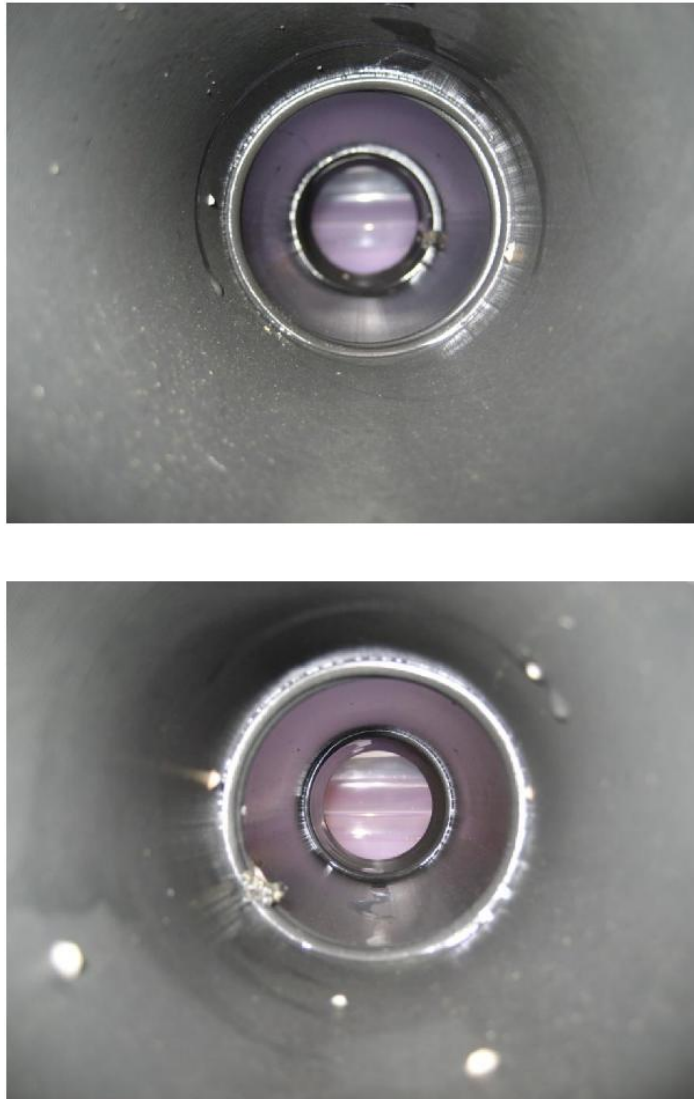
- Little or no macrofouling in any of the three spools.
- Although there is a complete lack of fouling in the Continuous Chloramine treatment spool (spool B3), the paucity of fouling in the Control spool (spool A3) provides little comparison against which to evaluate the efficacy of any of the treatments.
- The lack of macrofouling in the Control spool is most likely due to the cropping of macrofouling larvae from the water supply by established filter-feeding organisms (mussels, barnacles, etc.) in the seawater supply line. There may be other contributing factors including the low flow velocities in portions of the system, and cropping of food items from the seawater flow as it passes through the supply line (reducing survival and growth of any organisms settling in the pipe spools).

**Figure 3-3. Pipe spool C3 (Shock Chlorination) October 28, 2014. Inlet (top) and Outlet (bottom).**

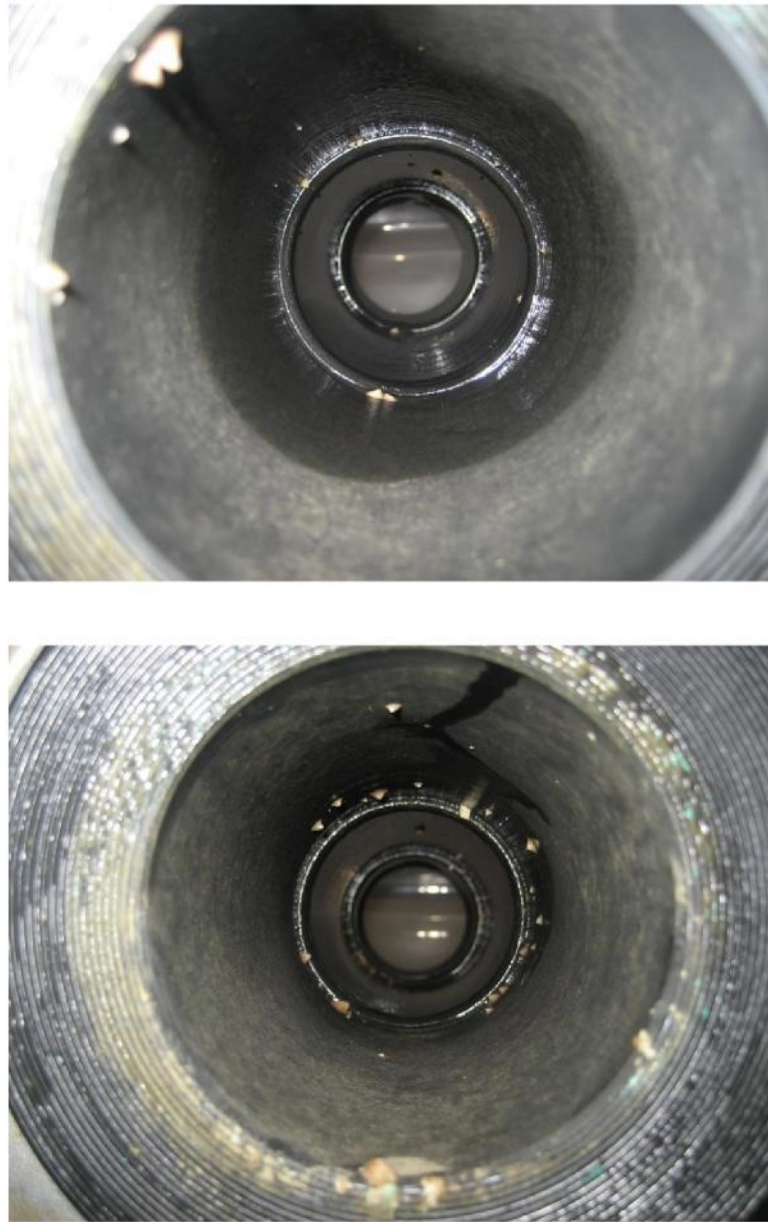
- No other macrofouling was found.
- No sand or debris was observed in the spool.

**Figure 3-4. Pipe spool A4 (Control) December 23, 2014. Inlet (top) and Outlet (bottom).**

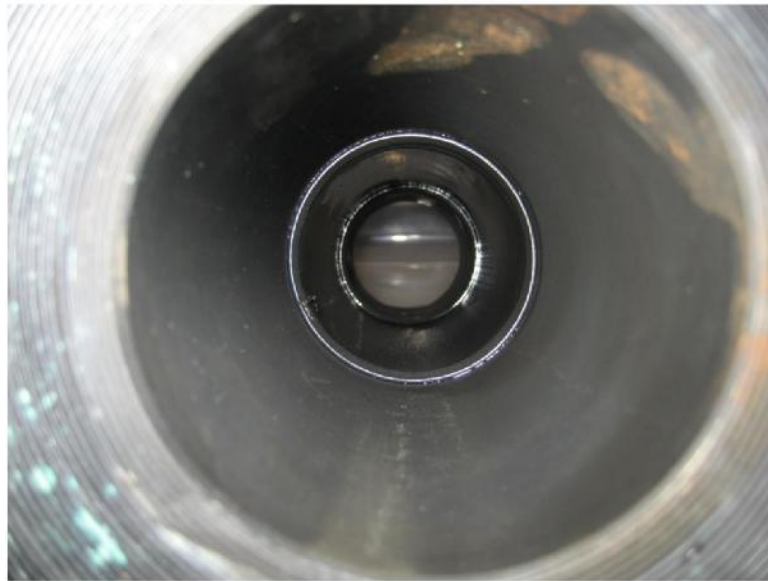
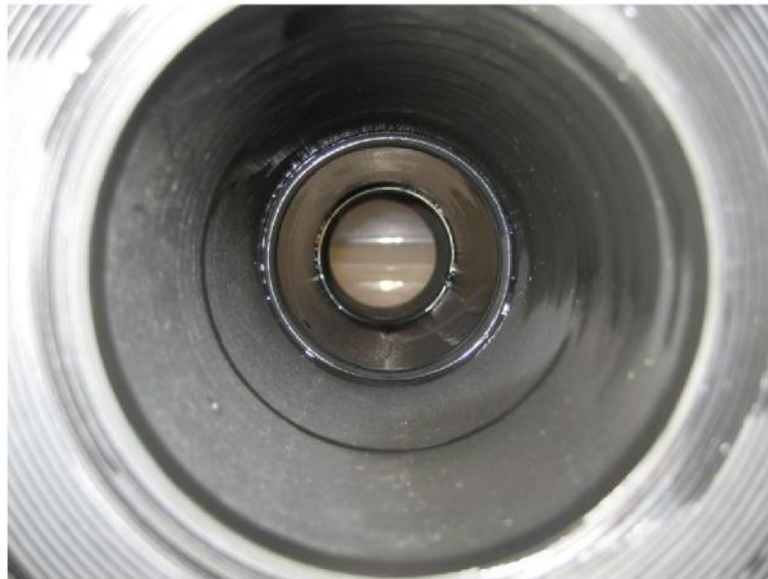
- This is the fourth pipe spool in spool row B and was treated with continuous injection of a chloramine solution.
- Photos taken from inlet and outlet ends (**Figure 3-5**).
- No macrofouling organisms were found.
- No slime/diatoms detected by touch or tissue wipe.
- No sand or debris, although a rust stain was observed in the inlet section (**Figure 3-5**).

**Figure 3-5. Pipe spool B4 (Continuous Chloramine Injection) December 23, 2014. Inlet (top) and Outlet (bottom).**

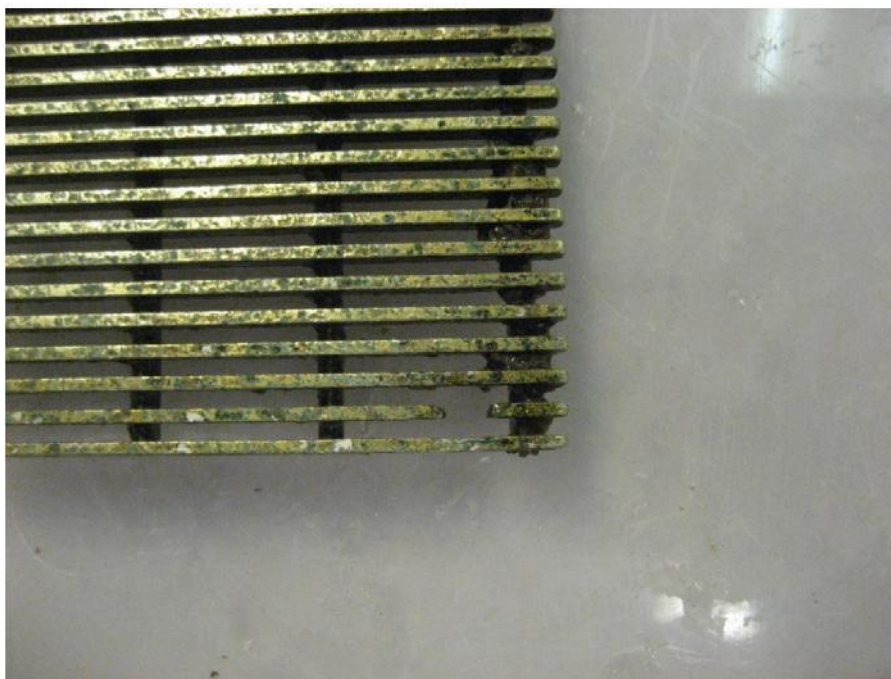
**Figure 4-15: 70-30 Cu-Ni (CDA715) wedgewire sample, photographed 05/25/17, showing erosion/corrosion at one of the four attachment points.**

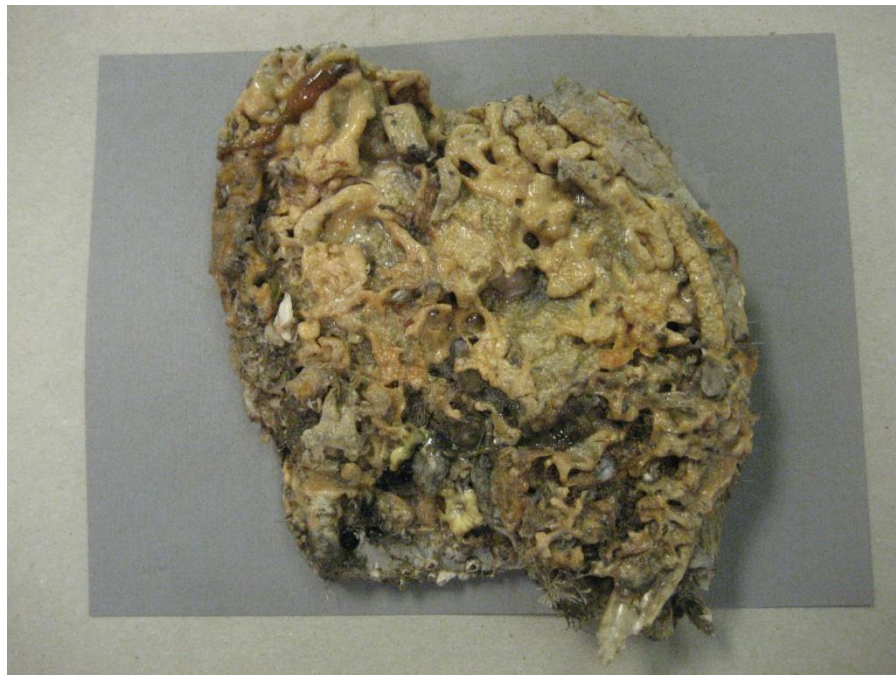
- Erect and encrusting bryozoans.
  - Calcareous worm tubes.
  - C/S tunicate.
  - Hydroids.
- As with the other plates, a variety of encrusting invertebrates were attached to the PVC frame and the plastic cable ties that secure the plate to the frame. In this case, there is little to differentiate between the stainless steel plate and the plastic components.

**Figure 4-19: 2205 stainless steel test plate (Test Plate 4), photographed 06/18/15 prior to biofouling inspection.**

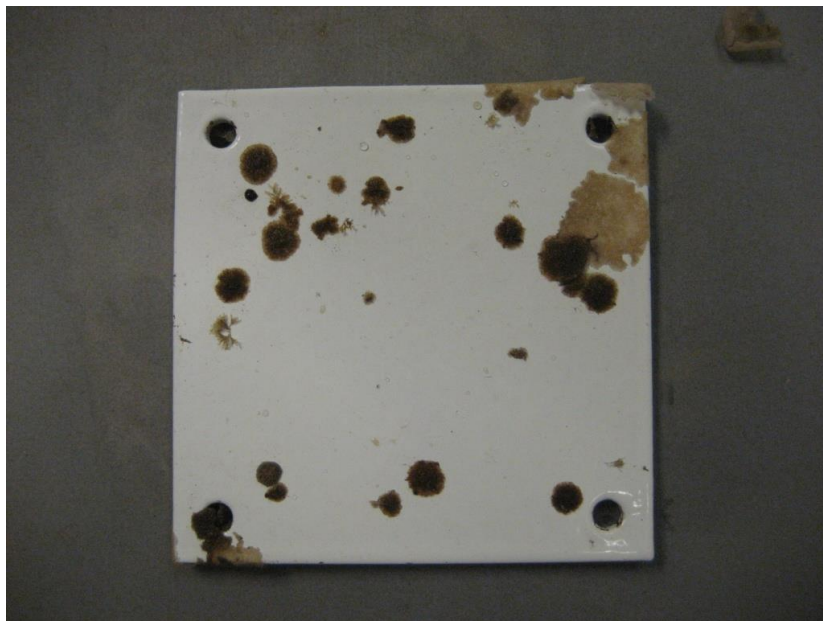
- The PVC frame was still much cleaner (less fouling) than the other four frames that had not dropped into the sediment within the intake structure.

**Figure 4-20: 2205 stainless steel test plate with foul release coating (Test Plate 5), photographed 06/18/15 prior to biofouling inspection.**

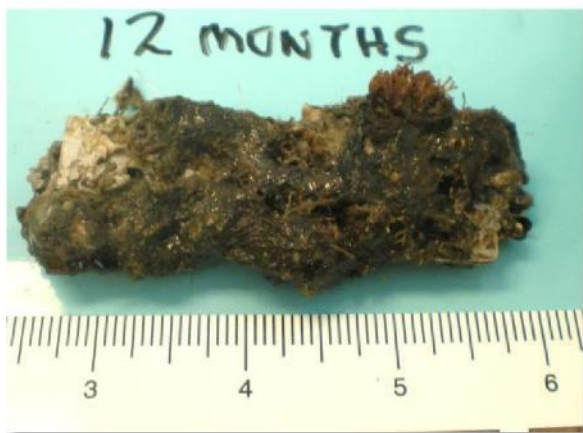
**Figure 4-24: Marine life attached to uncoated 2205 Duplex stainless steel coupon with a weld.**

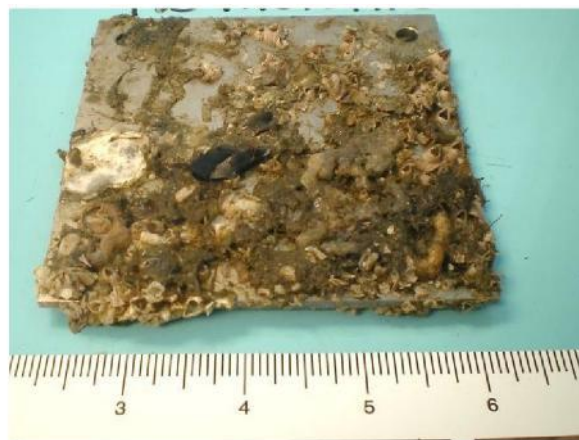
**Figure 4-25: Marine life attached to uncoated 2205 Duplex stainless steel flat plate.**

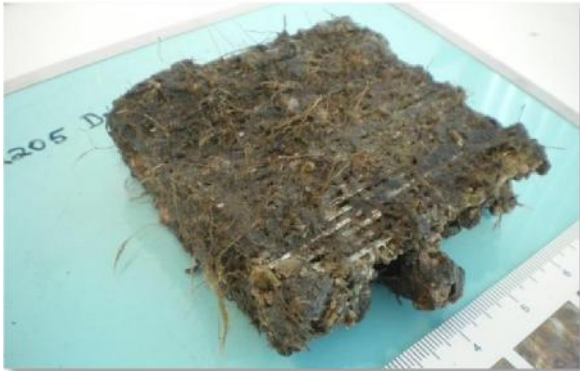
**Figure 4-26: Marine life attached to uncoated 2205 Duplex stainless steel wedgewire screen.**

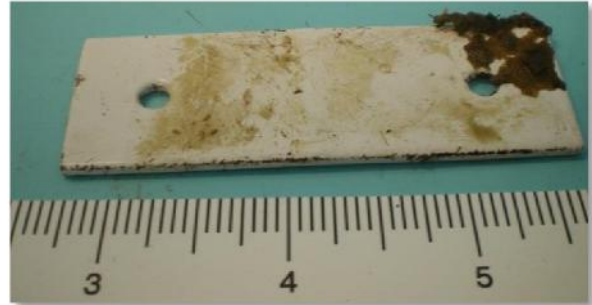
**Figure 4-27: Slight damage to coating on edge and initiation of biofouling on corner of coated 2205 Duplex stainless steel coupon.**

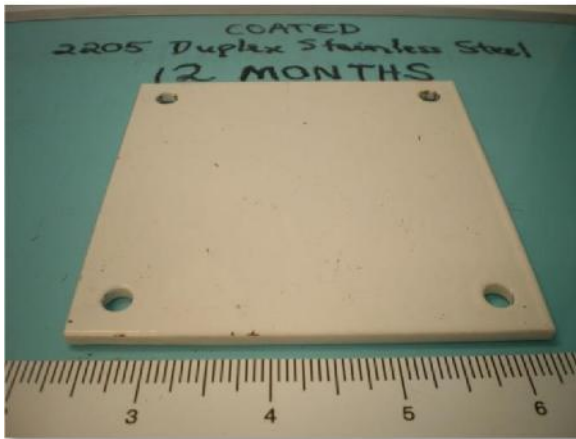
**Figure 4-28: Coated 2205 Duplex stainless steel flat plate in good condition.**

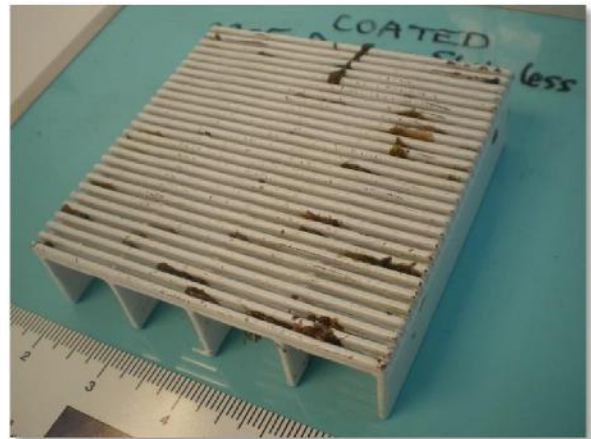
**Figure 4-29: Coating damage to coated 2205 Duplex stainless steel wedgewire sample.**

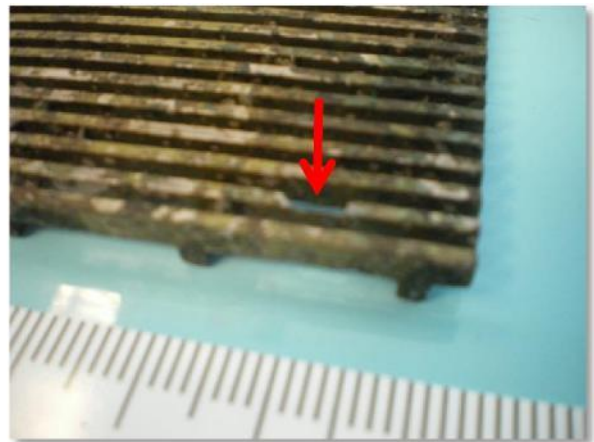
Figures 4-33, 4-38, and 4-43 show some typical mechanical damage to the screen wires that was observed on the 70-30 Cu-Ni, 90-10 Cu-Ni, and Z Alloy screens. The damage was observed at each corner of the screen where the screens were secured to the test rack. The mechanical damage may have been caused by the turbulence in the water and the abrasion by the zip ties that prevented the passivation of the metal at those locations. The exposed metal was corroded and metal loss occurred.

Figure 4-33: Mechanical damage to 70-30 Cu-Ni wedgewire screen.

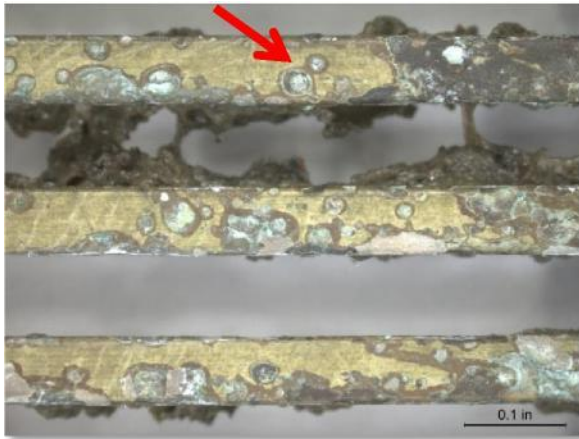
Figure 4-34: 70-30 Cu-Ni wire screen at 10X magnification, pitting and discoloration.

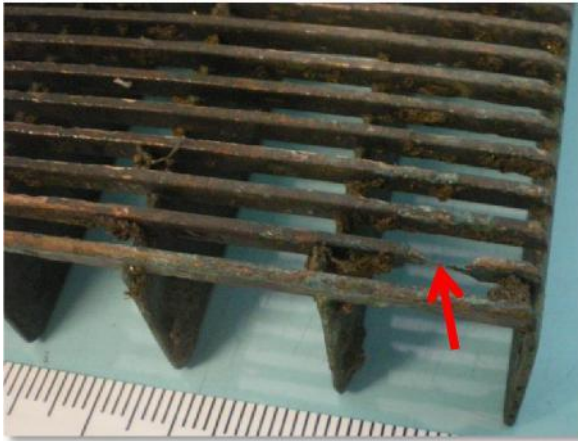
Figure 4-38: Mechanical damage to 90-10 Cu-Ni wedgewire screen.

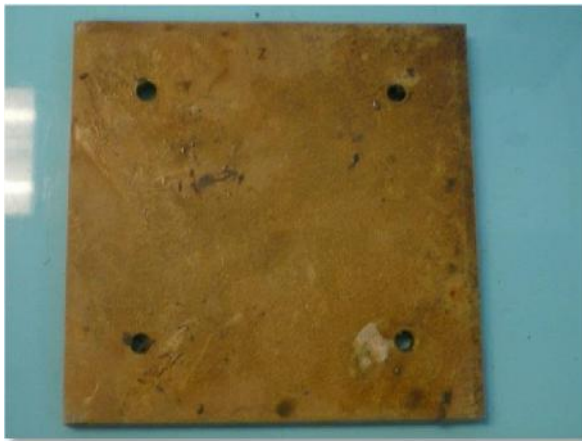
**Figure 4-42: Minimal corrosion was observed on the Z alloy flat plate.**

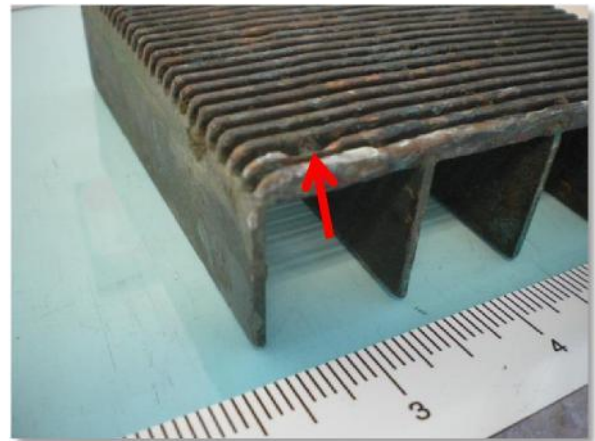
**Figure 4-43: Mechanical damage to Z alloy wedgewire screen.**

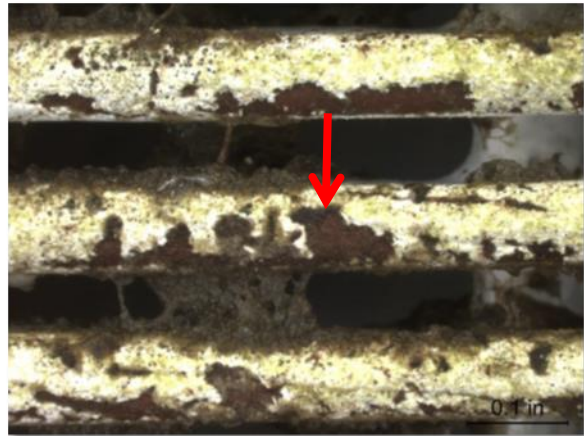
**Photo 4-6: Detail view (10x) of coating damage on 2205 Duplex SS, before cleaning.**

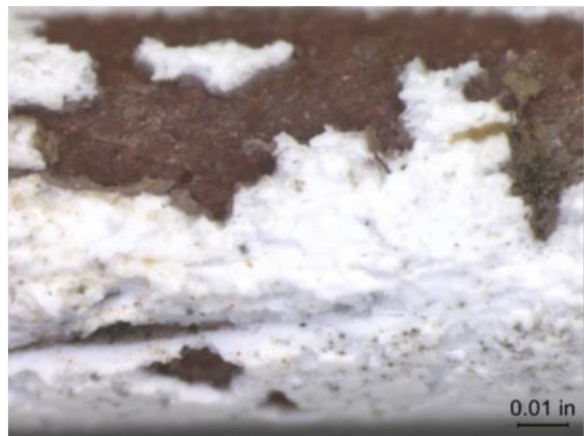
**Photo 4-8: Detail view (50x) of coating damage, after cleaning.**

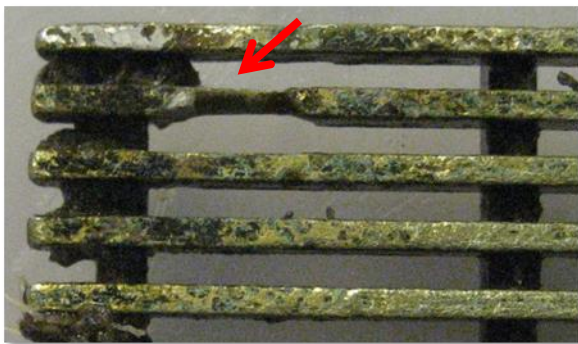
Photo 4-11: Mechanical damage to 70-30 Cu-Ni wedgewire screen at top left corner.

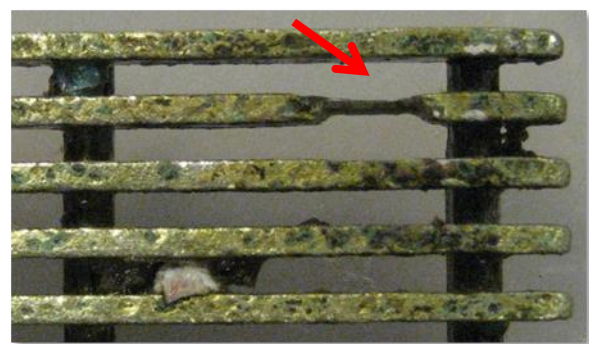
Photo 4-12: Mechanical damage to 70-30 Cu-Ni wedgewire screen top right corner.

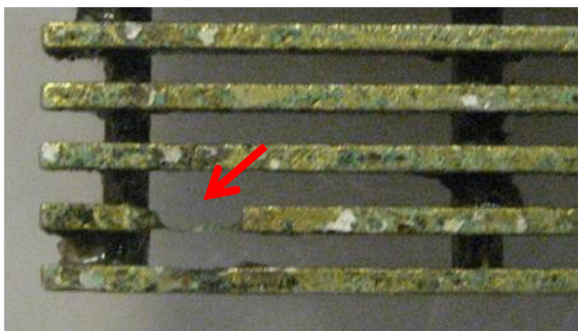
**Photo 4-13: Mechanical damage to 70-30 Cu-Ni wedgewire screen at bottom left corner.**

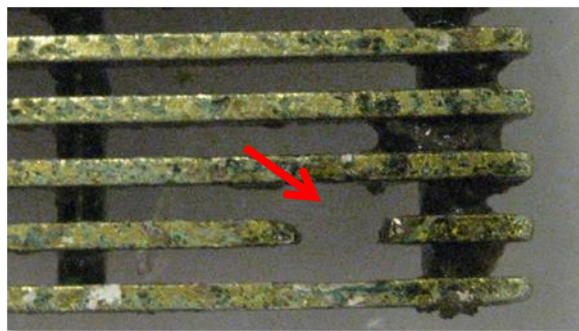
**Photo 4-14: Mechanical damage to 70-30 Cu-Ni wedgewire screen at bottom right corner.**
