Subject: Corrosion Engineering Services
West Basin Municipal Water District Wedge Wire Screens

Tetra Tech provided Corrpro with a sample of a 90/10 copper-nickel wedge wire screen that was part of a desalinization plant owned and operated by the West Basin Municipal Water District. The screens were reportedly experiencing fouling, which is believed to be a result of corrosion or causing corrosion of the screens themselves. In addition to the sample of wedge wire screen, Tetra Tech provided Corrpro with a chemical analysis of the screens, a water analysis and a number of photographs that demonstrate the issues the screens are having. In order to assess the condition of the screens, Corrpro performed the following tasks:

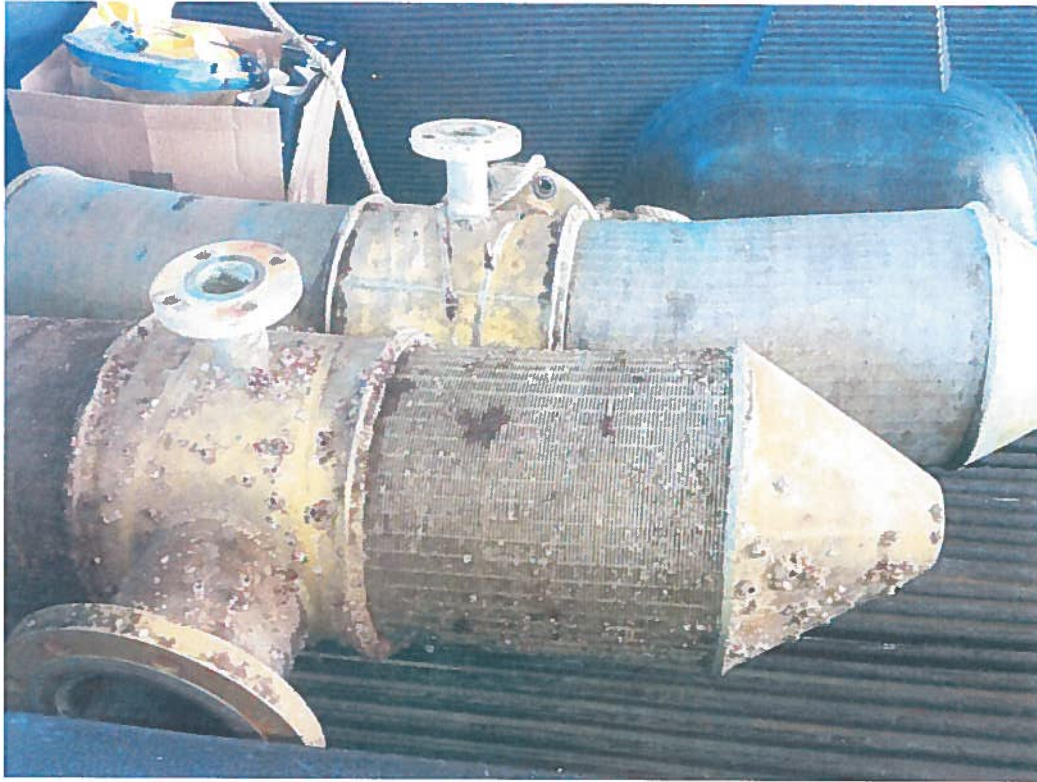
Figure 1 shows a photograph that was supplied by Tetra Tech of the wedge wire screen assembly. The wedge wire screen is fabricated from 90-10 copper-nickel. Copper-nickel (Cu-Ni) alloys were developed specifically for seawater service and contain 9-11 percent nickel, 1-2 percent iron, 0.5-1.0 percent manganese, 0.5 max zinc, 0.05 max carbon, 0.02 max percent lead, 0.02 percent max sulfur and no more than 0.1 percent other elements. The iron and manganese are added to promote resistance to velocity and impingement effects. Various compositions are available for different uses. The alloys are used for offshore, power, desalination industries and Navy and merchant shipping. The alloy has inherent resistance to biofouling. This property is advantageous in avoiding or reducing the necessity for biocide dosing in condensers and seawater systems, and in reducing drag forces and cleaning regimes on offshore platforms and boat hulls. Studies have shown that some corrosion of the alloy (release of copper ions) is required to impart anti-fouling resistance and that the antifouling resistance will be compromised or stopped if corrosion ceases.¹ The initial general corrosion rate of 90-10 Cu-Ni in clean flowing seawater is relatively high initially (about 0.51 mil per year where 1 mil = 0.001 inch) and slowly decreases to about 0.04 mils per year after 14 years. Initial corrosion rates are lower in tidal or quiet or tidal seawater but the long term corrosion rates are about the same in all cases. The good corrosion performance of 90-10 Cu-Ni is adversely affected by pollution, including sulfides and ammonia in aerated seawater. A sulfide concentration of 0.01 ppm is sufficient to cause corrosion of 90-10 Cu-Ni.² Pitting and stress corrosion cracking can occur. A characteristic of sulfide corrosion is a black scale on the surface. Copper-nickel alloys have good resistance to pitting and crevice corrosion and are not susceptible to chloride or sulfide stress corrosion cracking. Sustained seawater velocity above about 3.5 m/s can affect corrosion rates because moving seawater removes the protective oxide scale exposing fresh metal to the environment and increases corrosion rates. Galvanic corrosion of the Cu-Ni is possible when the alloy is coupled to stainless steel, nickel alloys and titanium. The Cu-Ni is the cathode (protected) when coupled to zinc, aluminum, steel and aluminum bronze, but this should be avoided as it reduces antifouling as mentioned above.

Figure 1. Wedge wire screens. Photo courtesy of Tetra Tech.

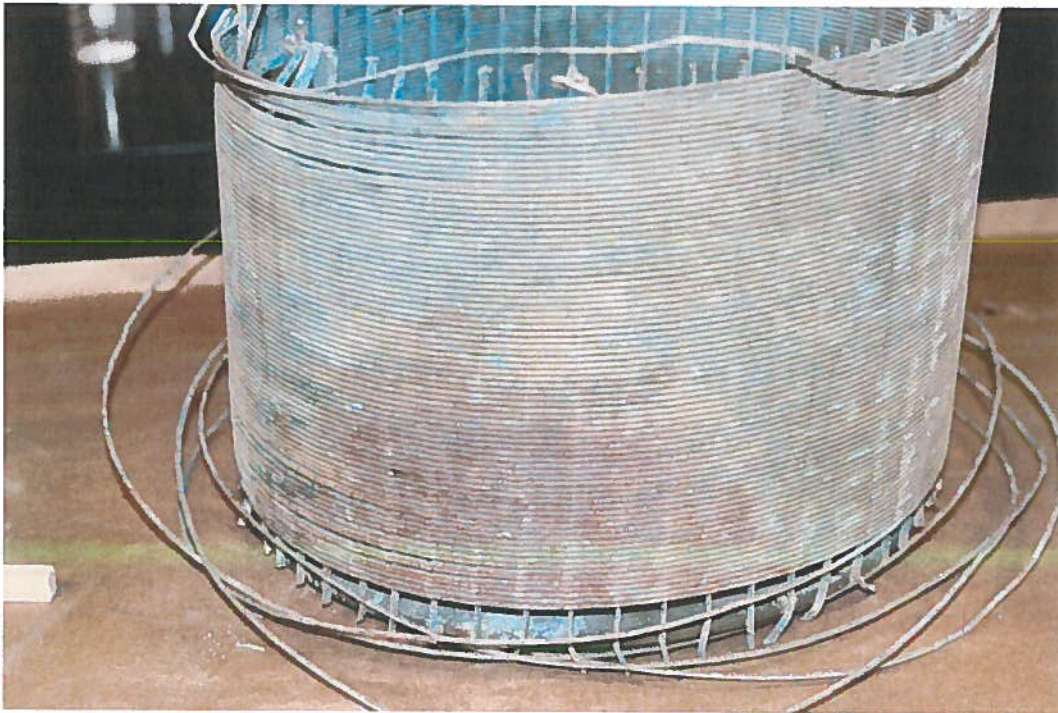
Figure 2 shows an overall view of the sample we received. The sample was about 9-inches long and 12-inches in diameter. It had a deposit on the metal surfaces which appeared green in some areas and brownish in others. Figures 3 and 4 show the different colorations observed.

Figure 2. Wedge wire screen examined by Corrpro.

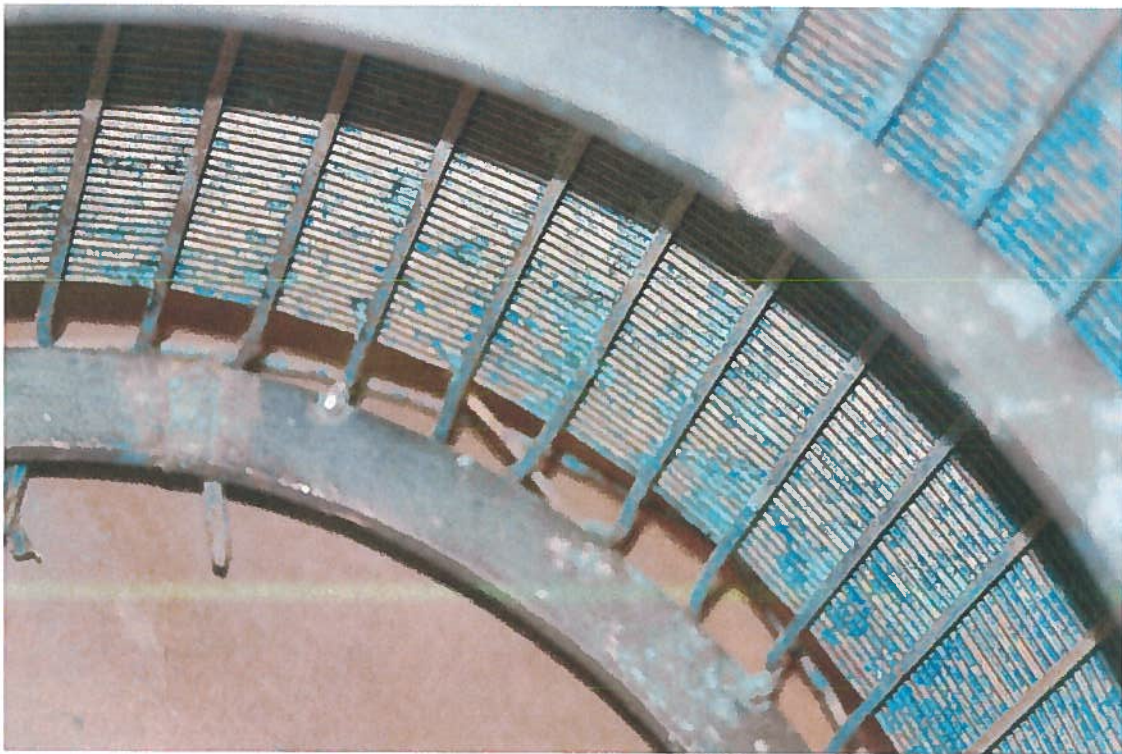
We mechanically removed the deposit in several areas and examined the metal beneath. The brown deposit was relatively easy to remove but the green colored deposit was better adhered to the metal. The lack of black coloration suggests that sulfides were not present in the influent water. The deposits were located everywhere on the screen sample we examined and there did not appear to be any localized concentrations. The metal substrate appeared relatively unaffected by corrosion - no pitting or significant general corrosion was observed. The greenish deposit was analyzed by Lehigh Testing Laboratories using energy dispersive x-ray analysis (EDXA) and x-ray diffraction (XRD). Appendix B presents their full report. These analyses show that the scale consists of the following:

Figure 4. Screen deposit.
