West Basin Municipal Water District Ocean Water Desalination Demonstration Project Final Report

FINAL

February 29, 2016

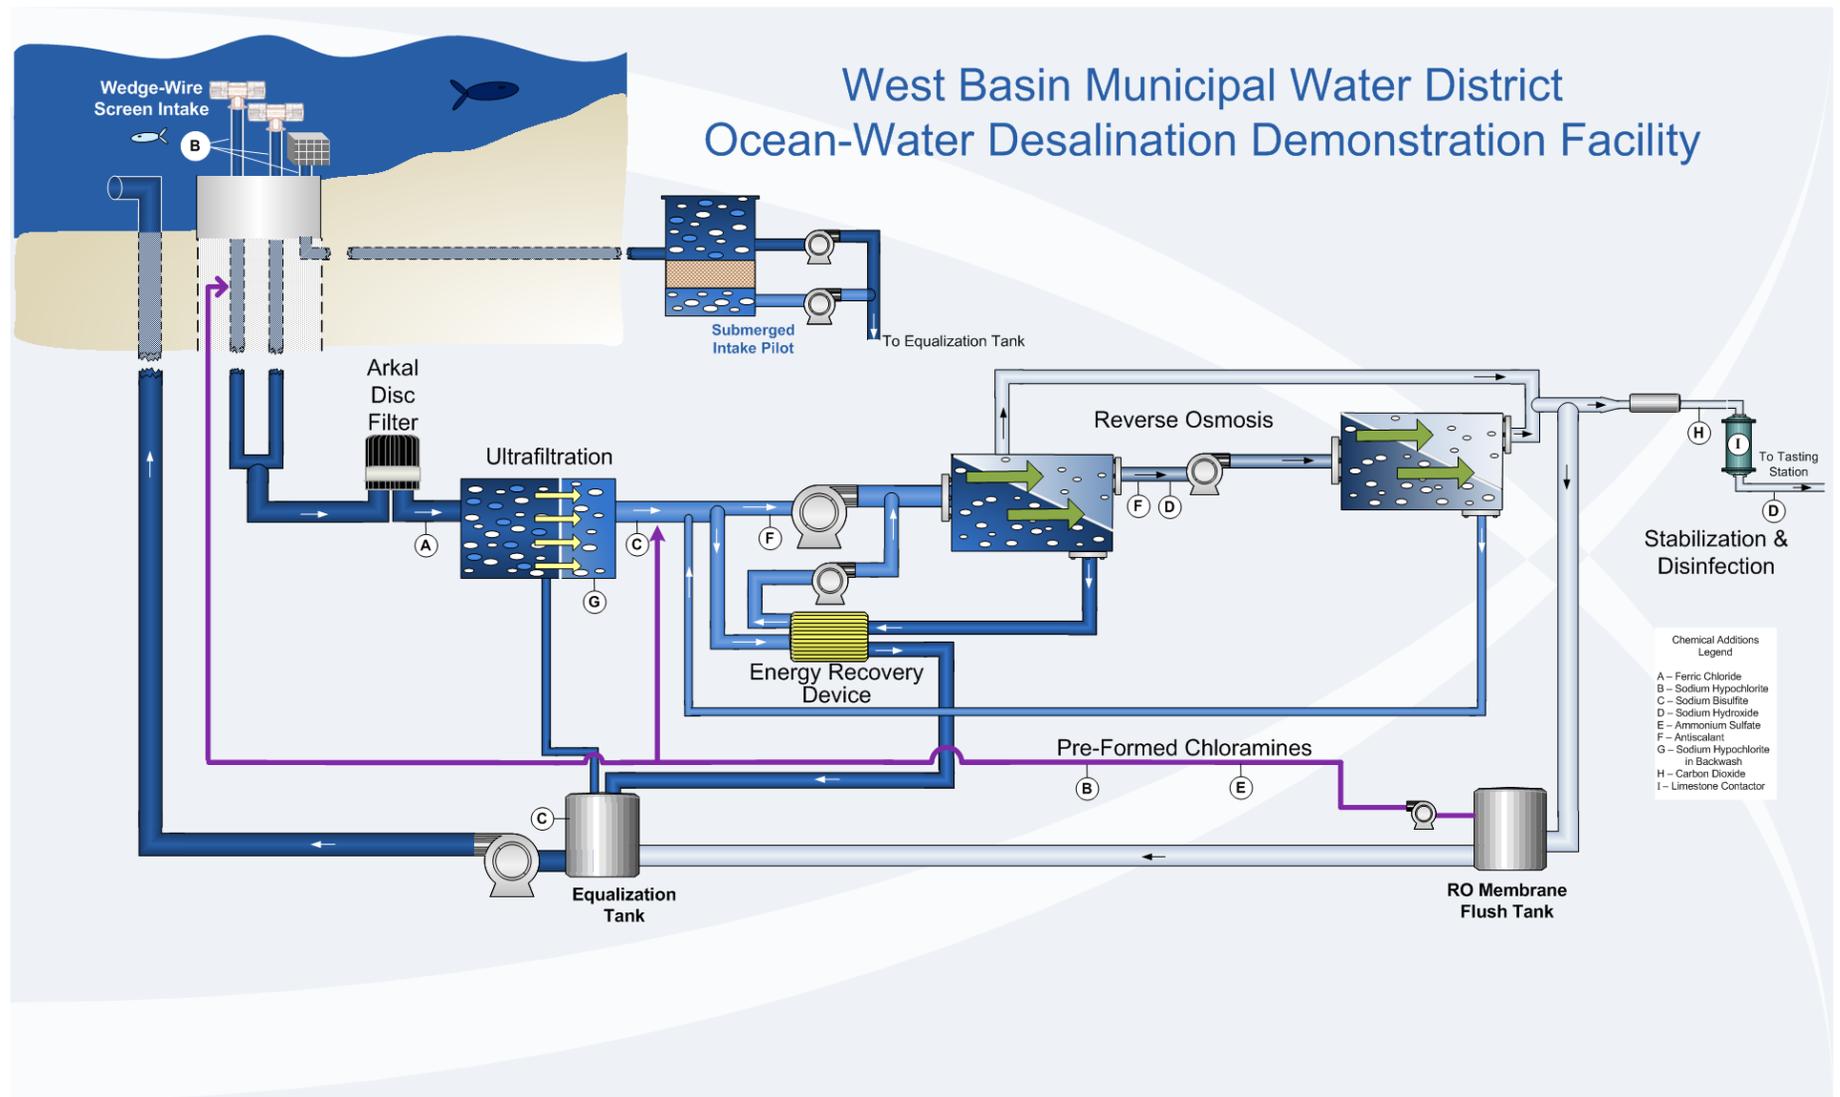
Figure 2-2: Schematic of Treatment System

The facility was designed to utilize approximately 580,000 GPD (347 GPM) of ocean water, testing various pretreatment and post-treatment options, using full-scale size equipment in the key points. The Reverse Osmosis (RO) process utilized approximately 110,000 GPD (70 GPM) of the source water, producing approximately 55,000 GPD of permeate (product water) and 55,000 GPD of ocean water concentrate, which was recombined and discharged through the existing outlet tunnel (there was not any “brine” discharged into the ocean, and the nominal chemicals used in the RO testing processes were neutralized prior to discharge, or discharged to the existing sanitary sewer). Approximately 80,000 GPD (55 GPM) of source water was utilized for a subsurface intake pilot study.

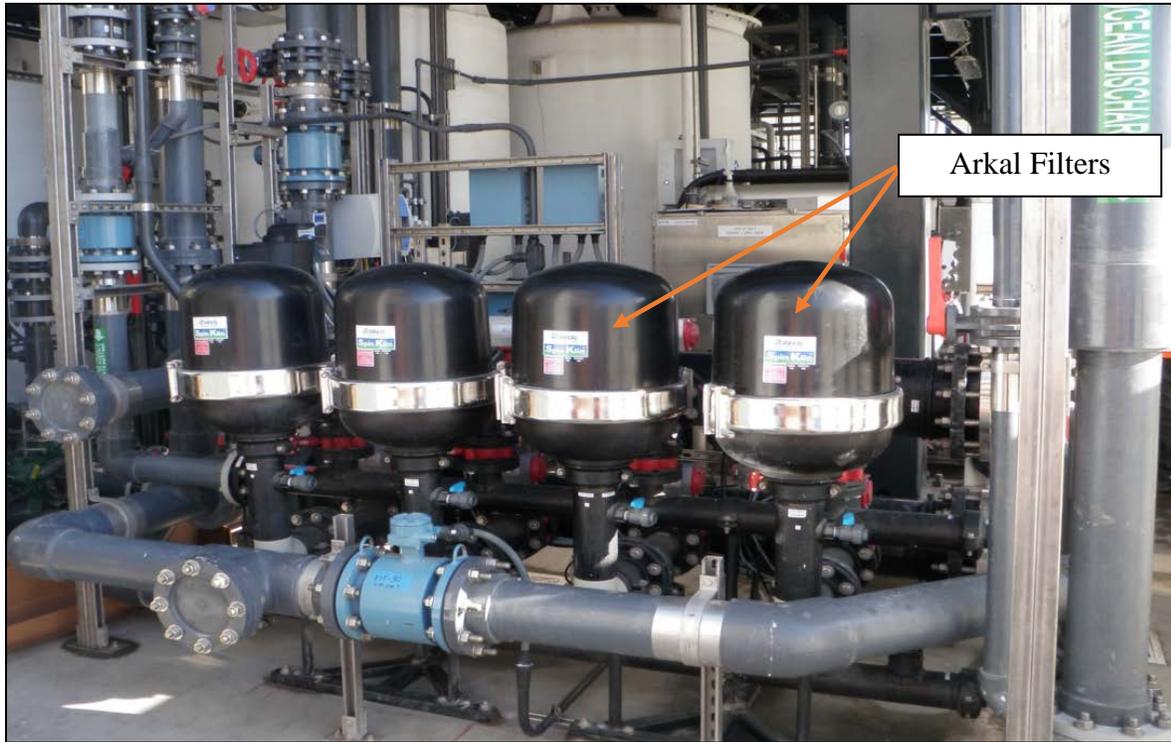
Figure 3-2: Arkal Filters

There were a total of four filters installed in a parallel configuration. Filters #1 and #2 were the default on-line filters. The model was 4” Galaxy and each filter pod contained five (5) spines. The filters utilized a self-clean backwash process without any interruption of the filtration process. The backwash cycle was triggered by a set differential pressure reading, typically seven (7) psig across the filters. The backwash pump was fed from the UF filtrate storage tank. The filters also underwent an osmotic shock once a day for a period of 10 minutes where the filters were soaked in RO permeate water. By introducing water with much lower salinity, and therefore lower osmotic pressure than the raw seawater, the potential growth of any organisms inside the filters may be disrupted and/or destroyed. Under normal operational conditions, the wash water was collected in a tank along with the reverse osmosis permeate and seawater concentrate to be discharged to the ocean.

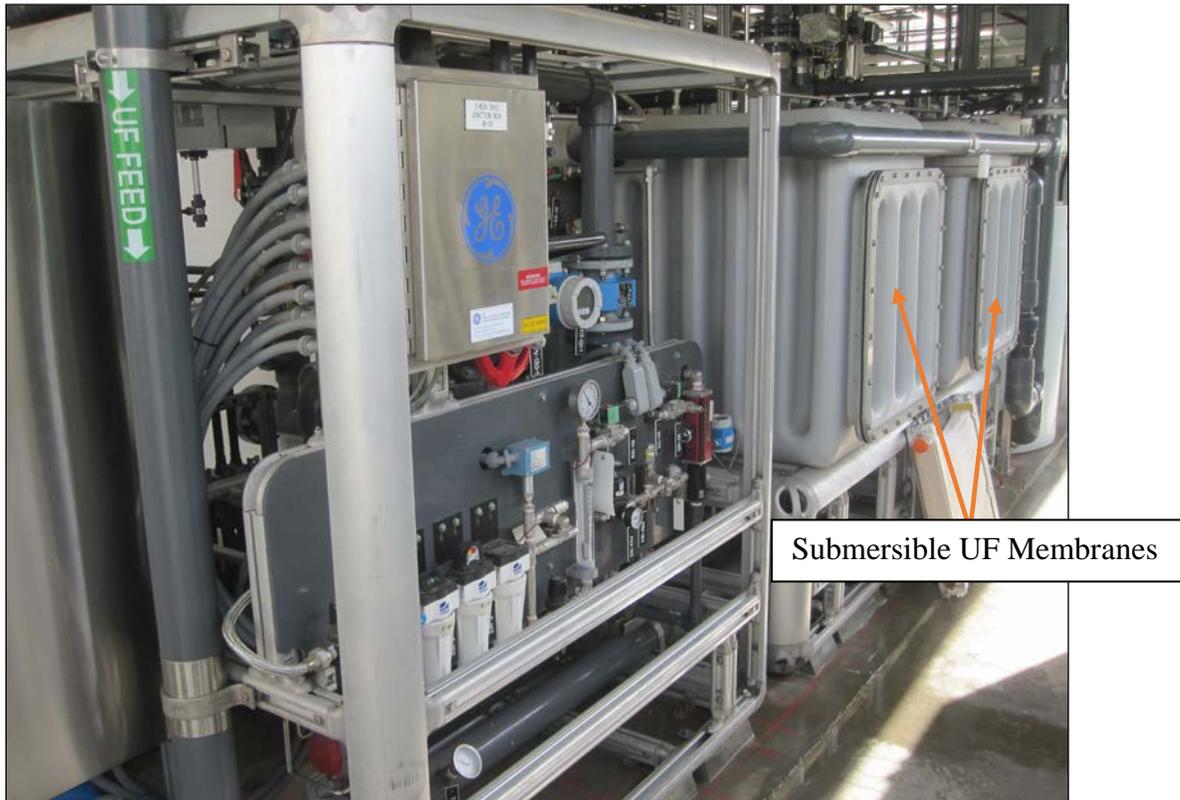
Figure 3-3: UF Filtration System.

Arkal filtrate fed an ultrafiltration system provided by GE-Zenon (Figure 3-3). The Zenon ultrafiltration system utilized ZeeWeed ZW 1000 hollow fiber membranes (Version 4, pore size 0.02 microns), immersed directly into two process tanks. The membrane cassettes were connected to a UF filtrate collection header and aeration hoses. The UF filtrate pump applied a suction to the filtrate collection header, drawing water through the membrane in an outside-in flow pattern. Table 3-1 presents the operating conditions for normal filtration conditions.

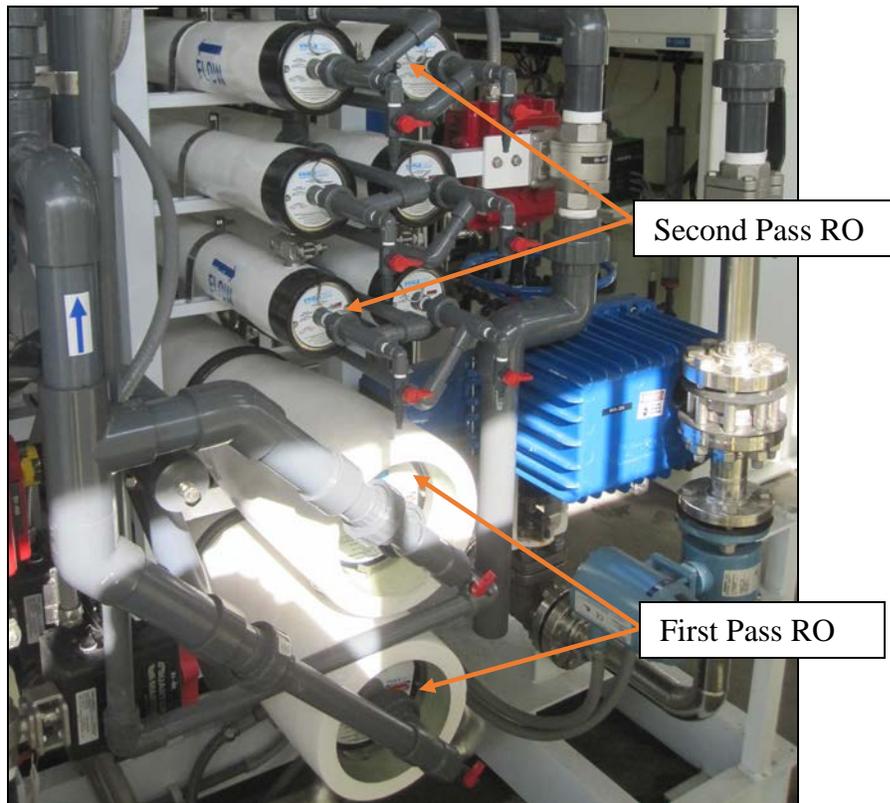
Figure 3-4: Reverse Osmosis System

As mentioned previously, the RO system was equipped with a Pressure Exchanger energy recovery device (ERD). The ERD pressurizes the RO feedwater by direct contact with the high pressure concentrate stream from the reverse osmosis system. The concentrate from the reverse osmosis membranes passes through the ERD, where its pressure is transferred directly to a portion of the incoming feedwater. This pressurized feedwater stream is approximately equal in volume and pressure of the concentrate stream. The ERD pumps the feedwater in parallel with the high pressure reverse osmosis pump. This reduces the high pressure pump flow requirement and therefore reduces energy consumption.

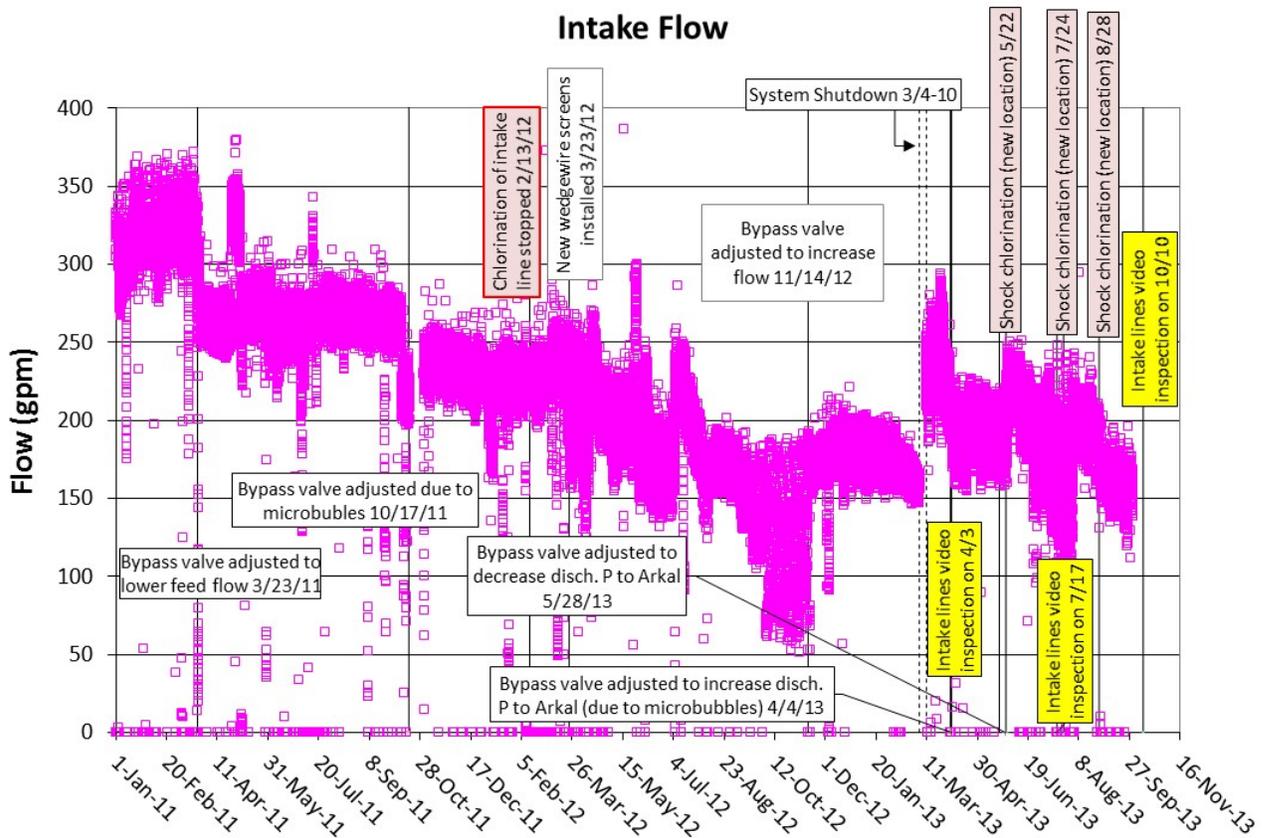
Figure 4-3: Intake Water Flow

At the beginning of the demonstration project (February 2011), feed flow was 300-350 gpm (Figure 4-3). The intake pumps were noisy at such flowrates, with vibration and cavitation being of concern. As such, flow was reduced to approximately 275 gpm on March 23, 2011 by throttling the bypass valve located downstream of the Arkal filters. The feed flow was steady at 275 gpm until the end of October 2011, when flow was again reduced to approximately 225 gpm due to micro-bubbles appearing in the influent flow, which were detrimental to marine life in an aquarium study being fed by this supply. The intake flow was stable at approximately 225 gpm until April 2012.

On November 14, 2012, feed flow increased to approximately 175 gpm following an adjustment to the pressure control valve on the bypass line. Flow remained stable until the end of February 2013, when it began to decrease and the system was shut down for intake line cleanup and pipeline modifications (March 4, 2013 to March 10, 2013). During this shutdown, the intake pipeline on the discharge side of the intake pumps was found to contain significant loads of mussels, shells, and other biogrowth. This demonstrated that the discharge side of the intake pumps was subject to biogrowth accumulation in the absence of shock chlorination or periods of anoxic condition. The wall-mounted pipeline at the forebay was cut and replaced with two parallel lines, while the section from the west gate to the Arkal feed was pressure washed. Following this cleaning, flow stabilized at approximately 200 gpm. An intake line video inspection performed on April 3, 2013 showed that the intake lines 150-ft upstream of the intake pumps were clean. This confirmed that alternating intake lines every four (4) days was effective in preventing biogrowth on the suction side of the intake pumps.

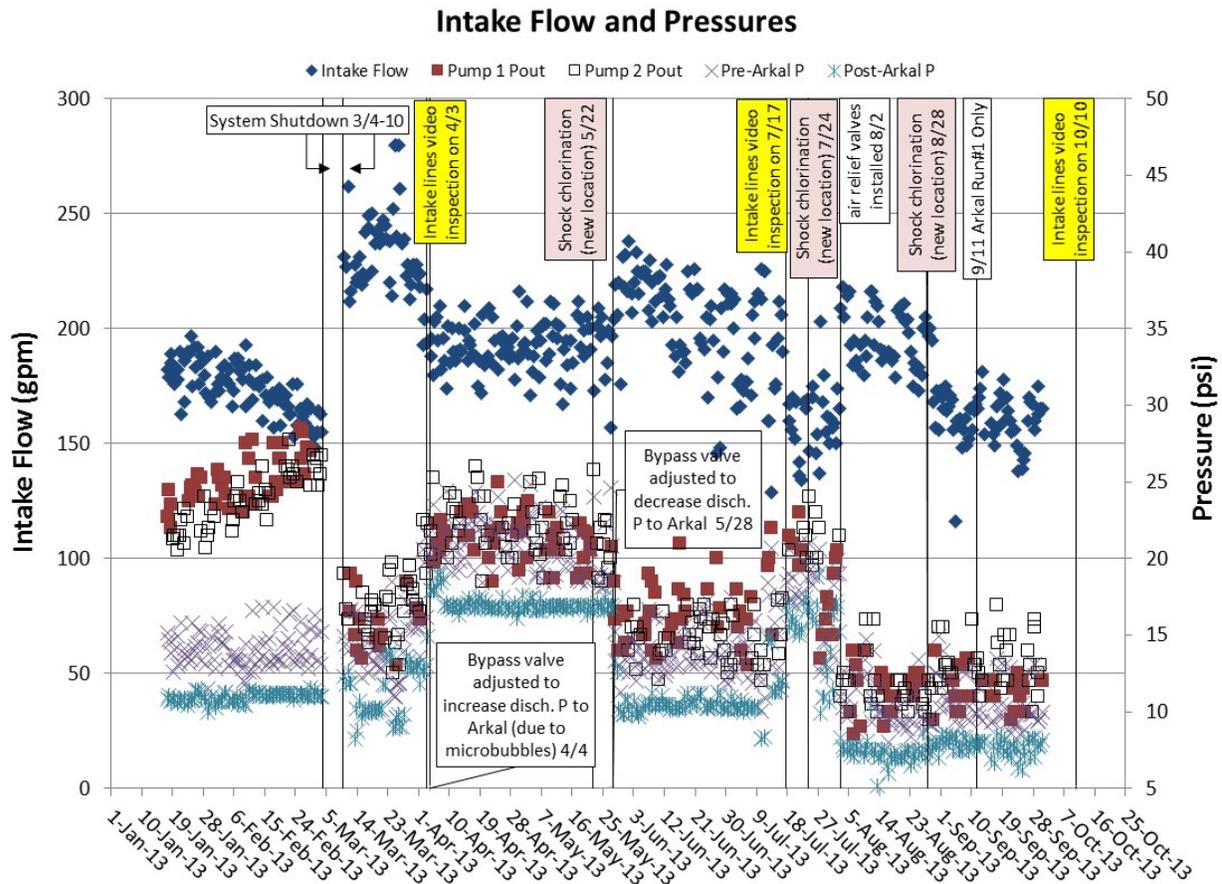
Figure 4-4: Daily Measurements for Intake Flow and Discharge Pressure

Figure 4-4 presents the daily measurements of (manually logged) of intake flow, discharge pressure for each pump (at forebay), and the pressure before and after the Arkal filters. Measurements were taken from January 2013 to the end of the project.

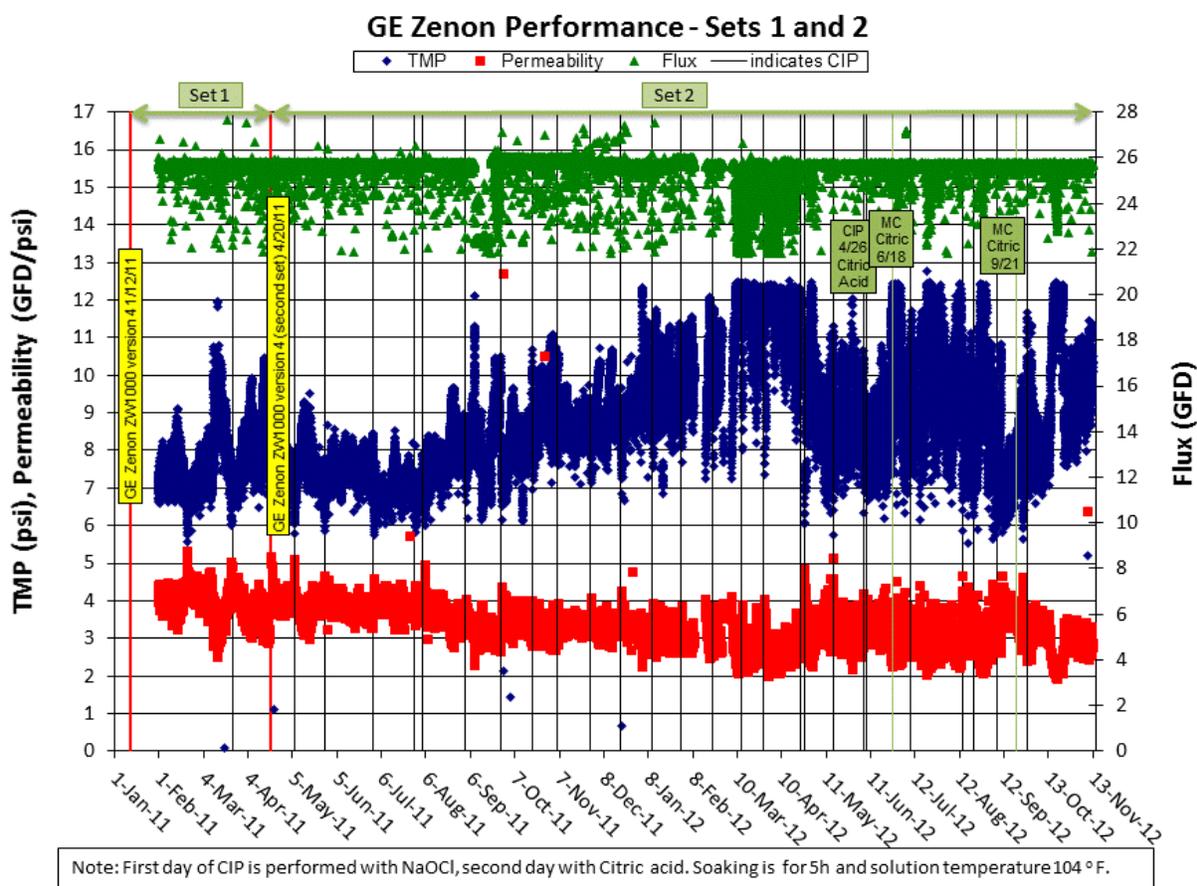
Figure 4-7: UF Membranes Performance – Sets 1 and 2

Note: Vertical lines designate CIP events, unless noted otherwise.

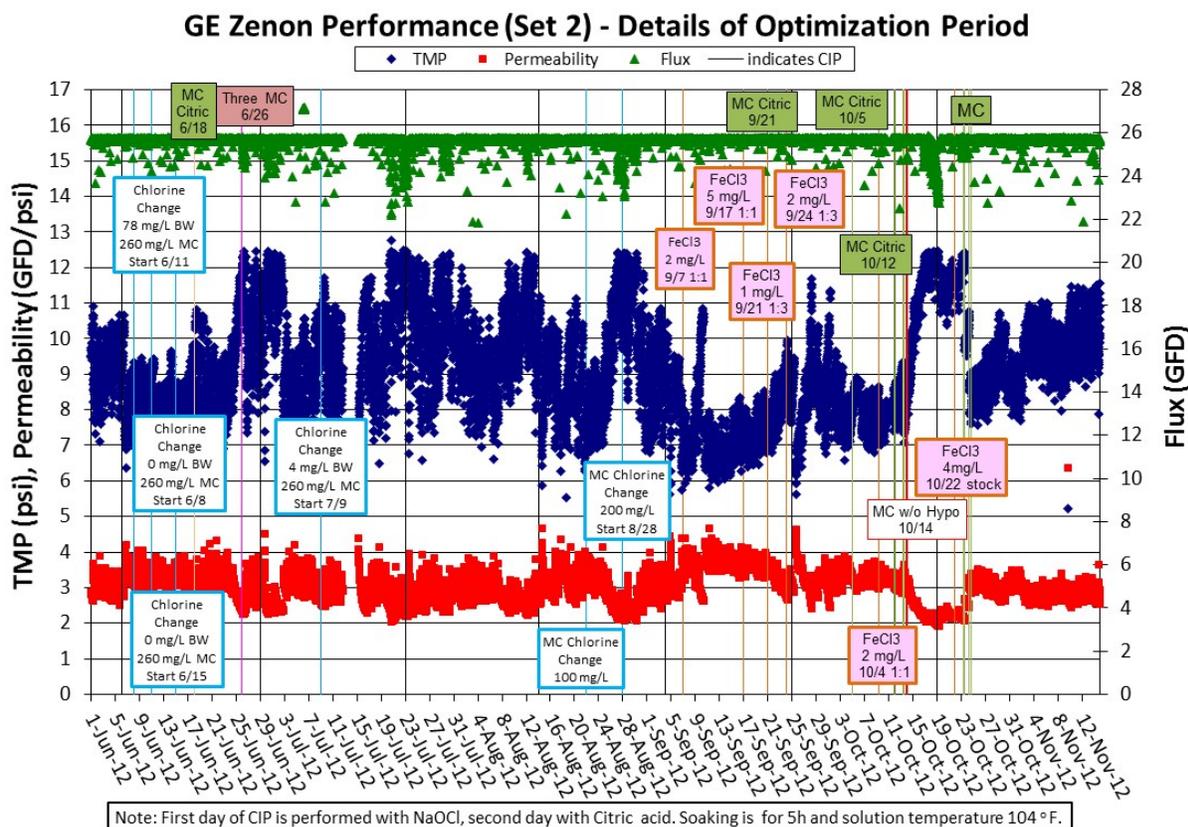
Figure 4-8: Details of Performance Optimization for Membrane Set 2

Note: Vertical lines designate CIP events, unless noted otherwise.

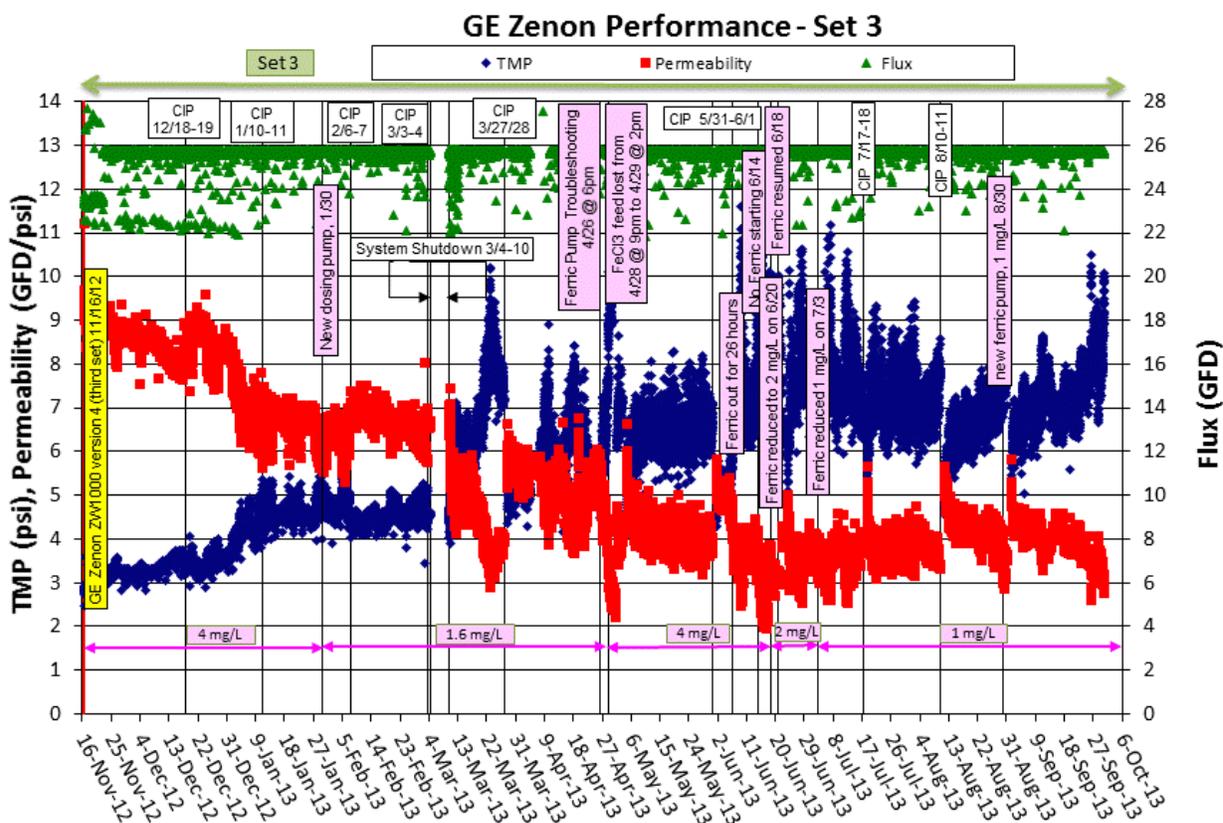
Figure 4-9: UF Membranes Performance – Set 3

As presented in Figure 4-9, permeability at startup was 9 gfd/psi and remained at this level for several weeks. This permeability level was similar to the permeability experienced during pilot testing in EL Segundo and significantly higher than for UF membranes sets 1 and 2. Following this period, permeability began a decline to 8 - 8.5 gfd/psi through the end of 2013. In the first week of January 2013, permeability decreased sharply from slightly above 8 to below 7 gfd/psi,

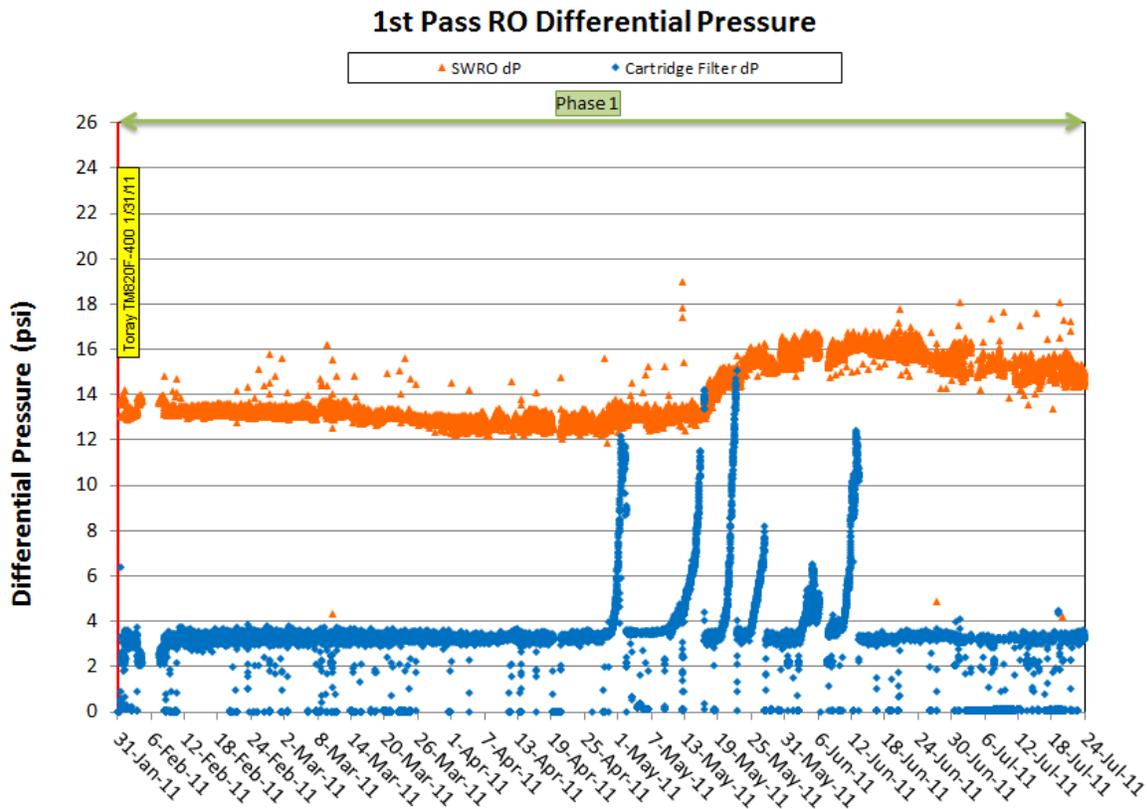
Figure 4-14: ΔP for Cartridge Filters and RO Membranes – Phase 1: Toray TM820F-400

Figure 4-14 shows the differential pressure across the pretreatment 5 micron cartridge filters and RO membranes. Figure 4-15 provides oxidation/reduction potential (ORP) data for the feed stream and normalized permeate conductivity. The ORP was typically 500 mV when the chloramines were online from February 2011 through mid-April 2011. In mid-April 2011, problems with the sodium hypochlorite pump developed; chloramines were only being dosed intermittently, and typically at a dose from 1-3 mg/L, below the targeted 5 mg/L. The decreased use of chloramines coincided with an increase in cartridge filter differential pressure on several occasions, as well as a gradual increase in SWRO membrane differential pressure from mid-May 2011 through early June 2011 (Figure 4-15). When chloramine dosing was more consistent, starting in mid-June 2011 after pump repairs took place, the differential pressure across the SWRO membranes stabilized, and even started to decrease in late June 2011.

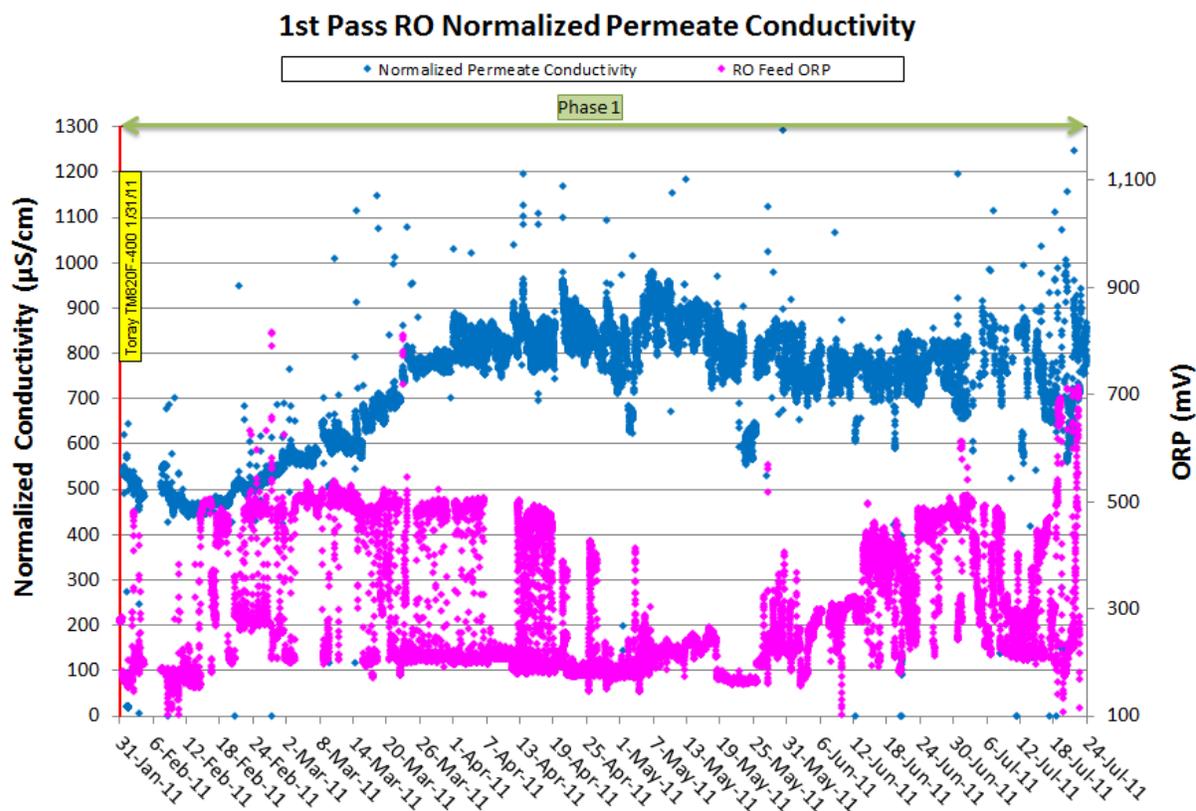
Figure 4-15: Permeate Conductivity and Feed ORP– Phase 1: Toray TM820F-400

Figure 4-15 shows the normalized permeate conductivity and ORP of the RO feedwater for Toray membranes. The preformed chloramine system was undergoing commissioning during the same timeframe as the RO system, and consistent dosing of chloramines in the RO feedwater began in mid-February 2011. The elevated feedwater ORP in the 500 mV range is indicative of preformed chloramines in the RO feedwater. During this period, there was a significant increase in normalized permeate conductivity over time, from about 500 $\mu\text{S}/\text{cm}$ immediately after commissioning to 850-900 $\mu\text{S}/\text{cm}$ on mid-April until the end of July 2011.

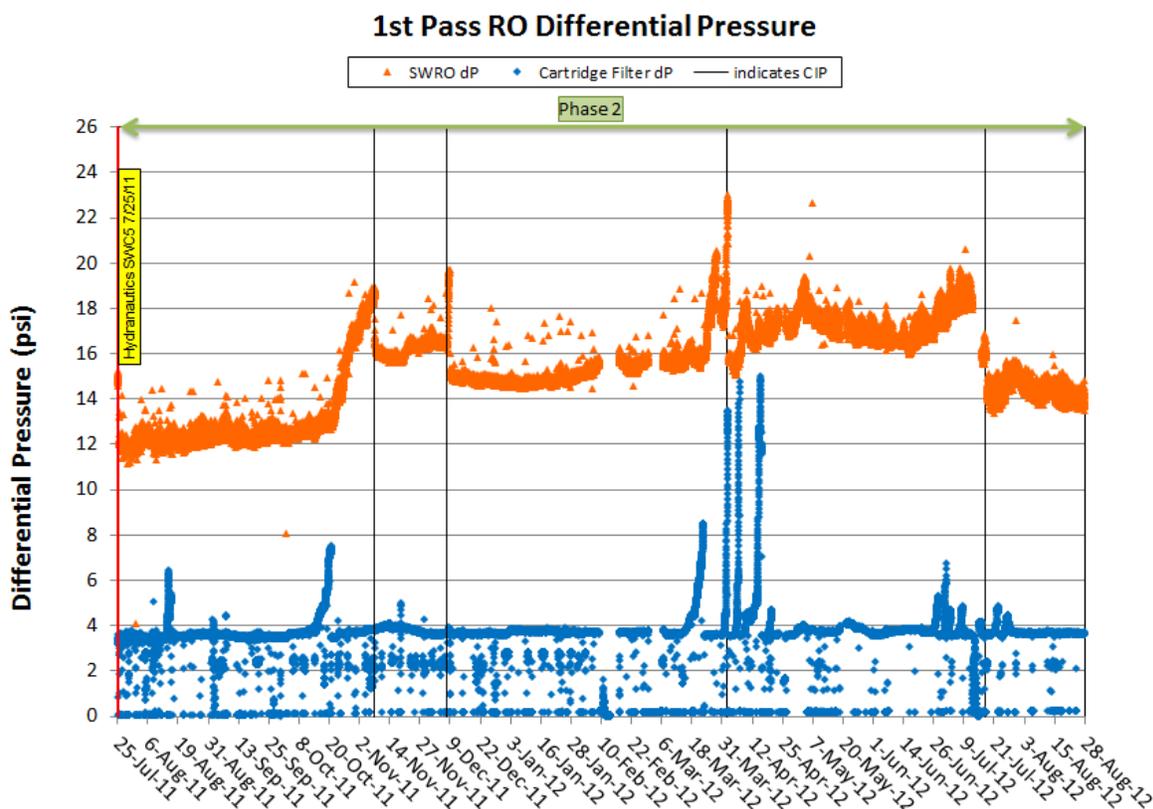
Figure 4-17: ΔP for Cartridge Filters and RO Membranes – Phase 2: Hydranautics SWC-5

Figure 4-17 presents the differential pressure across the cartridge filters (CF) in the pretreatment system together with the differential pressure from the 1st Pass RO for Phase 2. For the first three months of operation, differential pressure across membranes was stable at 12-13 psi, after which it spiked to 19 psi. The differential pressure in the cartridge filters also spiked in that period from the normal 4 psi to almost 8 psi. Chloramines were not run since the beginning of October 2011, and it is believed that some biofouling had developed both in the cartridge filters and RO membranes. The CF were replaced and two CIPs were performed on November 11, 2011 and December 8, 2011. The second CIP (December 8, 2011) was performed because the first one reduced the differential pressure by only 2 psi. However, the second CIP on November 11, 2012 only reduced the differential pressure by an additional 1.5 psi, and as such, the baseline of 12-13 psi could not be reestablished.

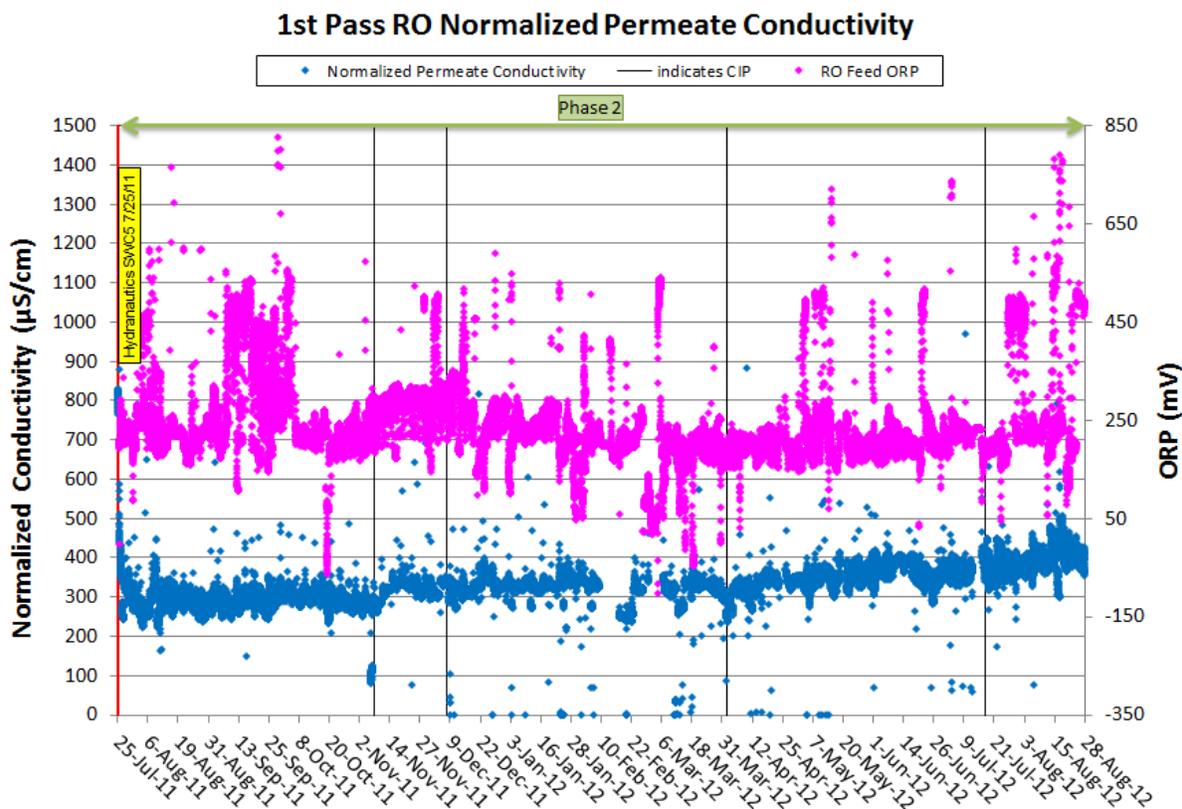
Figure 4-18: Permeate Conductivity and Feed ORP– Phase 2: Hydranautics SWC-5

Figure 4-18 presents the normalized permeate conductivity and ORP of the feedwater. Permeate conductivity was about 300 $\mu\text{S}/\text{cm}$ until November 11, 2011, when it stepped up to approximately 350 $\mu\text{S}/\text{cm}$. On this date, the intake line (1 mm screen) was chlorinated and it is possible that a slug of chlorine had reached the RO, oxidizing the membrane to a small extent. Another step up in permeate conductivity occurred at the end of April 2012, which was consistent with the increase in chloride, boron and bromide in the RO permeate. Around this time, the chloramine system was operating and the ORP in RO feed had spiked to values above

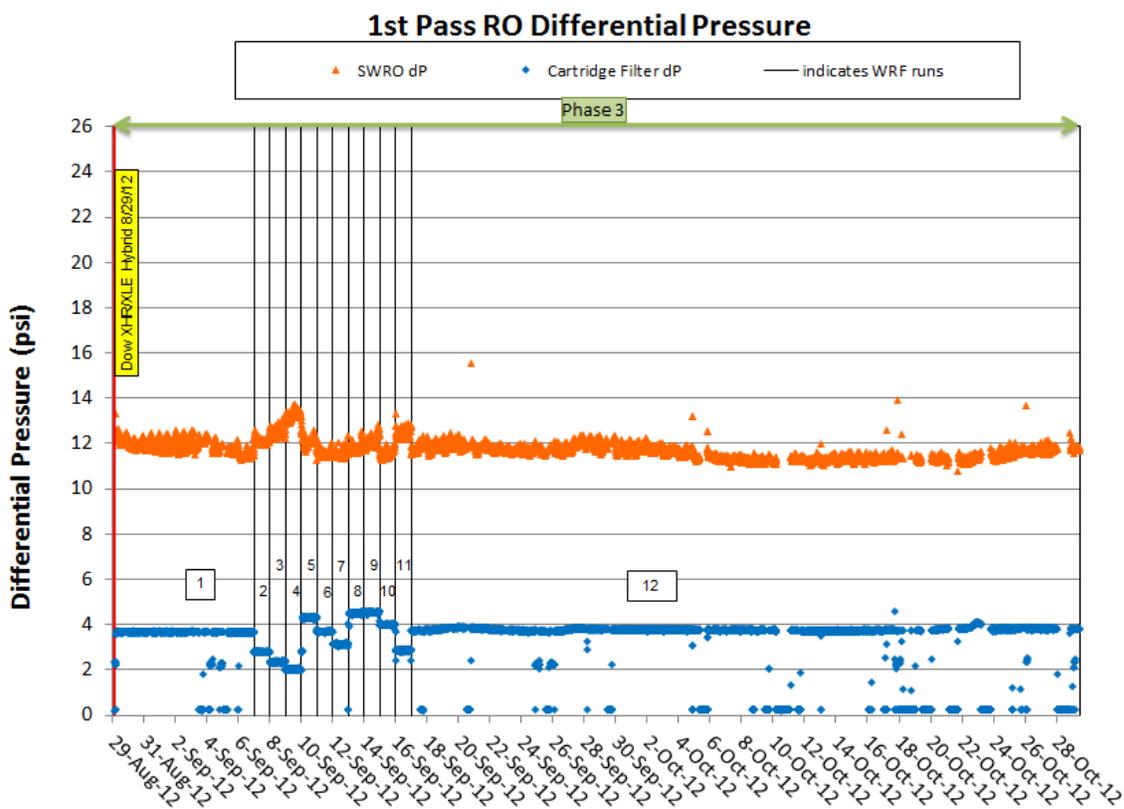
Figure 4-20: ΔP for Cartridge Filters and RO Membranes – Phase 3: Dow Hybrid XHR/XLE

Figure 4-20 presents the differential pressure in the cartridge filters and across Dow membranes in Phase 3. Similar to the discussion for permeability, differential pressure was varying by only 1-2 psi for the runs with operating setpoints deviated far from the historical 9 gfd and 50% recovery. The variation in the differential pressure for the cartridge filters (which is not normalized) is explained by the different feed flows across the filters, which is the highest in Run #9 (85.6 gpm), followed by Run #8 (81.3 gpm), and Runs #5 and #10 (77.8 gpm): the higher the feedwater flow to the cartridge filters, the higher the differential pressure.

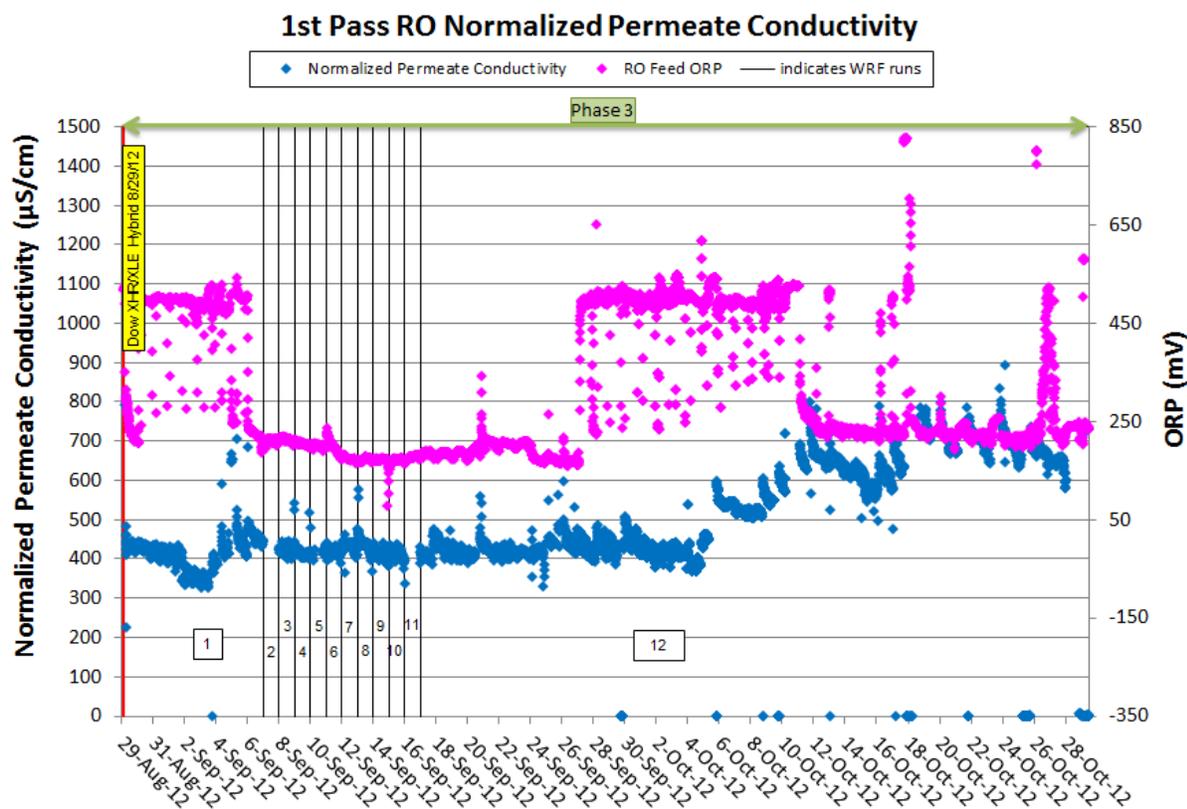
Figure 4-21: Permeate Conductivity and Feedwater ORP – Phase 3: Dow Hybrid XHR/XLE

Permeate conductivity and ORP of the feedwater for Phase 3 are presented in Figure 4-21. The conductivity was between 425 to 450 $\mu\text{S}/\text{cm}$, except for a short period on September 2 to 4, 2012 when the permeate conductivity decreased to 350 $\mu\text{S}/\text{cm}$. Upon investigation of the conductivity decline during early September, it resulted that it was due to the conductivity meters which were re-calibrated in that period.

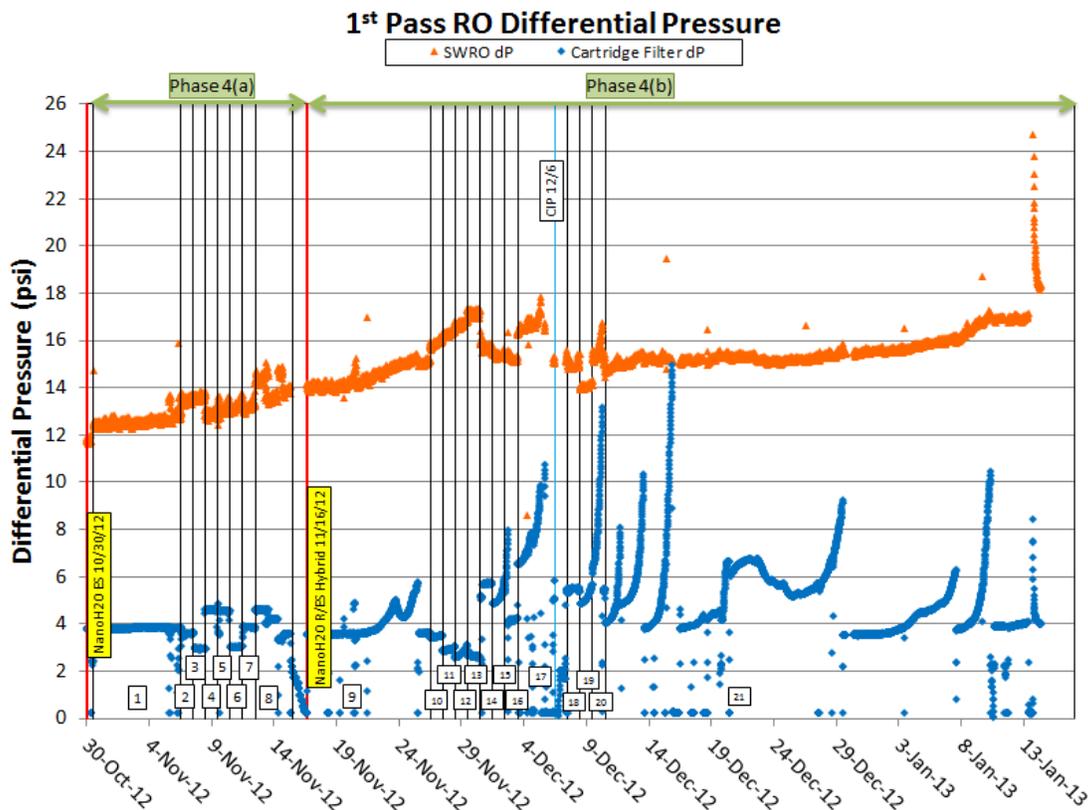
Figure 4-23: ΔP for Cartridge Filters and RO Membranes Phase 4 – NanoH₂O ES and R/ES Hybrid

Figure 4-23 presents differential pressure across cartridge filters and RO membranes in Phase 4. The overall trend in phases 4a and 4b is a slight increase. Although some of the higher values in runs 10-20 are due to changes in operating conditions. A CIP was performed on December 12, 2012 using Avista P-111, under the same cleaning regime as previous cleanings. As observed during Run #17, an approximately 2 psi reduction in RO differential pressure was achieved with membrane cleaning. After the CIP, differential pressure remained stable for three weeks and then began a slow increase again (run 21).

Cartridge filters were replaced again on January 7, 2013 in response to a differential pressure increase, coincidental with a 1 psi differential pressure increase in the RO membranes. The spike and recovery in RO differential pressure, observed on January 13, 2013, appears to be an anomaly associated with RO feed pipeline cleaning activities (sanitization of pipes and cartridge filters housing between UF filtrate tank and RO membrane pressure vessels).

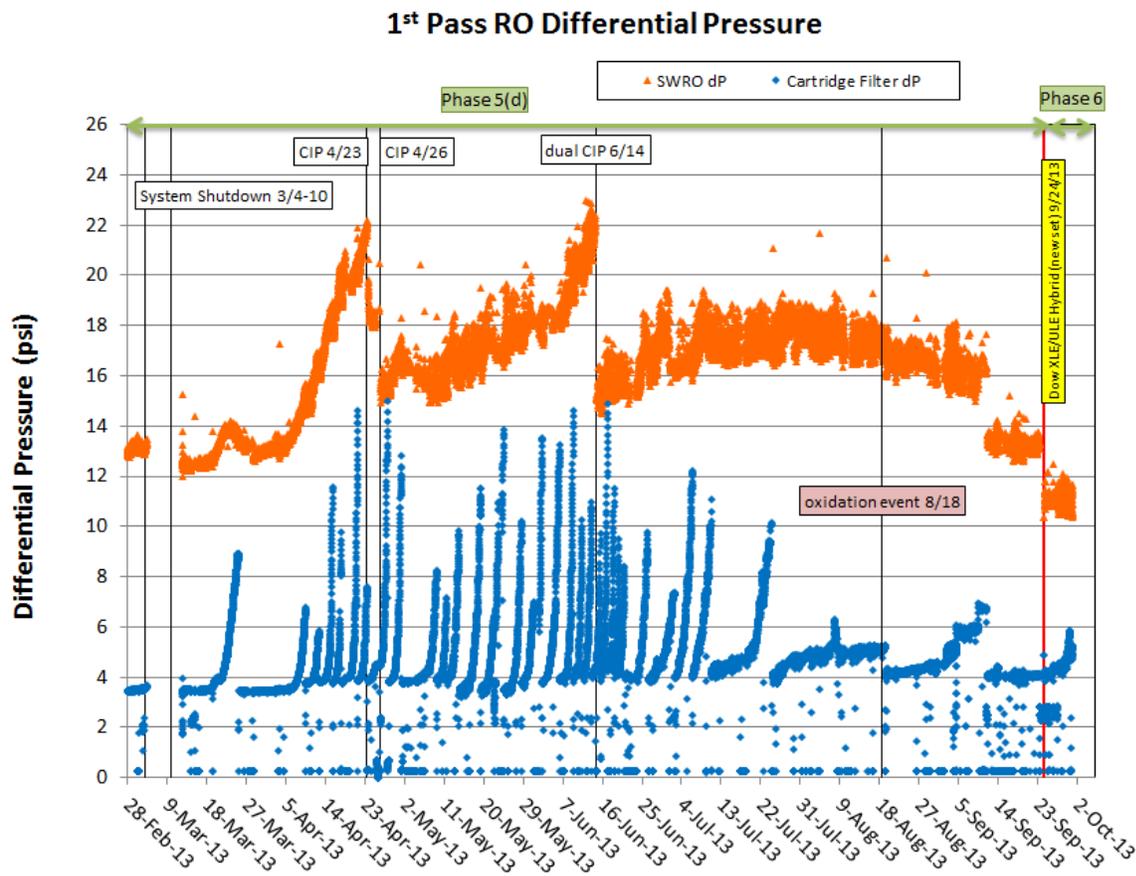
In the RO system, there were two noteworthy spikes in differential pressure, one at the end of April 2013 and one mid-June 2013 (Figure 4-28), when differential pressure reached 22 psi (from a baseline of 12-13 psi). During these events, the feed water quality was poor as shown by high turbidity in the UF feed and filtrate (Figure 4-12) as well as higher levels of Chlorophyll-a in the intake water, suggesting possible red tide events occurring during this time. Two CIPs were performed on April 23, 2013 and April 26, 2013 with Avista P-111 (as before), which resulted in a reduction in differential pressure from 22 psi to 16 psi. Avista P-111 targets removal of silt and organic foulants such as colloidal silica, clays, organic color and bacterial slime, but not iron deposits. This suggests the fouling of RO membranes in late April 2013 was mainly biological in nature. Chloramines were not operating during this time (restarted August 2013).

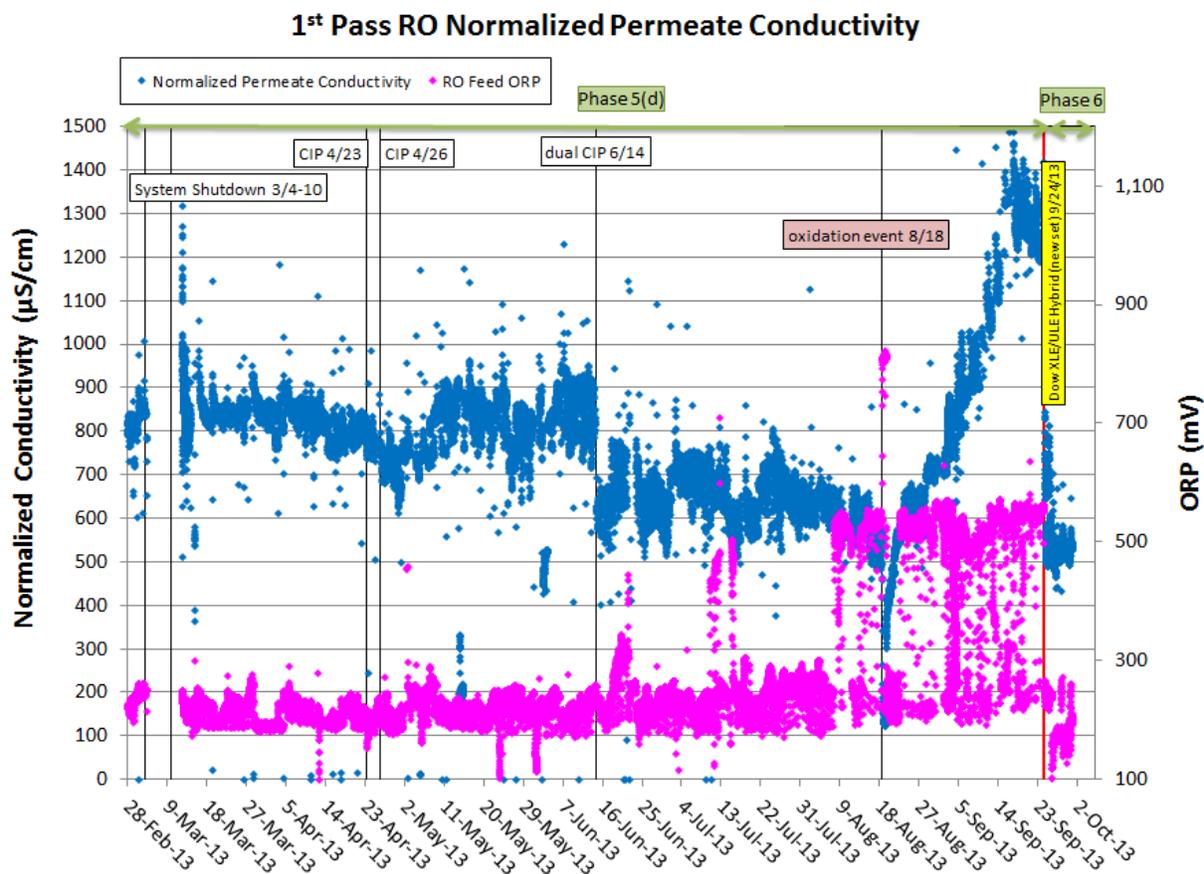
Figure 4-30 presents the normalized conductivity of the permeate for Phase 5(d). The spike in RO permeate conductivity observed on March 12, 2013 was related to the system startup after the general shutdown period for intake pipeline cleanup and modifications. From system restart in March 2013 to the second CIP on June 14 2013, conductivity was fairly constant, varying between 800 $\mu\text{S}/\text{cm}$ and 900 $\mu\text{S}/\text{cm}$. Following the CIP on June 14, 2013, conductivity stepped down significantly and varied between 600 $\mu\text{S}/\text{cm}$ to 700 $\mu\text{S}/\text{cm}$ until the oxidation event in August 2013. Such behavior after a CIP event is atypical for RO membranes, which normally observe a slight increase in permeate conductivity (decrease of rejection). Other parameters did not vary significantly in this period (permeability, differential pressure).
