West Basin Municipal Water District Ocean Water Desalination Demonstration Project Final Report

FINAL

February 29, 2016

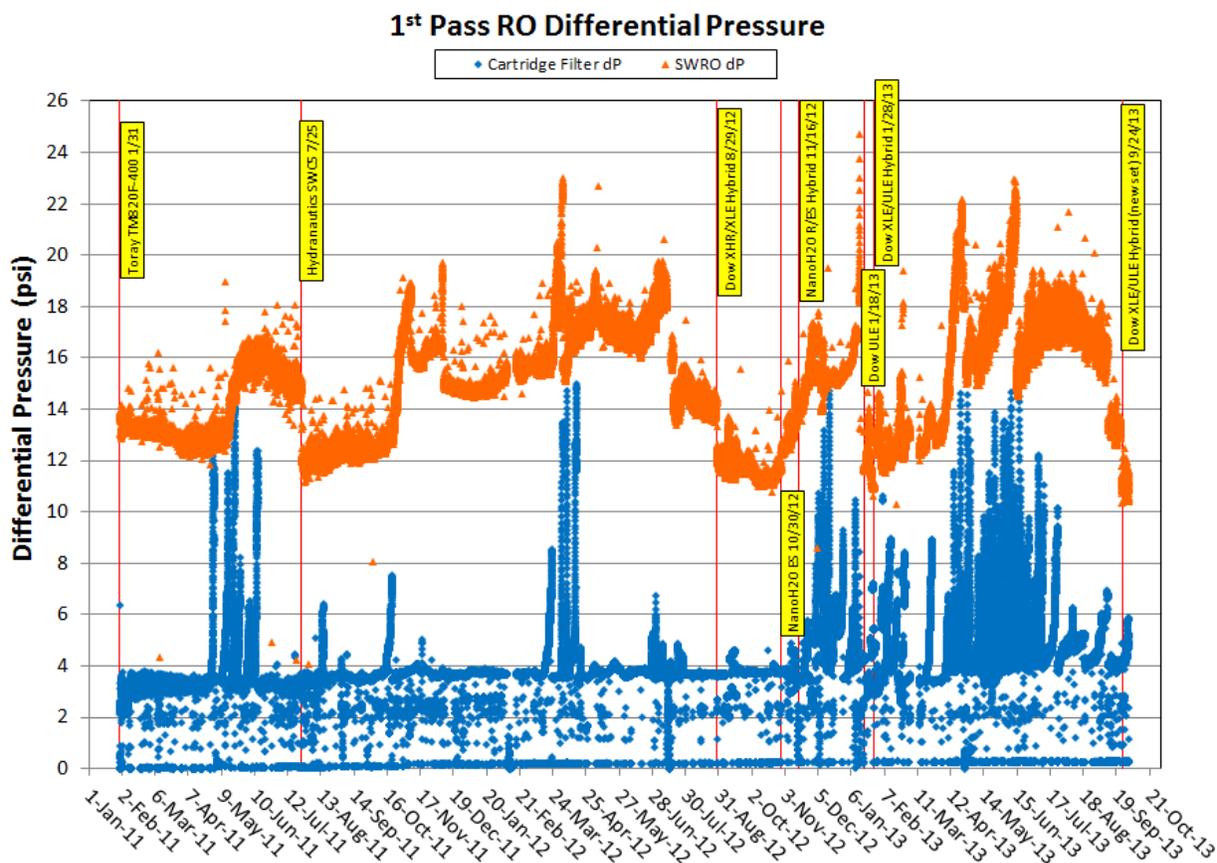
- Figure 4-32 shows the differential pressure across all membranes used in this study. When comparing the startup periods, all membrane sets presented similar values (12-13 psi) (Figure 4-32);

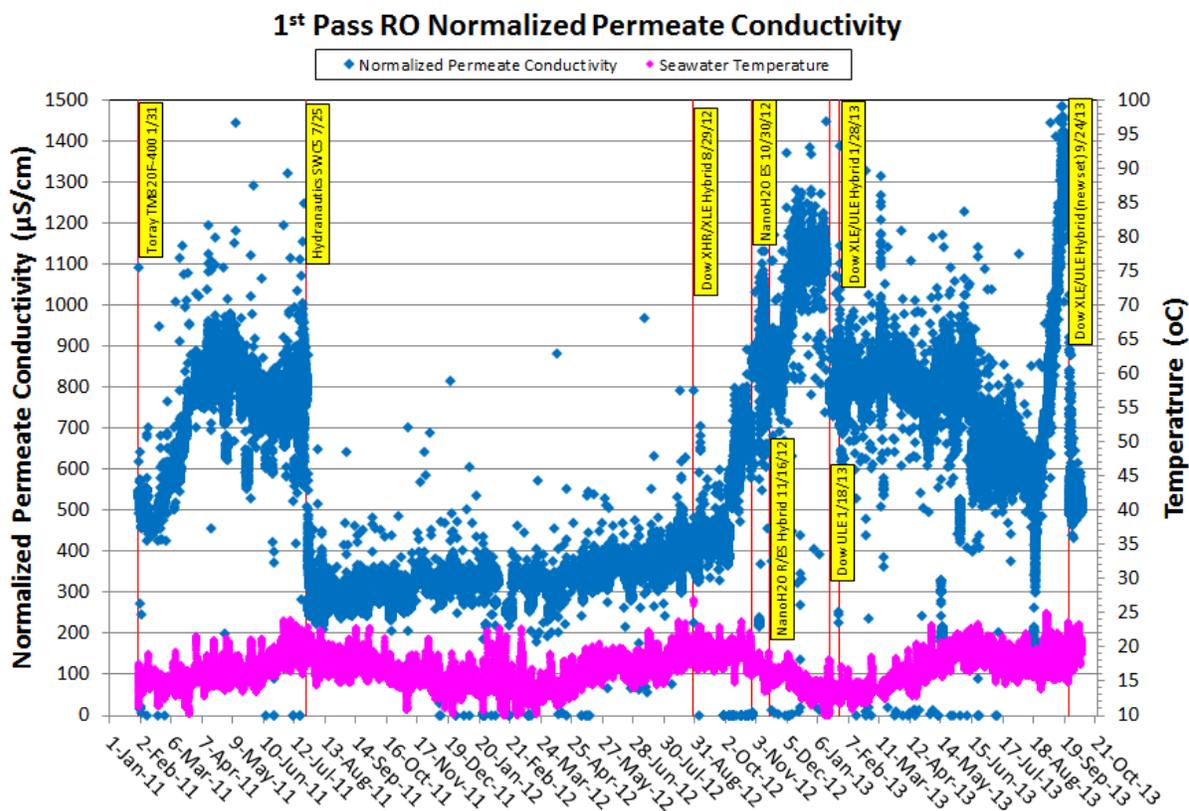
- Figure 4-33 presents the permeate conductivity for the three membrane sets used in the study. The normalized permeate conductivity was lowest for Hydranautics SWC-5 and Dow XHR/XLE (300-400 $\mu\text{S}/\text{cm}$), followed by Toray TM820F and second set of Dow XLE/ULE hybrid (500 $\mu\text{S}/\text{cm}$). The highest permeate conductivity was observed for NanoH₂O membranes and Dow ULE (800 $\mu\text{S}/\text{cm}$). This is generally inline with what was anticipated for the membranes respective class; however, it was observed that for NanoH₂O membranes (both ES and R/ES hybrid) as well as for Dow ULE and XLE/ULE hybrid set 1, the conductivity of the permeate was significantly higher than projected;
- Details of permeate water quality are presented in Section 5;

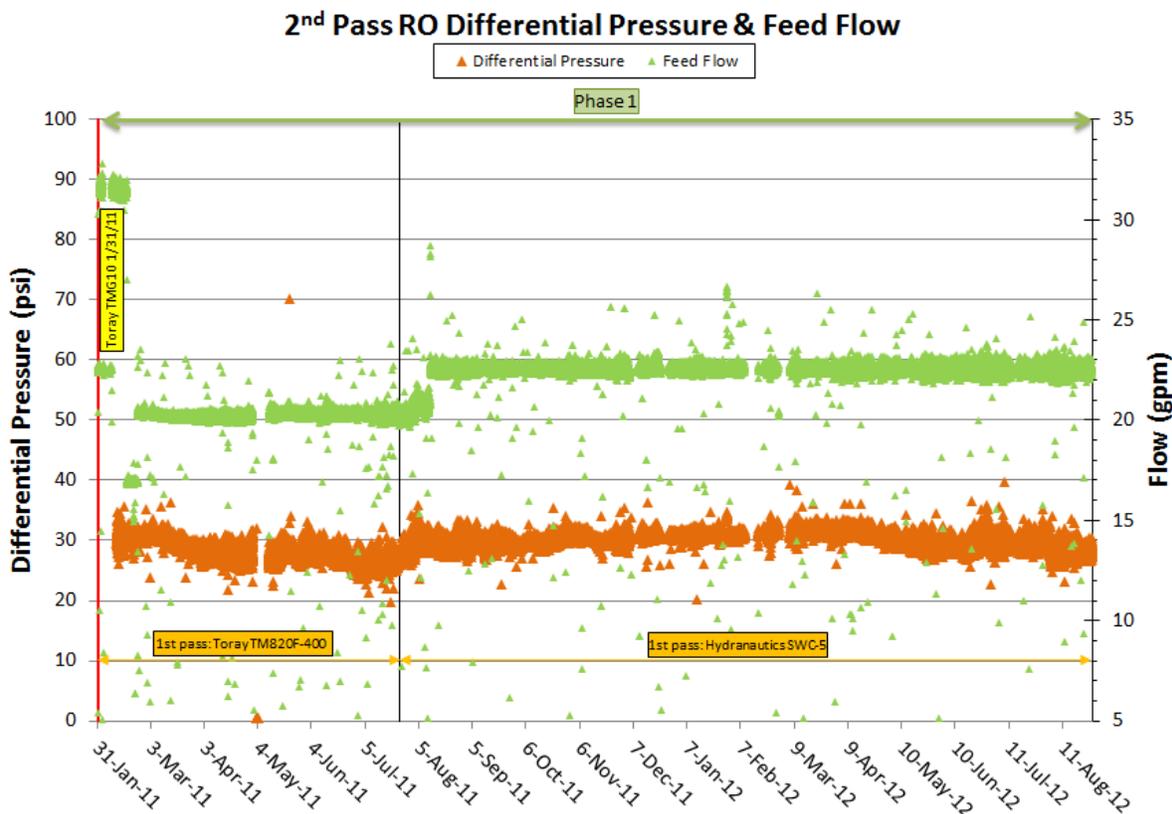
Figure 4-38 presents the differential pressure across the membranes in the second-pass. Toray membranes' differential pressure was stable at around 27 psi when the feed flow was 20 gpm and increased to about 30 psi with the increase in feed flow to 22 gpm. No cleaning was performed for this membrane set.

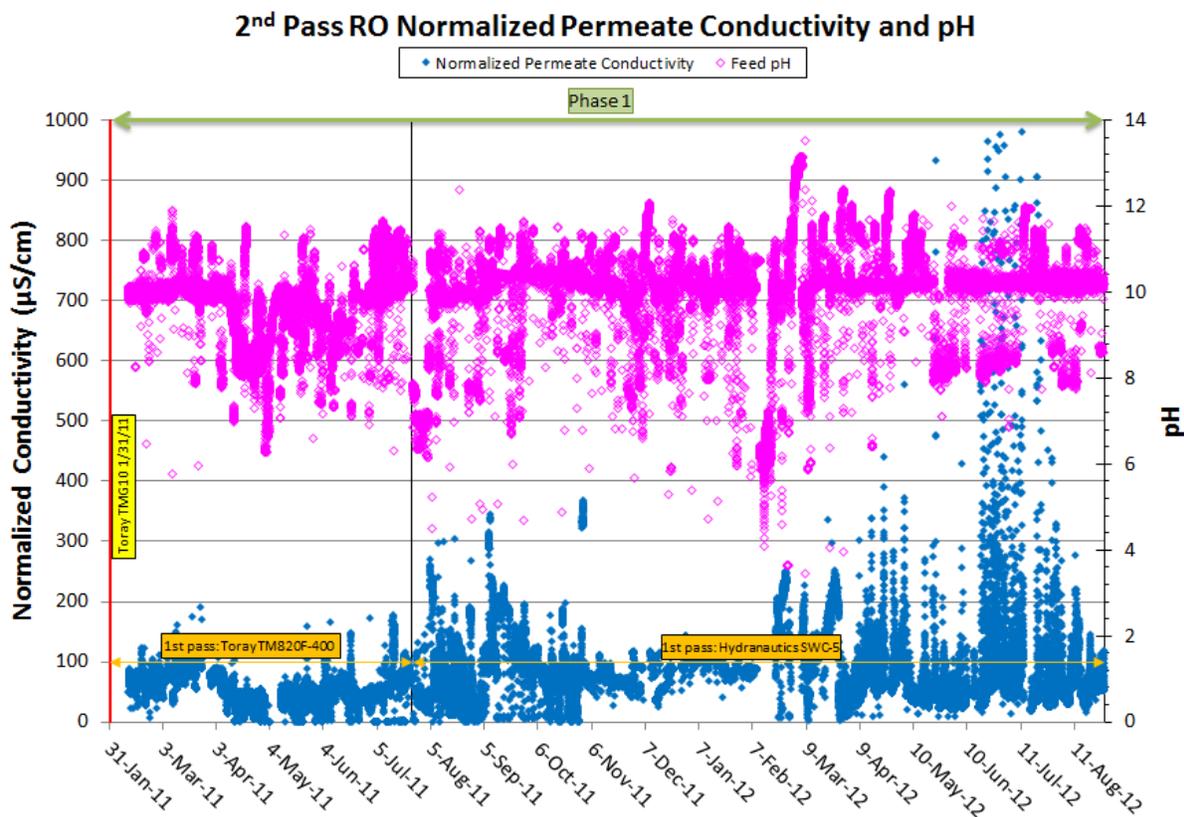
Figure 4-39 shows the permeate conductivity and feed pH. The increasing trend in normalized permeate conductivity for the Toray membrane in the first month after commissioning is either due to the increasing SWRO permeate conductivity (despite normalization), which is the feed water to the second-pass RO, or to potential oxidation of the membranes in the second-pass, coincidental with the oxidation of membranes in the first-pass (occurred from beginning of March 2011, as shown in Figure 4-37). Fluctuations of the permeate conductivity values was a chronic issue. The permeate conductivity probe was frequently cleaned and calibrated; however, it is believed that it malfunctioned due to entrained air. Readings with the Myron L handheld meter from April to November 2011 showed a relatively stable trend, with permeate conductivity values around 100 $\mu\text{S}/\text{cm}$. When membranes in the 1st pass were replaced with Hydranautics SWC-5 on July 25, 2011, they provided a much lower feed conductivity to the second-pass (down to 300 $\mu\text{S}/\text{cm}$); however, the conductivity in the second-pass permeate remained elevated

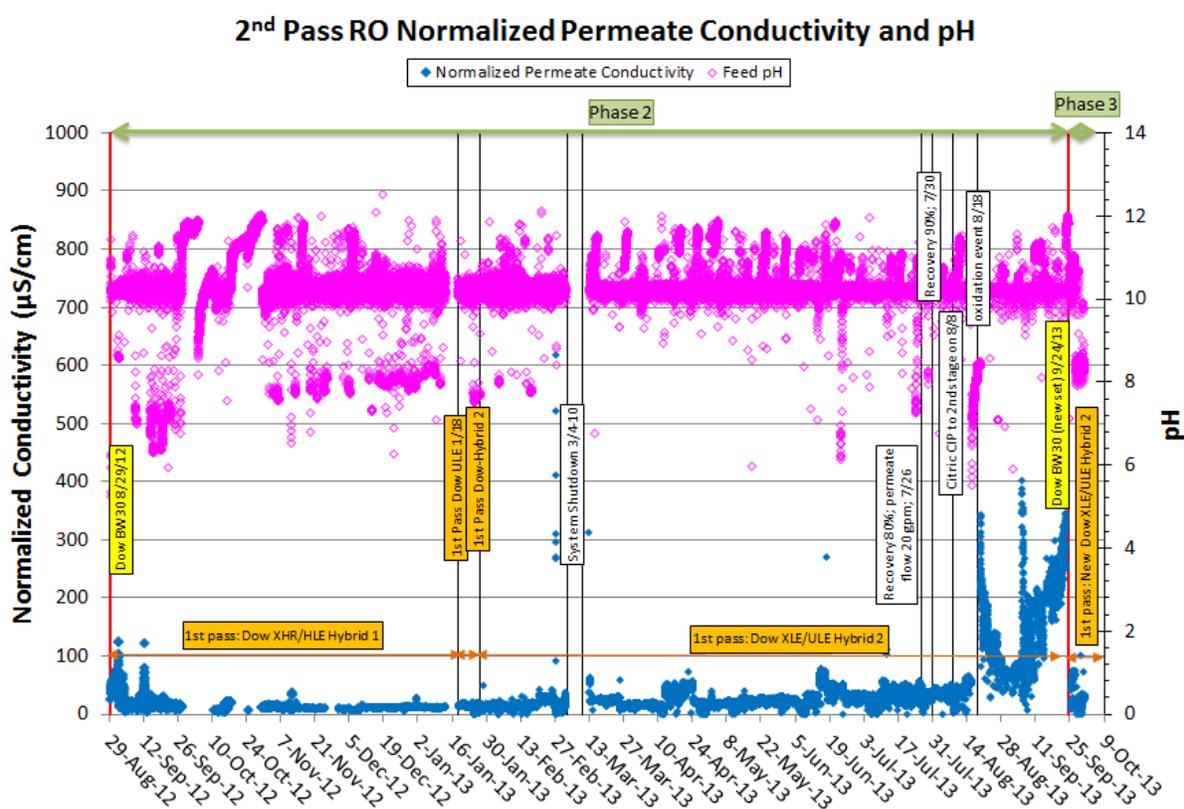
Figure 4-42 presents the normalized permeate conductivity for the second-pass for Phases 2 and 3, together with feed pH. The permeate conductivity values were steady and low, with variations between 7 $\mu\text{S}/\text{cm}$ and 50 $\mu\text{S}/\text{cm}$, depending on feed conductivity (i.e. 1st pass permeate, tail end). Controlling feed pH was challenging, which averaged 10.2, but varied by almost one pH unit. Feed pH was found to vary less at higher flow rates. For example, at 28 gpm the pH only varied between 10.0 and 10.4. As discussed above, conductivity increased greatly after the oxidation event when the membranes were compromised.

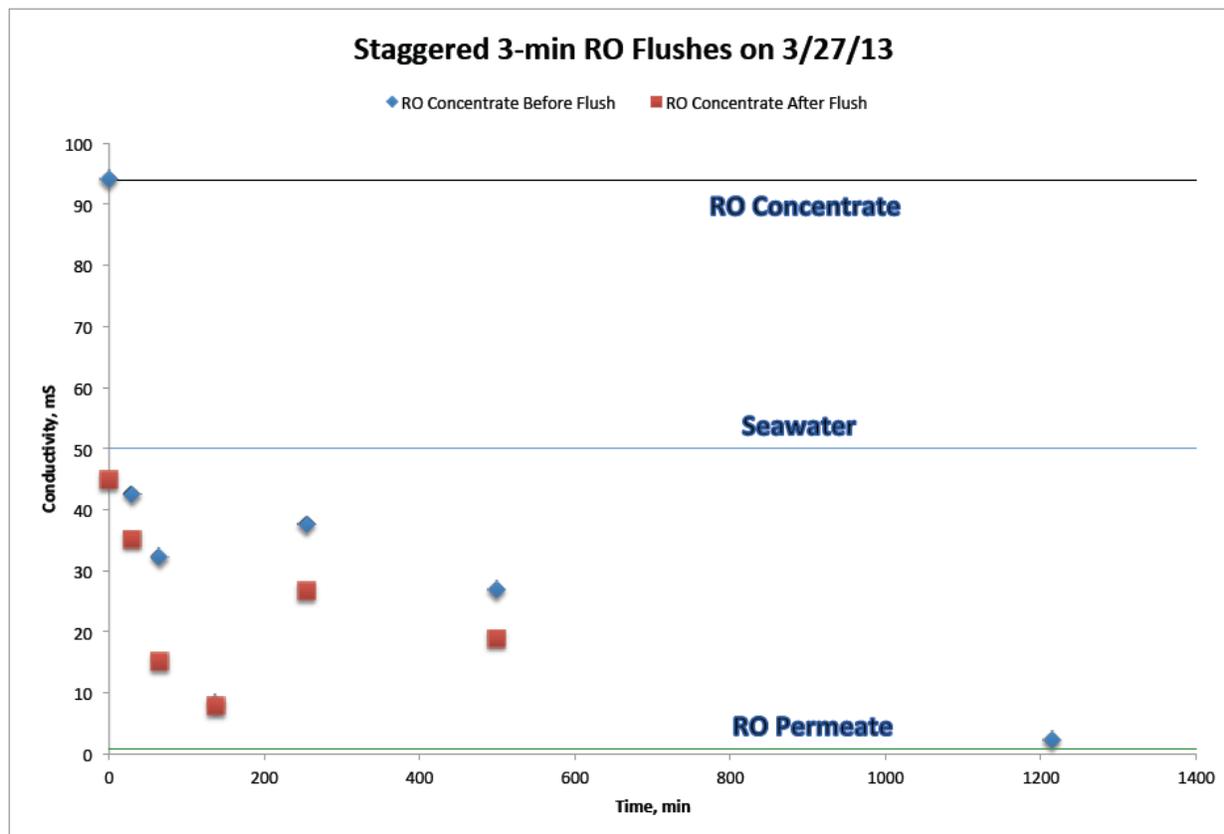
Figure 4-52: Results of RO Flush Test

The flush sequence for system shutdowns was re-evaluated, modified to include a series of increasing flush stages over an approximately 8-hour period, as well as redundant SBS pumping, and tested during the third quarter of 2013. A review of existing data from past chloramine/bromamine bench work and membrane oxidation at the pilot plant was completed. An initial test of the modified system of flushing the pressure vessels with RO permeate was conducted on March 27, 2013, and results are shown in Figure 4-52. Based on the positive preliminary test results and fixes to the SBS chemical feed system, including a redundant SBS dosing system, the preformed chloramines were restarted in the UF feed during Q3 2013.
