Subject: September 2014 WBMWD Biofouling Test Rack I Inspection

West Basin Intake Biofouling Test Test Rack I September 17, 2014

Duration of Testing: June 17, 2014 – September 16, 2014 (92 days)

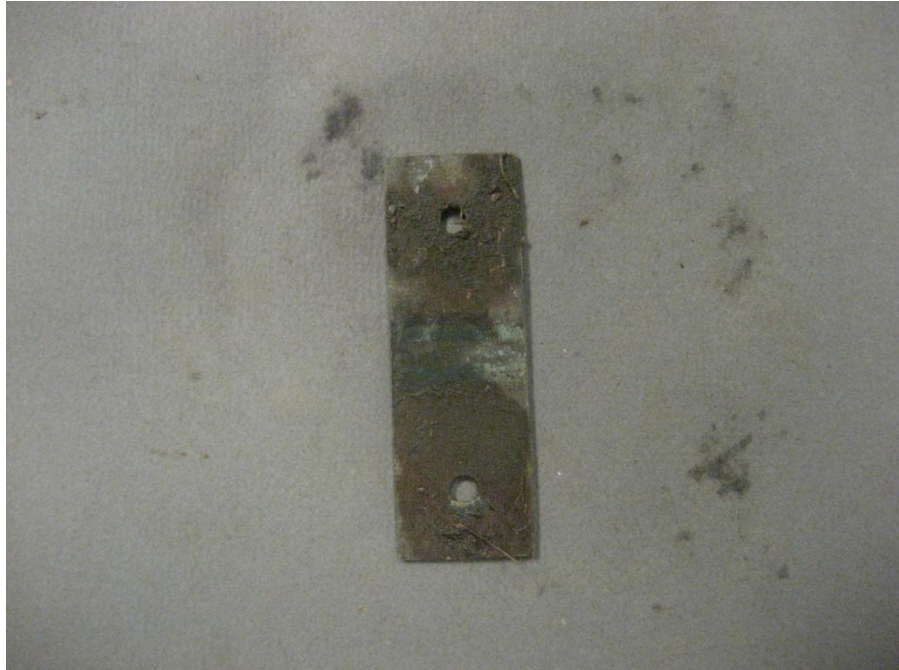
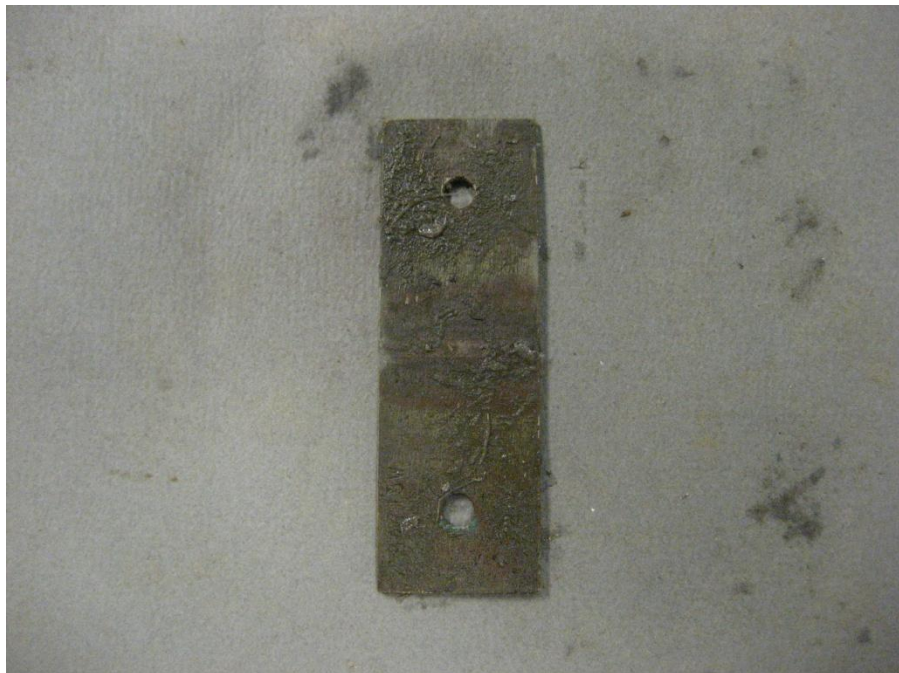
Figure 9. 70/30 Cu/Ni (CDA715) Wedgewire sample, photographed 12/30/14.

- **CDA 715 (70/30 Copper/Nickel); wedgewire sample and coupon (IIIA5 and IIIB5):**
 - Wedgewire sample (IIIA5) (**Figure 9**)
 - The CDA 715 WW sample was similar to the CDA 706 and Z-Alloy samples, but with more filamentous red algae (about 10 percent coverage), more of a diatom and silt film/layer, and only a little green patina on the metal's surface. There were a few hydroids and a few erect bryozoans. No barnacles or other macrofouling aside from the hydroids and bryozoans. All fouling and debris was easily removed with a soft nylon brush after photographing and inspection.

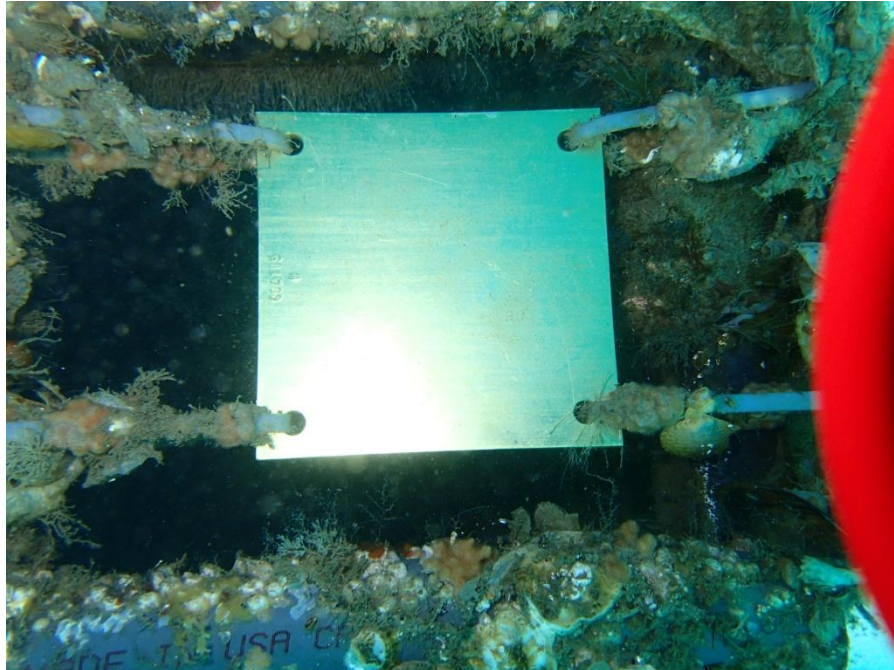
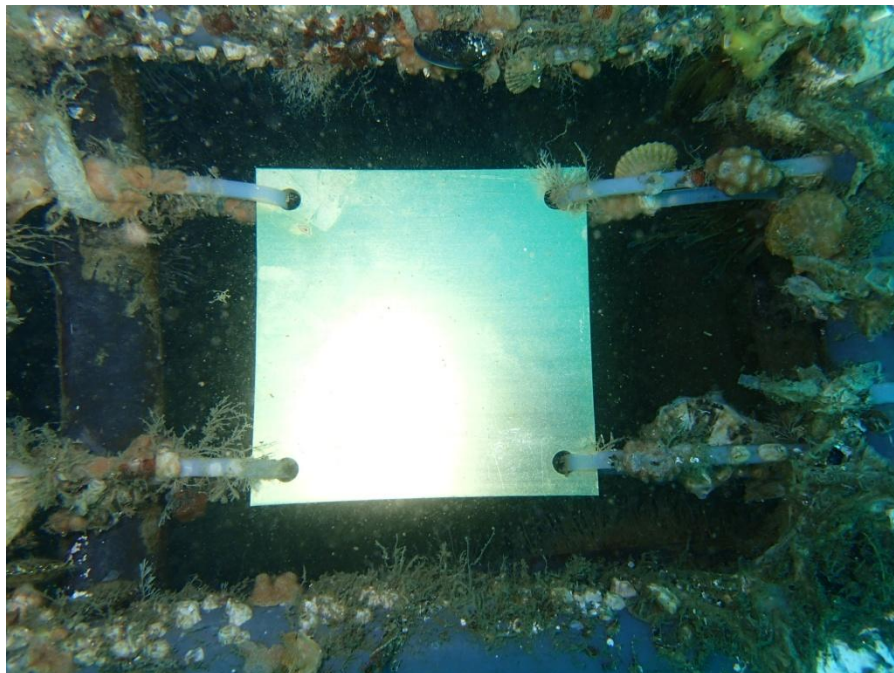
Figure 11. 90/10 Cu/Ni (CDA706) test plate (Test Plate 1), photographed 12/29/14 in situ after removal of its Vexar mesh bag.

- **CDA 706 (90/10 Copper/Nickel), Plate 1, (Figure 11)**
 - The plate is almost entirely covered with a blue-green patina.
 - No attached macrofouling is visible in the photographs of the plate.
 - Hydroids, acorn barnacles, colonial tunicate, erect bryozoans, and other invertebrates are attached to the PVC frame and the plastic cable ties that secure the plate to the frame.
- **CDA 715 (70/30 Copper/Nickel), Plate 2, (Figure 12)**
 - The plate is very clean with almost no discoloration or oxidation visible in the photo.
 - No attached macrofouling.
 - Hydroids, acorn barnacles, solitary and colonial tunicates, bryozoans, mussels, scallops, sponges, tube worms, and other invertebrates are

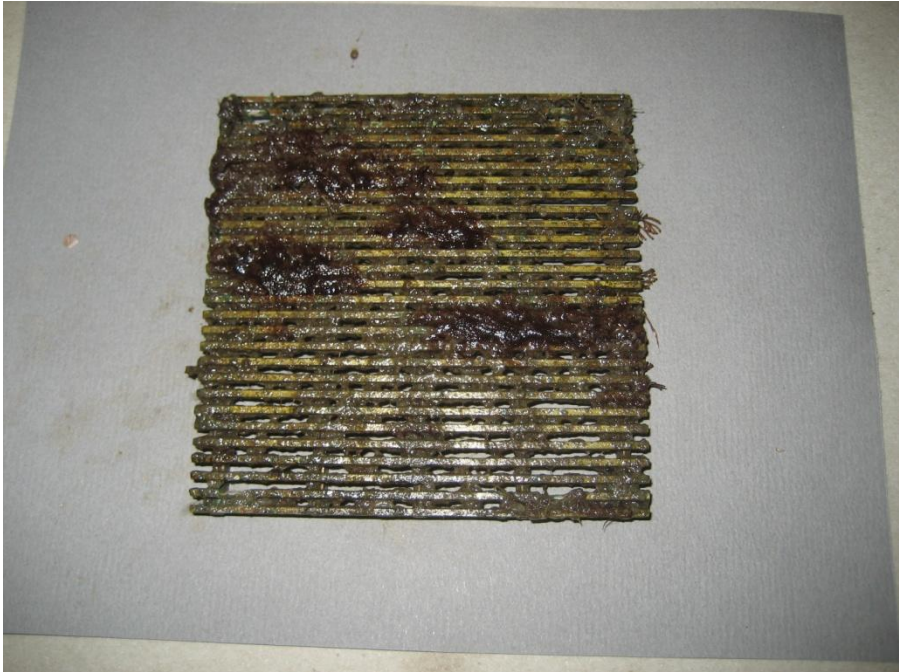
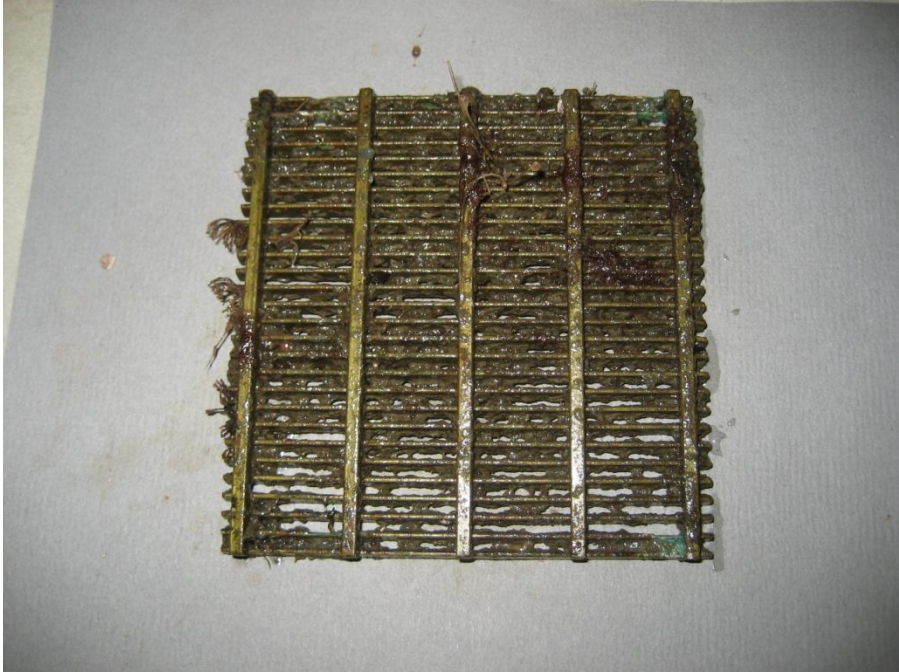
Figure 8. 2205 stainless steel coupon, photographed 04/22/15.

- Coupon (IVA4) (**Figure 8**)
 - The coupon was also heavily fouled with no metal visible. Hydroids (up to 2 cm long), filamentous red algae, erect and encrusting bryozoans, and tunicates covering most of its surface. Beneath the hydroids were 60 to 80 barnacles (*M. californicus*) ranging in size from 2 to 15 mm. Intermixed with the hydroids were 8 mussels (4 to 6 mm), some other small white bivalves (*Hiatella?*), amphipod and worm tubes, encrusting red coralline algae, and sponges. The original weight of the coupon was about 22 grams, with the attached fouling the weight was about 52 grams. The fouling was firmly attached and was not removed for fear of damaging the coupon prior to metal analyses.

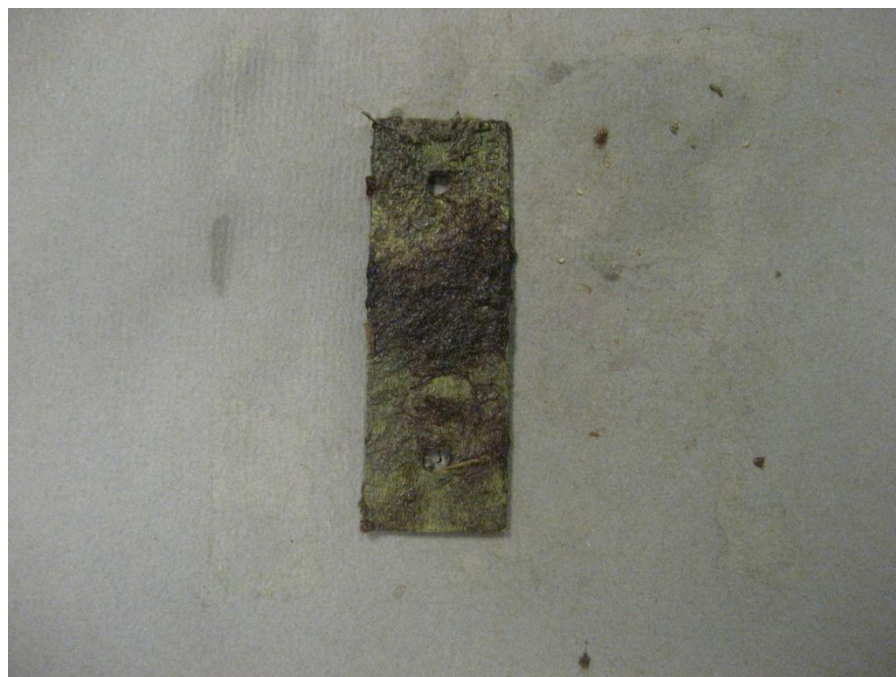
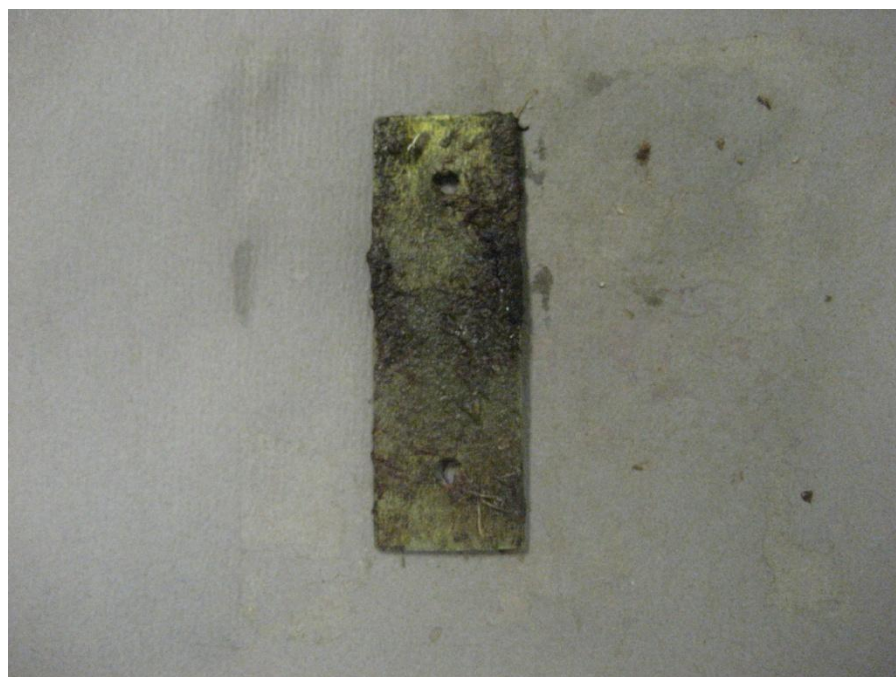
Figure 9. 70/30 Cu/Ni (CDA715) Wedgewire sample, photographed 04/22/15.

- **CDA 715 (70/30 Copper/Nickel); wedgewire sample and coupon (IVA5 and IVB5):**
 - Wedgewire sample (IVA5) (**Figure 9**)
 - The CDA 715 WW sample was similar to the CDA 706 and Z-Alloy samples, but with more of the surface, about 60 percent, covered by amphipod tubes and filamentous red algae. There was also more of a diatom and silt film/layer, and only a little green patina on the metal's surface. There were a few hydroids and all appeared to no longer have polyps at their tips. Eight very small mussels (largest 2 mm in length). There were no barnacles or other macrofouling aside from the hydroids and mussels. All fouling and debris was easily removed with a soft nylon brush after photographing and inspection. There was accelerated corrosion/erosion of the Wedgewire at the sites of the plastic cable ties.

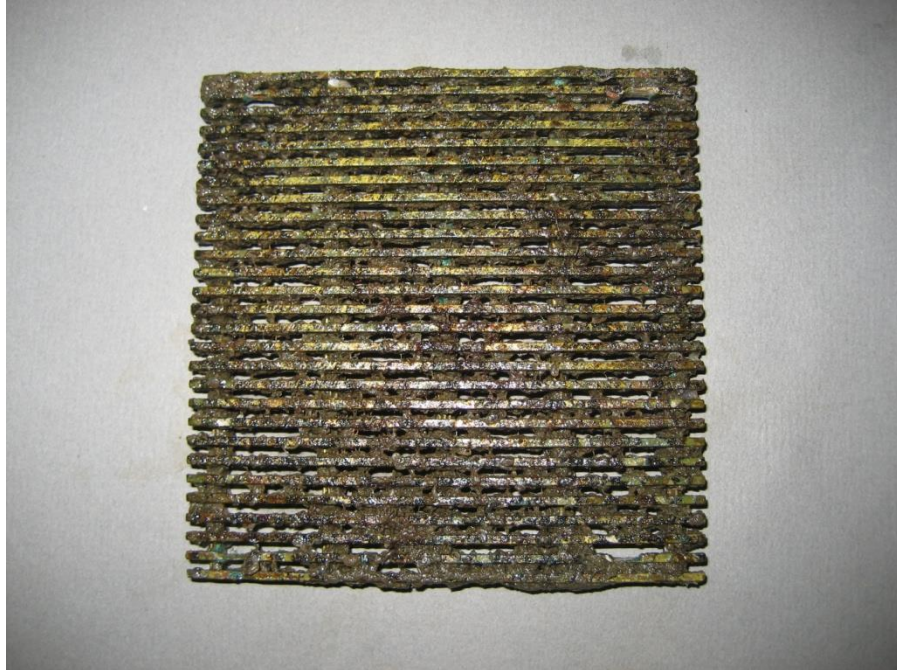
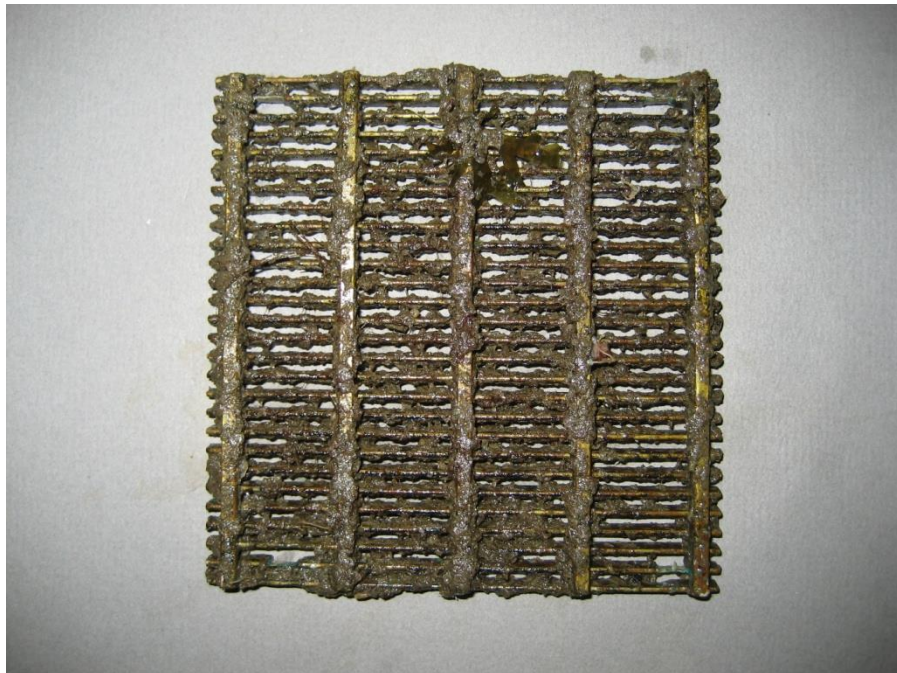
Figure 8. 2205 stainless steel coupon, photographed 06/17/15.

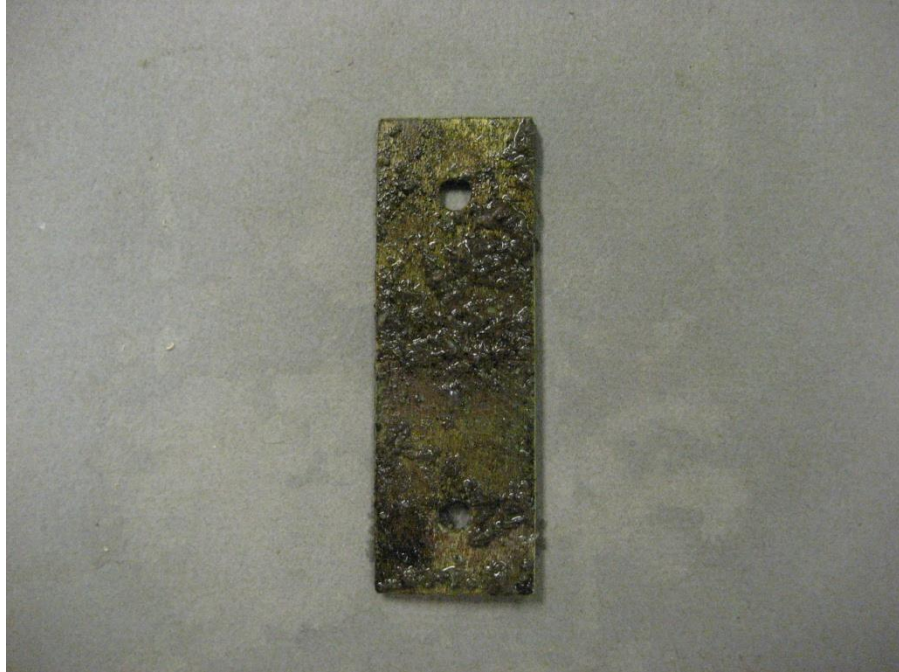
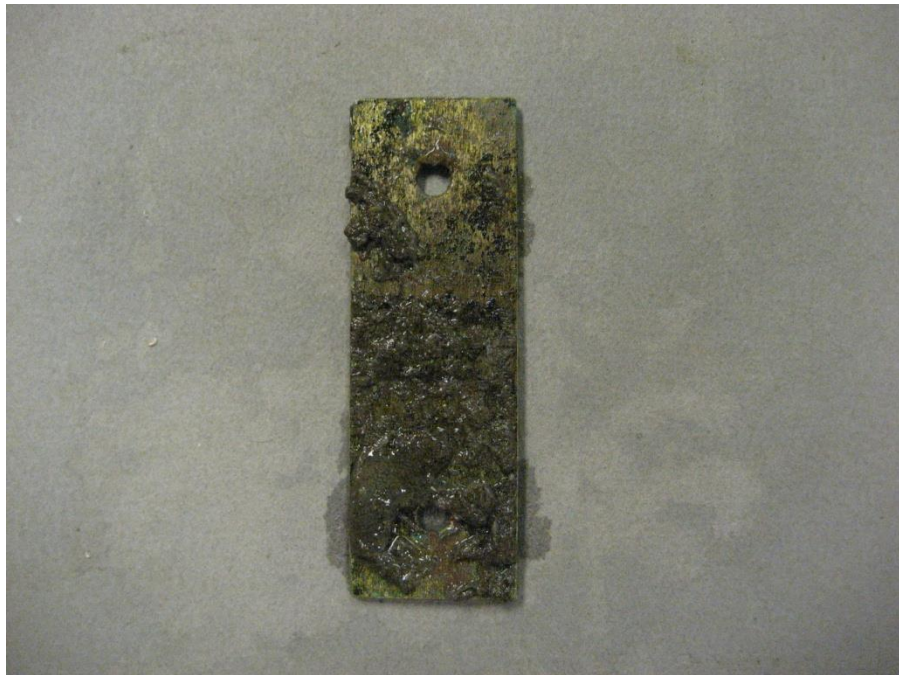
Figure 9. 70/30 Cu/Ni (CDA715) Wedgewire sample, photographed 06/17/15.

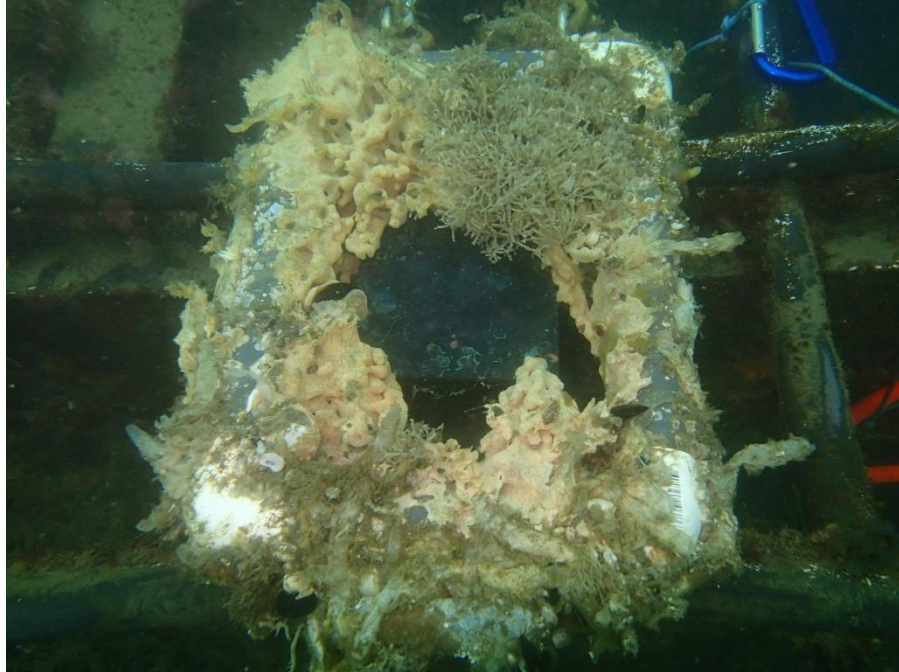
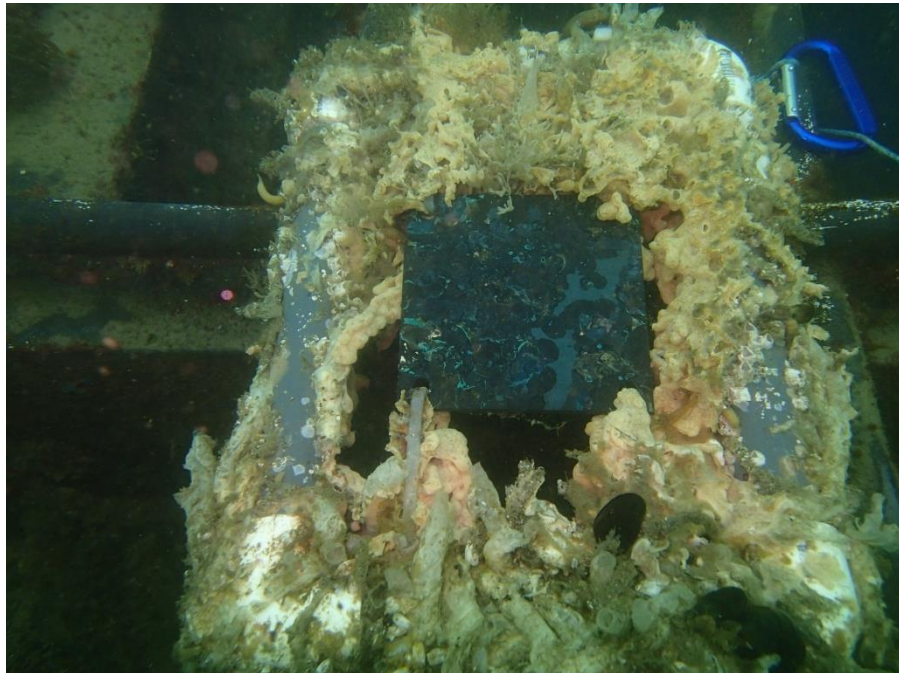
Figure 10. 70/30 Cu/Ni (CDA715) coupon, photographed 06/17/15.

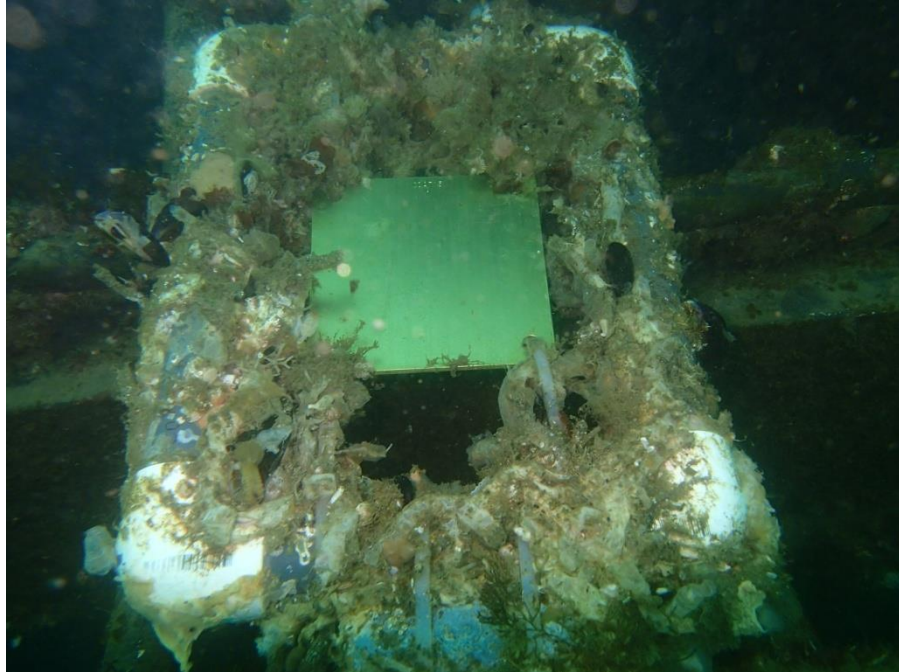
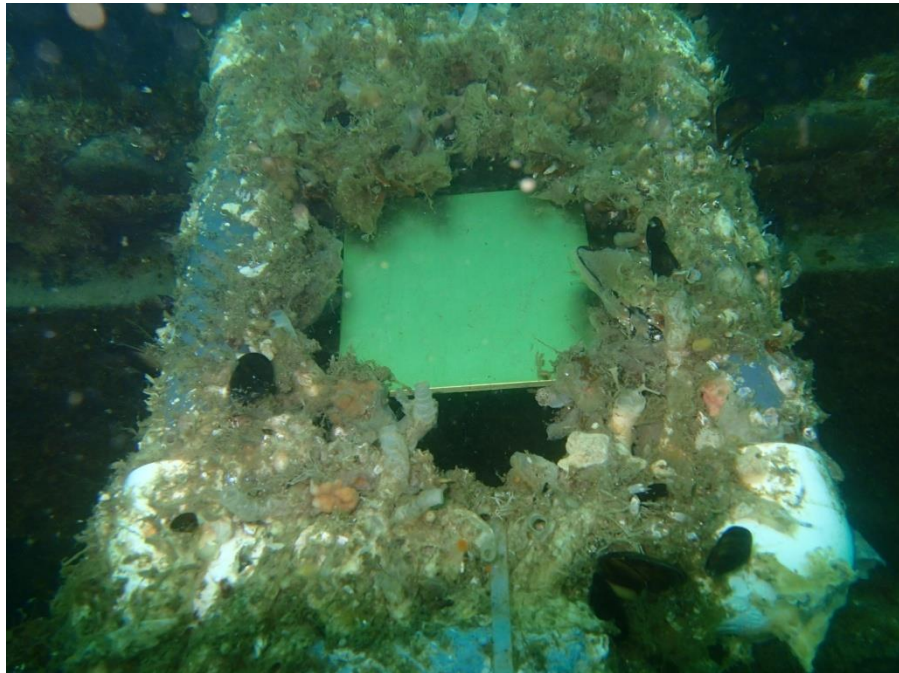
- **CDA 706 (90/10 Copper/Nickel), Plate 1, (Figures 11 and 12)**
 - The plate is almost entirely covered with a dark blue-green patina. This tends to flake off when the plate is handled.

Figure 12. 90/10 Cu/Ni (CDA706) test plate (Test Plate 1), photographed 06/18/15 prior to biofouling inspection.

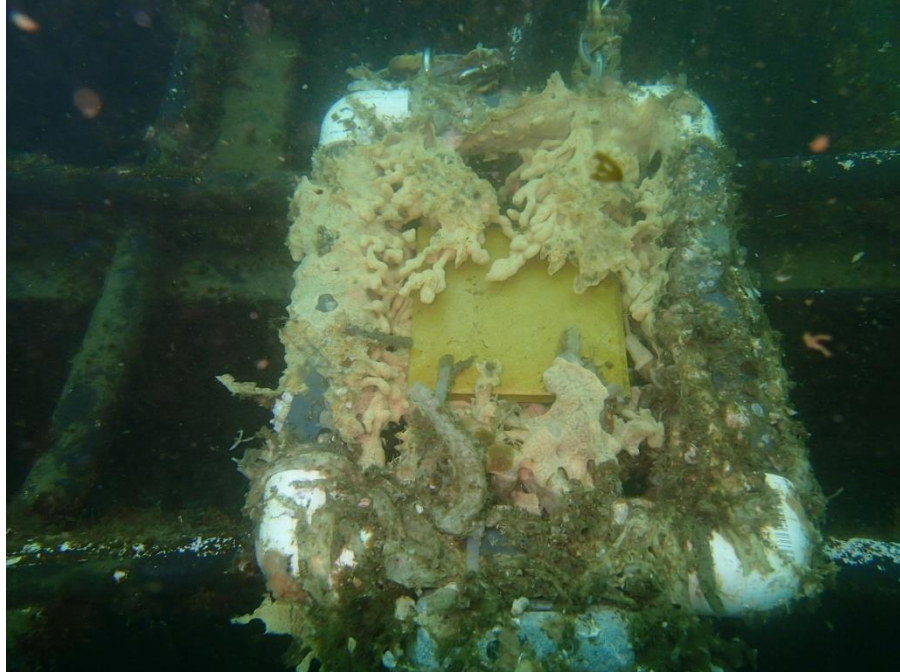
- No attached macrofouling.
 - No slime detectable
 - No algae, diatoms, or silt.
- **CDA 715 (70/30 Copper/Nickel), Plate 2, (Figures 13 and 14)**
 - The plate is very clean with almost no discoloration or oxidation visible (a very slight, light-green discoloration). The plate looks almost new.

Figure 14. 70/30 Cu/Ni (CDA715) test plate (Test Plate 2), photographed 06/18/15 prior to biofouling inspection.

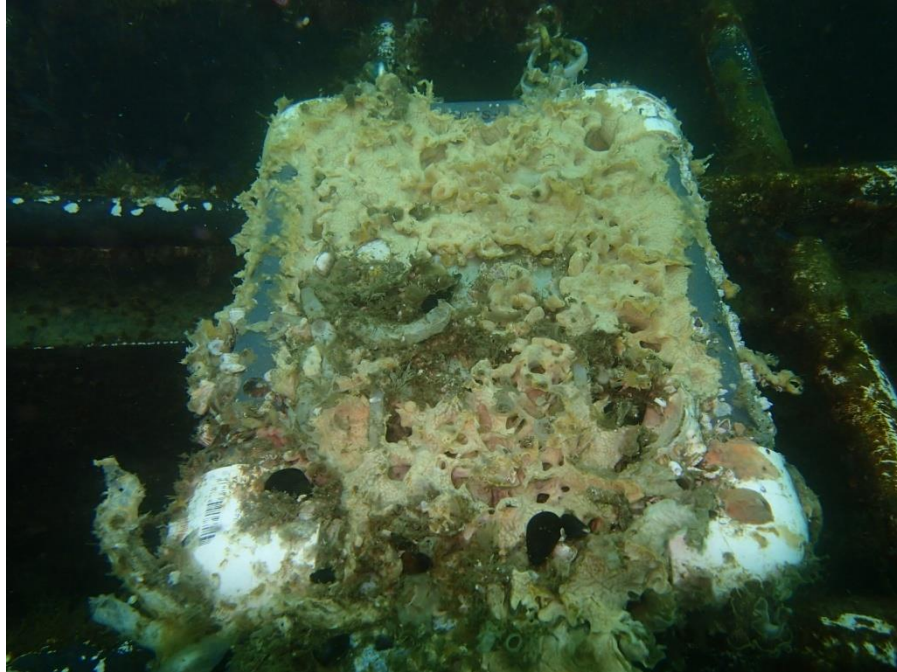
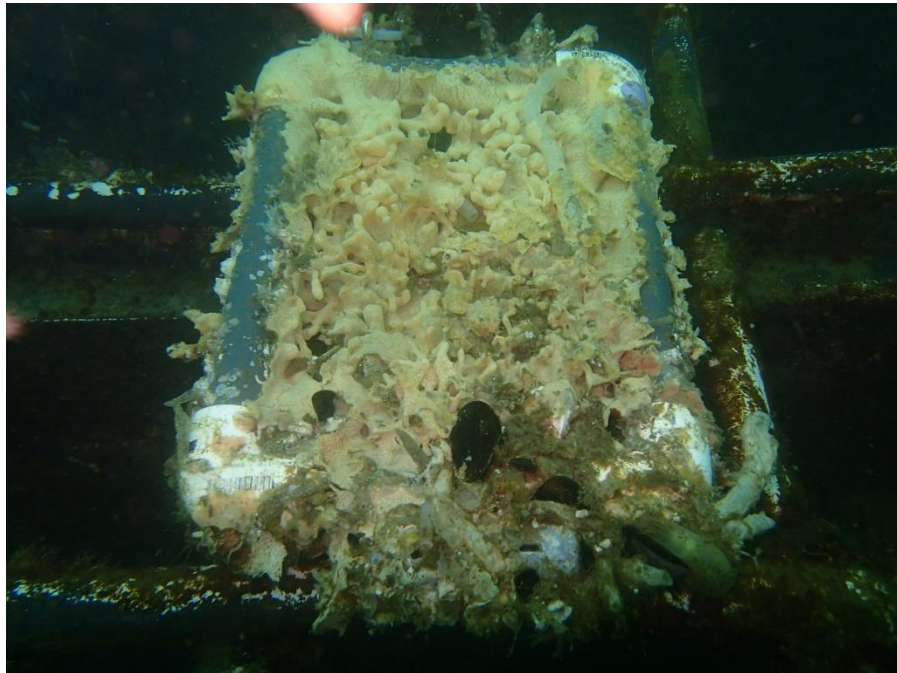
- **Z-alloy, Plate 3, (Figures 15 and 16)**
 - The plate is very clean, except for a single 19 mm mussel that had been attached to one of the cable ties. When the cable tie was removed, the mussel remained loosely attached to the plate by three byssal threads.

Figure 16. Z-alloy test plate (Test Plate 3), photographed 06/18/15 prior to biofouling inspection.

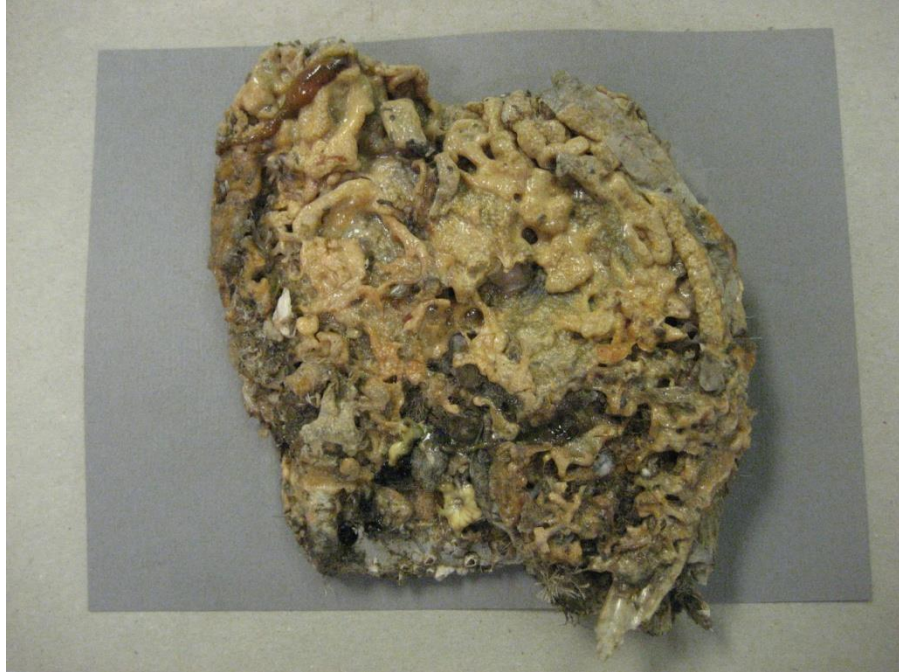
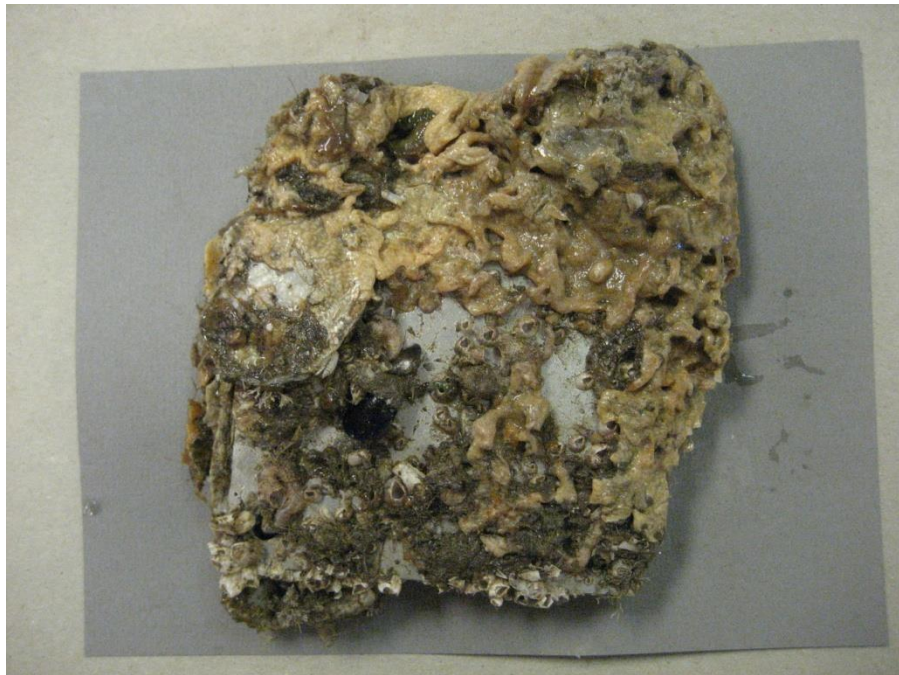
- Motile species: 8 small (3 mm) amphipods stranded on the plate.
- **2205 Stainless Steel (uncoated), Plate 4, (Figures 17 and 18)**
 - This plate is very heavily fouled; almost completely covered with macrofouling, primarily a large, expansive encrusting sponge. Very little metal visible. Other species include:

Figure 17. 2205 stainless steel test plate and PVC frame (Test Plate 4), photographed 06/16/15 in situ after removal of its Vexar mesh bag.

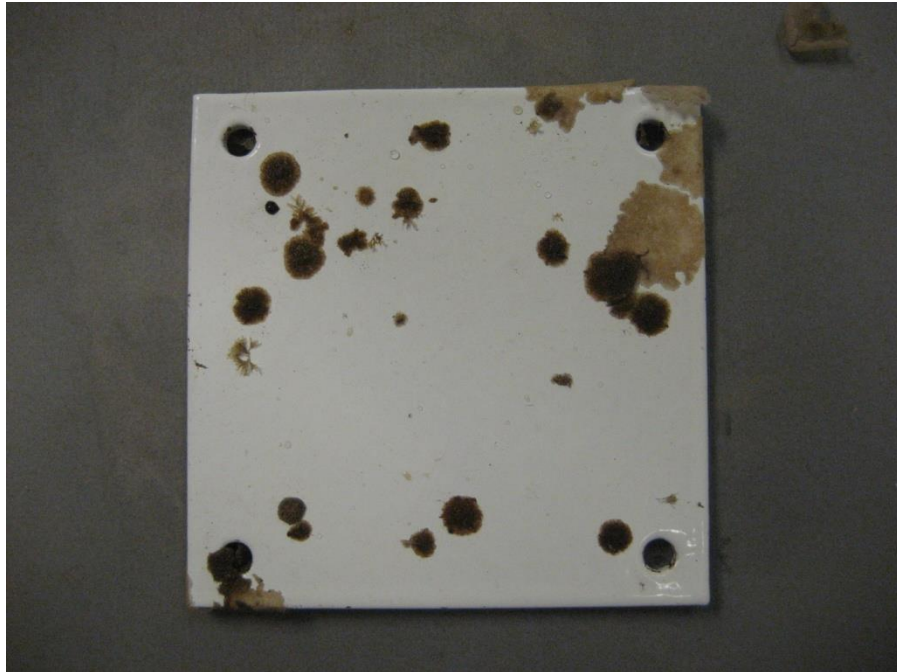
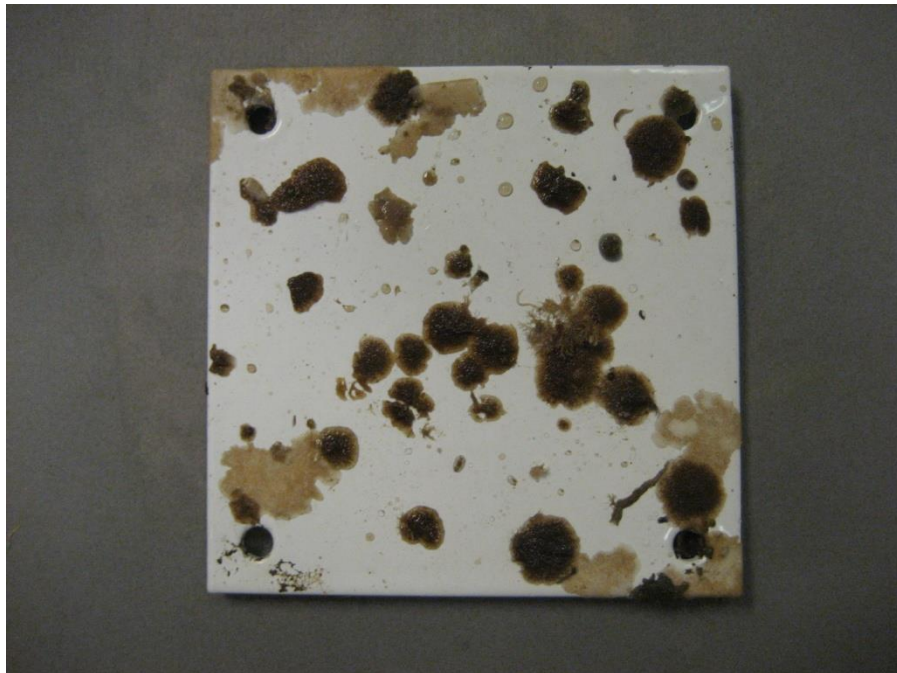
- **2205 Stainless Steel with foul release coating, Plate 5, (Figures 19 and 20)**
 - As stated earlier, this plate and its frame and bag were missing when the divers arrived at the WB intake in April 2015. The cords that suspended the frame may have failed, but remained intact on the other four plates. The plate was found lying in the soft sediment and was retrieved from inside the intake by the divers and returned to its original position. The cords were replaced on all five of the plate frames.

Figure 19. 2205 stainless steel test plate with foul release coating and PVC frame (Test Plate 5), photographed 06/16/15 in situ after removal of its Vexar mesh bag.
