WEST BASIN MUNICIPAL WATER DISTRICT OCEAN WATER DESALINATION INTAKE CORROSION STUDY

November 2014

V&A Project No.: 13-0376

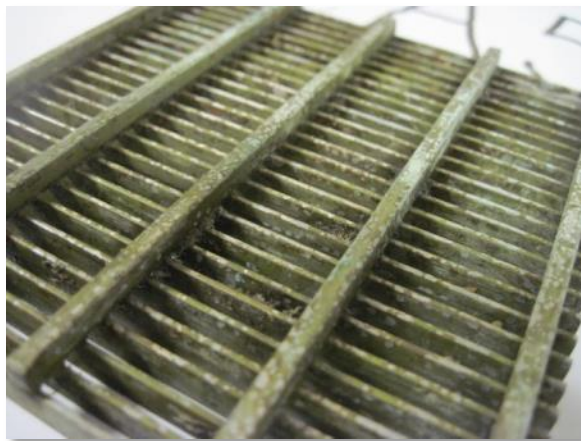
Photo 3-3. 70-30 Cu-Ni 4-inch by 4-inch wedge wire screen

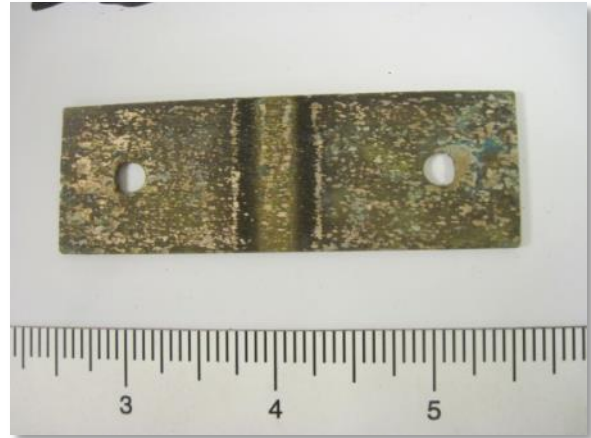
Photo 3-6. 90-10 Cu-Ni 1-inch by 3-inch coupon with weld

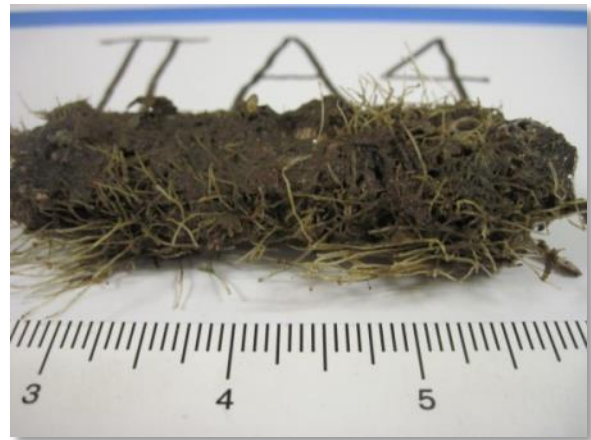
Photo 3-8. 2205 Duplex stainless Steel 1-inch by 3-inch coupon with a weld.

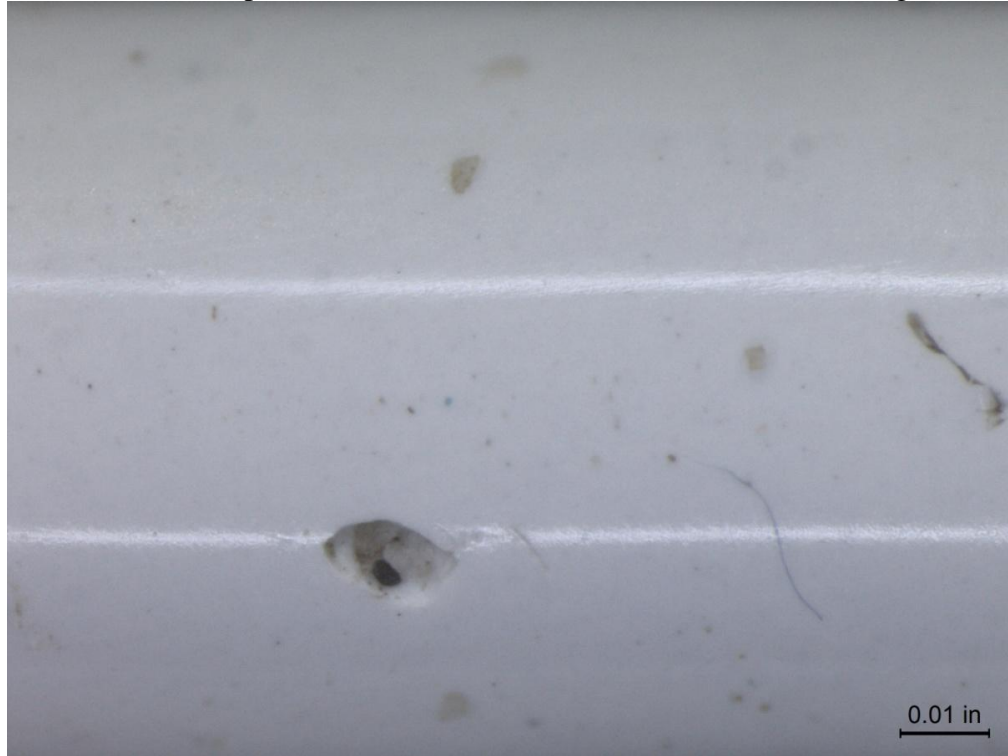
(a) Coated Duplex 2205 Stainless Steel Screen 1, Before Cleaning 10X

(b) Coated Duplex 2205 Stainless Steel Screen 1, Before Cleaning 50X

Figure 13 Optical macrographs of duplex 2205 stainless steel with anti-biofouling coating screen 1 after a 3 month corrosion test, before cleaning.

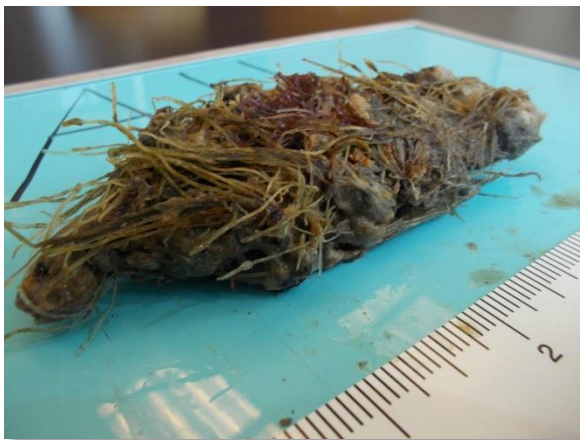
Photo 3-1. Marine life attached to uncoated 2205 Duplex stainless steel coupon with a weld.

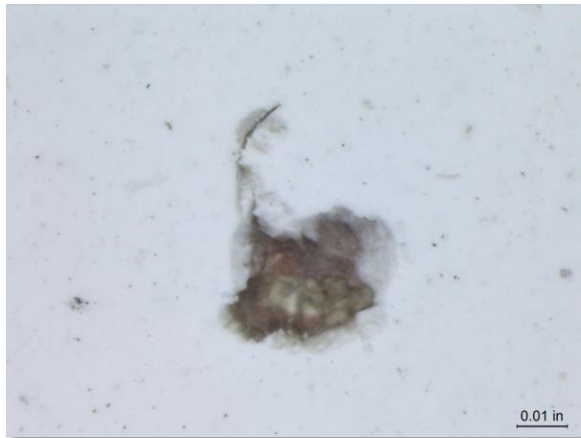
Photo 3-19. 2205 Duplex SS coupon surface exposed at an area of coating damage.

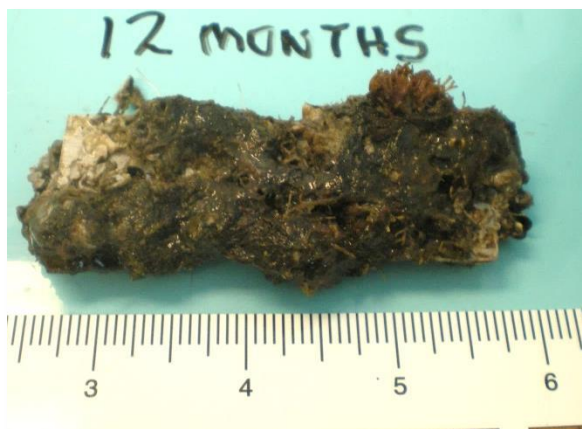
Photo 3-1. Marine life attached to uncoated 2205 Duplex stainless steel coupon with a weld.

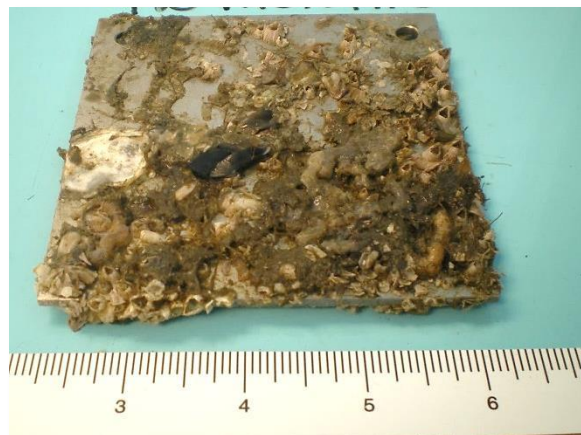
Photo 3-2. Marine life attached to uncoated 2205 Duplex stainless steel flat plate.

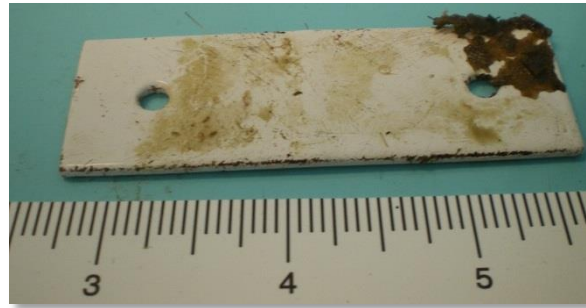
Photo 3-4. Slight damage to coating on edge and initiation of biofouling on corner of coated 2205 Duplex stainless steel coupon.

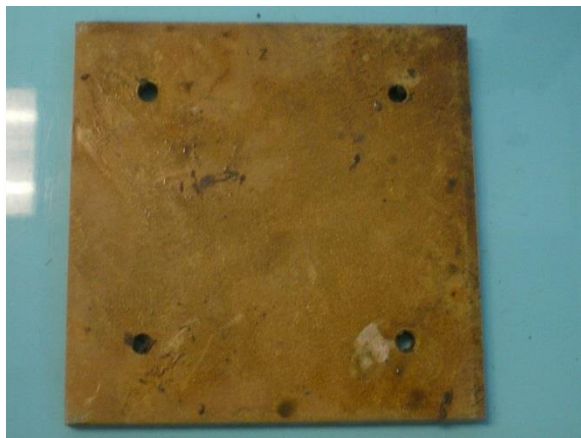
Photo 3-19. Minimal corrosion was observed on the Z alloy flat plate.

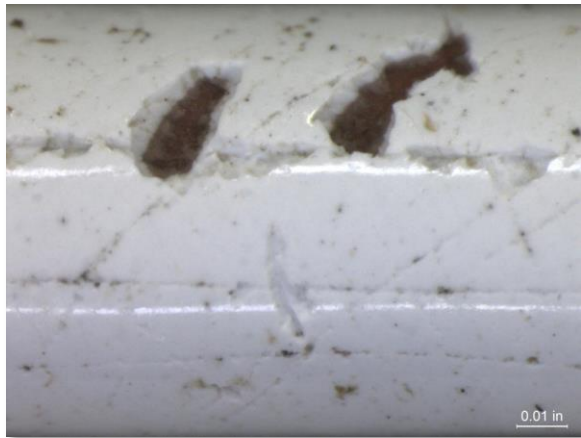
Photo 3-25. 2205 Duplex SS wedge wire screen surface exposed at an area of coating damage.

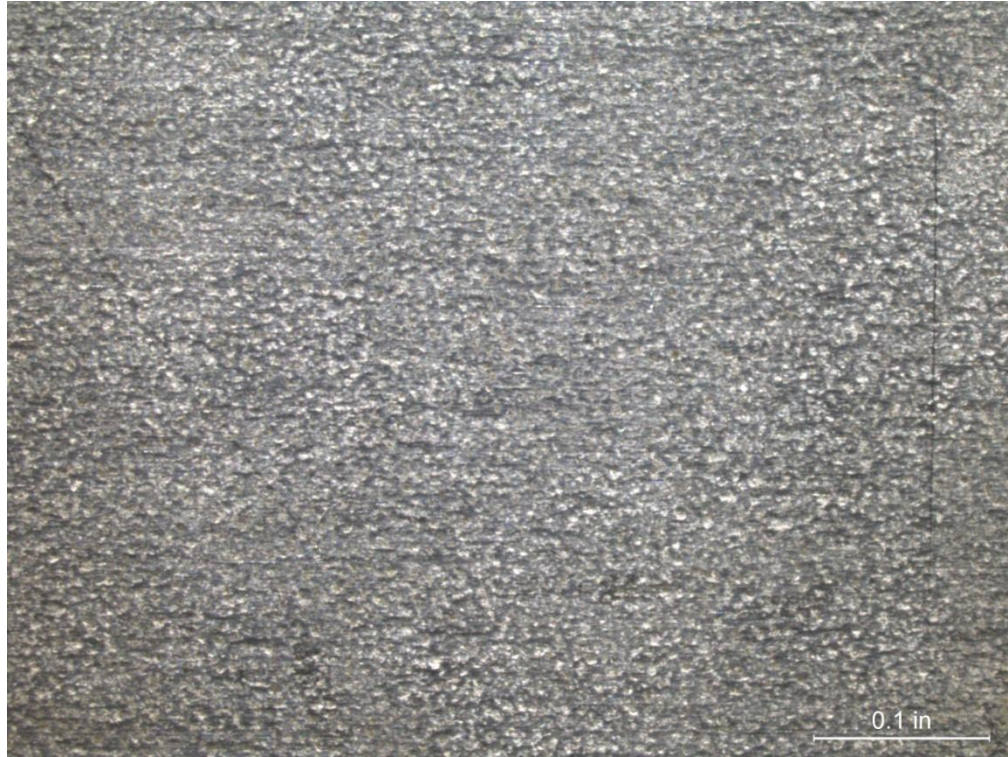
Figure 33 Optical macrographs of duplex 2205 stainless steel plate after a 12 month corrosion test, after cleaning.

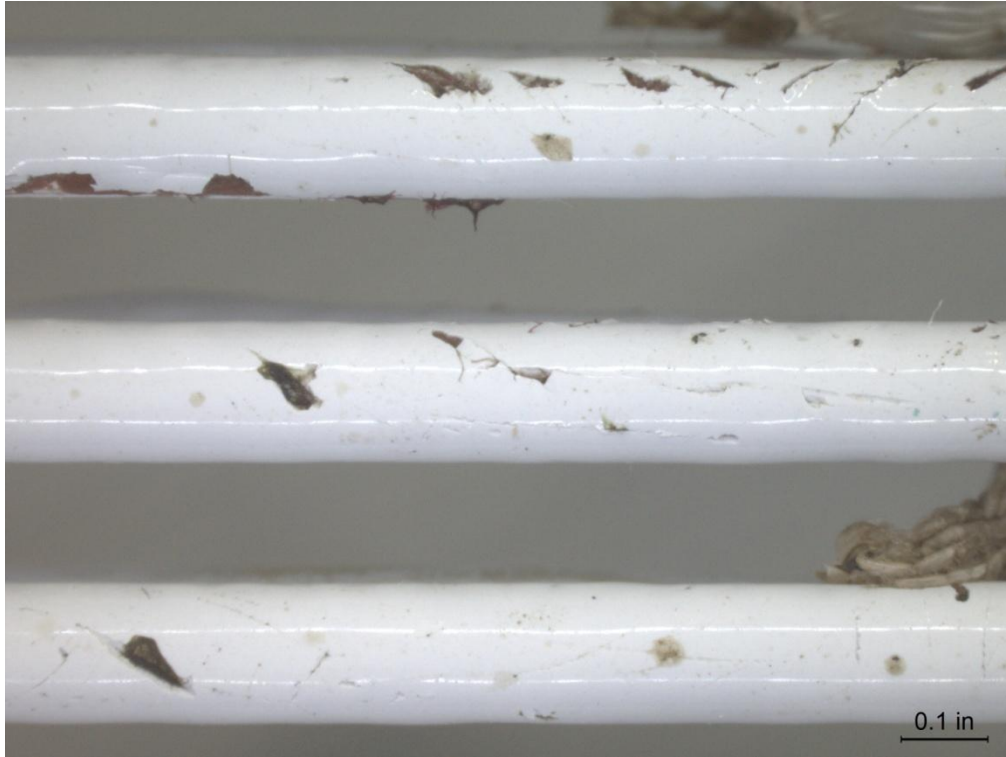
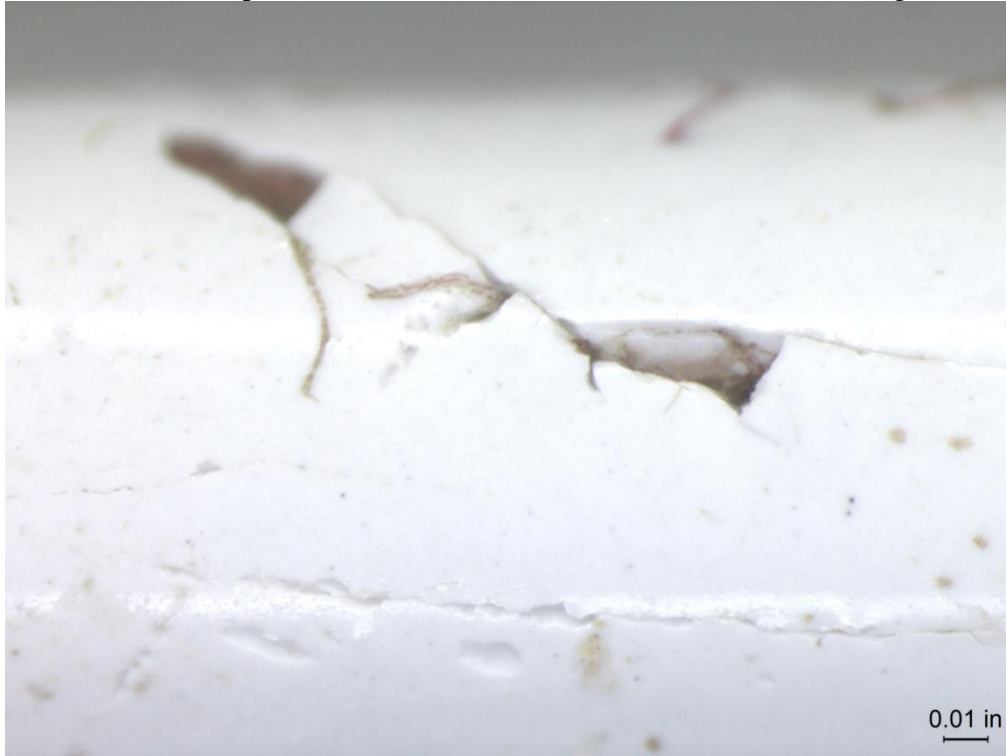
(a) Coated Duplex 2205 Stainless Steel Screen 3, Before Cleaning 10X

(b) Coated Duplex 2205 Stainless Steel Screen 3, Before Cleaning 50X

Figure 27 Optical macrographs of duplex 2205 stainless steel with anti-biofouling coating screen 3 after a 10 month corrosion test, before cleaning.

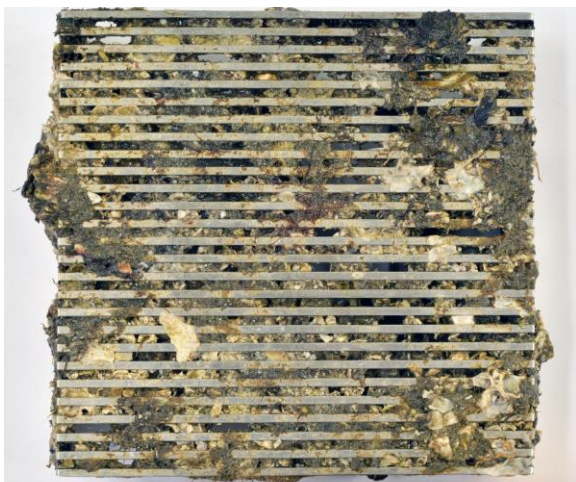
Photo 3-1. Uncoated 2205 Duplex SS wedge wire screen, before cleaning.

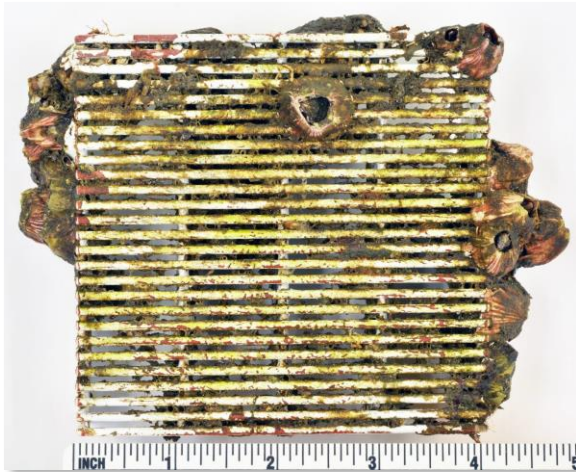
Photo 3-5. Coated 2205 Duplex SS wire screen, before cleaning.
