FINAL  
INTAKE BIOFOULING  
AND CORROSION STUDY  
(UPDATED)

**West Basin Ocean Water Desalination  
Demonstration Facility Intake  
Biofouling and Corrosion Study**

**April 18, 2018**

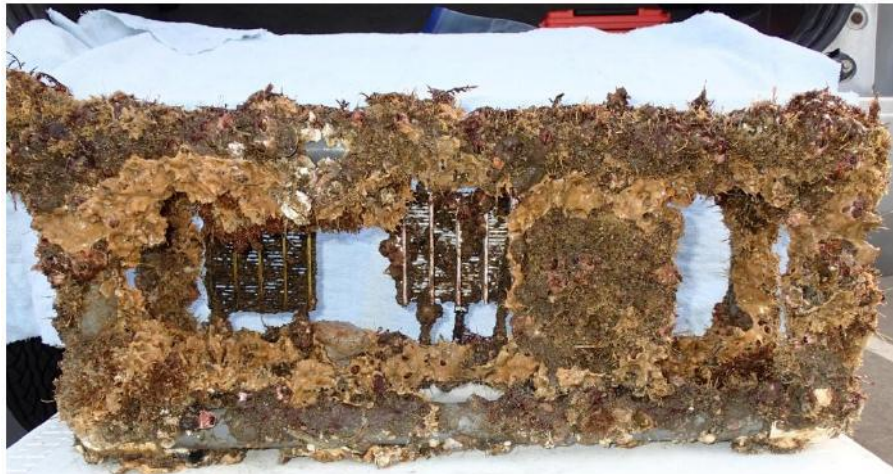
**Figure 4-11: Rack V with three remaining wedgewire samples still attached, photographed 05/23/17.**

Test Material	Biofouling Notes	
PVC test rack	The PVC test rack was heavily fouled to the point where almost none of the PVC was visible. The encrusting biofouling layer exceeded 25mm (1 inch) in thickness on some portions of the rack (See Figure 4-11).	
CDA 706 (90 – 10 Copper Nickel)	Wedgewire sample: Missing from the rack.	Coupon: N/A
Z-Alloy	Wedgewire sample: Missing from the rack.	Coupon: N/A
2205 SS (stainless steel) with antifouling coating	<p>Wedgewire sample: About 80 percent of the sample’s outer surface had a light covering of diatoms and filamentous or encrusting red algae. There were 45 – 50 acorn barnacles (<i>Megabalanus californicus</i>) that ranged in size from 5 – 24 mm. The majority of the barnacles were on the underside of the sample attached to the flat metal sides and reinforcing ribs. About 85% of the outer wedgewire face was not occluded by the barnacles or other fouling.</p> <p>Most of the barnacles were firmly attached, usually at locations where some damage or imperfection in the foul-release coating allowed the barnacle to get a foothold on the bare metal or the primer coat under the foul-release coating. Barnacles that had settled on undamaged portions of the coating could be easily removed with gentle pressure.</p> <p>There were also some hydroids and amphipod tubes on the underside of the sample and attached to the barnacle shells. (See Figure 4-12)</p>	Coupon: N/A

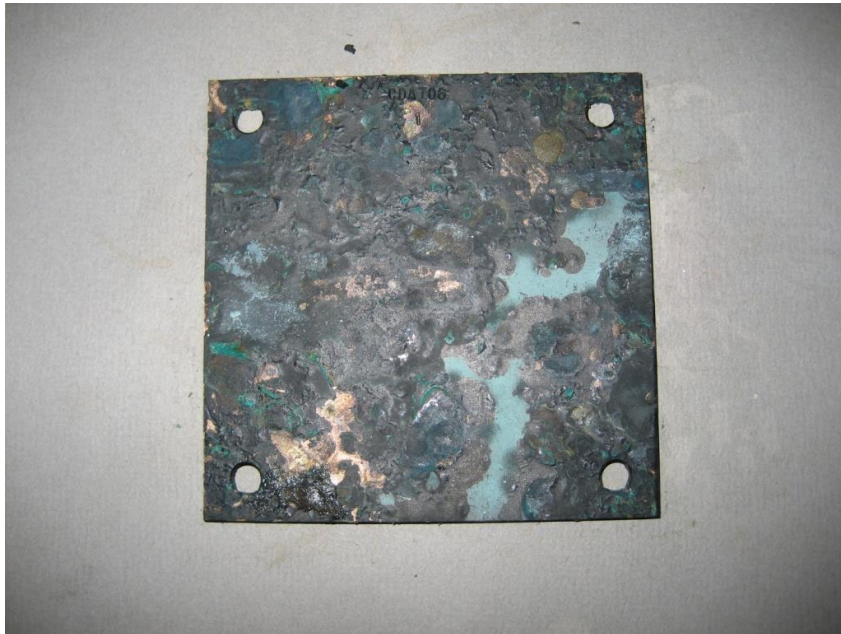
**Figure 4-16: 90/10 Cu-Ni (CDA706) test plate (Test Plate 1), photographed 06/18/15 prior to biofouling inspection.**

- **CDA 706 (90/10 Copper/Nickel), Plate 1, (Figure 4-16)**
  - The plate is almost entirely covered with a dark blue-green patina. This tends to flake off when the plate is handled.
  - No attached macrofouling.
  - No slime detectable.
  - No algae, diatoms, or silt.

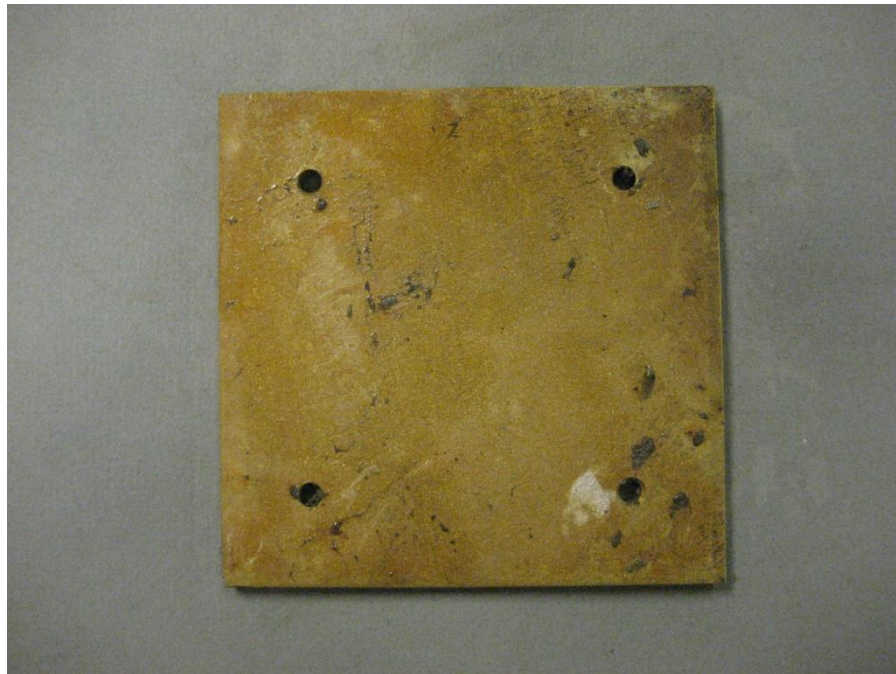
**Figure 4-18: Z-alloy test plate (Test Plate 3),  
photographed 06/18/15 prior to biofouling inspection.**

- The plate is very clean, except for a single 19 mm mussel that had been attached to one of the cable ties. When the cable tie was removed, the mussel remained loosely attached to the plate by three byssal threads.
- No attached macrofouling.
- The plate has a light brown/gold patina. This is a duller finish than the CDA 715 plate, but does not have the patina of the CDA 706 plate.
- Motile species: 8 small (3 mm) amphipods stranded on the plate.

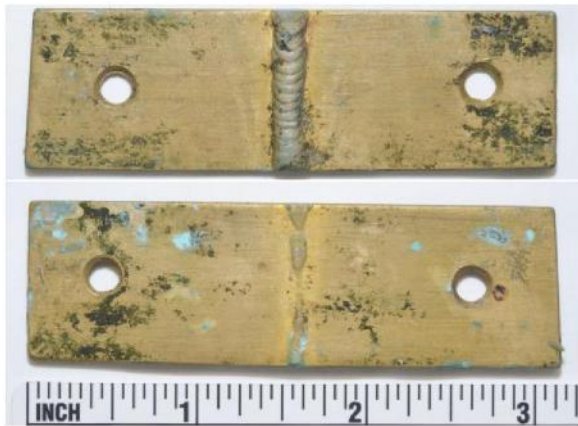
Figure 4-39: Z alloy 1-inch by 3-inch coupon with weld front.

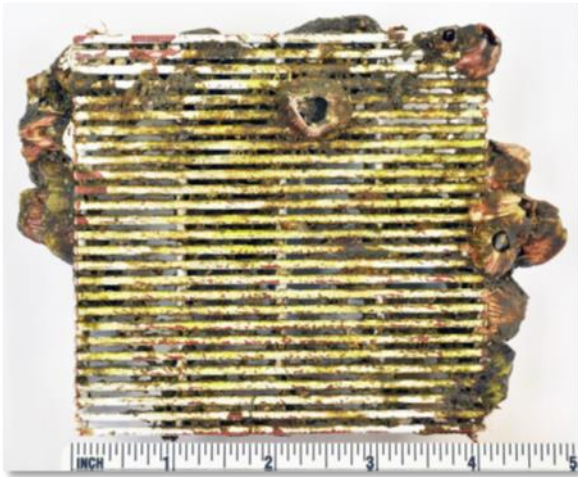
**Photo 4-5: Coated 2205 Duplex SS wire screen, before cleaning.**
