WEST BASIN MUNICIPAL WATER DISTRICT OCEAN WATER DESALINATION INTAKE CORROSION STUDY

November 2014

V&A Project No.: 13-0376

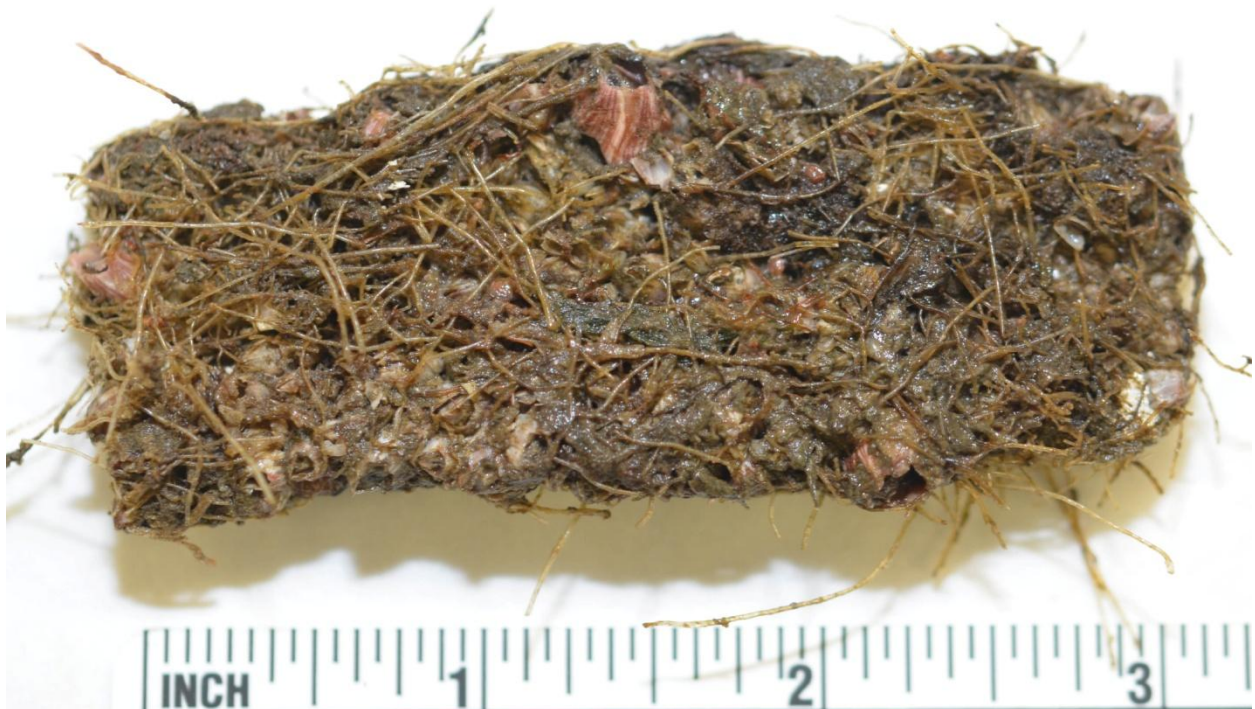
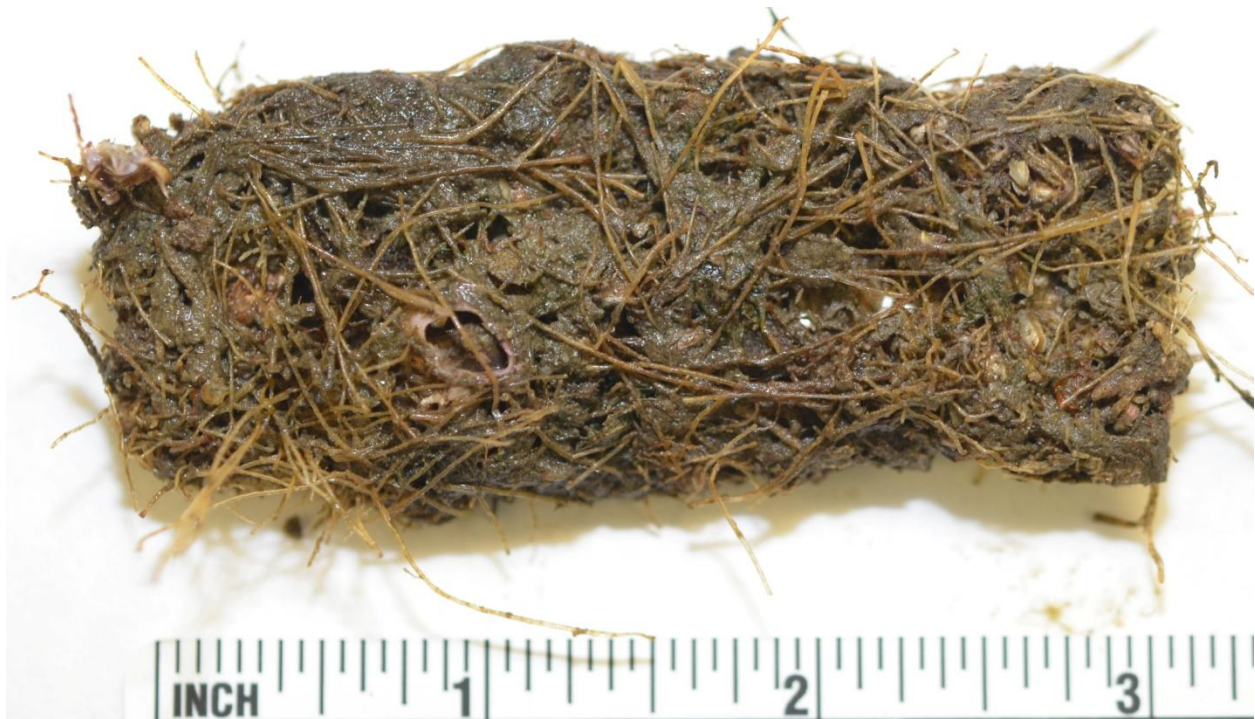
Figure 2 Photographs of duplex 2205 stainless steel coupon 6 (a) front and (b) back side after a 3 month corrosion test.

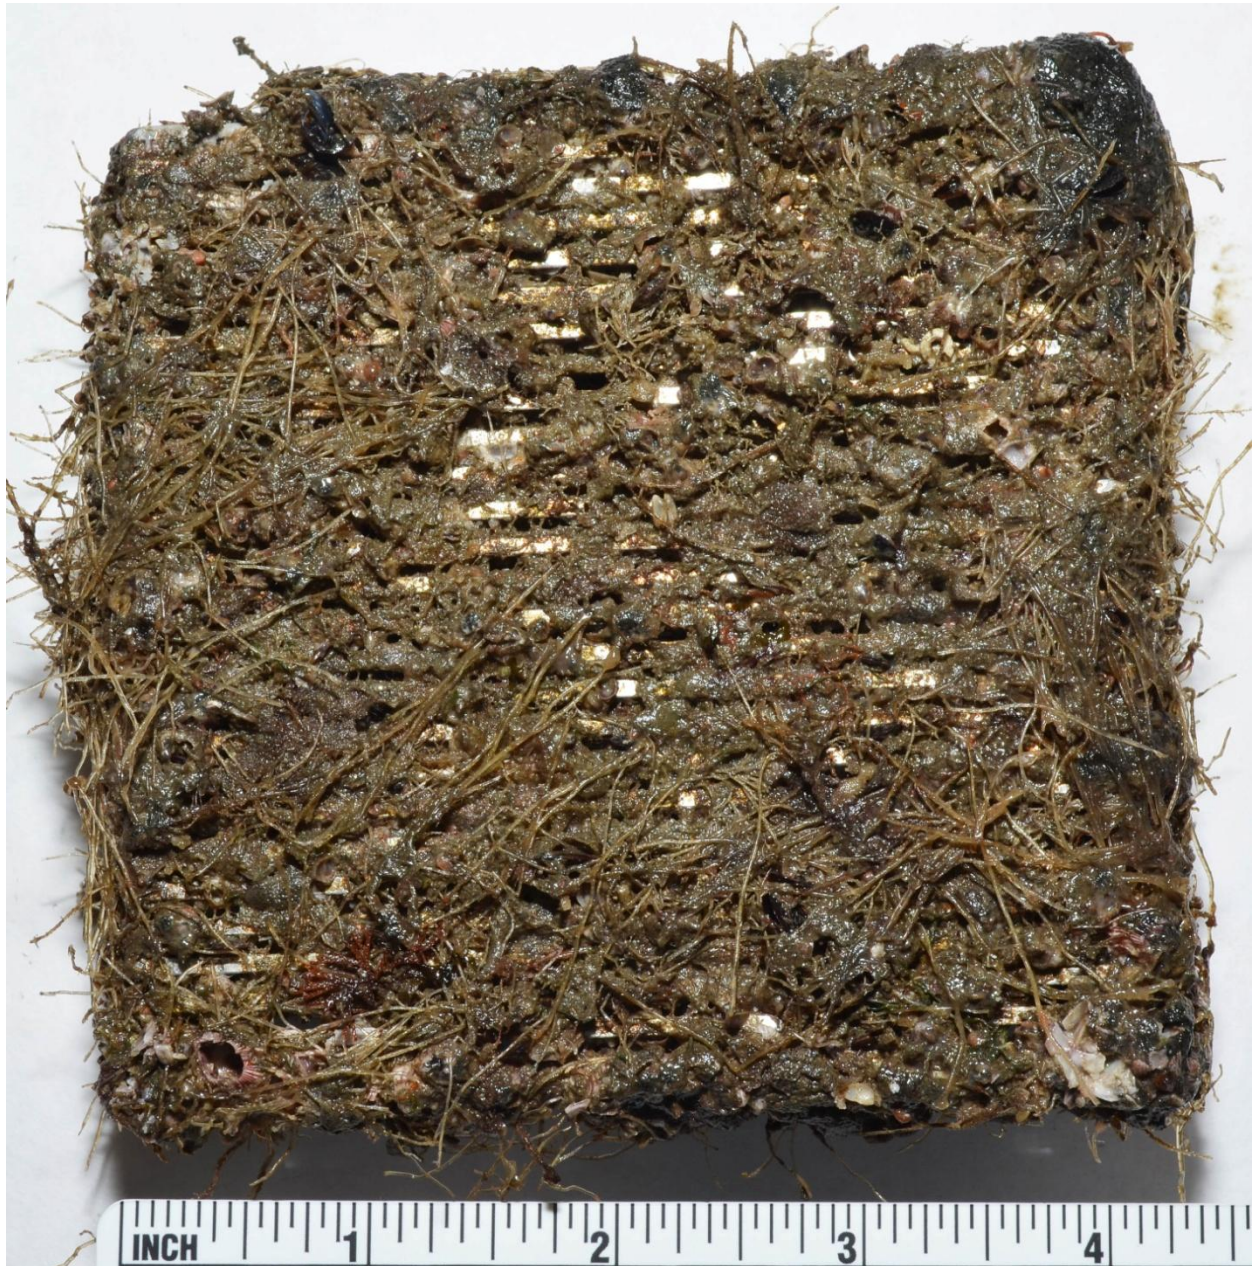
Figure 4 Photograph of duplex 2205 stainless steel screen 1 after a 3 month corrosion test.

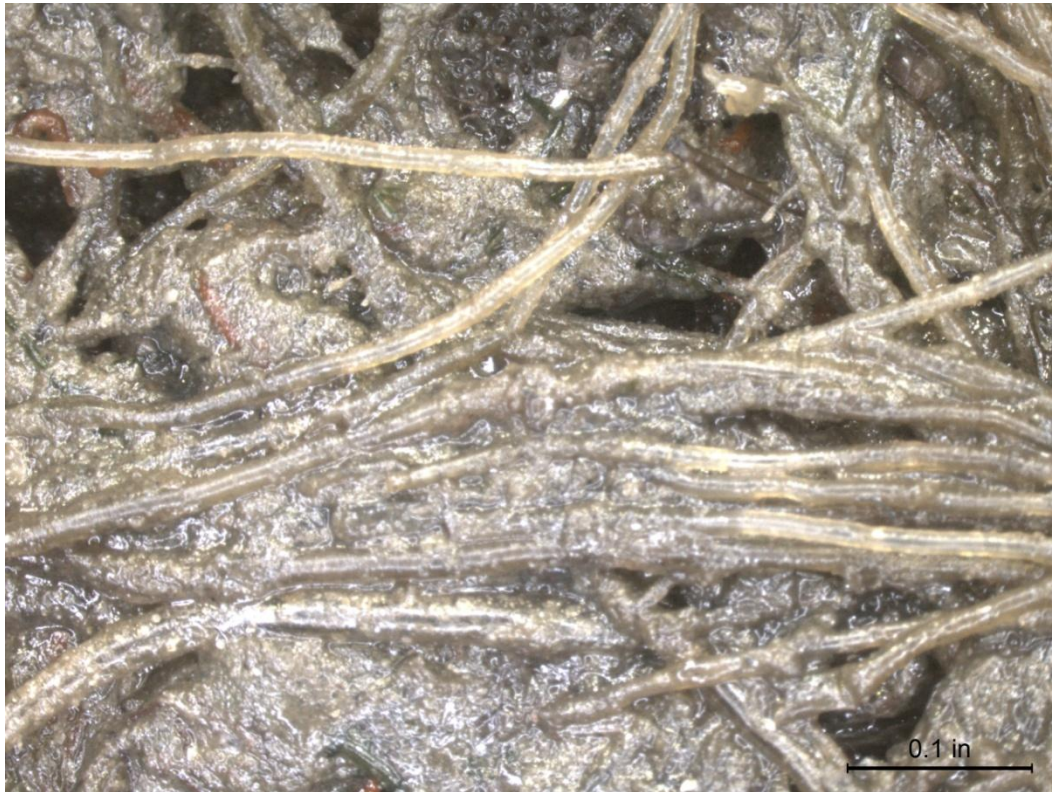
Figure 6 Optical macrographs of duplex 2205 stainless steel coupon 6 after a 3 month corrosion test, before cleaning.

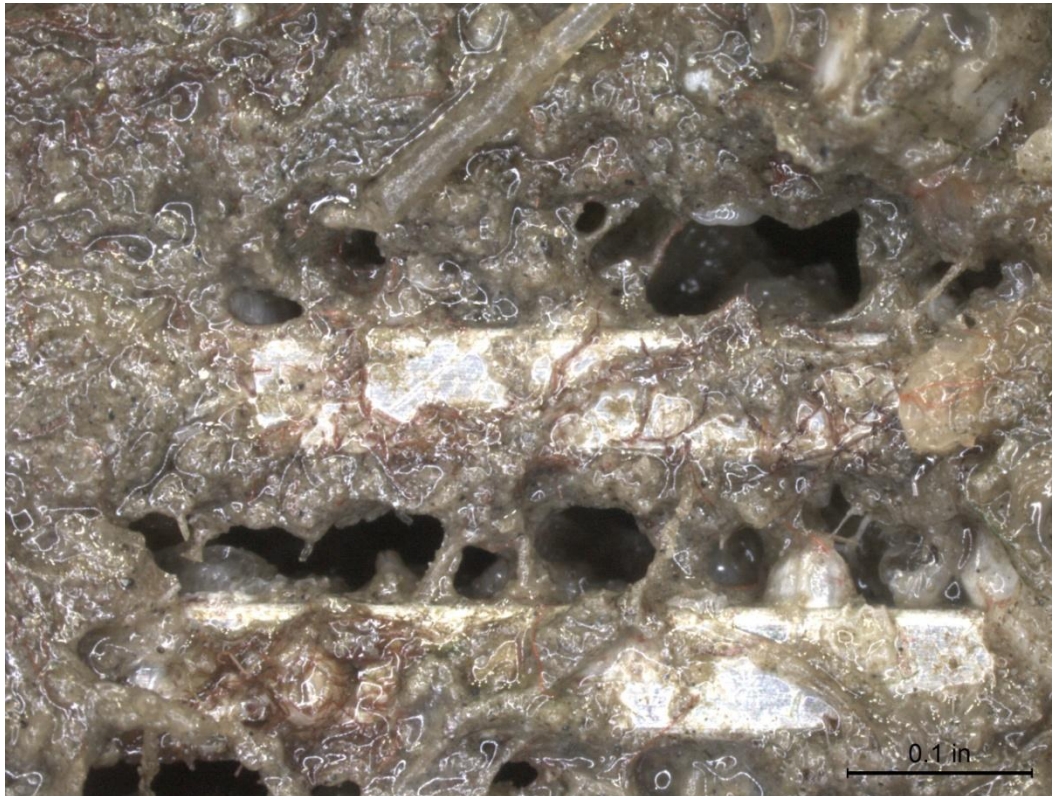
Figure 9 Optical macrographs of duplex 2205 stainless steel screen 1 after a 3 month corrosion test, before cleaning.

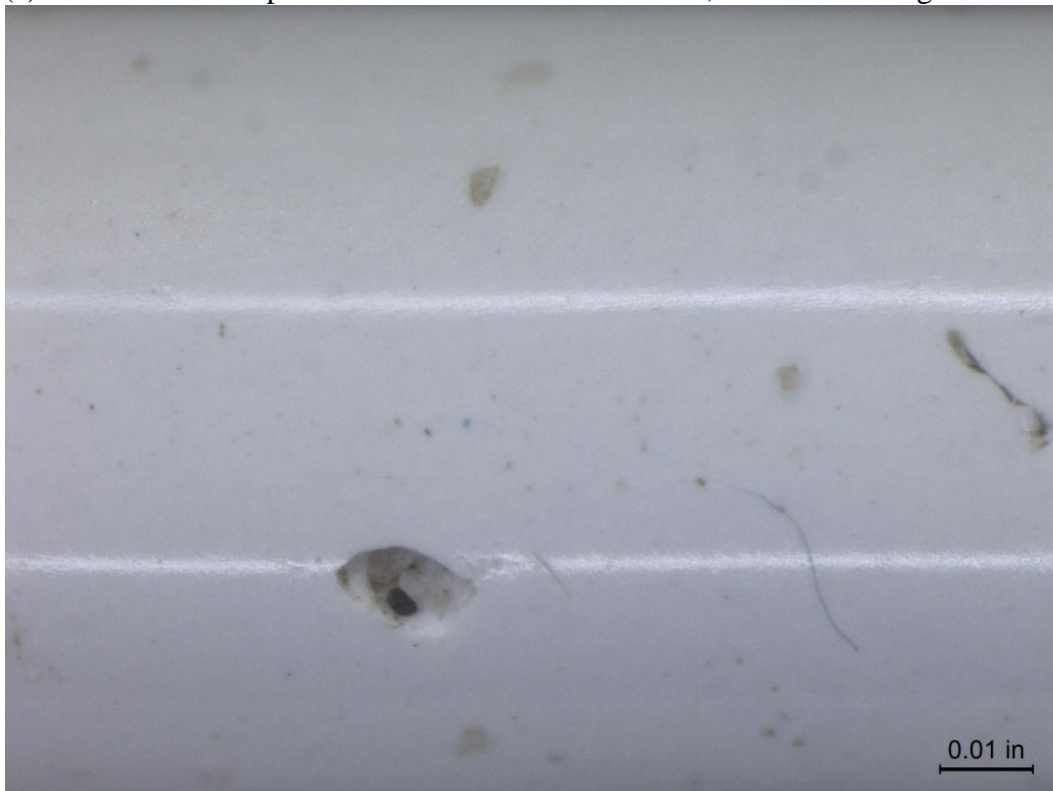
Figure 9 Optical macrographs of duplex 2205 stainless steel with anti-biofouling coating screen 1 after a 3 month corrosion test, before cleaning.

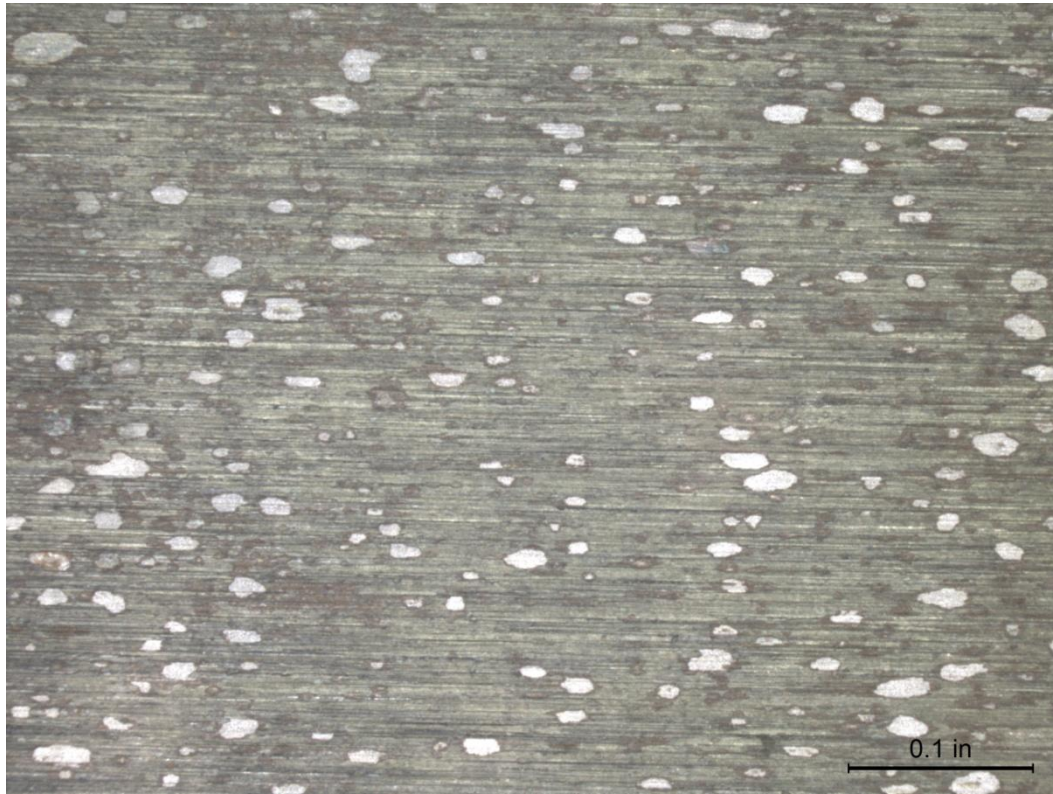
Figure 6 Optical macrographs of CDA 715 coupon 1 after a 3 month corrosion test, before cleaning.

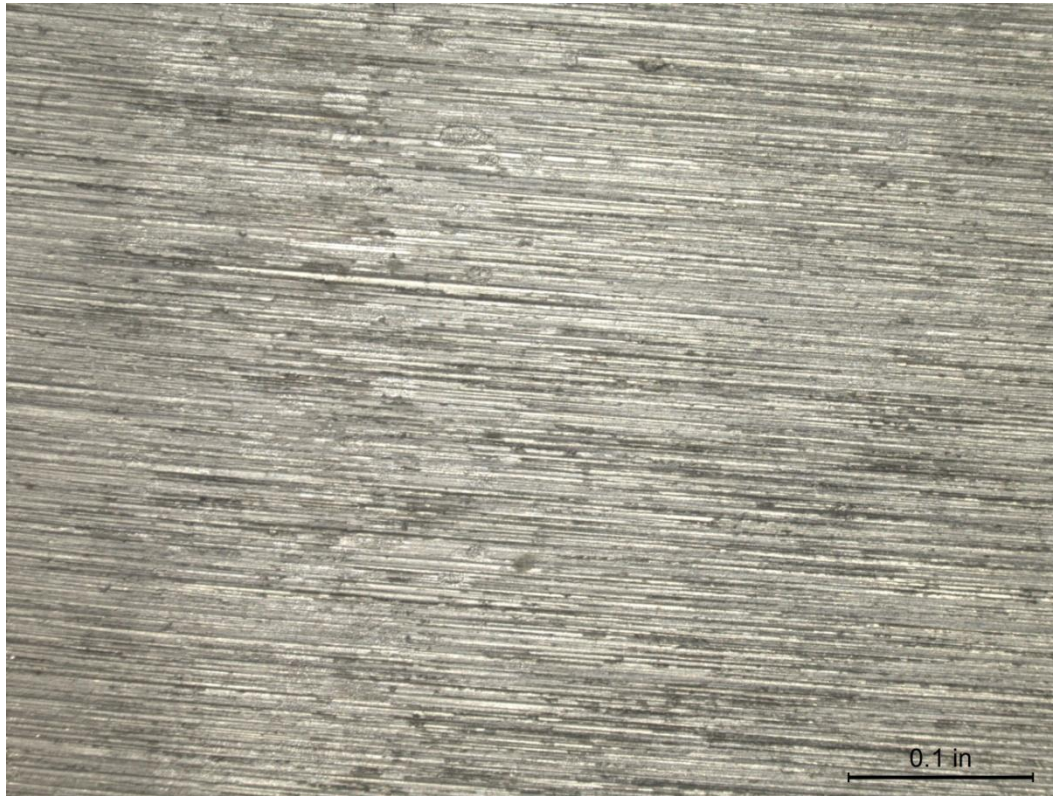
Figure 7 Optical macrographs of CDA 715 coupon 1 after a 3 month corrosion test, after cleaning.

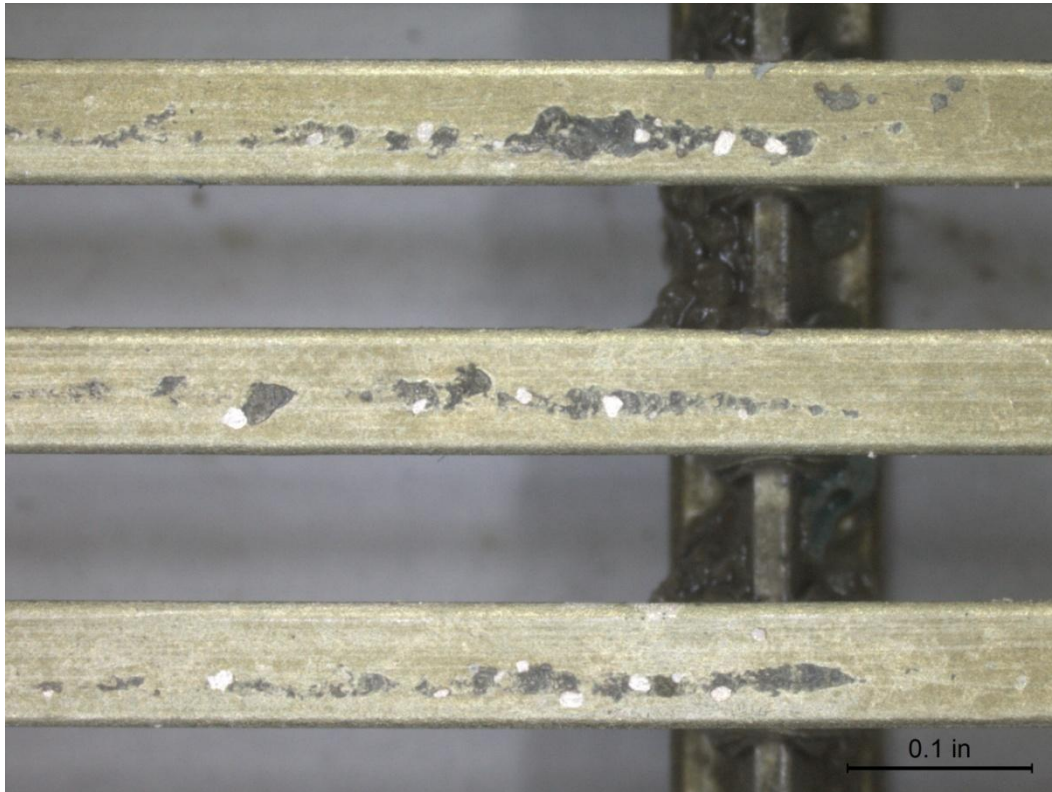
Figure 9 Optical macrographs of CDA 715 screen 1 after a 3 month corrosion test, before cleaning.

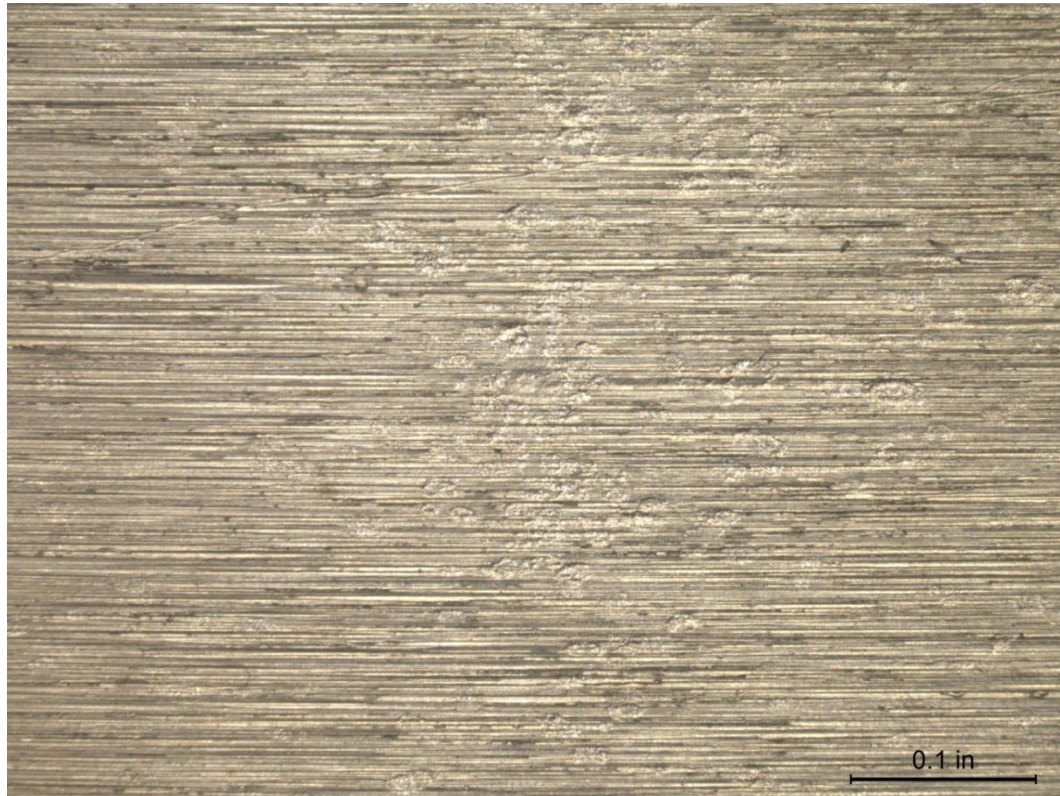
Figure 7 Optical macrographs of CDA 706 coupon 1 after a 3 month corrosion test, before cleaning.

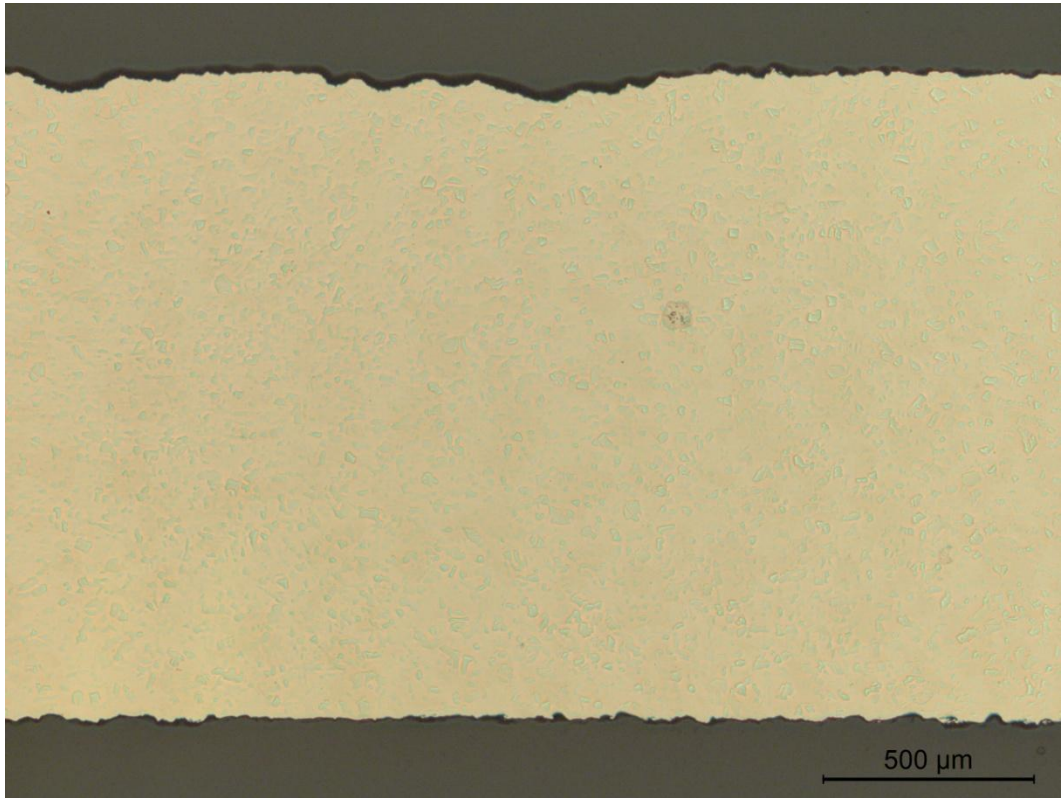
Figure 17 Optical micrographs of CDA 706 coupon 1. The pit was approximately 80 μm deep.

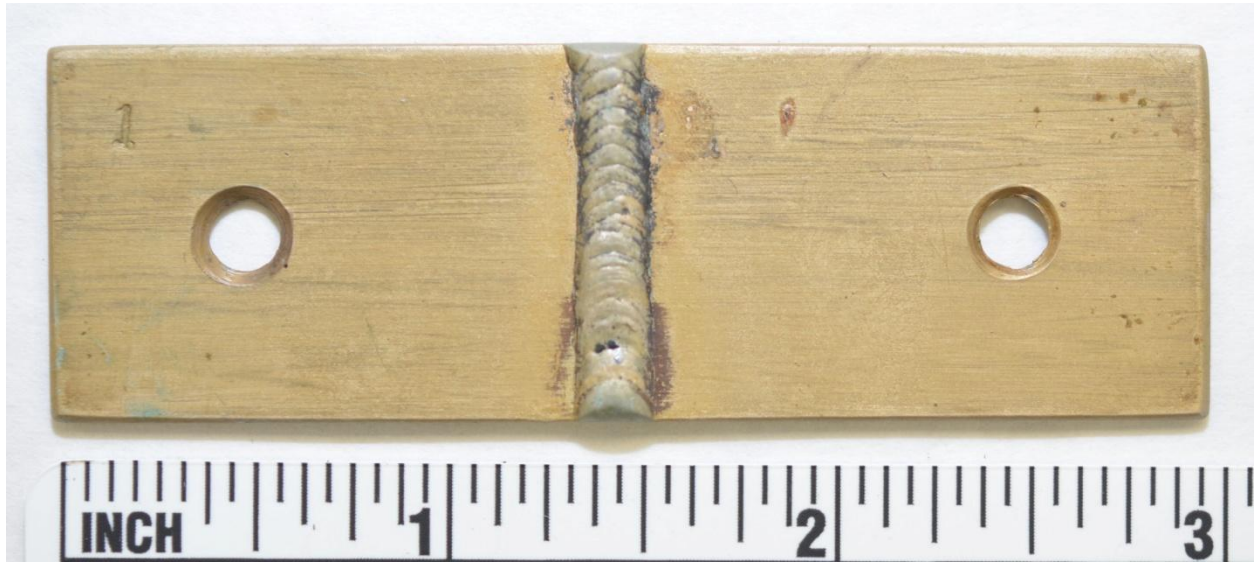
Figure 2 Photographs of Z-Alloy coupon 1 (a) front and (b) back side after a 3 month corrosion test.

Photographs of the baseline coupon are shown in Figure 1. Photographs of coupon 1, after 3 months of corrosion testing, are shown in Figure 2.

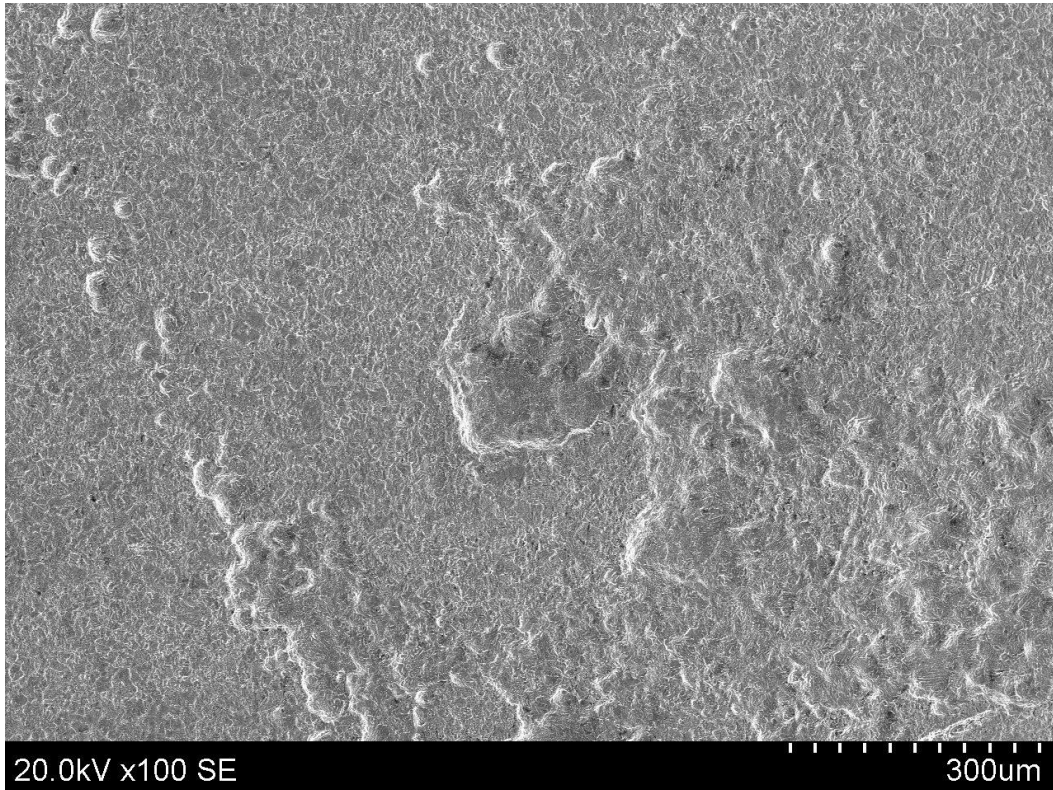
Figure 14 Scanning electron micrographs of Z-Alloy coupon 1 after a 3 month corrosion test, after cleaning.

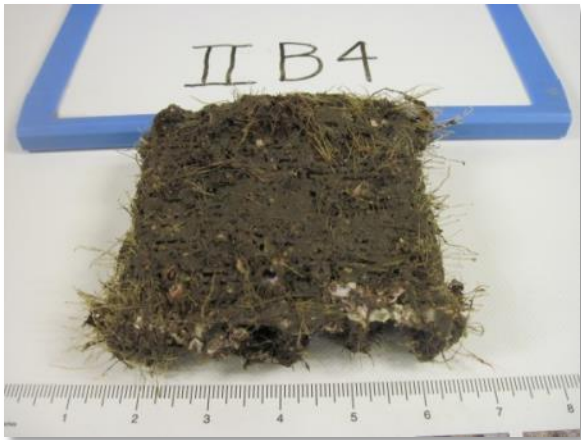
Photo 3-7. 2205 Duplex stainless steel 4-inch by 4 inch wedge wire screen.

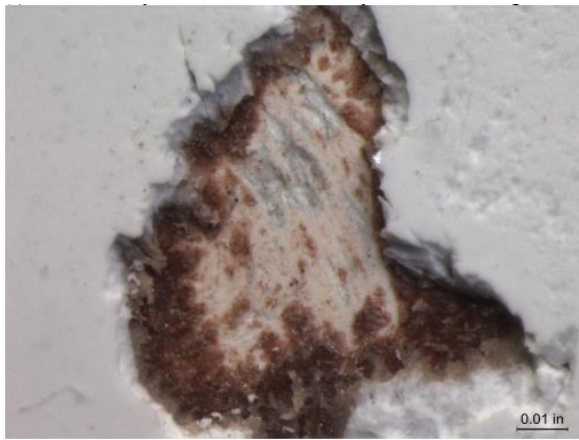
The highest pitting rate was observed on the Foul Release-Coated 2205 Duplex Stainless Steel coupons. However, the mass loss was primarily due to the coating that was removed (see Photo 3-11 and Photo 3-12) from the samples and may not represent the metal loss. Pits on the small cross sectional areas of the wire screens were difficult to measure, but it is assumed that the screens have the same pitting rates as the coupons.

Photo 3-11. 2205 Duplex SS coupon surface exposed at an area of coating damage.

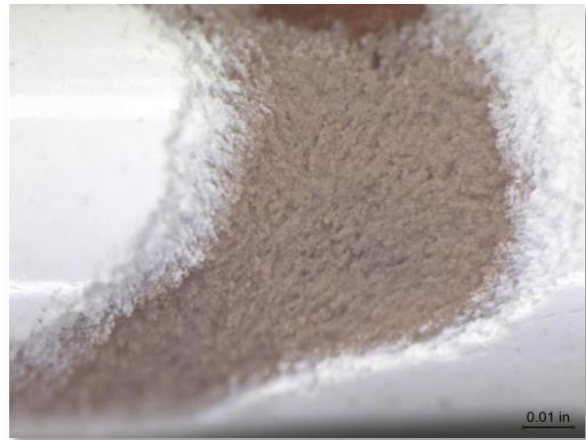
Photo 3-12. 2205 Duplex SS wedge wire screen surface at an area of coating damage.

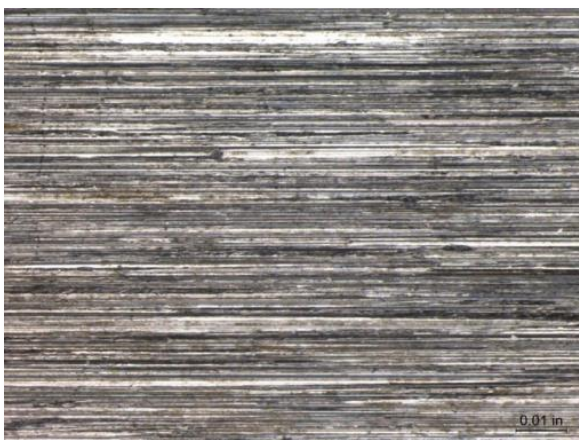
Photo 3-13. 2205 Duplex SS coupon surface after cleaning under 50X magnification.

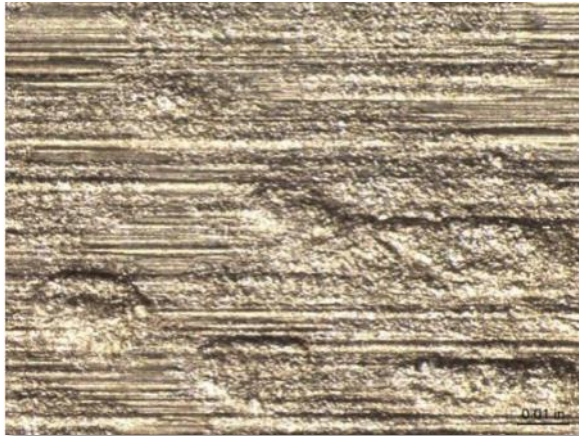
Photo 3-15. CDA 706 coupon 2 at 50x magnification after cleaning

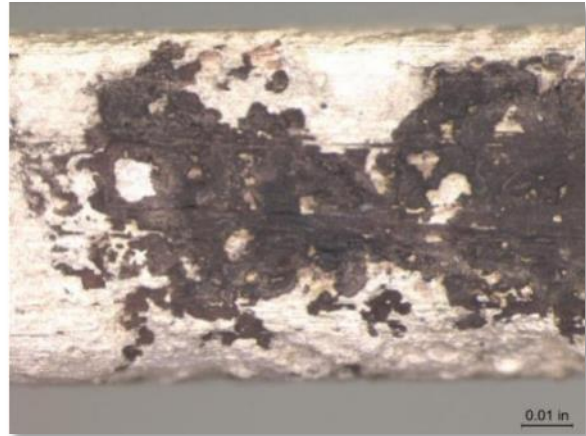
Photo 3-16. CDA 706 Screen 2 at 50X magnification after cleaning.

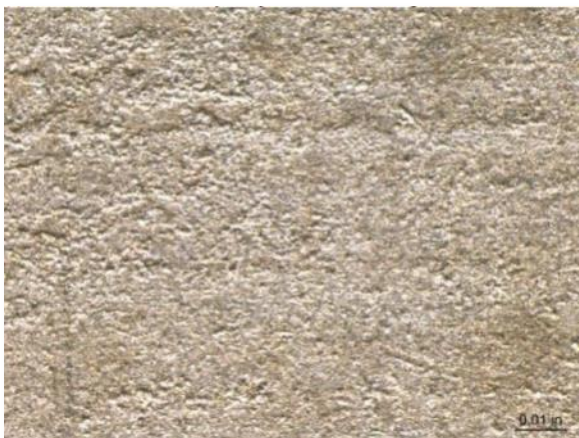
Photo 3-19. Z Alloy Screen at 50X magnification after cleaning.

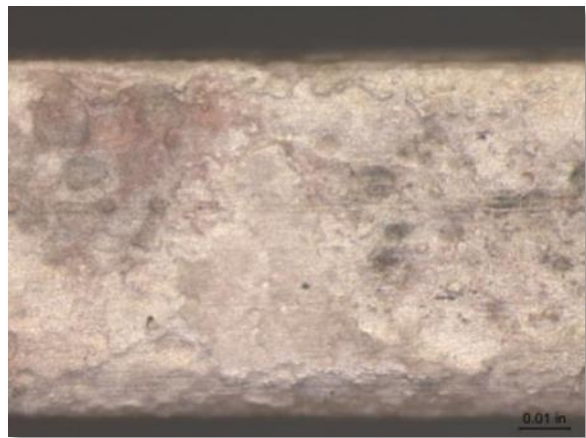
Photo 3-20. Z Alloy Screen at 50X magnification after cleaning.

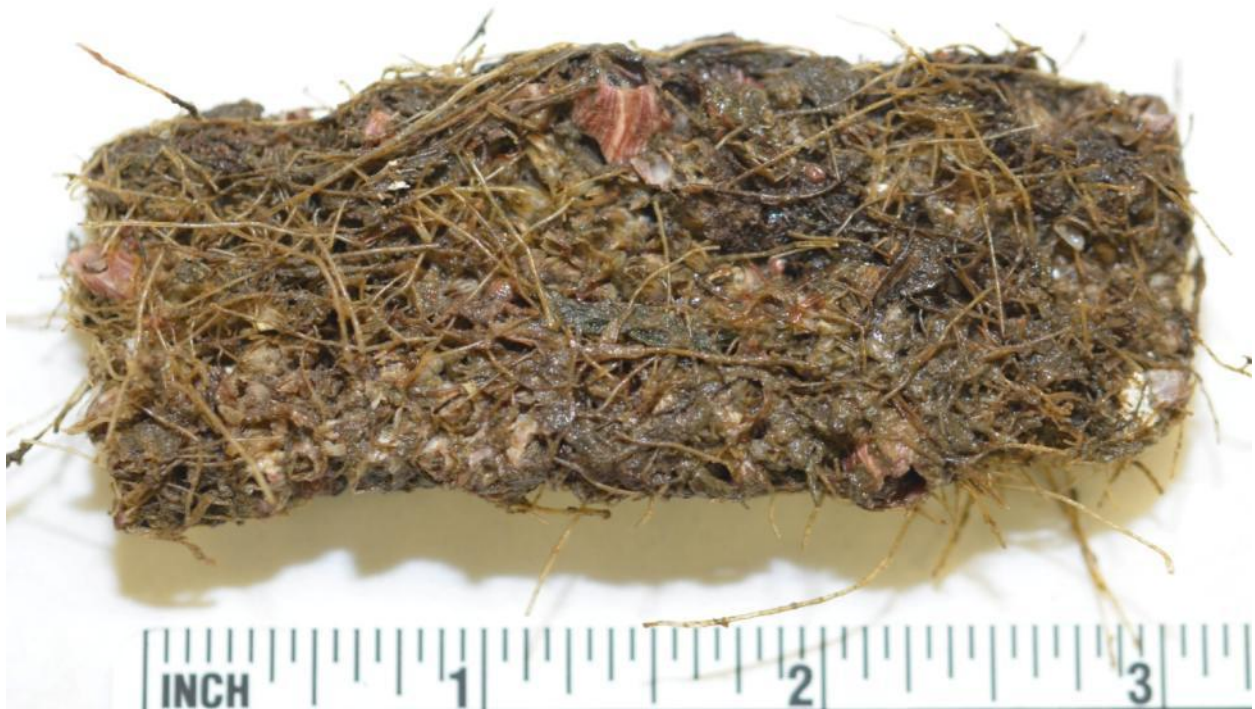
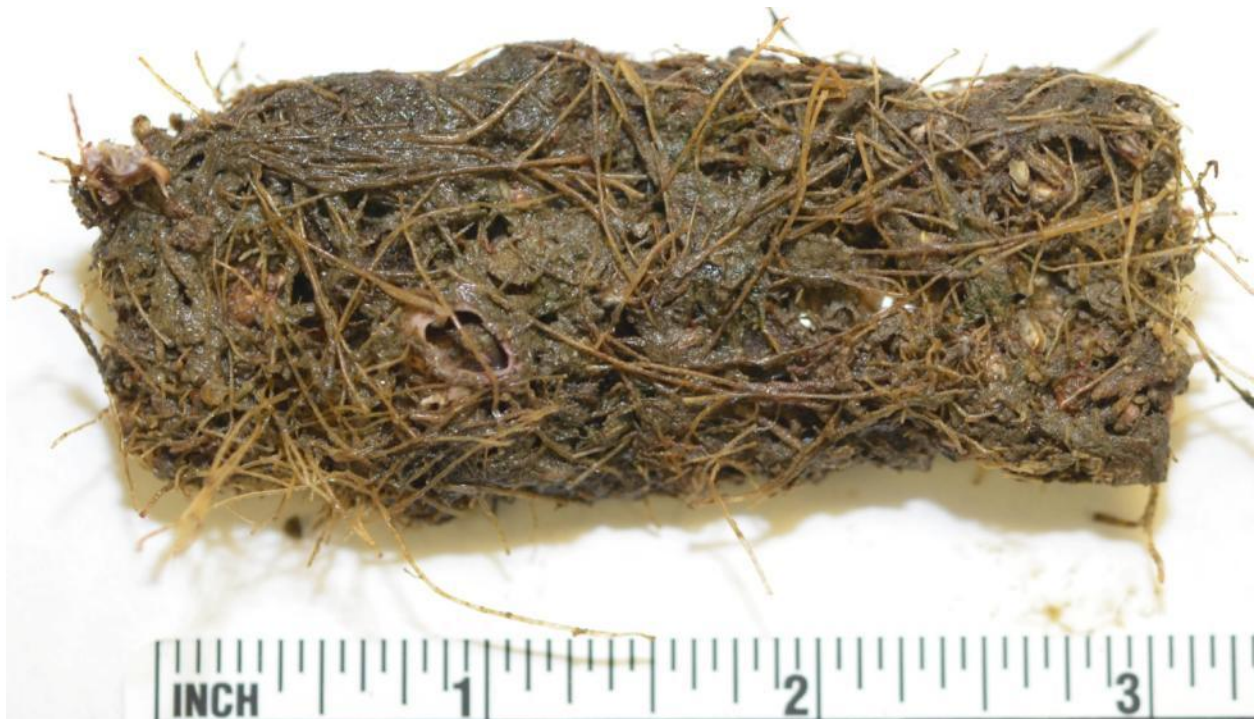
Figure 2 Photographs of duplex 2205 stainless steel coupon 6 (a) front and (b) back side after a 3 month corrosion test.

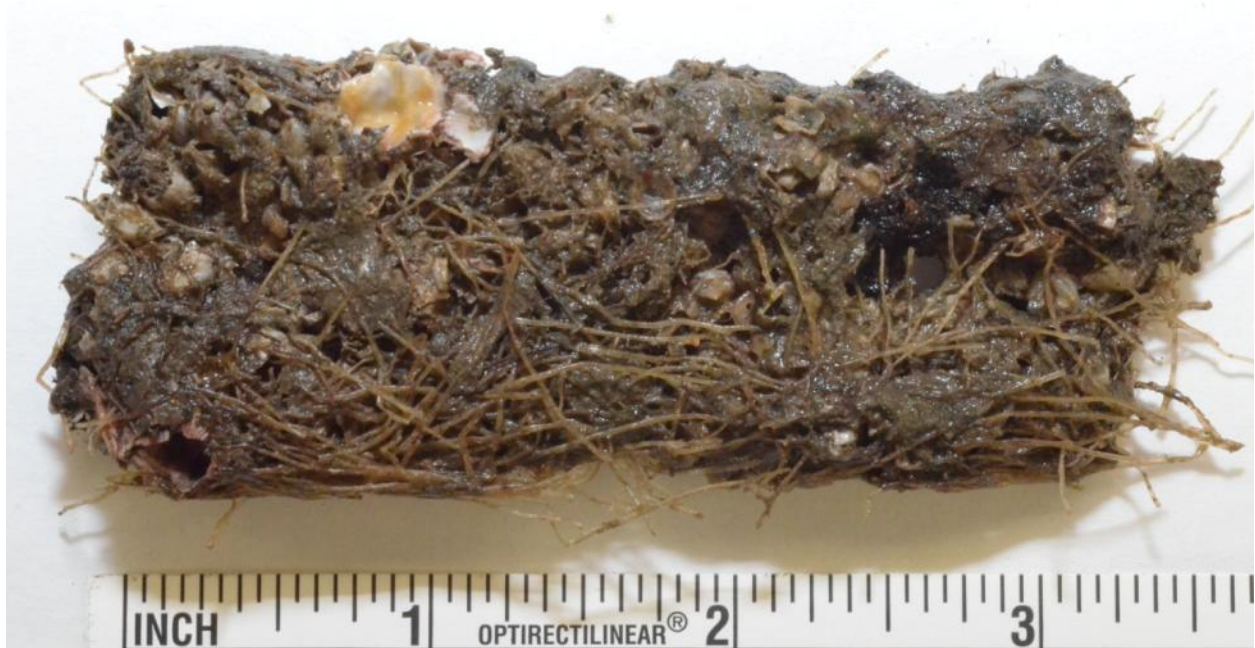
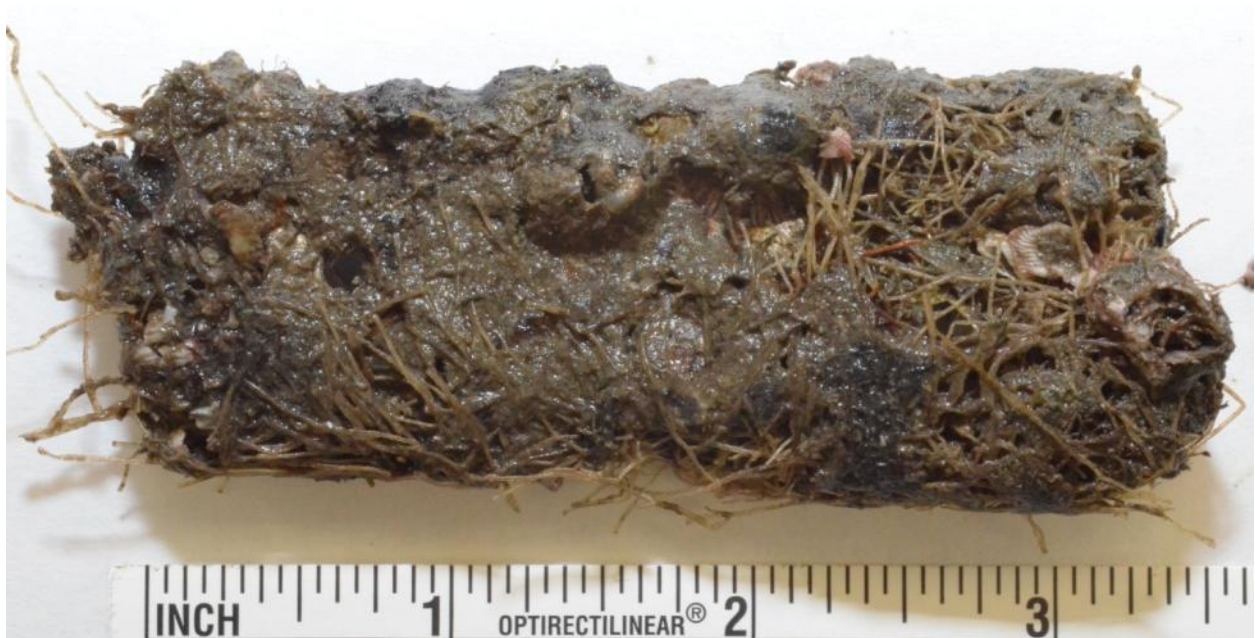
Figure 3 Photographs of duplex 2205 stainless steel coupon 7 (a) front and (b) back side after a 6 month corrosion test.

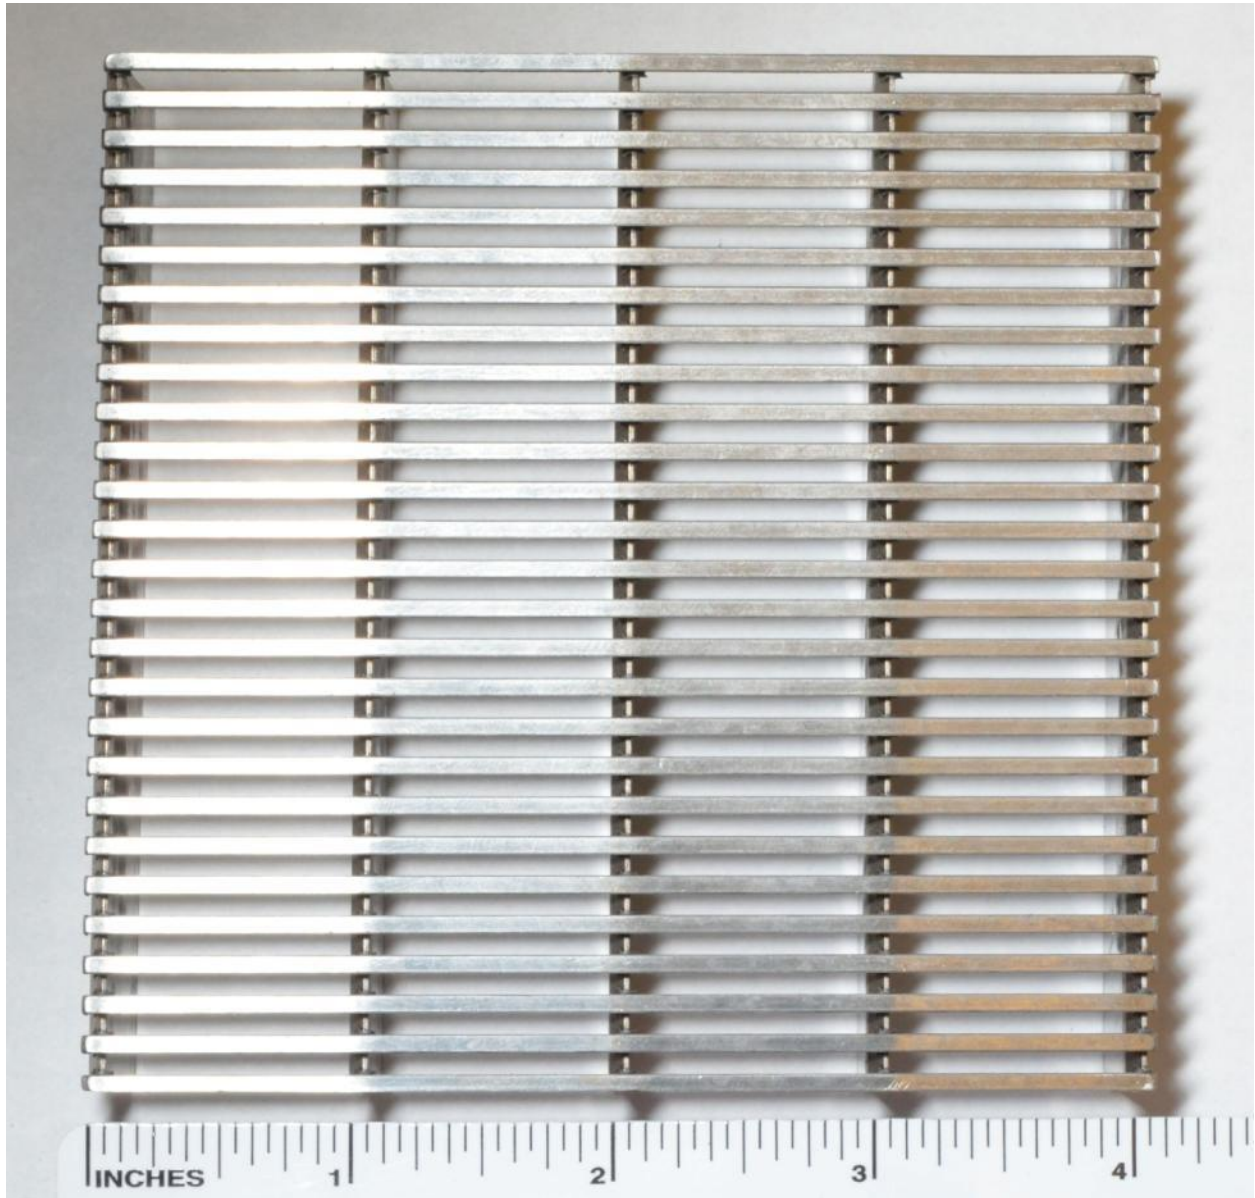
Figure 4 Photograph of the duplex 2205 stainless steel baseline screen.

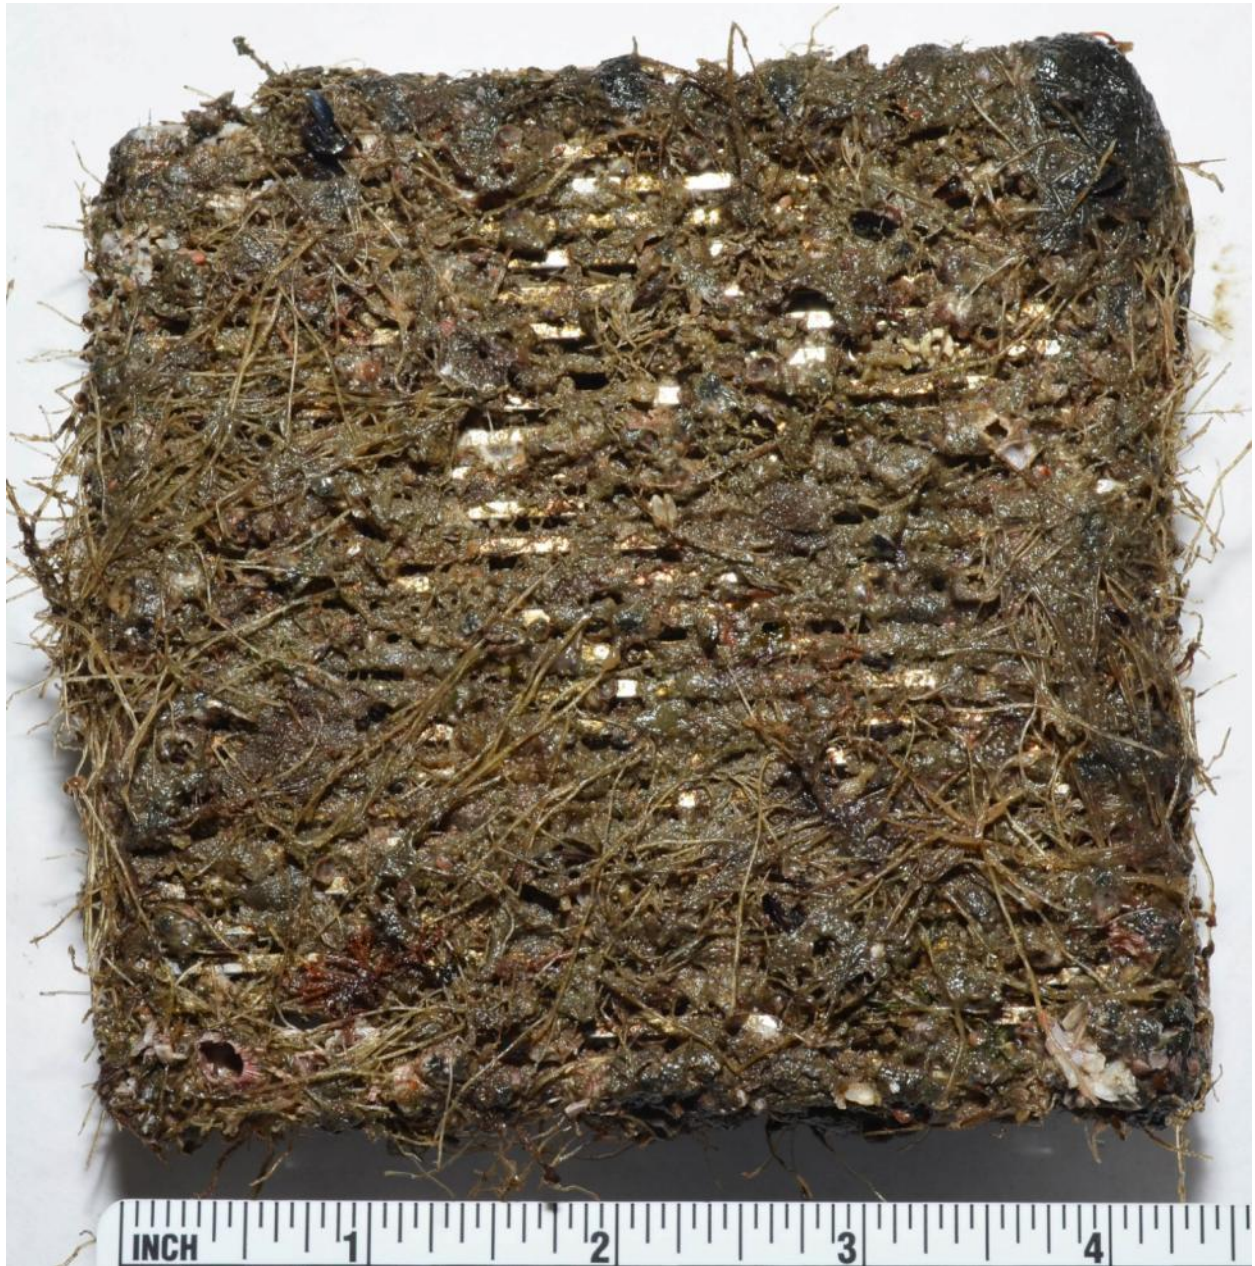
Figure 5 Photograph of duplex 2205 stainless steel screen 1 after a 3 month corrosion test.

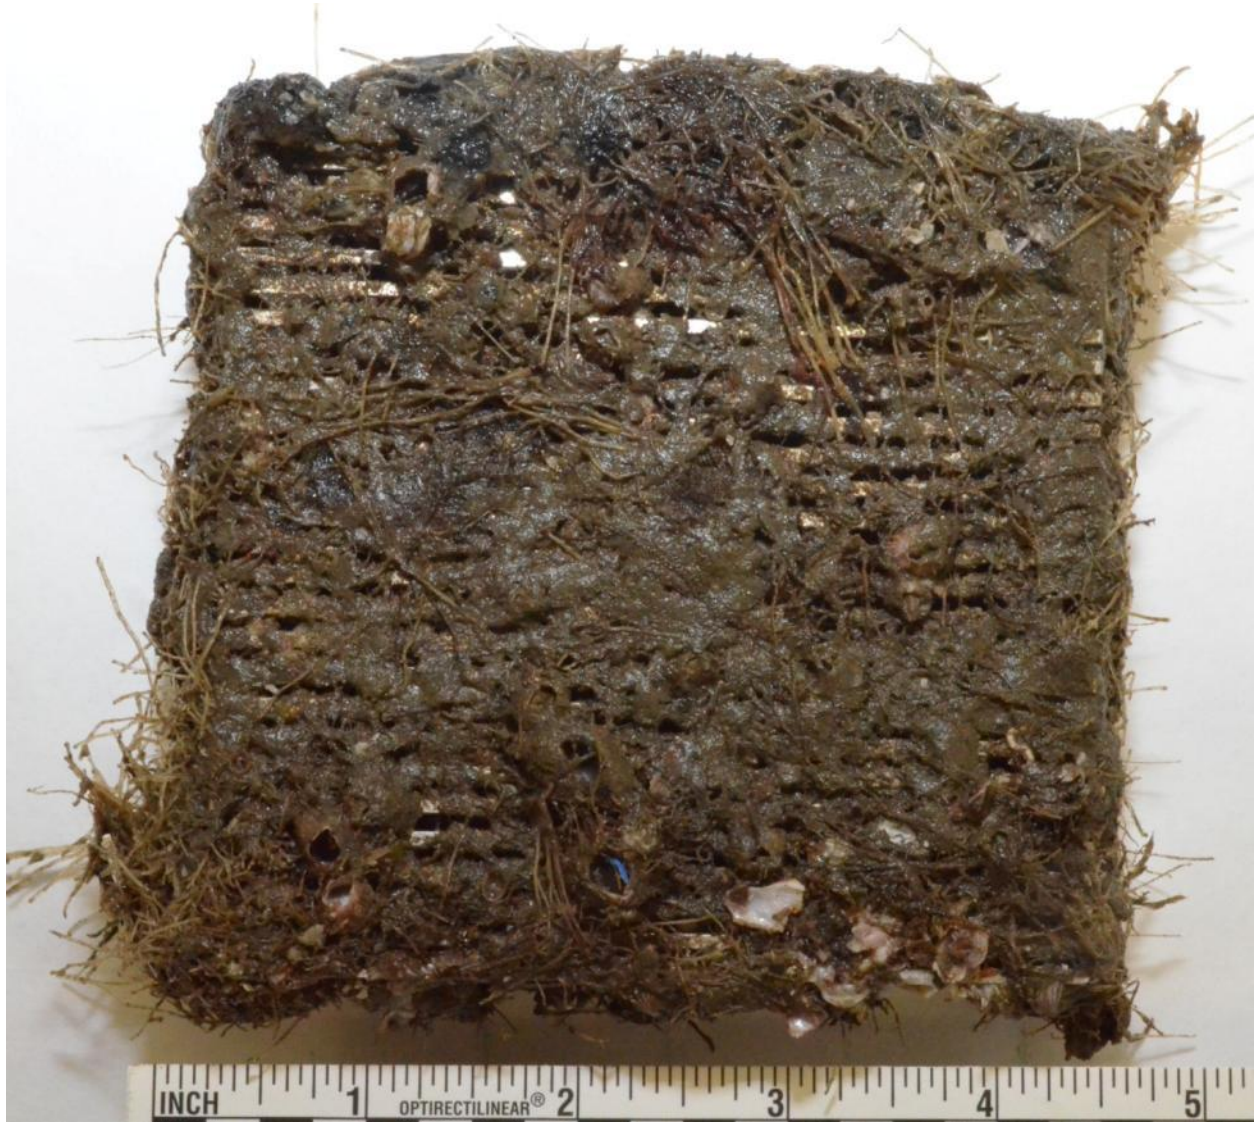
Figure 6 Photograph of duplex 2205 stainless steel screen 2 after a 6 month corrosion test.

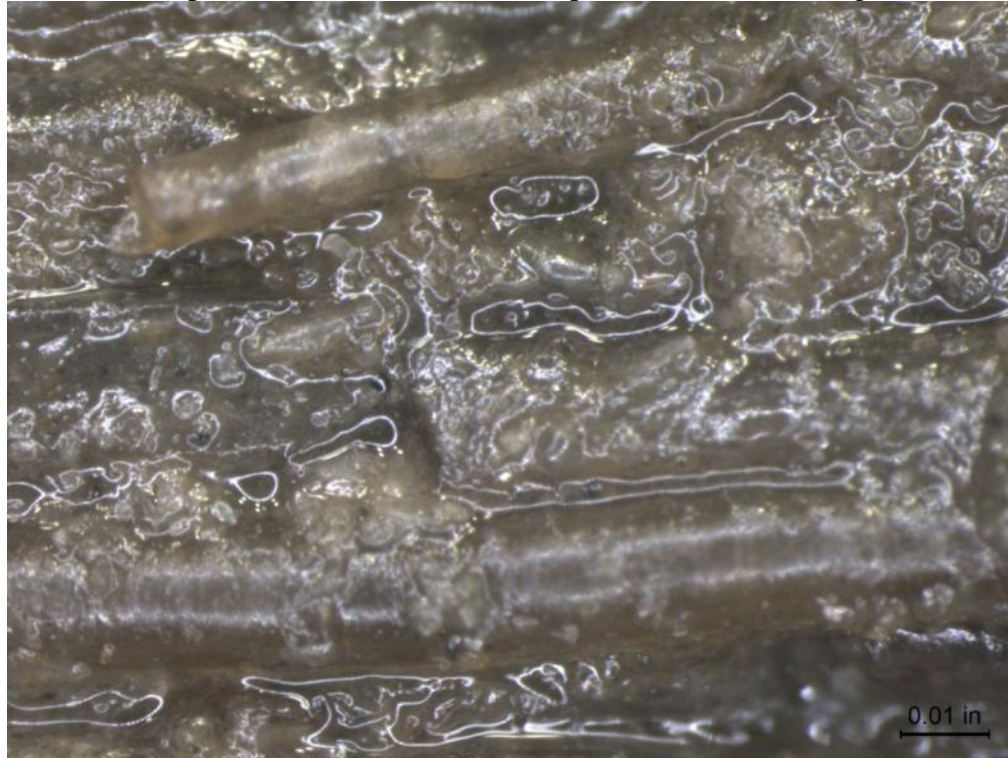
(b) Duplex 2205 Stainless Steel Coupon 6, Before Cleaning 50X

Figure 8 Optical macrographs of duplex 2205 stainless steel coupon 6 after a 3 month corrosion test, before cleaning.
