WEST BASIN MUNICIPAL WATER DISTRICT OCEAN WATER DESALINATION INTAKE CORROSION STUDY

November 2014

V&A Project No.: 13-0376

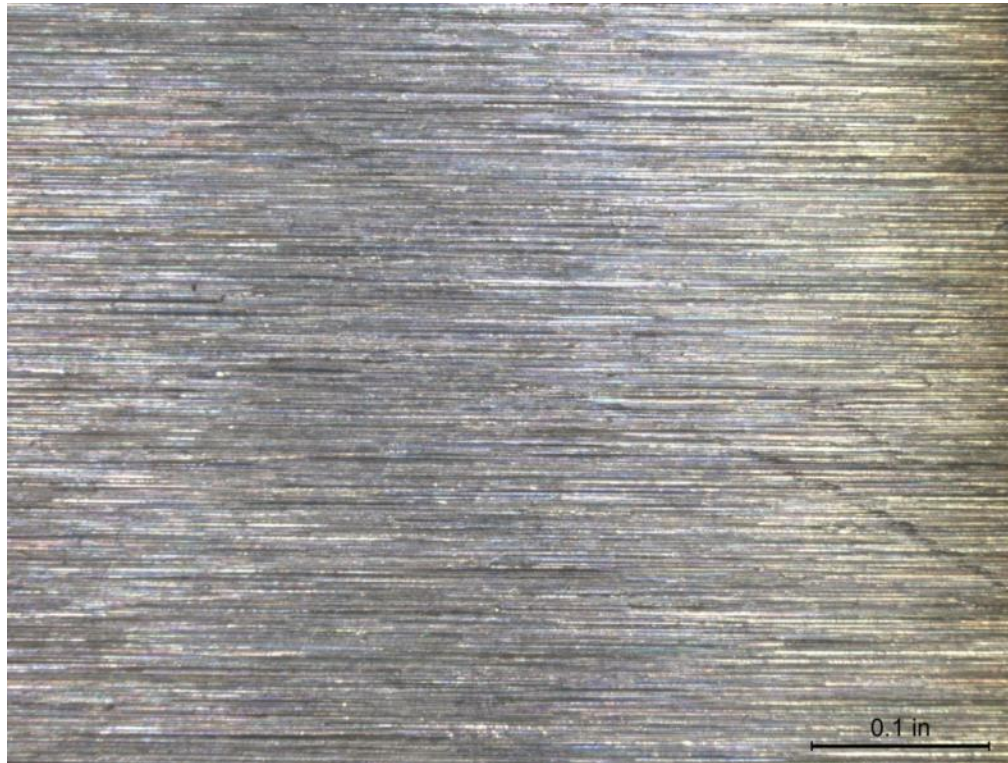
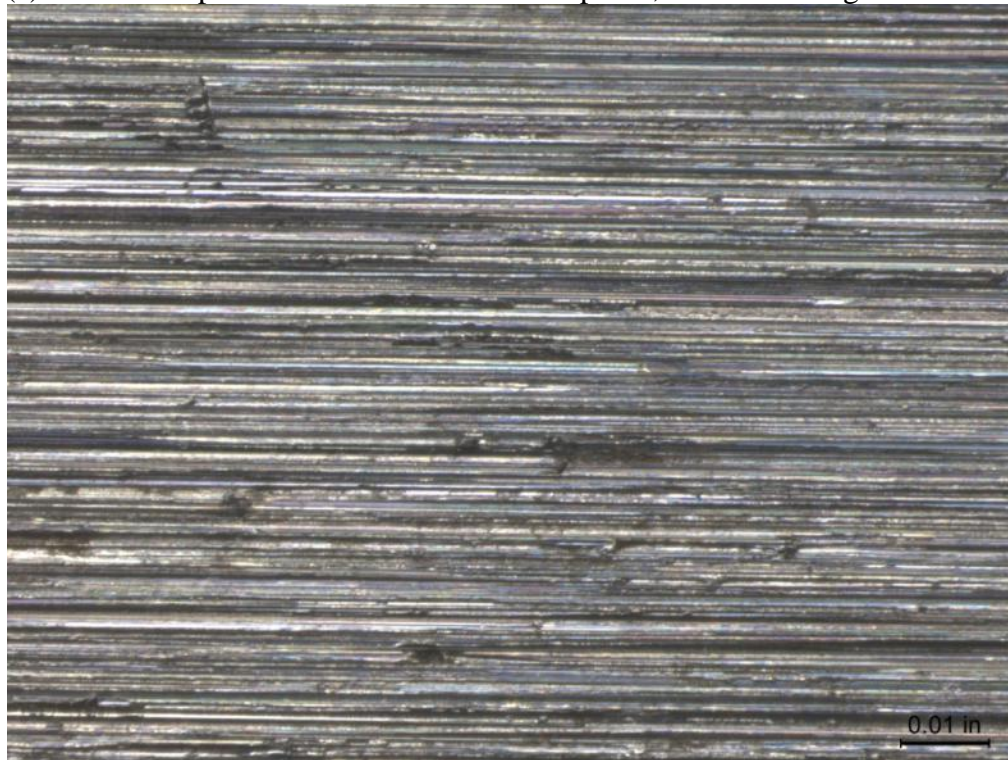
(a) Duplex 2205 Stainless Steel Coupon 6, After Cleaning 10X

(b) Duplex 2205 Stainless Steel Coupon 6, After Cleaning 50X

Figure 9 Optical macrographs of duplex 2205 stainless steel coupon 6 after a 3 month corrosion test, after cleaning.

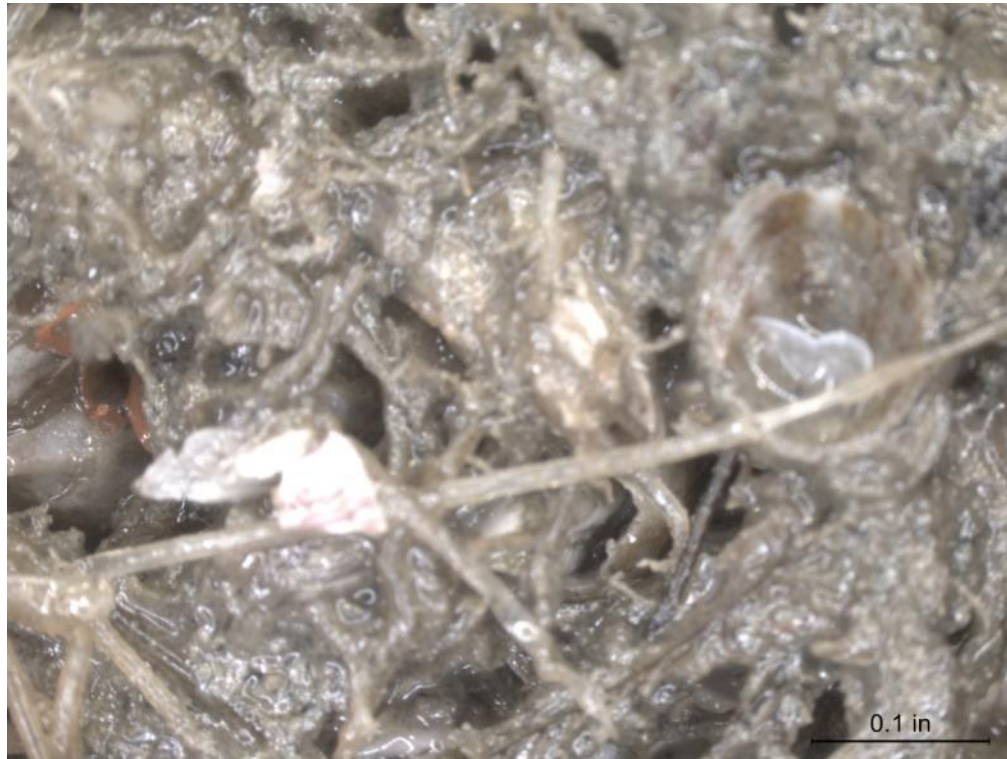
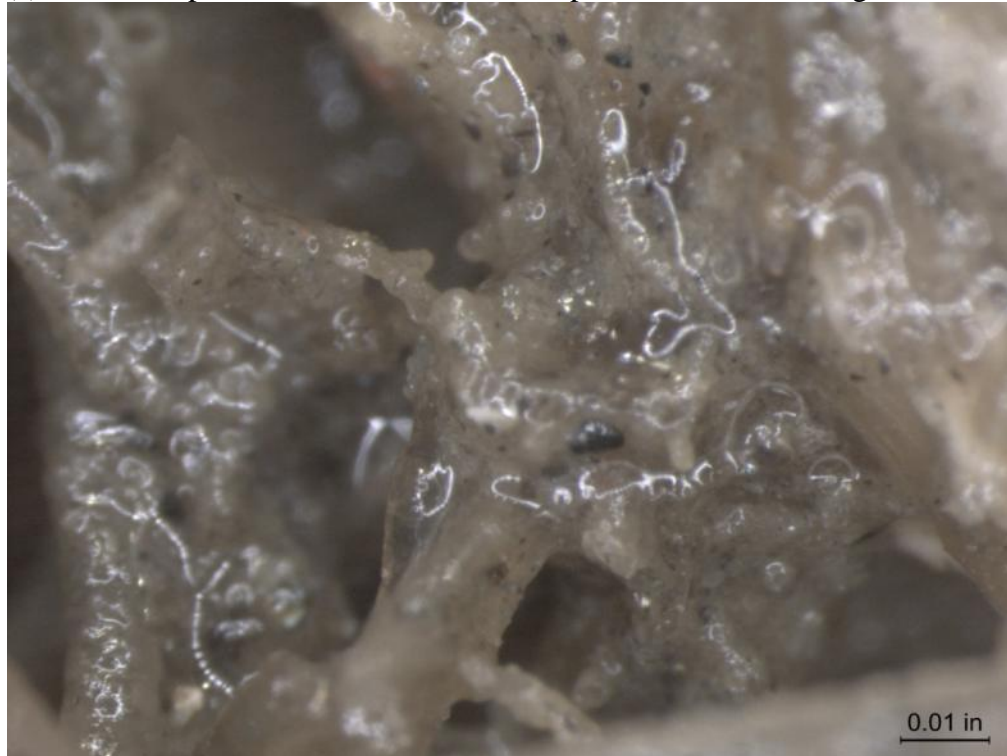
(a) Duplex 2205 Stainless Steel Coupon 7, Before Cleaning 10X

(b) Duplex 2205 Stainless Steel Coupon 7, Before Cleaning 50X

Figure 10 Optical macrographs of duplex 2205 stainless steel coupon 7 after a 6 month corrosion test, before cleaning.

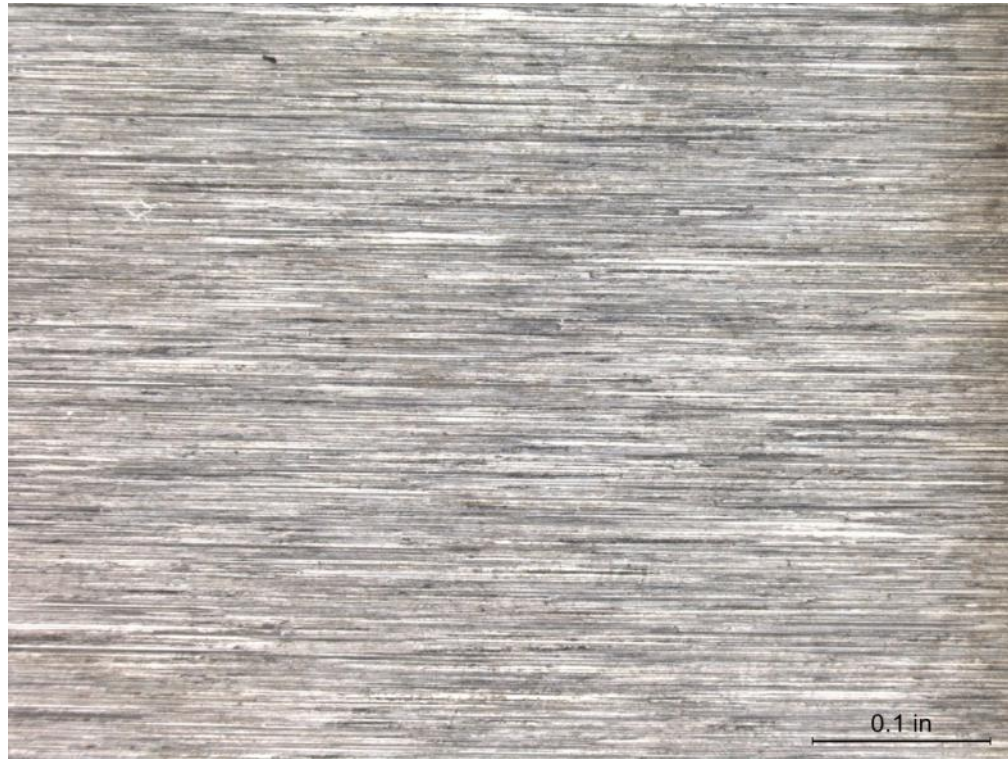
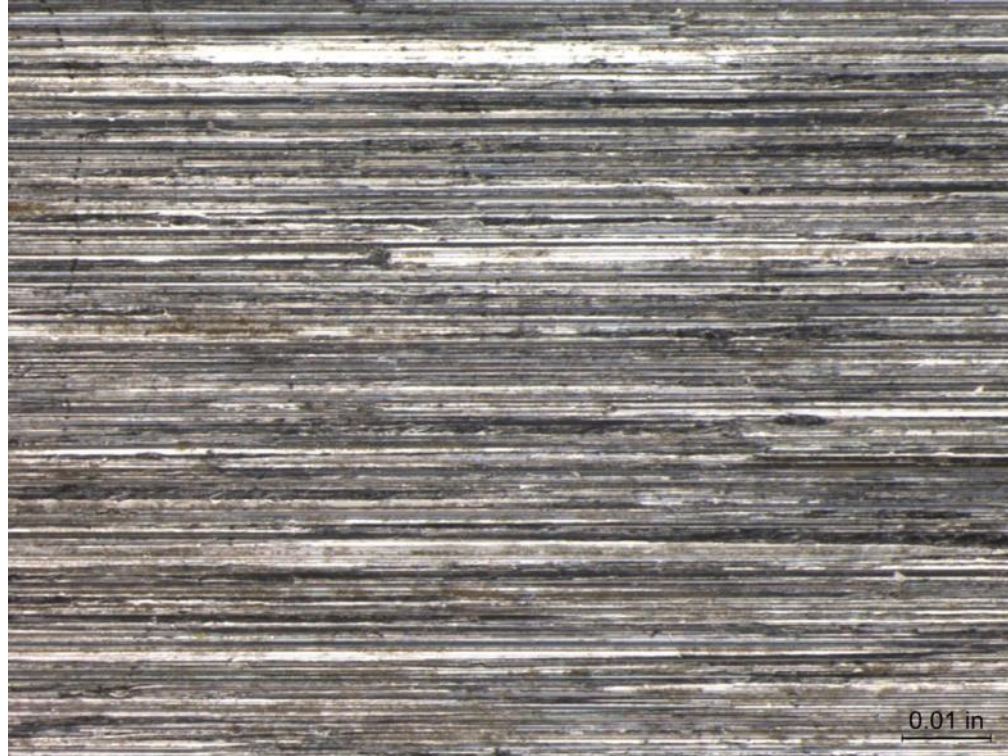
(a) Duplex 2205 Stainless Steel Coupon 7, After Cleaning 10X

(b) Duplex 2205 Stainless Steel Coupon 7, After Cleaning 50X

Figure 11 Optical macrographs of duplex 2205 stainless steel coupon 7 after a 6 month corrosion test, after cleaning.

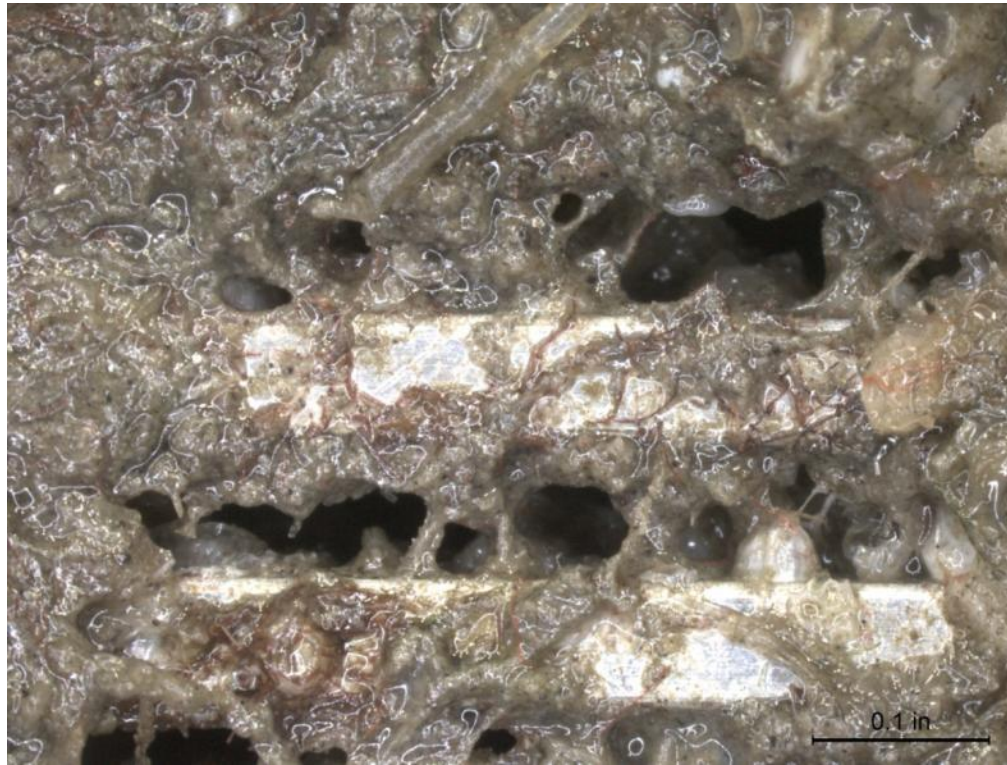
(a) Duplex 2205 Stainless Steel Screen 1, Before Cleaning 10X

(b) Duplex 2205 Stainless Steel Screen 1, Before Cleaning 50X

Figure 13 Optical macrographs of duplex 2205 stainless steel screen 1 after a 3 month corrosion test, before cleaning.

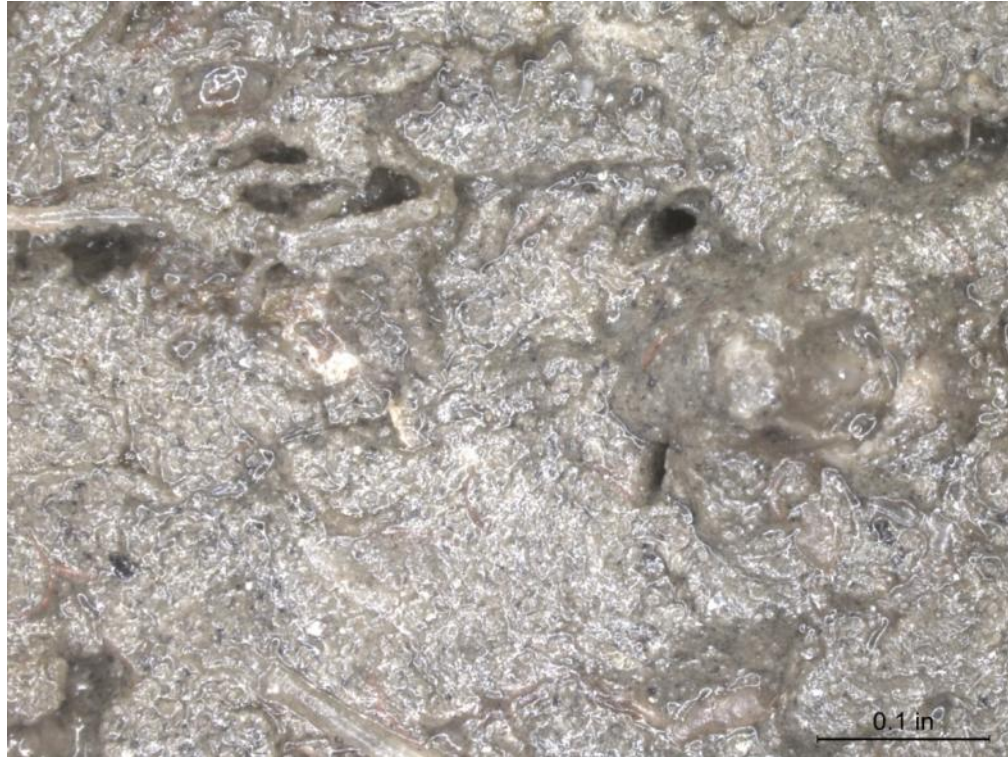
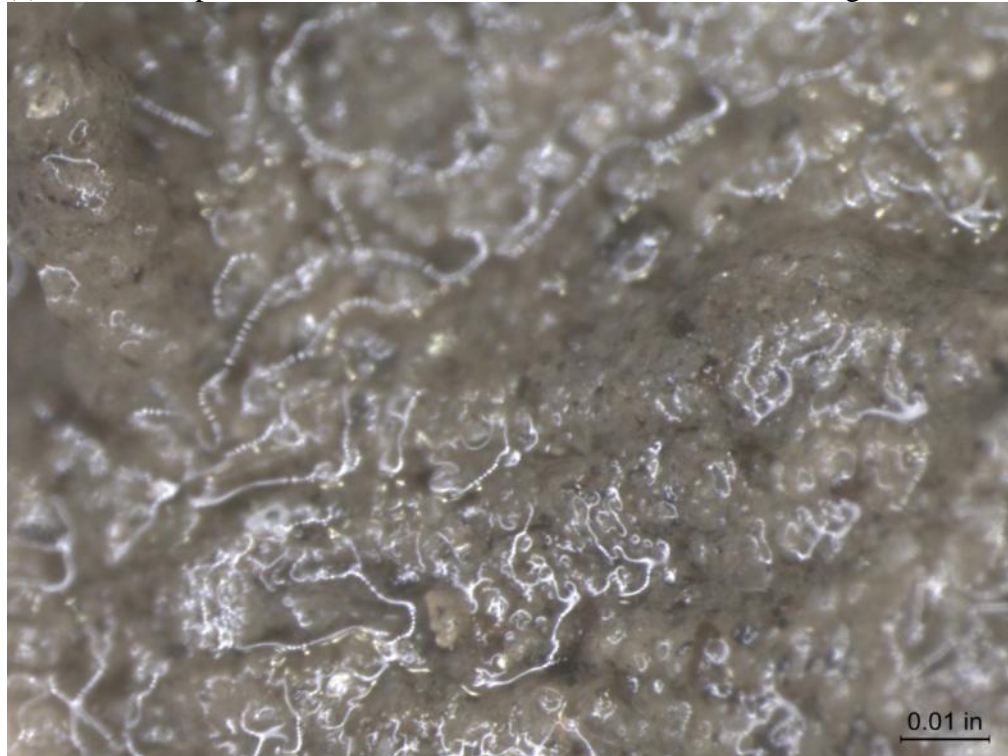
(a) Duplex 2205 Stainless Steel Screen 2, Before Cleaning 10X

(b) Duplex 2205 Stainless Steel Screen 2, Before Cleaning 50X

Figure 15 Optical macrographs of duplex 2205 stainless steel screen 2 after a 6 month corrosion test, before cleaning.

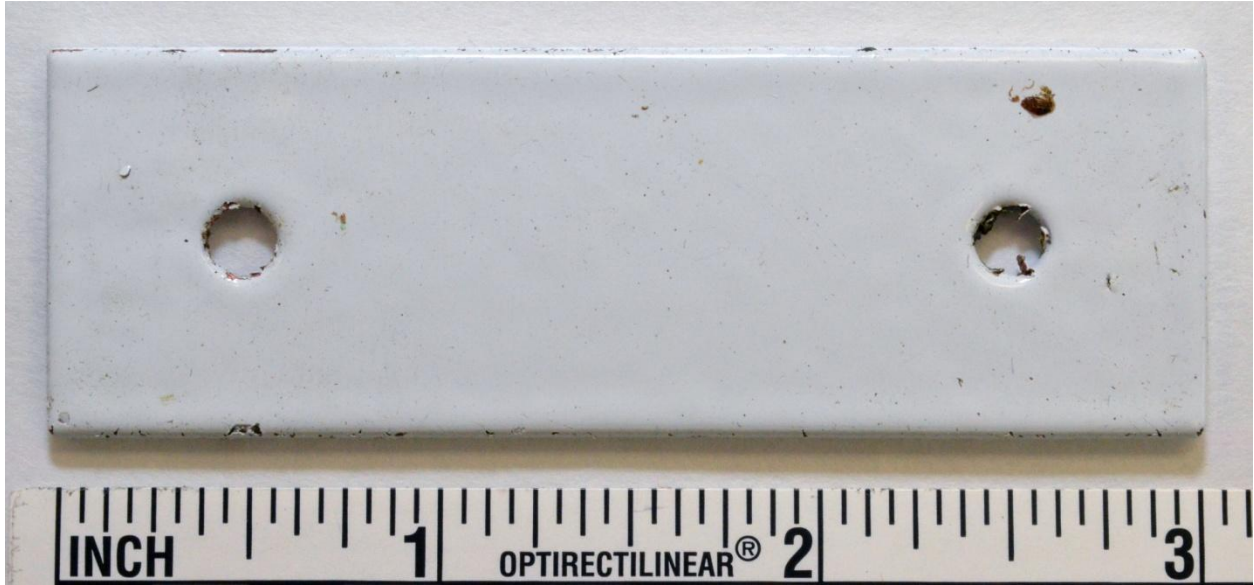
(a) Coated Duplex 2205 Stainless Steel Coupon 2, Front Side

(b) Coated Duplex 2205 Stainless Steel Coupon 2, Back Side

Figure 3 Photographs of duplex 2205 stainless steel with anti-biofouling coating coupon 2 (a) front and (b) back side after a 6 month corrosion test.

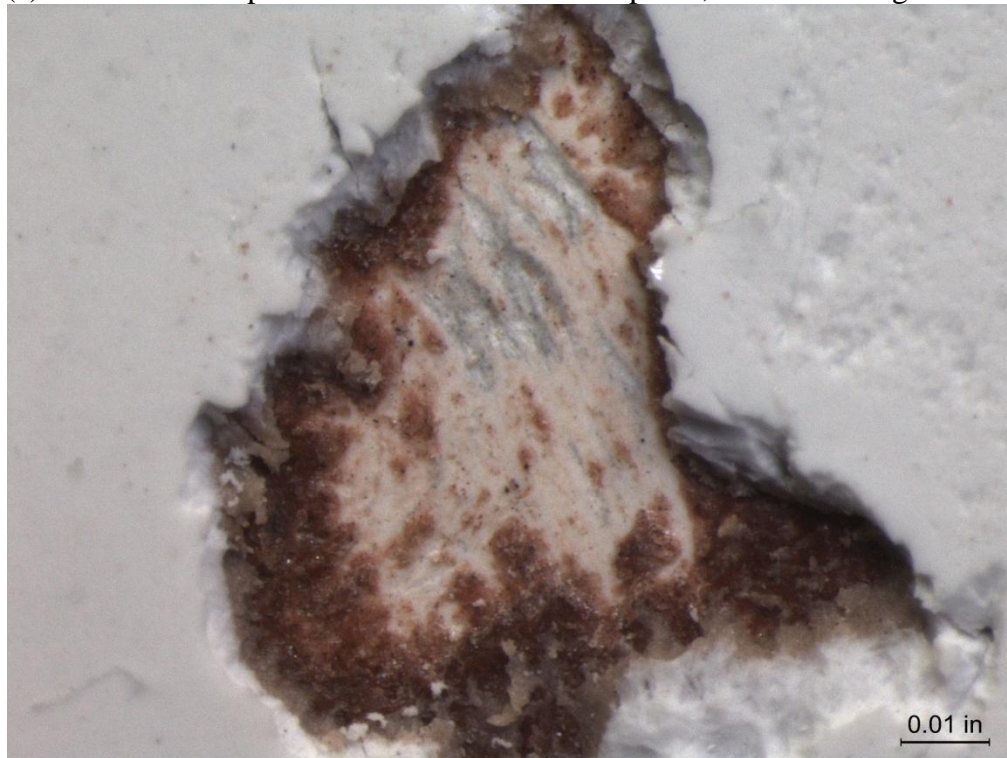
(a) Coated Duplex 2205 Stainless Steel Coupon 2, After Cleaning 10X

(b) Coated Duplex 2205 Stainless Steel Coupon 2, After Cleaning 50X

Figure 11 Optical macrographs of duplex 2205 stainless steel with anti-biofouling coating coupon 2 after a 6 month corrosion test, after cleaning.

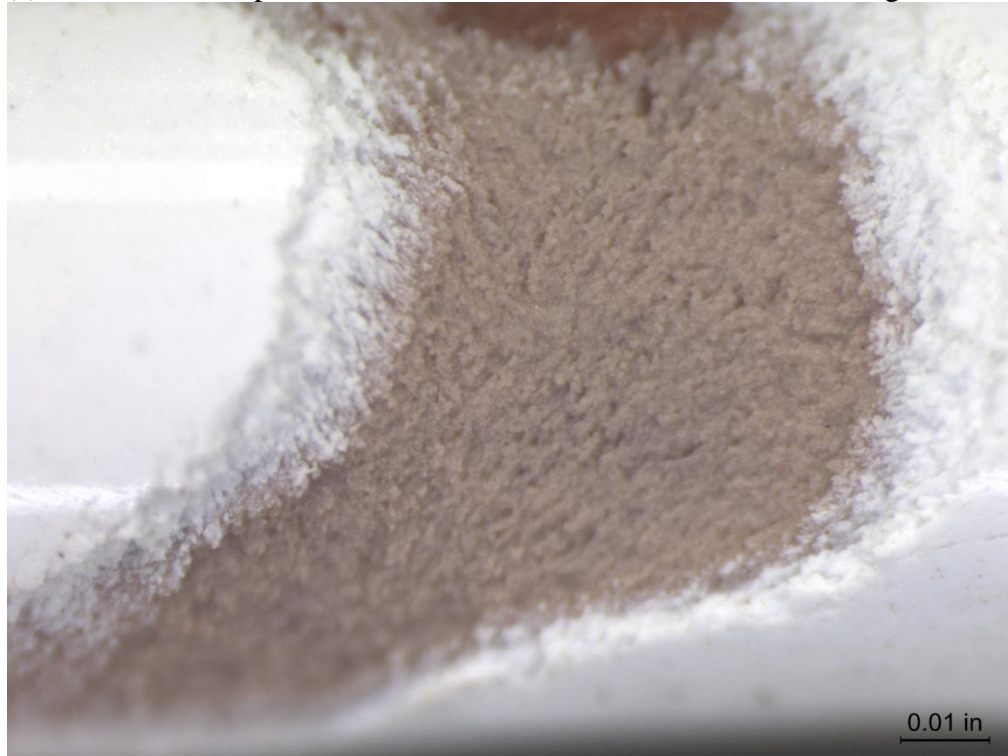
(a) Coated Duplex 2205 Stainless Steel Screen 2, After Cleaning 10X

(b) Coated Duplex 2205 Stainless Steel Screen 2, After Cleaning 50X

Figure 16 Optical macrographs of duplex 2205 stainless steel with anti-biofouling coating screen 2 after a 6 month corrosion test, after cleaning.

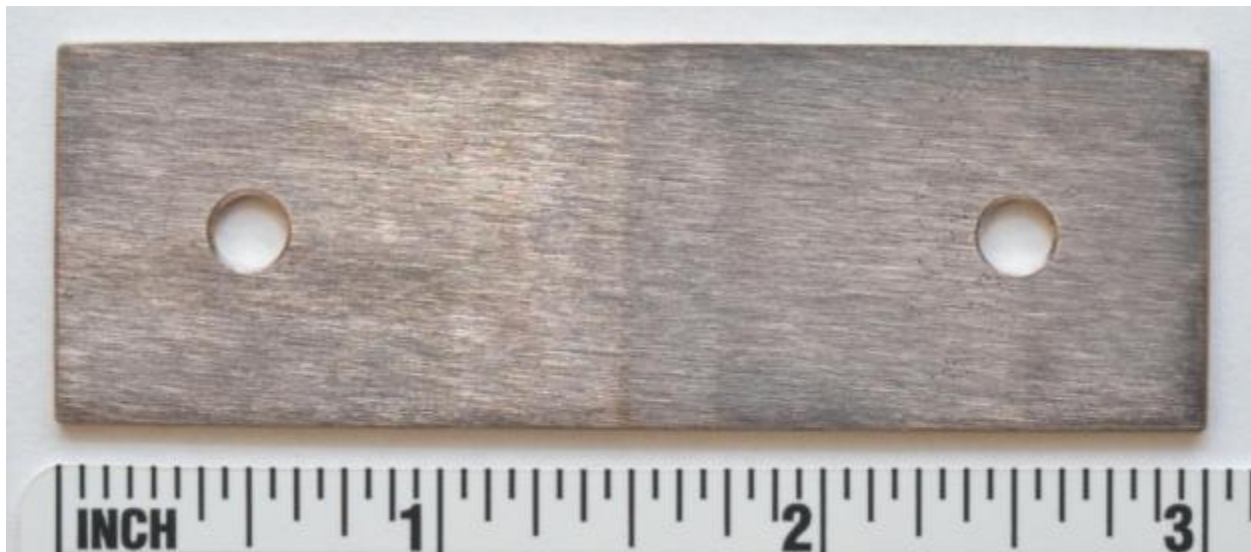
(a) CDA 706 Baseline Coupon, Front Side

(b) CDA 706 Baseline Coupon, Back Side

Figure 1 Photographs of the CDA 706 baseline coupon (a) front and (b) back side.

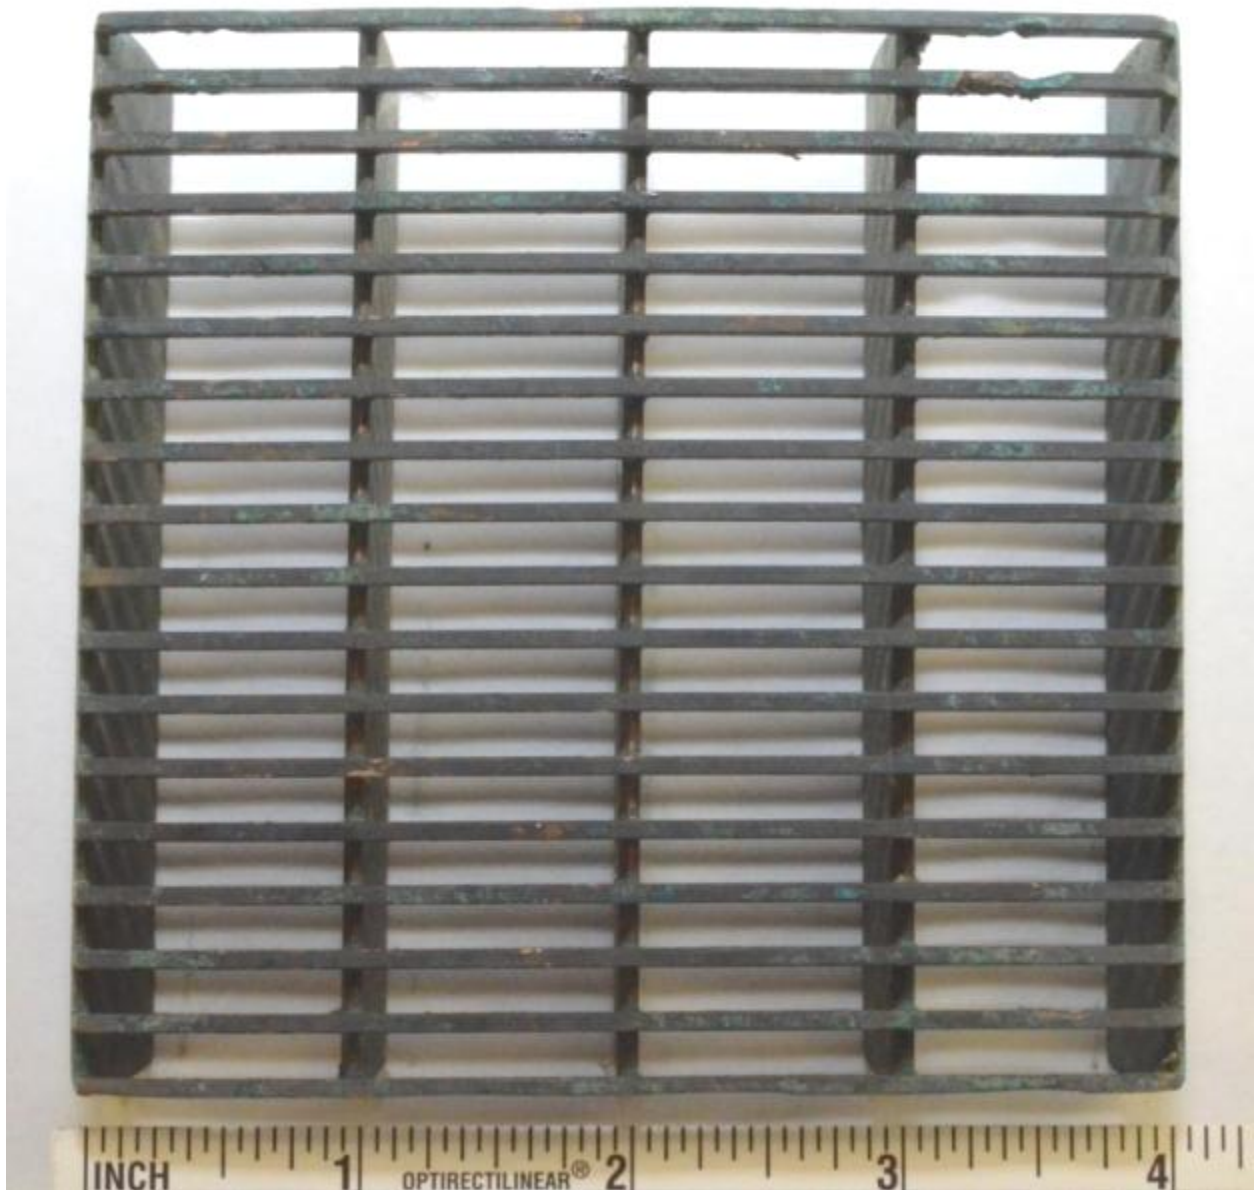
CDA 706 Screen 2

After 6 months of corrosion testing, the coupon had lost 0.550 grams of material and had a corrosion rate of 0.023 millimeters per year. After 6 months of corrosion testing, the screen had lost 15.24 grams of material and had a corrosion rate of 0.067 millimeters per year.

Figure 6 Photograph of CDA 706 screen 2 after a 6 month corrosion test.

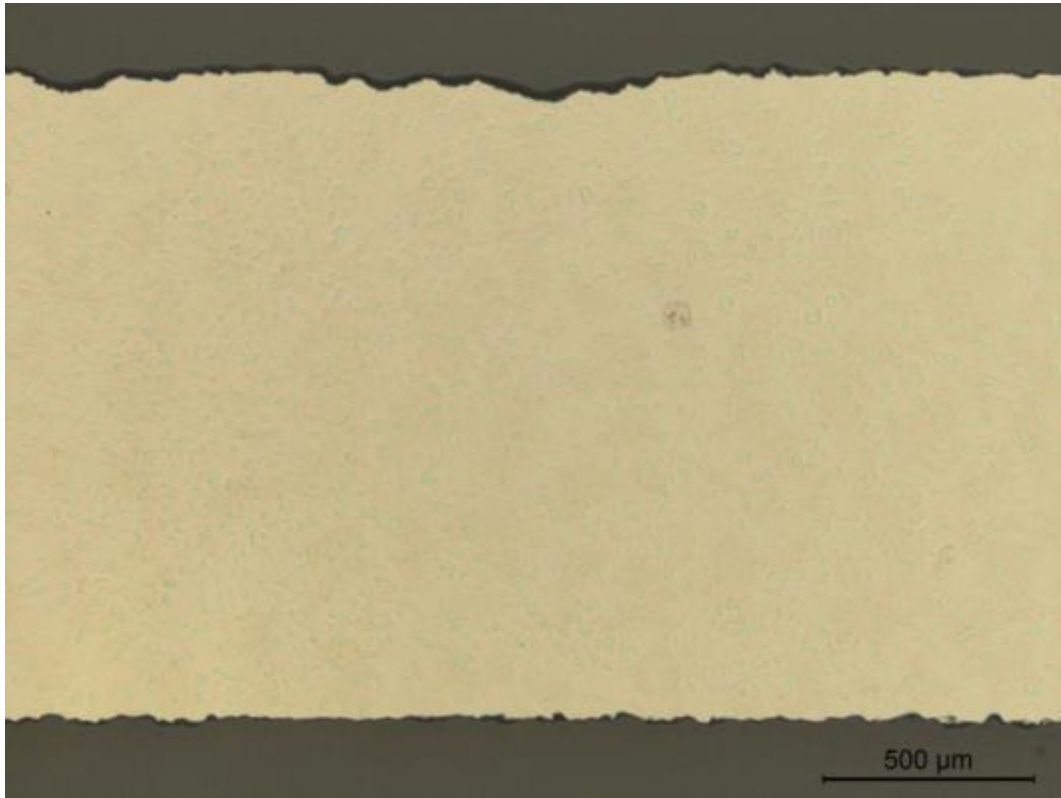
Figure 27 Optical micrographs of CDA 706 coupon 1.

A cross section was taken from the coupon and prepared for a metallographic examination. Optical micrographs of the surface for coupon 1 are shown in Figure 27. An elliptical pit was observed in coupon 1, measuring 50 μm deep. Optical micrographs of the surface for coupon 2 are shown in Figure 28. An elliptical pit was observed in coupon 2, measuring 22 μm deep.

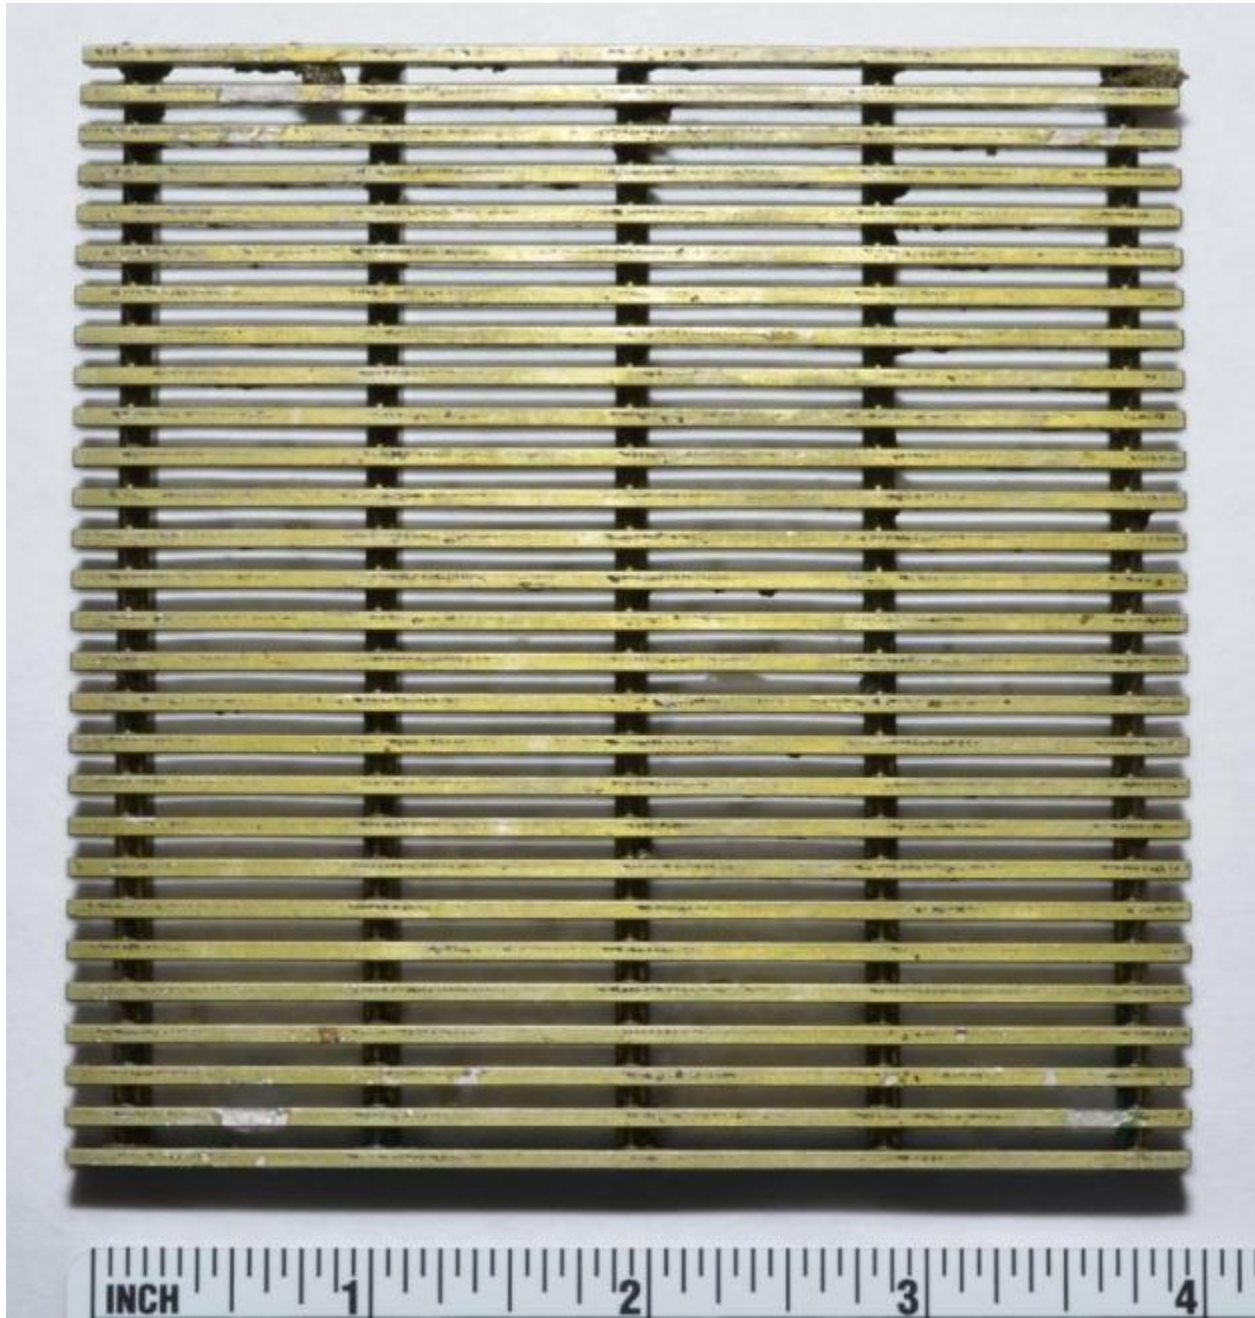
Figure 5 Photograph of CDA 715 screen 1 after a 3 month corrosion test.

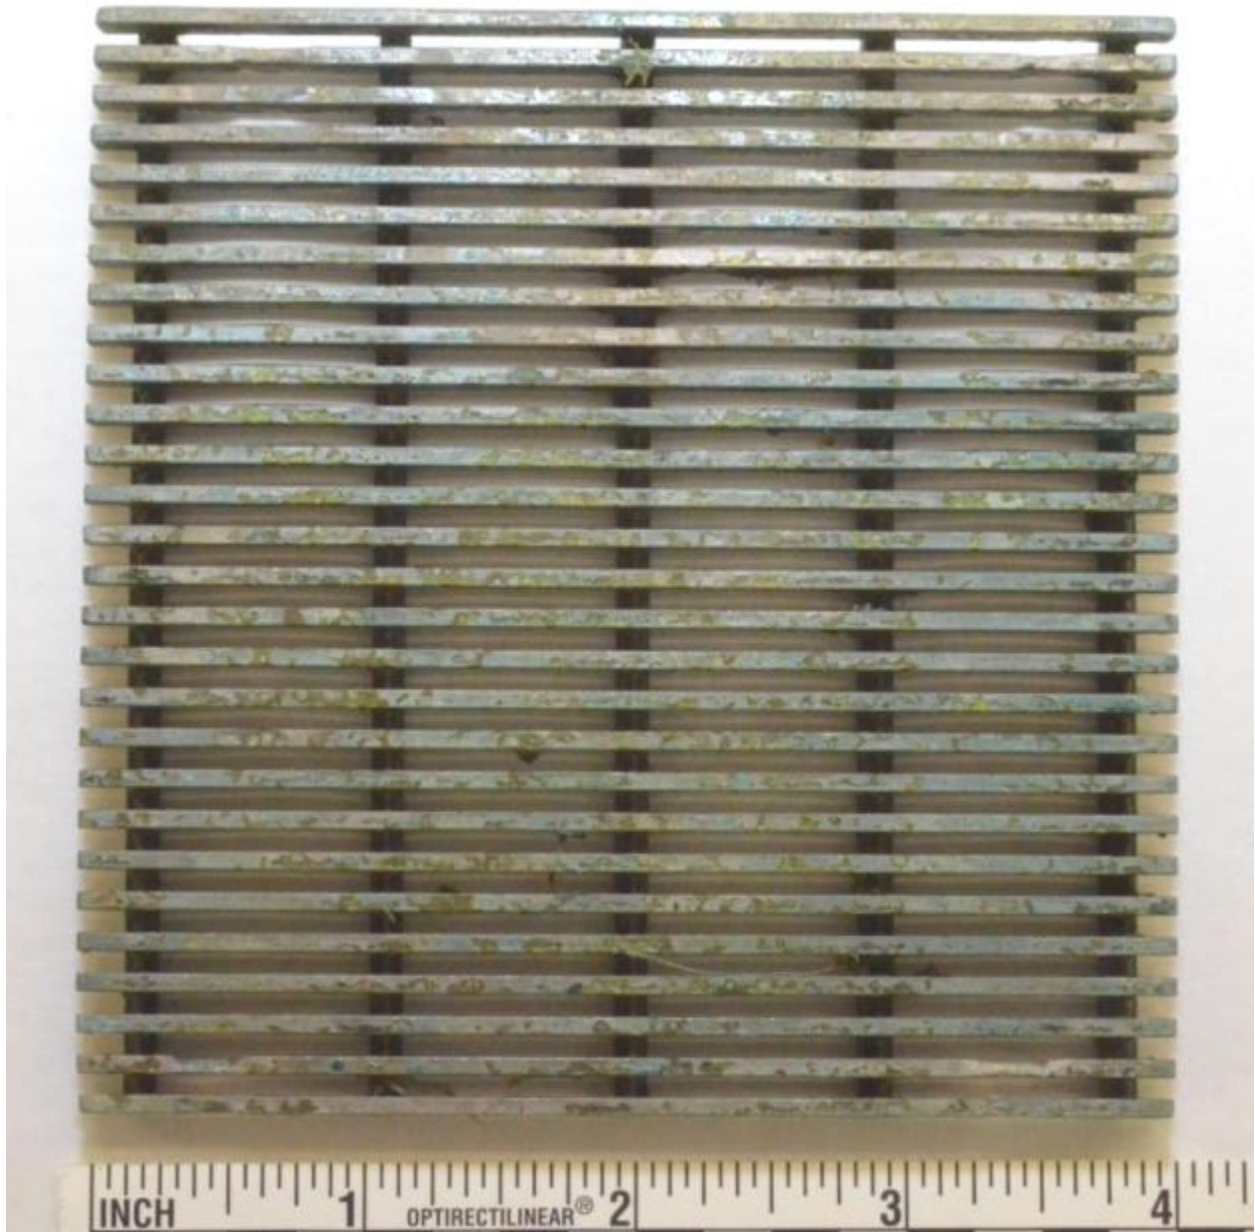
Figure 6 Photograph of CDA 715 screen 2 after a 6 month corrosion test.

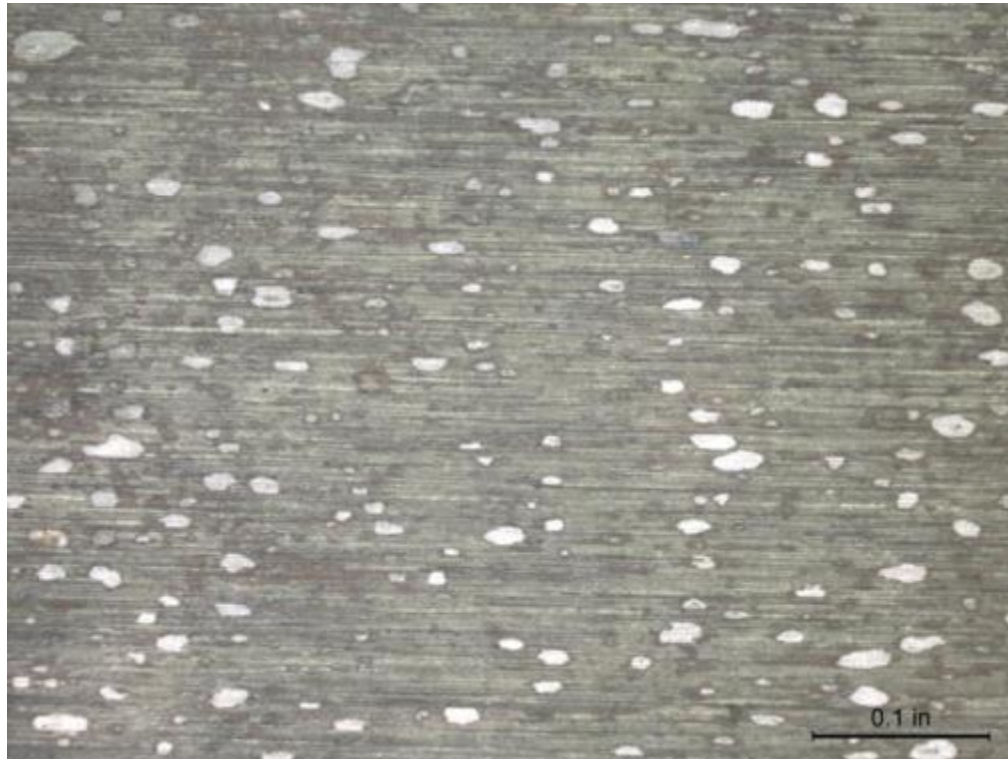
Figure 8 Optical macrographs of CDA 715 coupon 1 after a 3 month corrosion test, before cleaning.

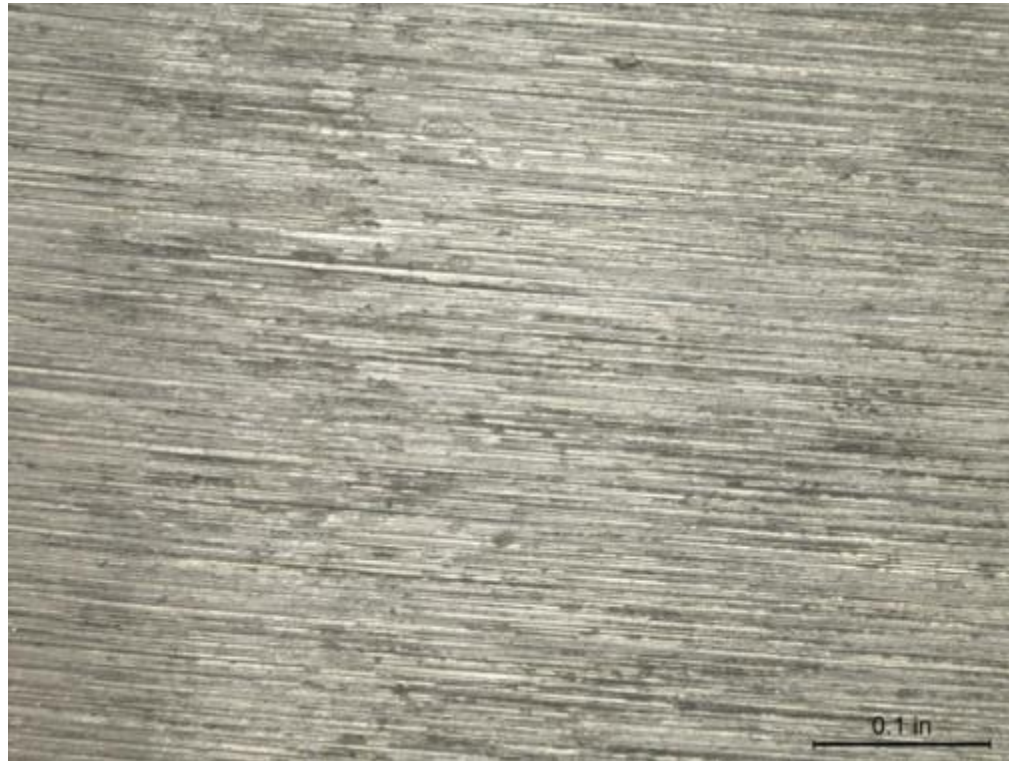
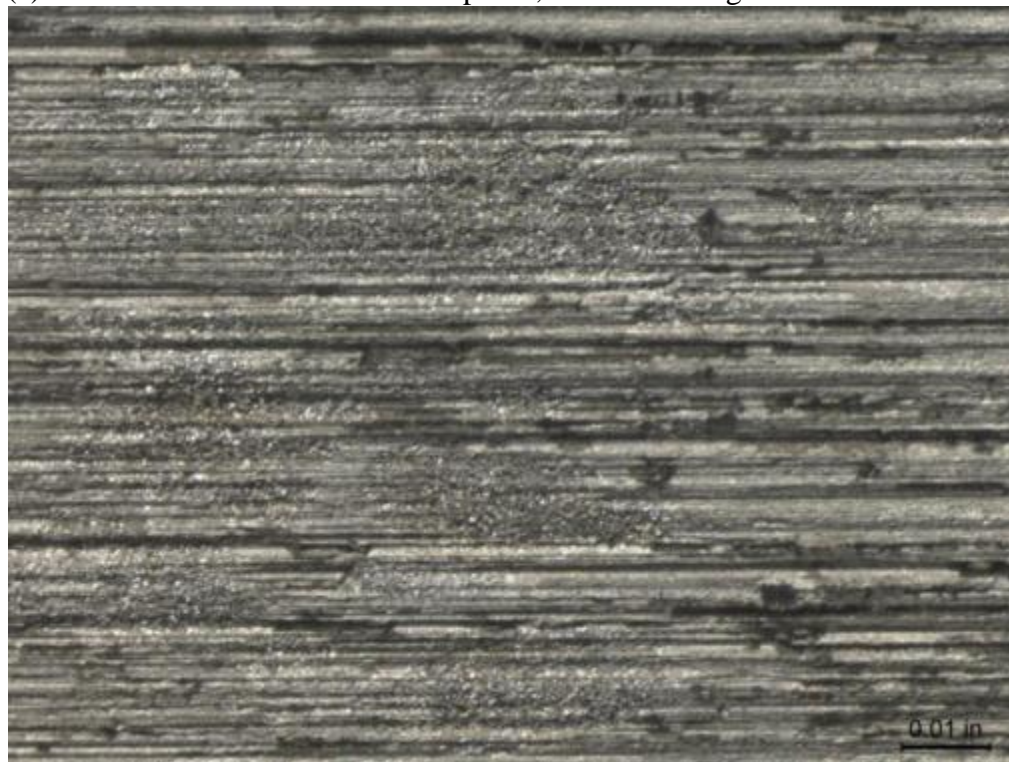
Figure 9 Optical macrographs of CDA 715 coupon 1 after a 3 month corrosion test, after cleaning.

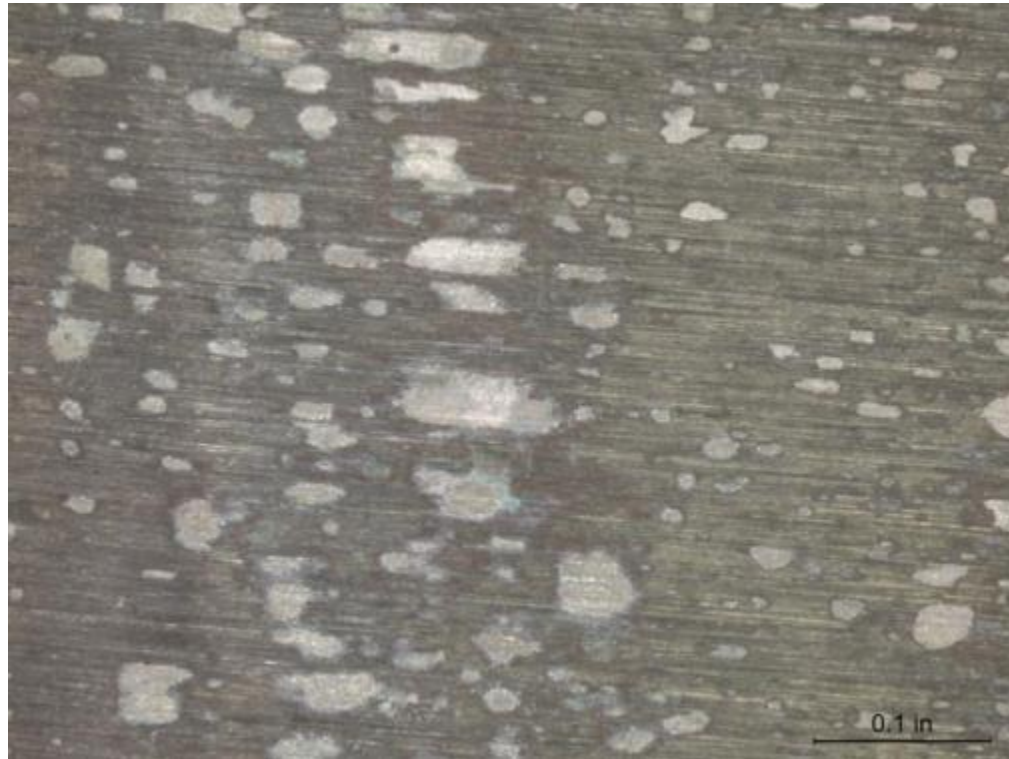
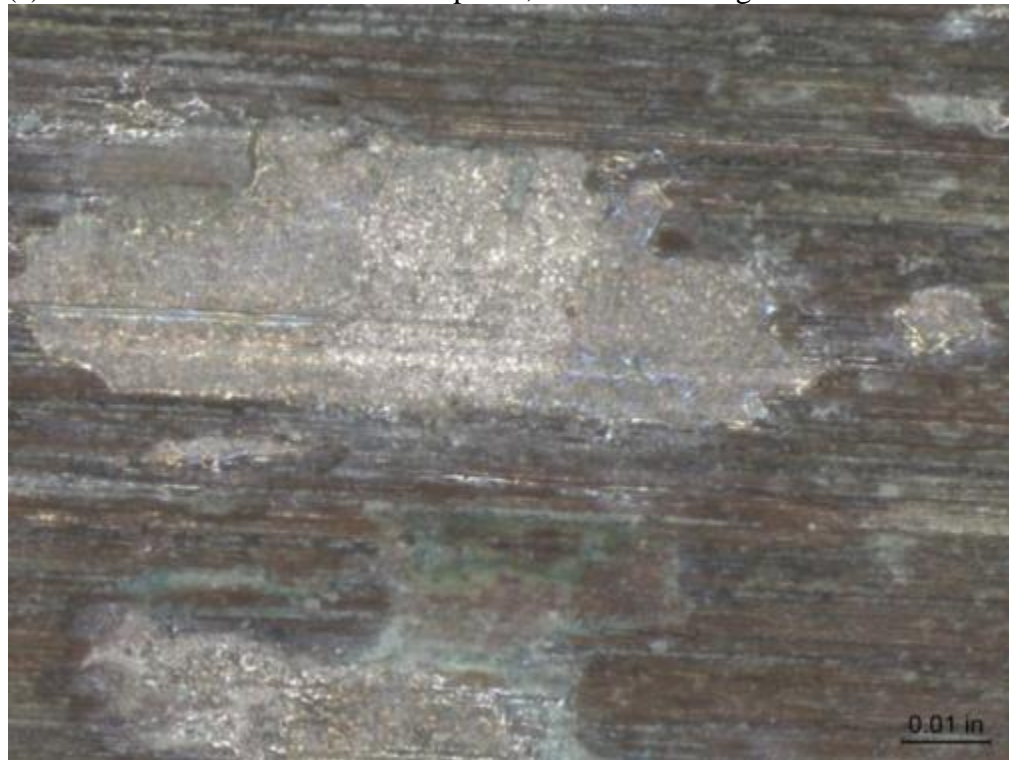
Figure 10 Optical macrographs of CDA 715 coupon 2 after a 6 month corrosion test, before cleaning.

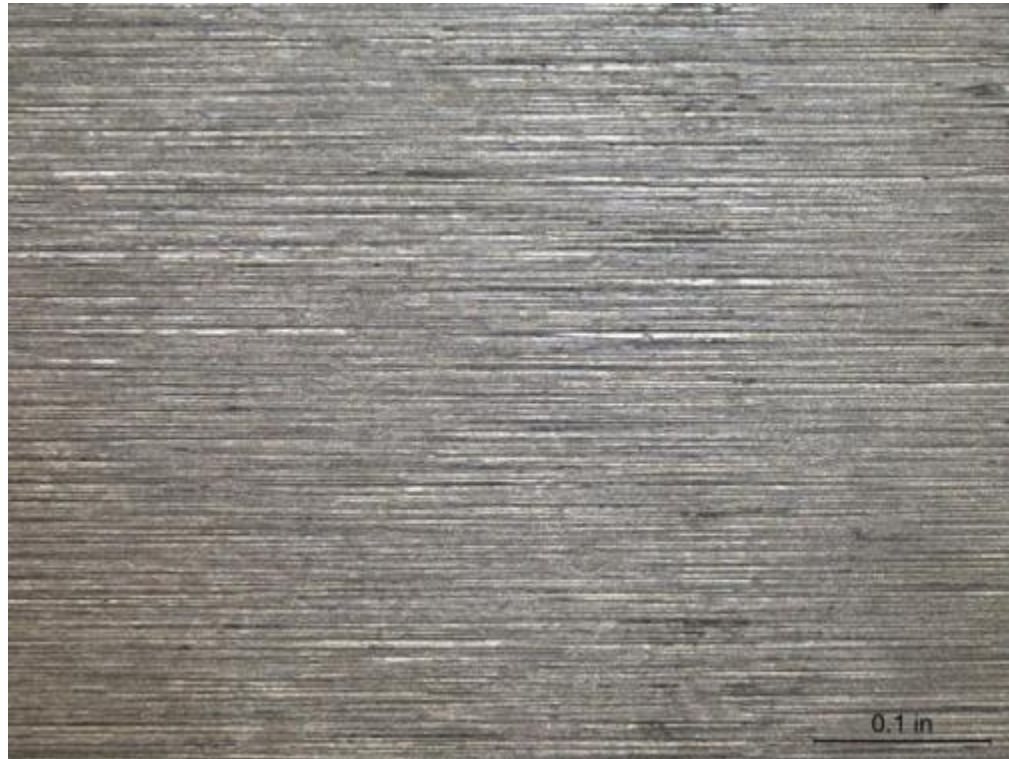
Figure 11 Optical macrographs of CDA 715 coupon 2 after a 6 month corrosion test, after cleaning.

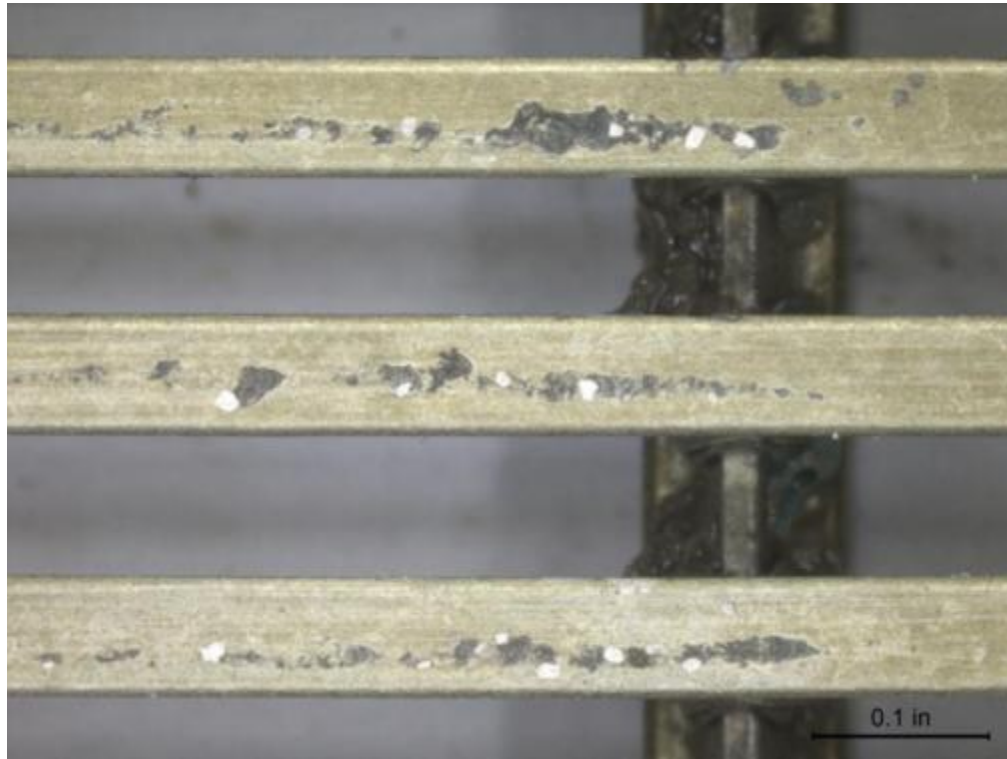
Figure 13 Optical macrographs of CDA 715 screen 1 after a 3 month corrosion test, before cleaning.

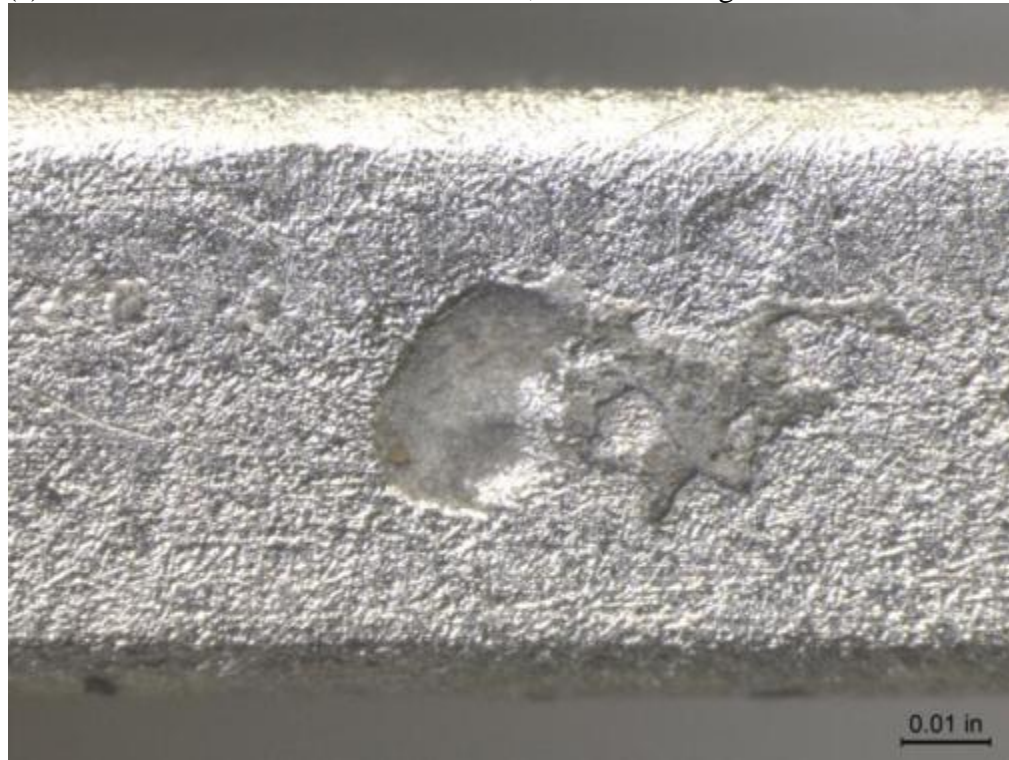
Figure 14 Optical macrographs of CDA 715 screen 1 after a 3 month corrosion test, after cleaning.
