WEST BASIN MUNICIPAL WATER DISTRICT OCEAN WATER DESALINATION INTAKE CORROSION STUDY

November 2014

V&A Project No.: 13-0376

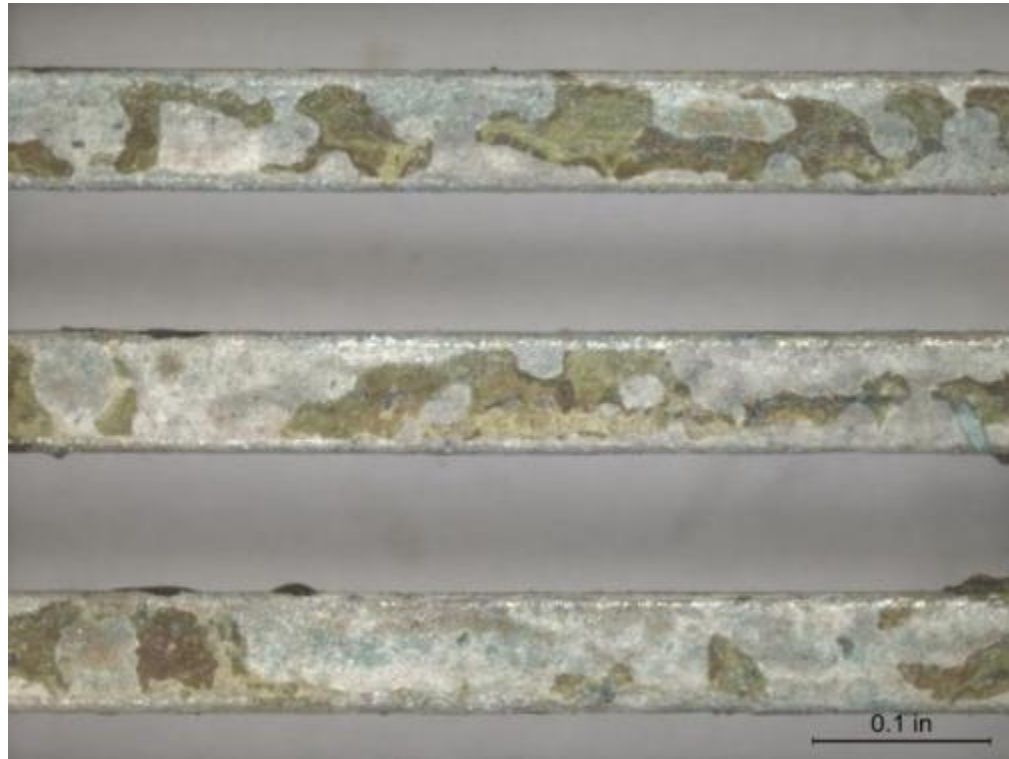
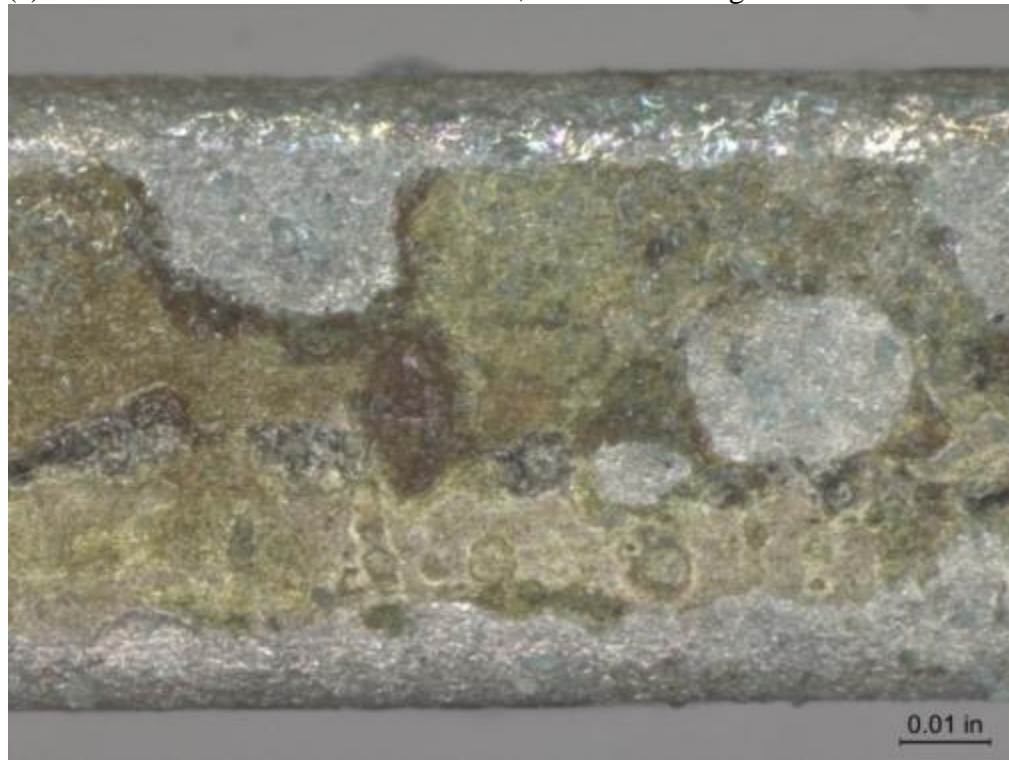
Figure 15 Optical macrographs of CDA 715 screen 2 after a 6 month corrosion test, before cleaning.

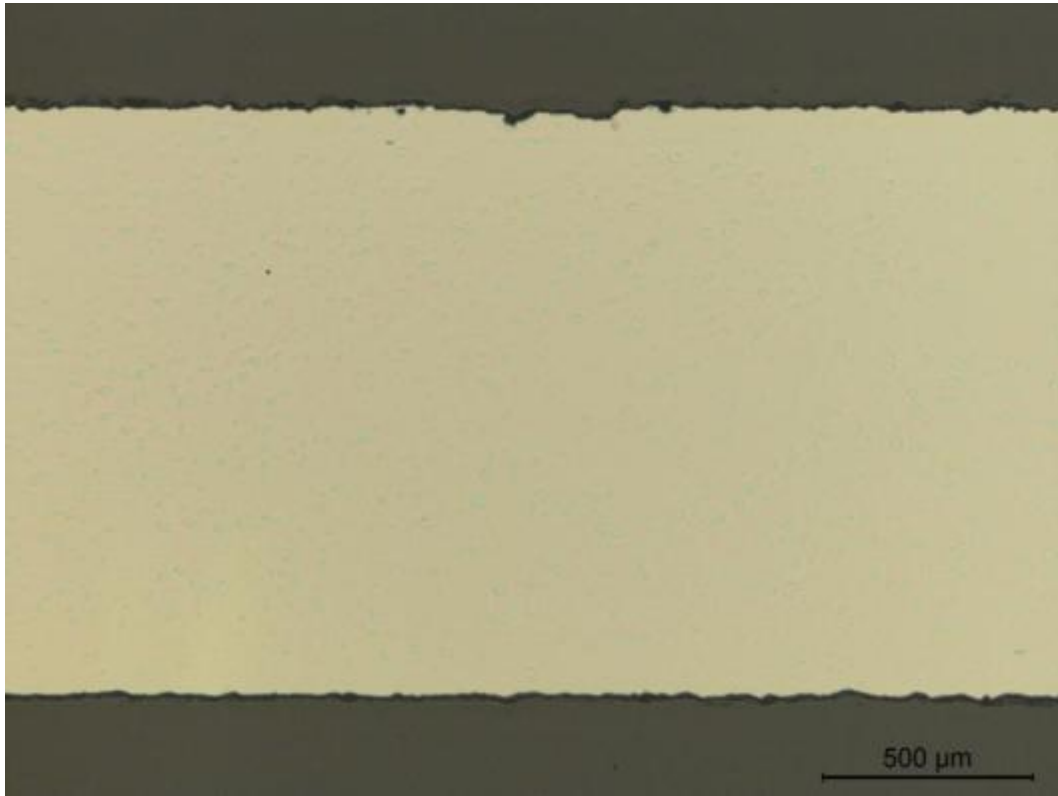
Figure 27 Optical micrographs of CDA 715 coupon 1.

Cross sections were taken from the coupon and prepared for a metallographic examination. An optical micrograph of the surface for coupon 1 is shown in Figure 27. A wide, shallow pit was observed in coupon 1, measuring 0.2 mm in depth. An optical micrograph of the surface for coupon 2 is shown in Figure 28. Small pits were observed in coupon 2, measuring 13 mm in depth.

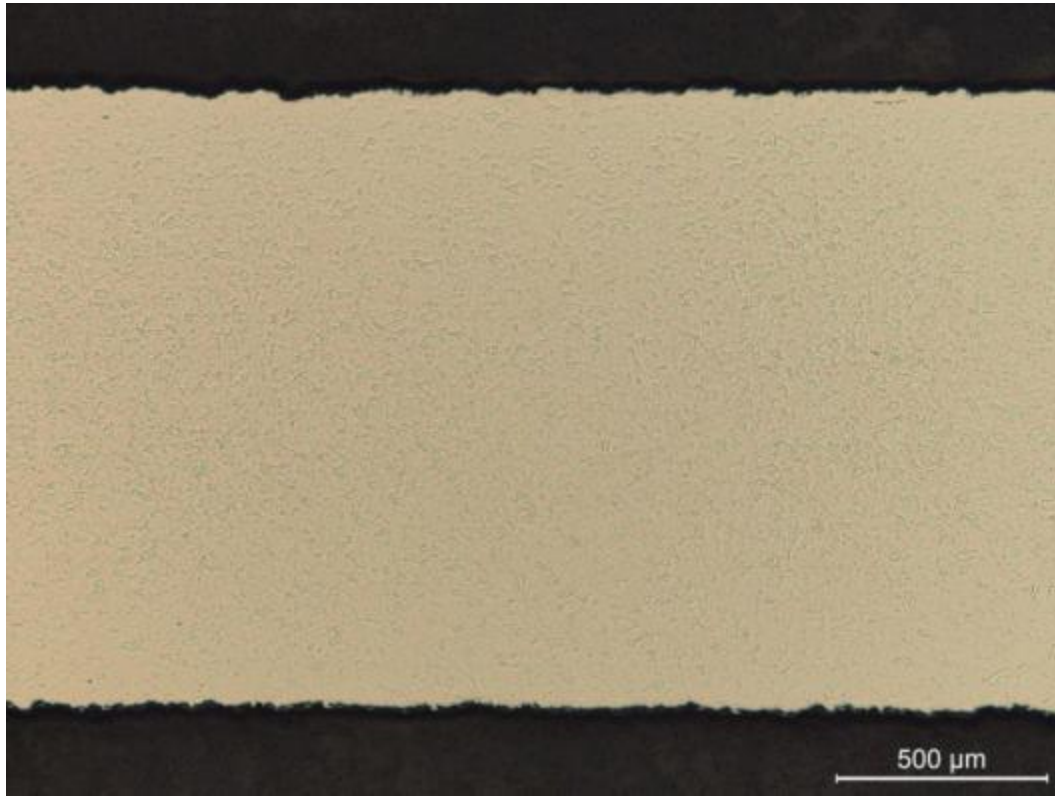
Figure 28 Optical micrographs of CDA 715 coupon 2.

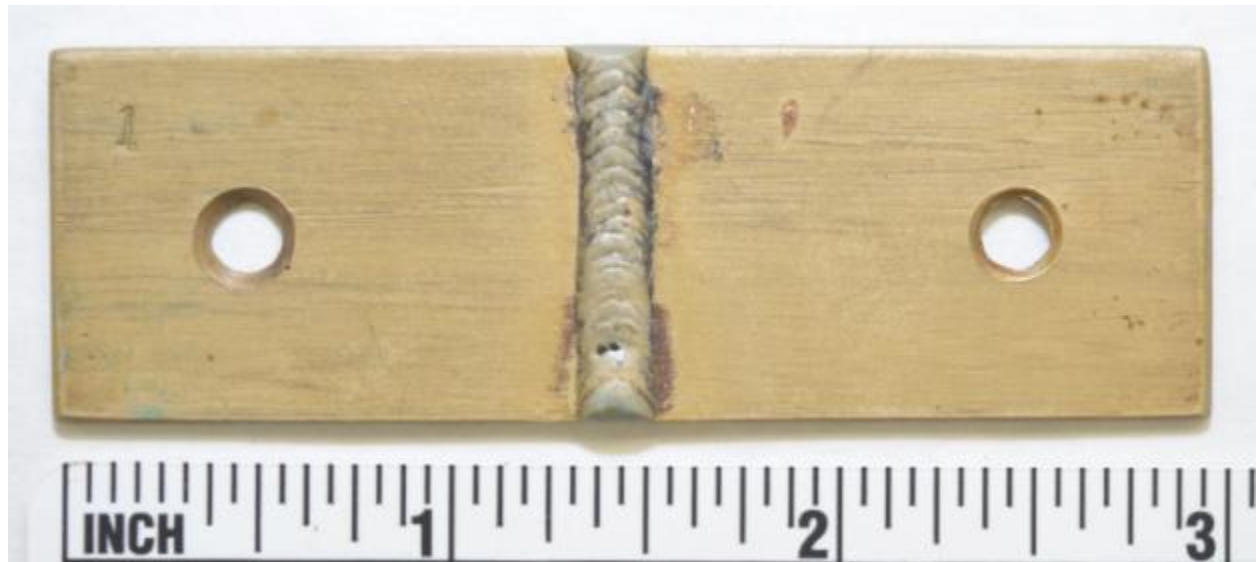
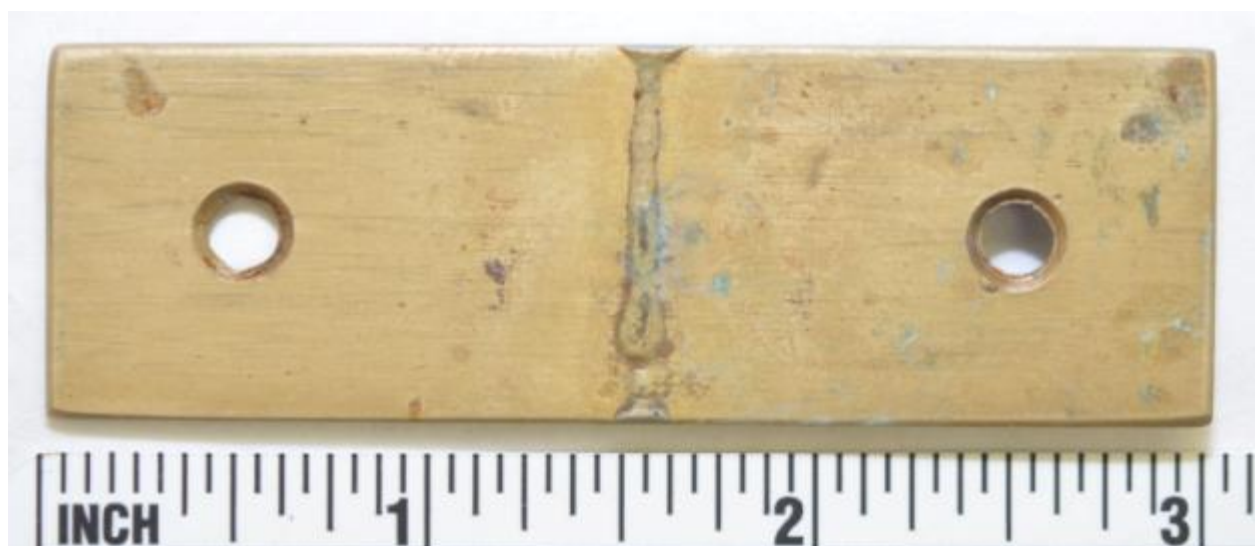
After 3 months of corrosion testing, the coupon had lost 0.172 grams of material and had a corrosion rate of 0.015 millimeters per year. After 3 months of corrosion testing, the screen had lost 14.96 grams of material and had a corrosion rate of 0.113 millimeters per year.

Figure 2 Photographs of Z-Alloy coupon 1 (a) front and (b) back side after a 3 month corrosion test.

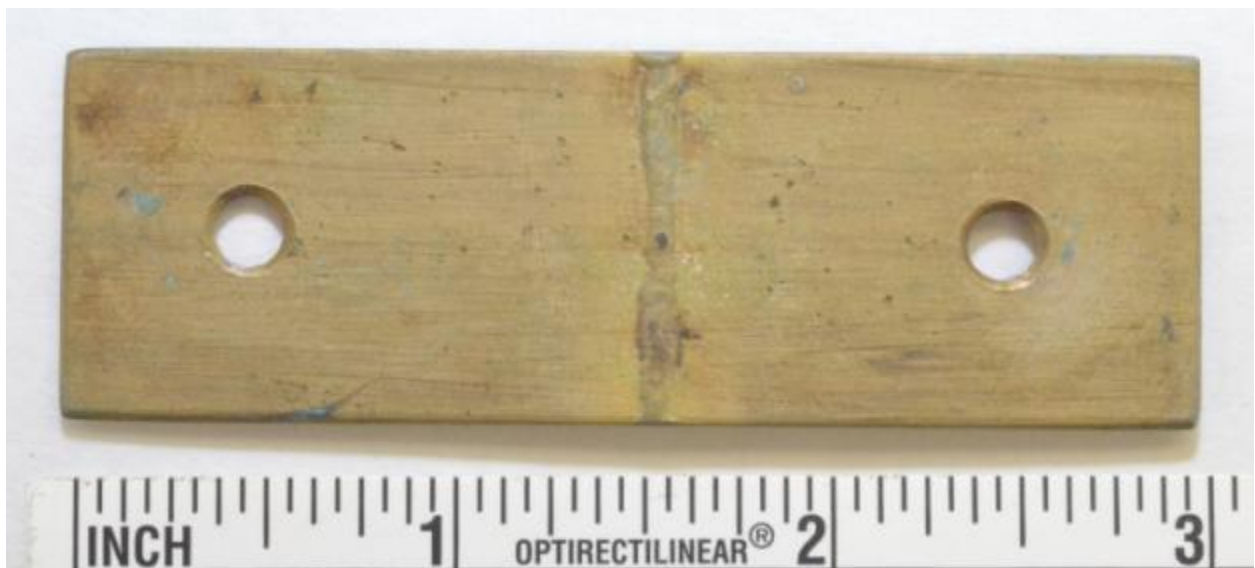
After 6 months of corrosion testing, the coupon had lost 0.236 grams of material and had a corrosion rate of 0.010 millimeters per year. After 6 months of corrosion testing, the screen had lost 16.71 grams of material and had a corrosion rate of 0.062 millimeters per year.

Figure 3 Photographs of Z-Alloy coupon 2 (a) front and (b) back side after a 6 month corrosion test.

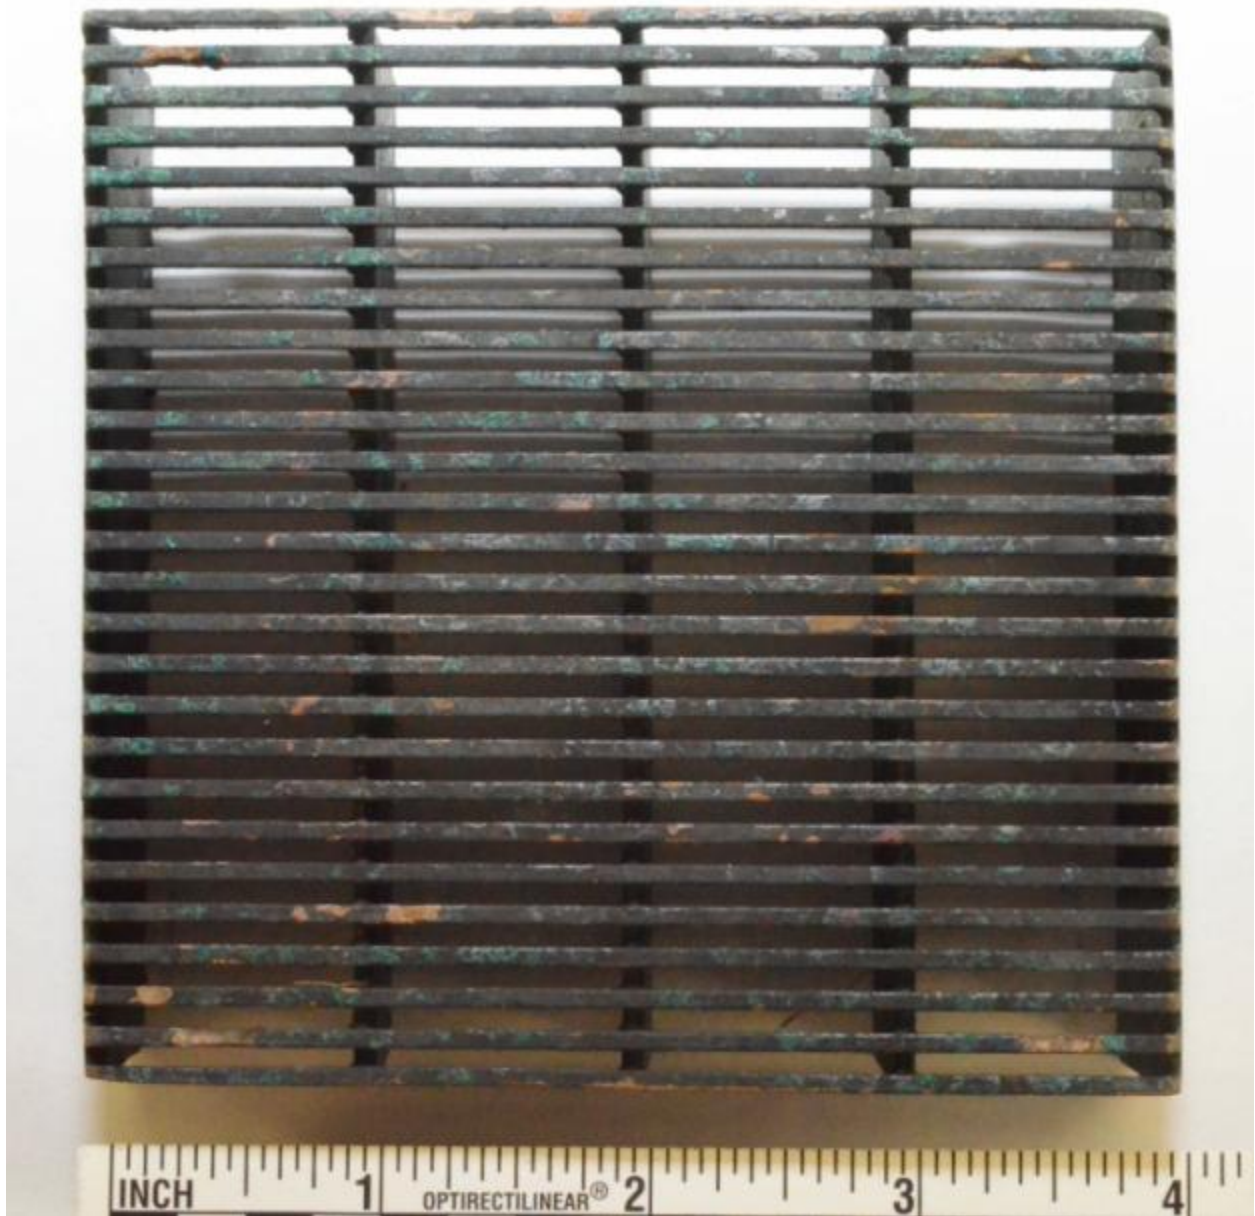
Z-Alloy Screen 2

Figure 6 Photograph of Z-Alloy screen 2 after a 6 month corrosion test.

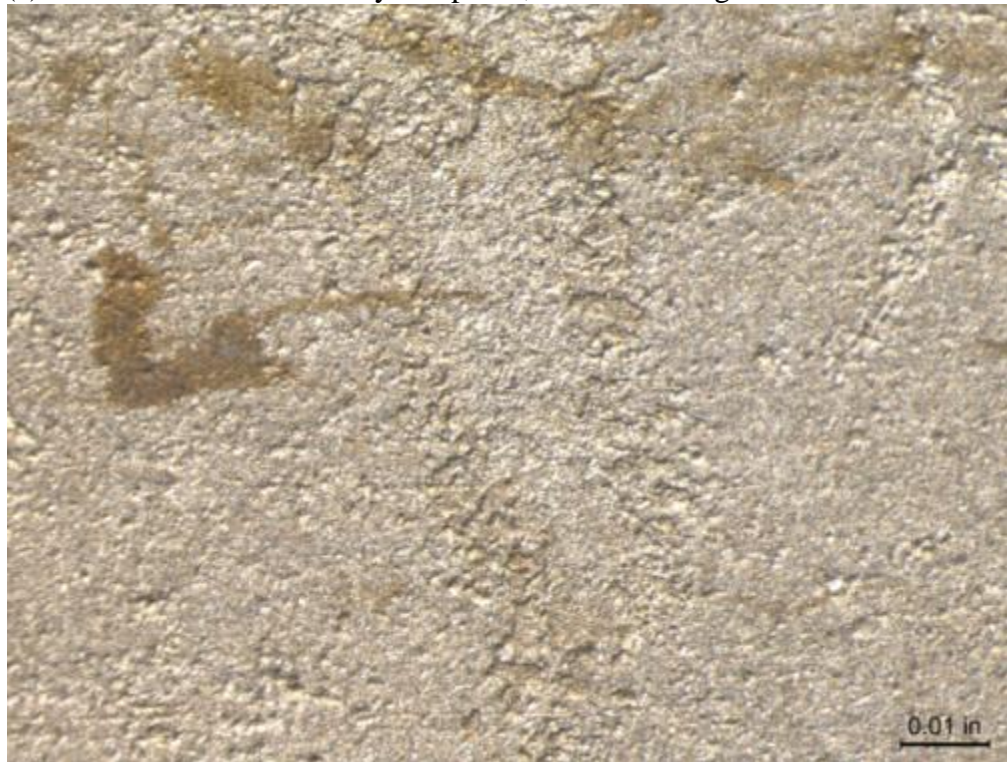
Figure 9 Optical macrographs of Z-Alloy coupon 1 after a 3 month corrosion test, after cleaning.

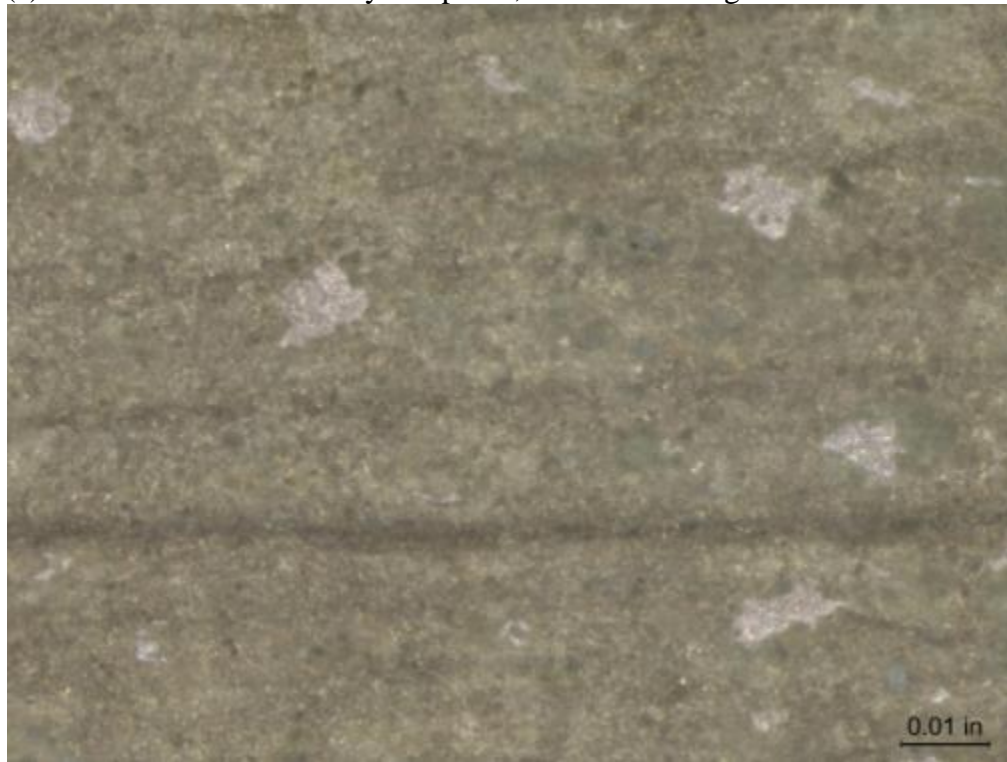
Figure 10 Optical macrographs of Z-Alloy coupon 2 after a 6 month corrosion test, before cleaning.

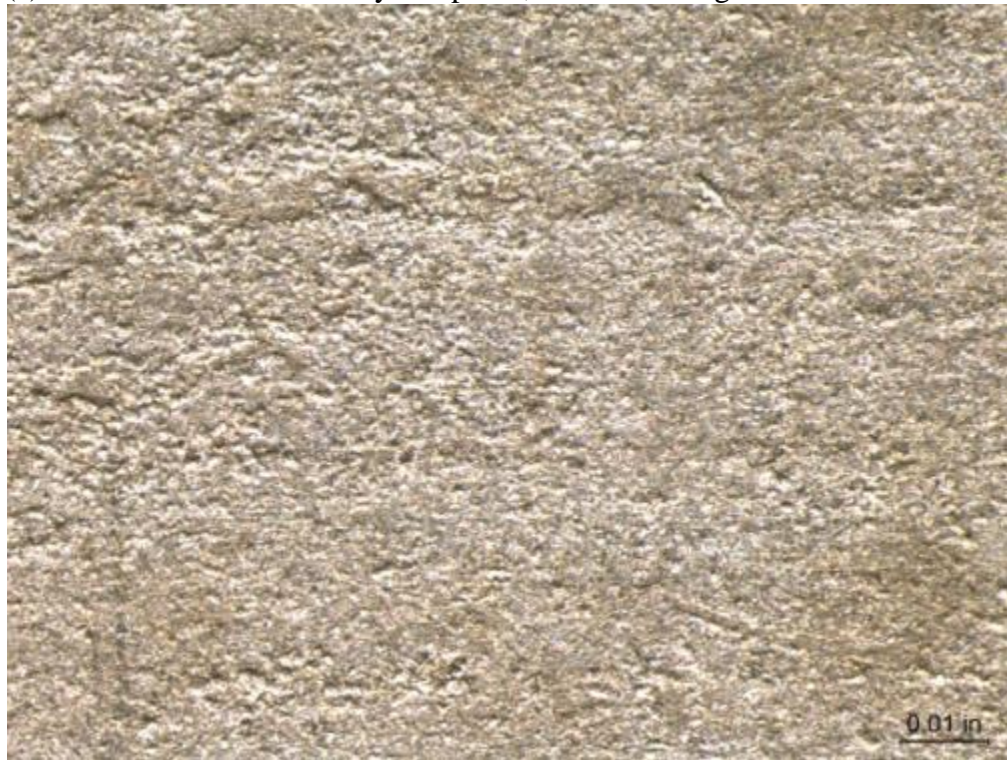
Figure 11 Optical macrographs of Z-Alloy coupon 2 after a 6 month corrosion test, after cleaning.

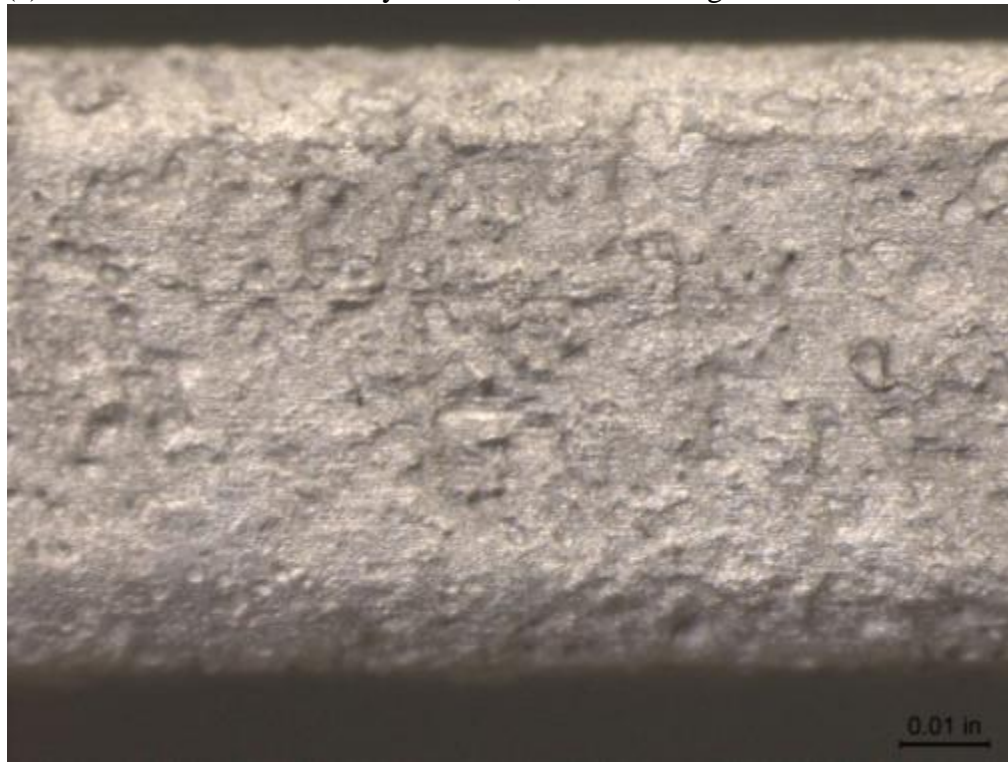
Figure 14 Optical macrographs of Z-Alloy screen 1 after a 3 month corrosion test, after cleaning.

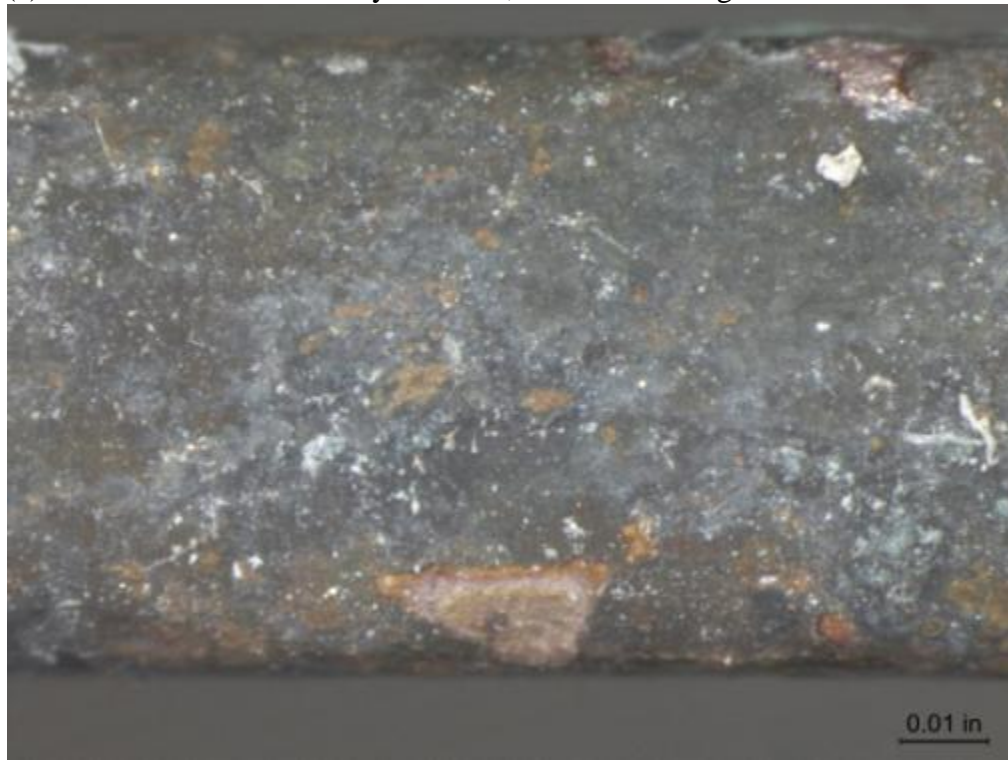
Figure 15 Optical macrographs of Z-Alloy screen 2 after a 6 month corrosion test, before cleaning.

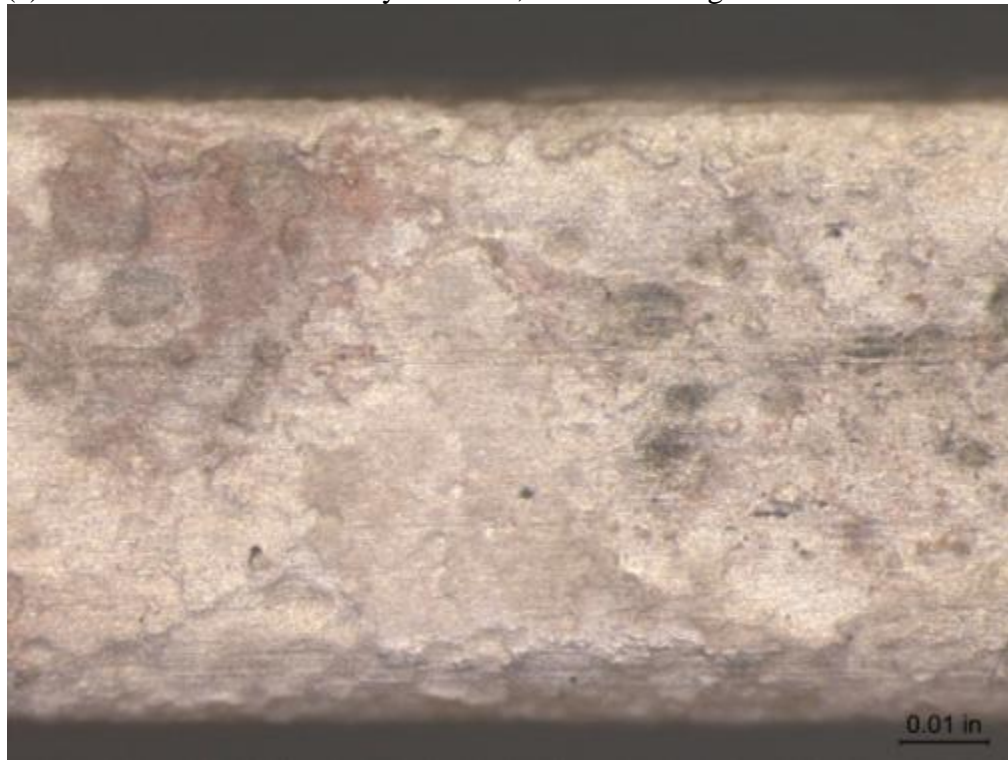
Figure 16 Optical macrographs of Z-Alloy screen 2 after a 6 month corrosion test, after cleaning.

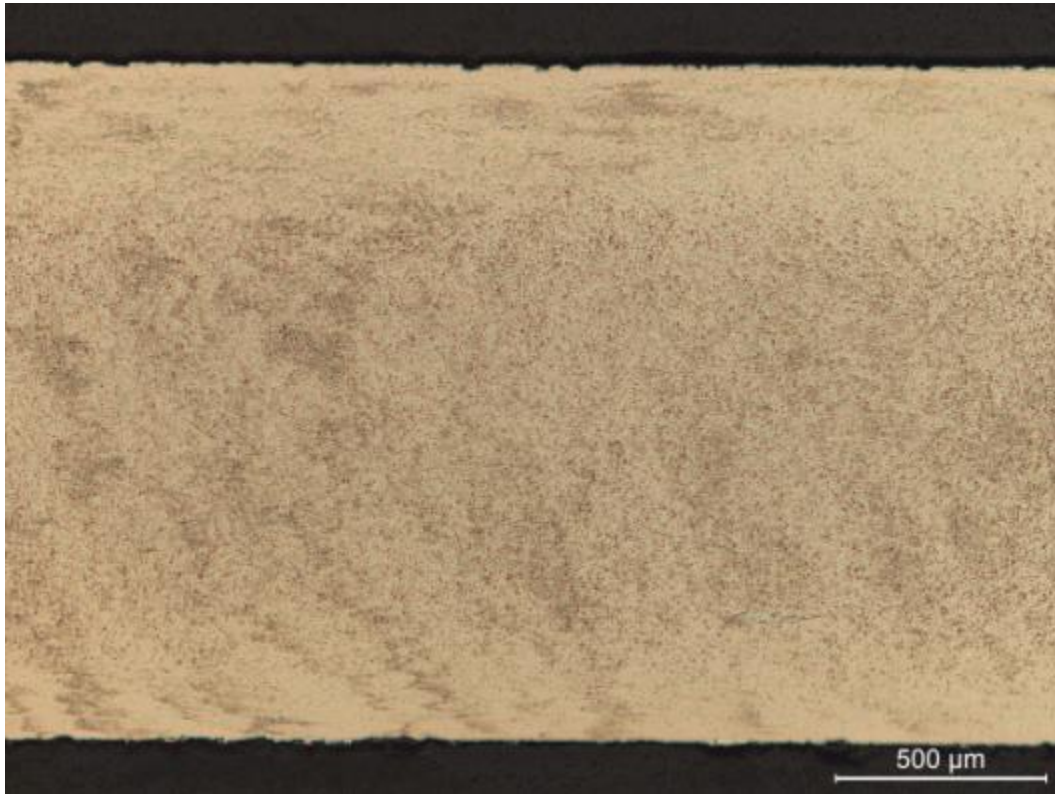
Figure 28 Optical micrographs of Z-Alloy coupon 2.

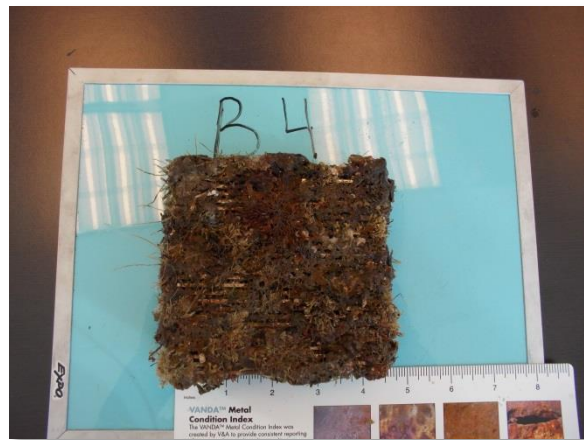
Photo 3-2. Marine life attached to uncoated 2205 Duplex stainless steel wedge wire screen.

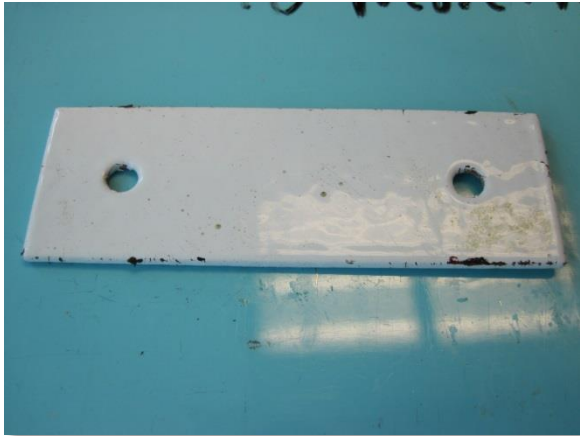
Photo 3-3. Minor damage to coating on edge of 2205 Duplex stainless steel coupon.

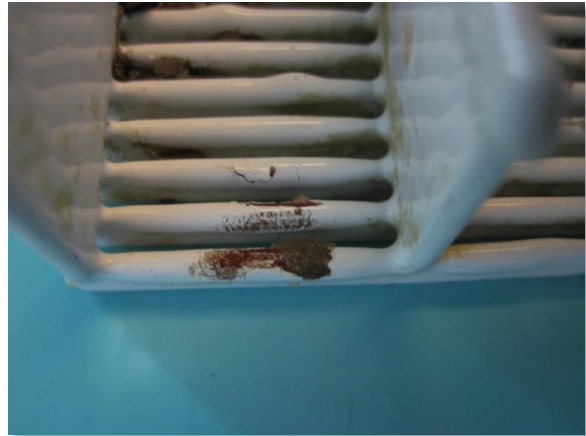
Photo 3-4. Coating damage to 2205 Duplex Stainless Steel wedge wire sample.

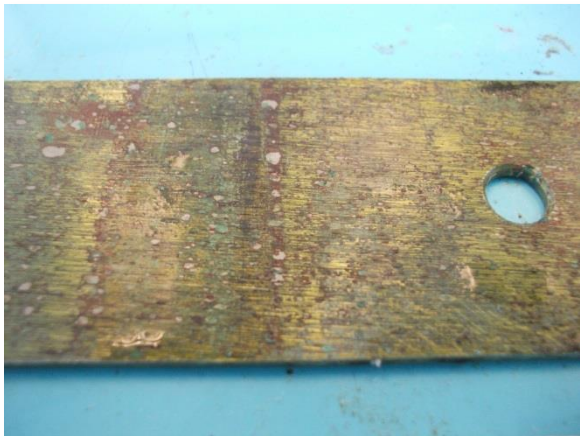
Photo 3-5. Detail view of weld on 70-30 Cu-Ni coupon.

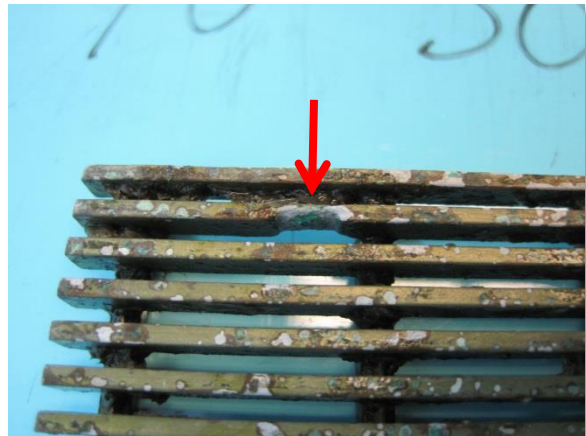
Photo 3-1 through Photo 3-14 show the samples before they were cleaned or analyzed. Photo 3-6, Photo 3-10, and Photo 3-14 show some typical mechanical damage to the screen wires that was observed on the 70-30 Cu-Ni, 90-10 Cu-Ni, and Z Alloy screens. The damage was observed at each corner of the screen where the screens were secured to the test rack. The mechanical damage may have been caused by the turbulence in the water and the abrasion by the zip ties that prevented the passivation of the metal at those locations. The exposed metal was corroded.

Photo 3-6. Mechanical damage to 70-30 Cu-Ni wedge wire screen.

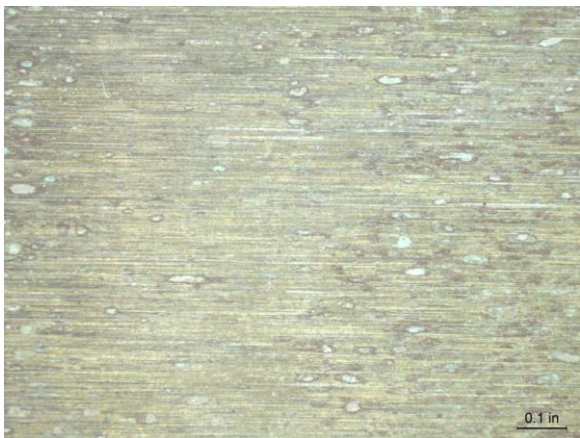
Photo 3-7. 70-30 Cu-Ni coupon at 10x magnification.

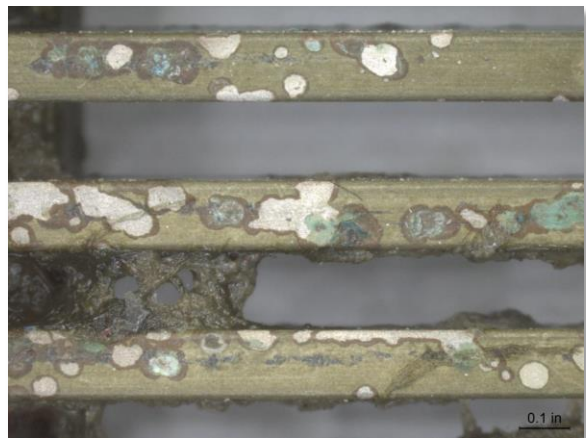
Photo 3-8. 70-30 Cu-Ni wire screen at 10x magnification.

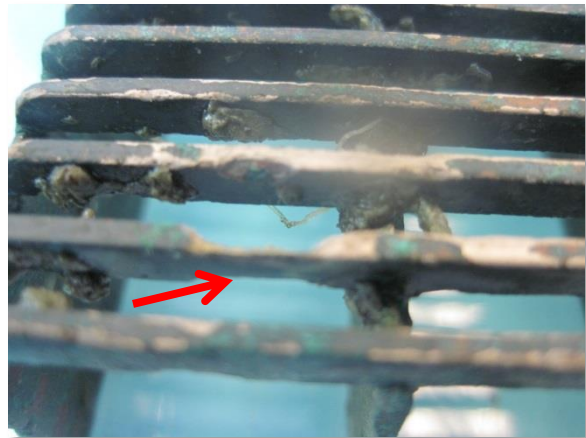
Photo 3-10. Mechanical damage to 90-10 Cu-Ni wedge wire screen.

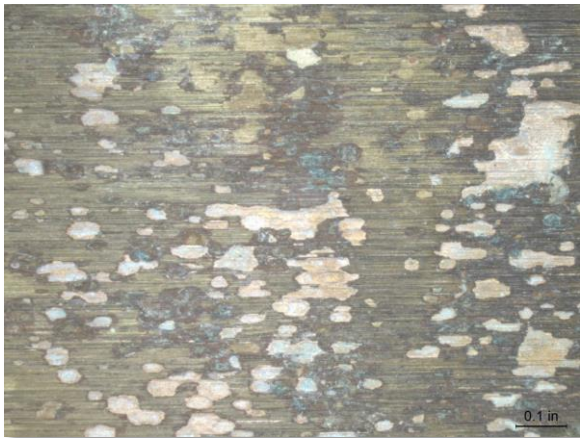
Photo 3-11. 90-10 Cu-Ni coupon at 10x magnification.

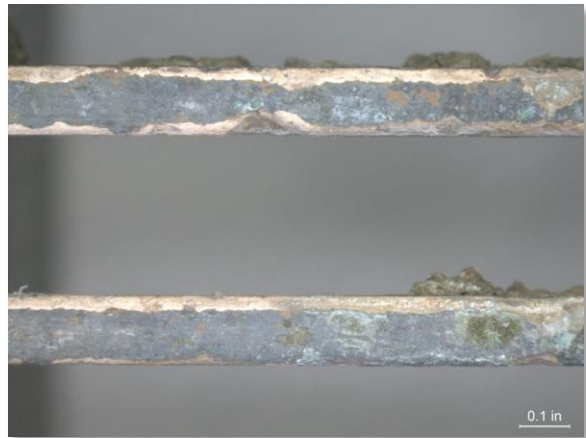
Photo 3-12. 90-10 Cu-Ni wire screen at 10x magnification.

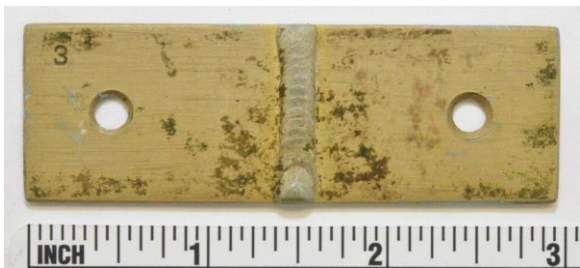
Photo 3-13. Z alloy 1-inch by 3-inch coupon with weld.

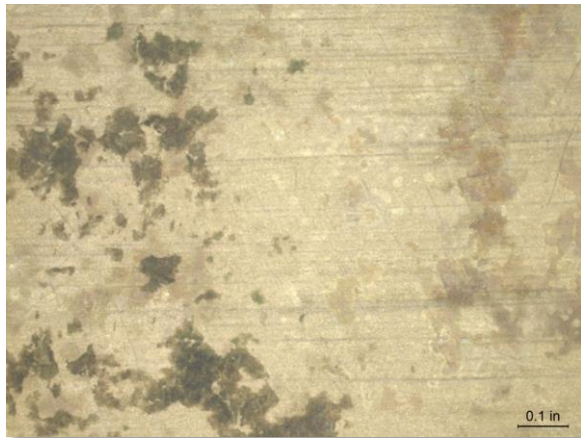
Photo 3-15. Z alloy coupon at 10x magnification.

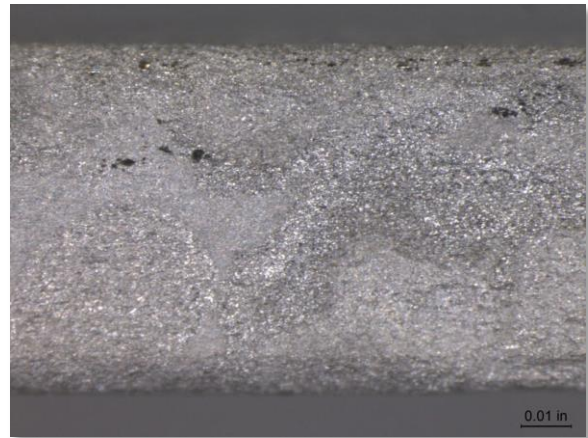
Photo 3-22. CDA 715 Screen at 50X magnification after cleaning.

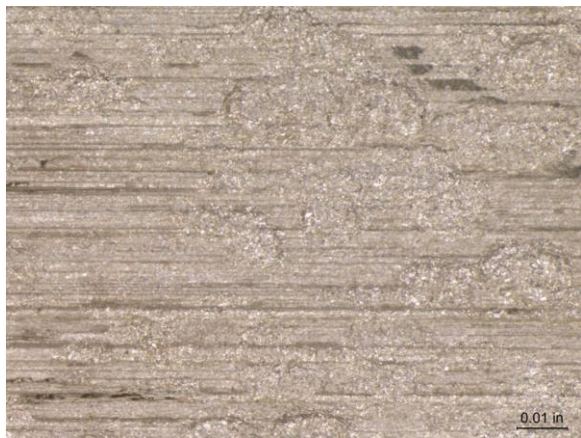
Photo 3-23. CDA 706 coupon at 50x magnification after cleaning.

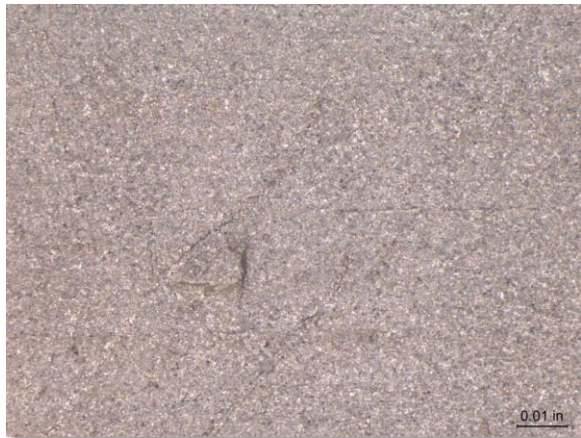
Photo 3-25. Z Alloy coupon at 50X magnification after cleaning.

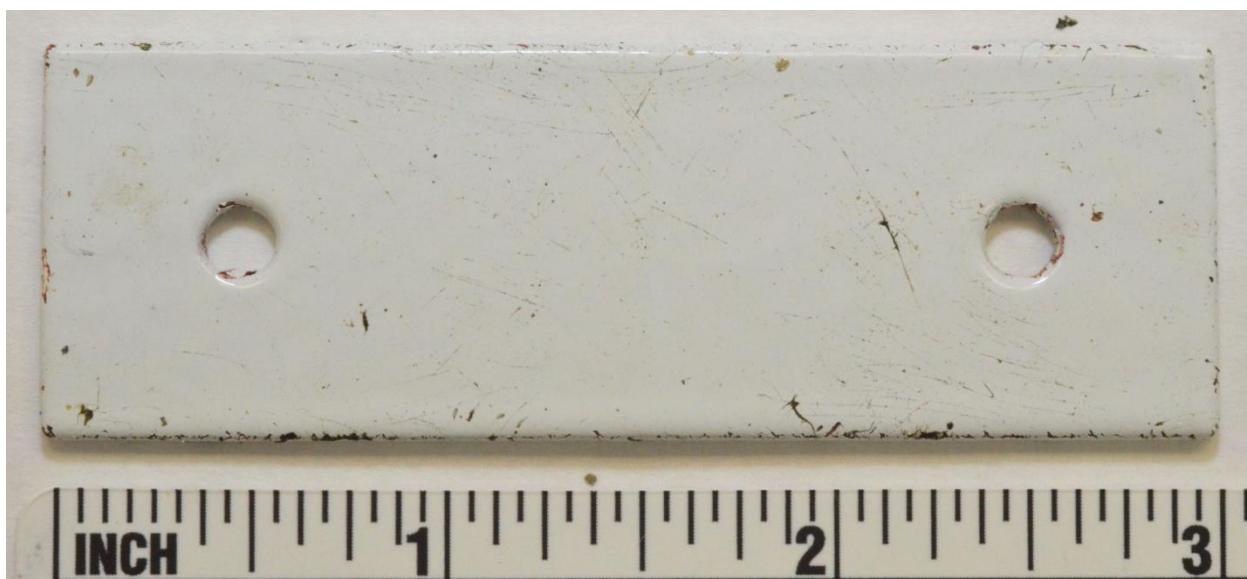
Figure 4 Photographs of duplex 2205 stainless steel with anti-biofouling coating coupon 3 (a) front and (b) back side after a 10 month corrosion test.

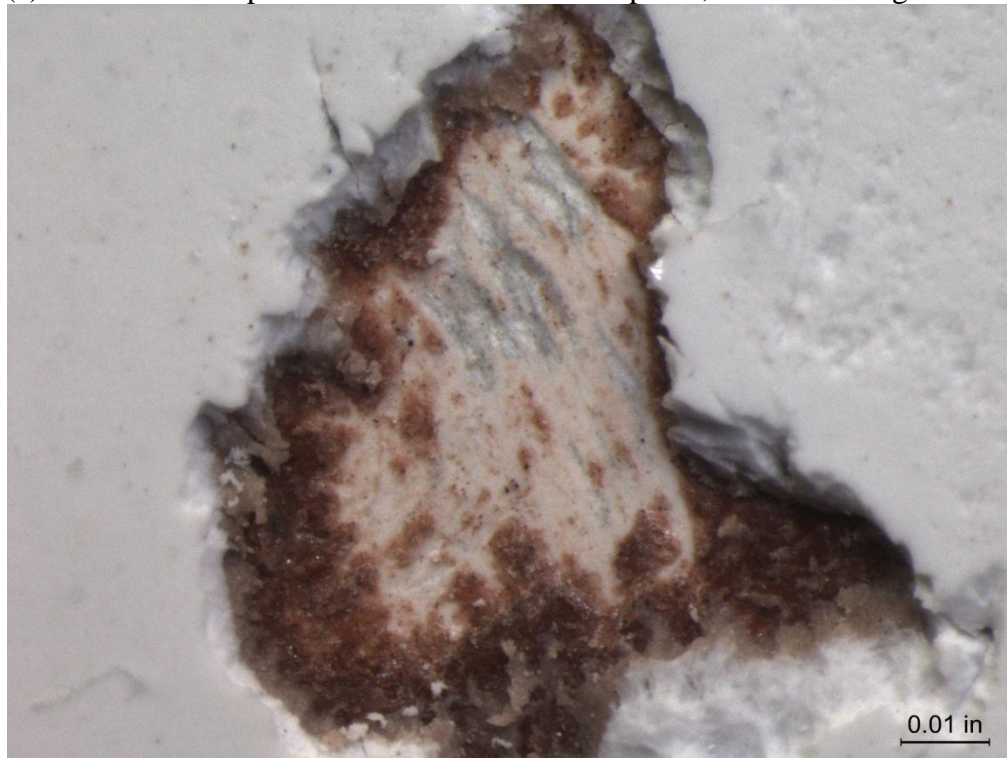
Figure 13 Optical macrographs of duplex 2205 stainless steel with anti-biofouling coating coupon 2 after a 6 month corrosion test, after cleaning.

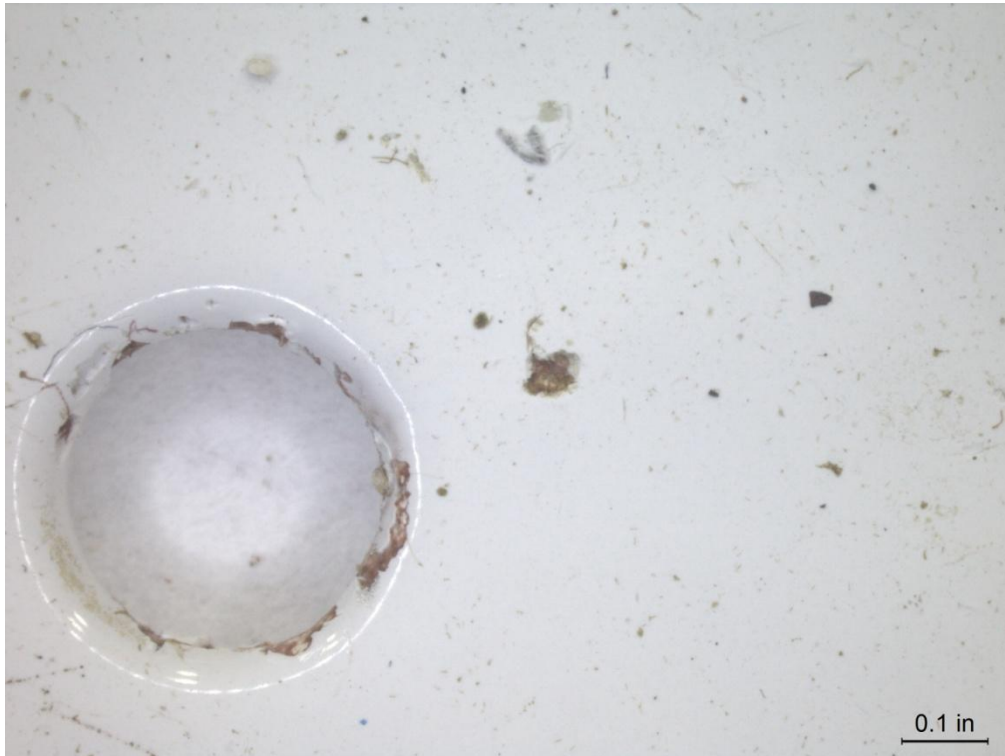
Figure 14 Optical macrographs of duplex 2205 stainless steel with anti-biofouling coating coupon 3 after a 10 month corrosion test, before cleaning.

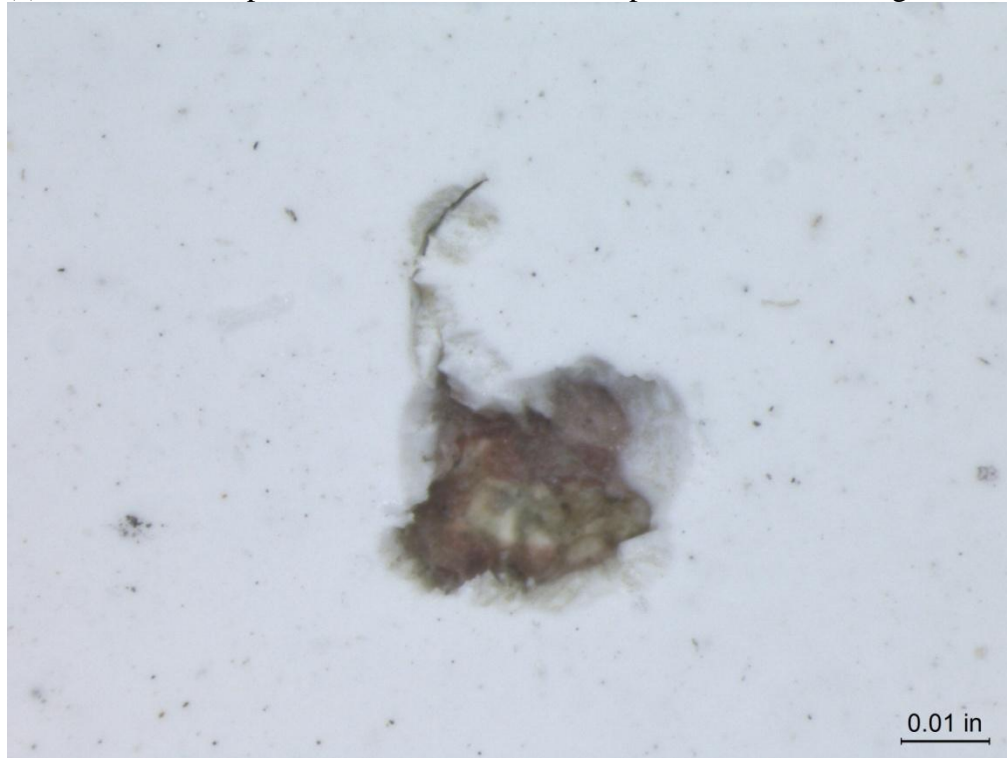
Figure 15 Optical macrographs of duplex 2205 stainless steel with anti-biofouling coating coupon 3 after a 10 month corrosion test, after cleaning.

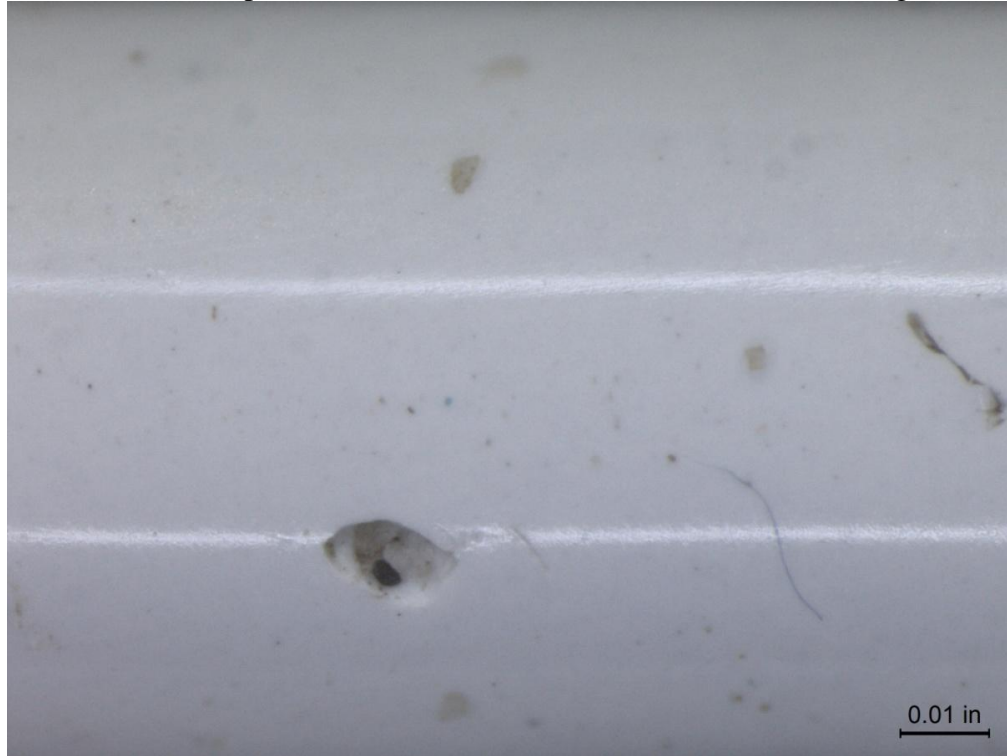
Figure 17 Optical macrographs of duplex 2205 stainless steel with anti-biofouling coating screen 1 after a 3 month corrosion test, before cleaning.

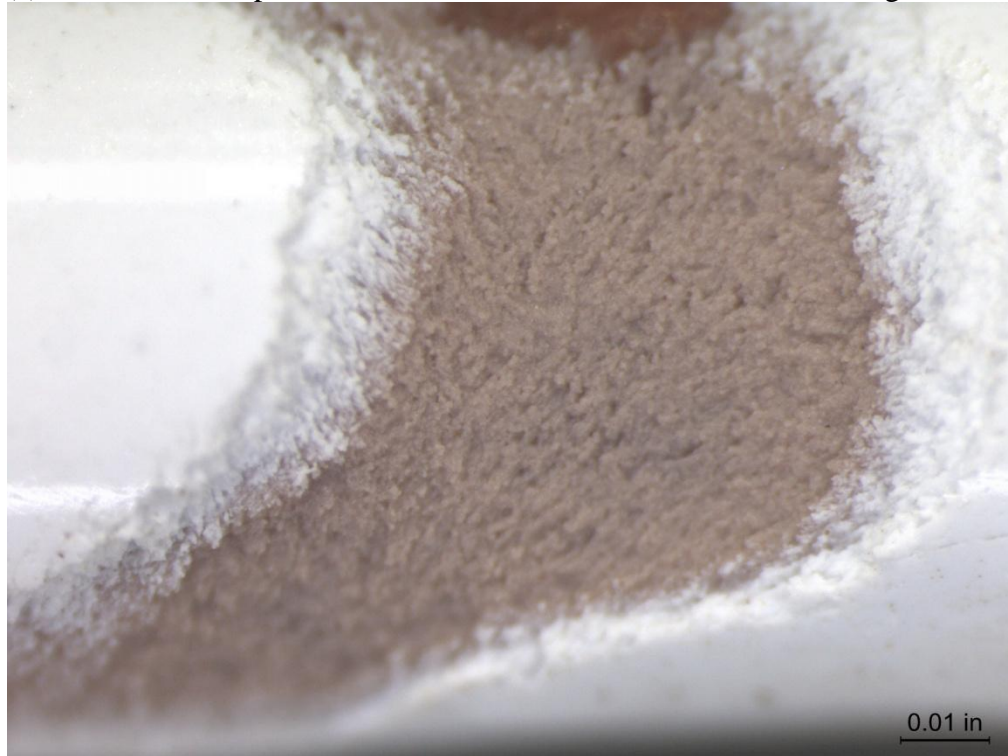
Figure 20 Optical macrographs of duplex 2205 stainless steel with anti-biofouling coating screen 2 after a 6 month corrosion test, after cleaning.

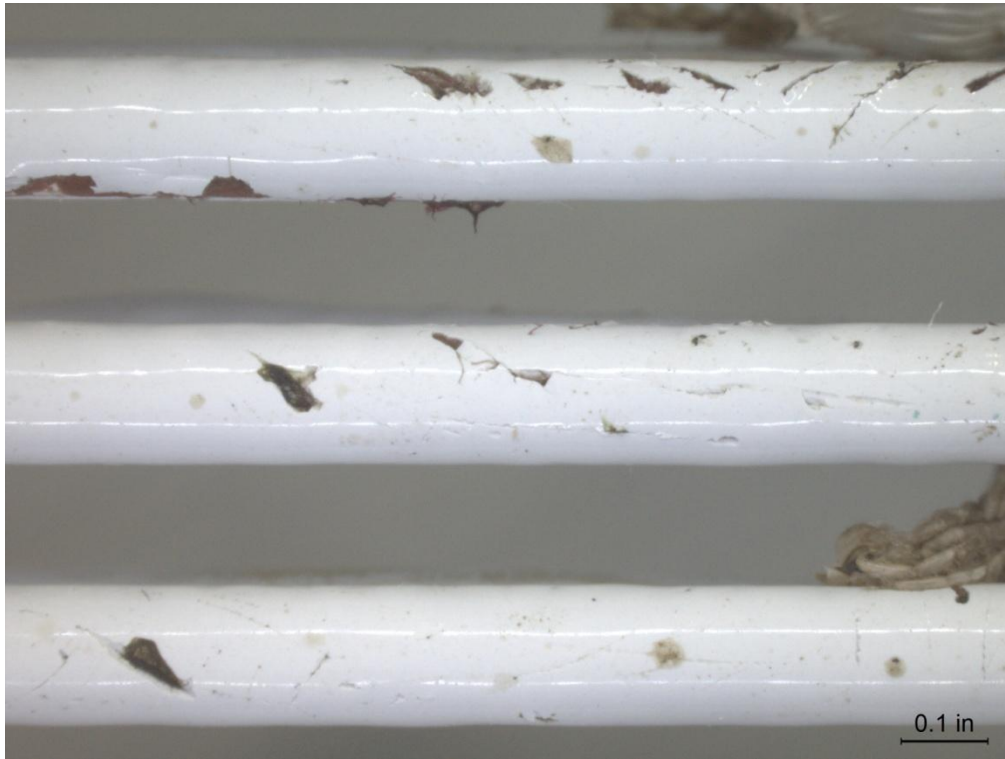
Figure 21 Optical macrographs of duplex 2205 stainless steel with anti-biofouling coating screen 3 after a 10 month corrosion test, before cleaning.
