WEST BASIN MUNICIPAL WATER DISTRICT OCEAN WATER DESALINATION INTAKE CORROSION STUDY

November 2014

V&A Project No.: 13-0376

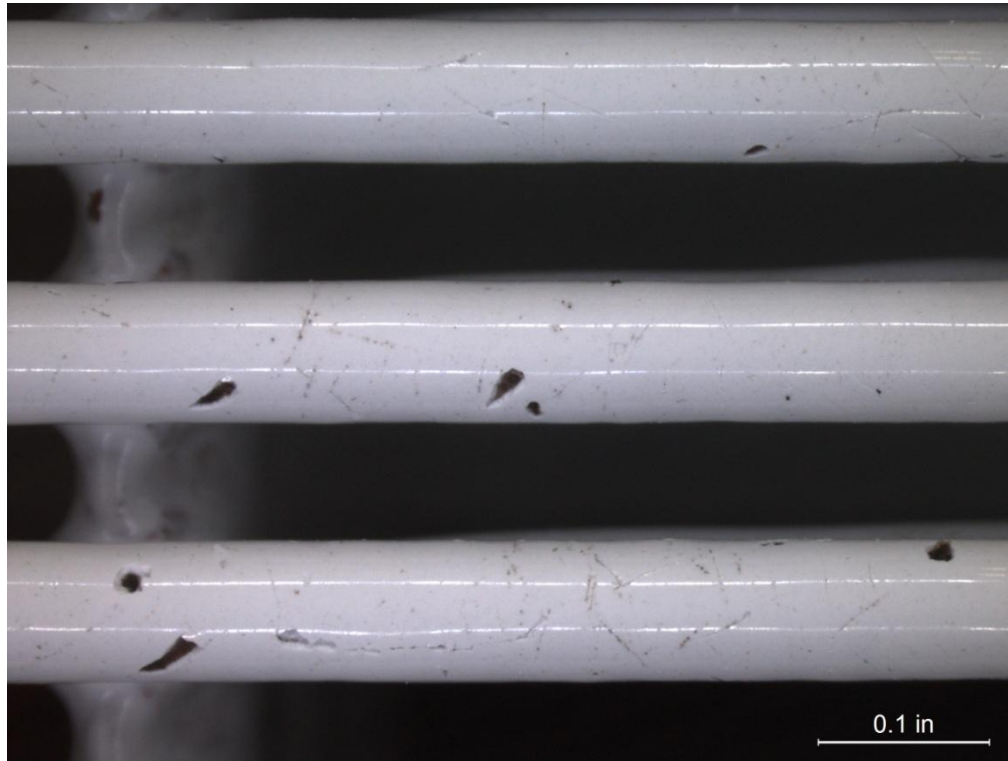
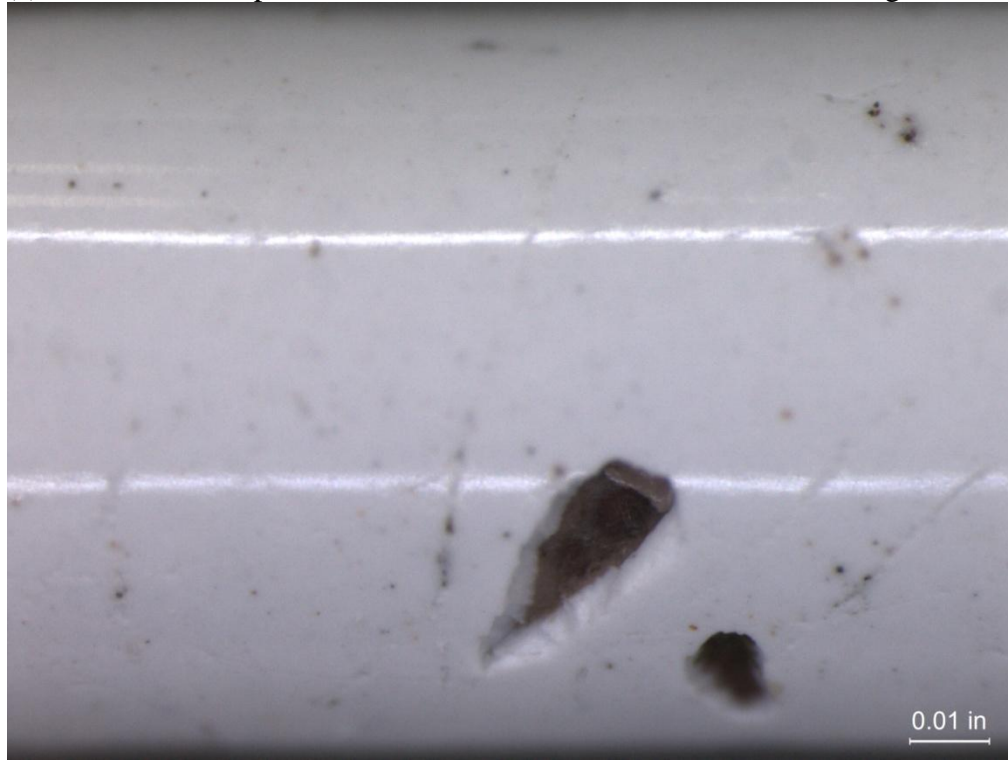
Figure 22 Optical macrographs of duplex 2205 stainless steel with anti-biofouling coating screen 3 after a 10 month corrosion test, after cleaning.

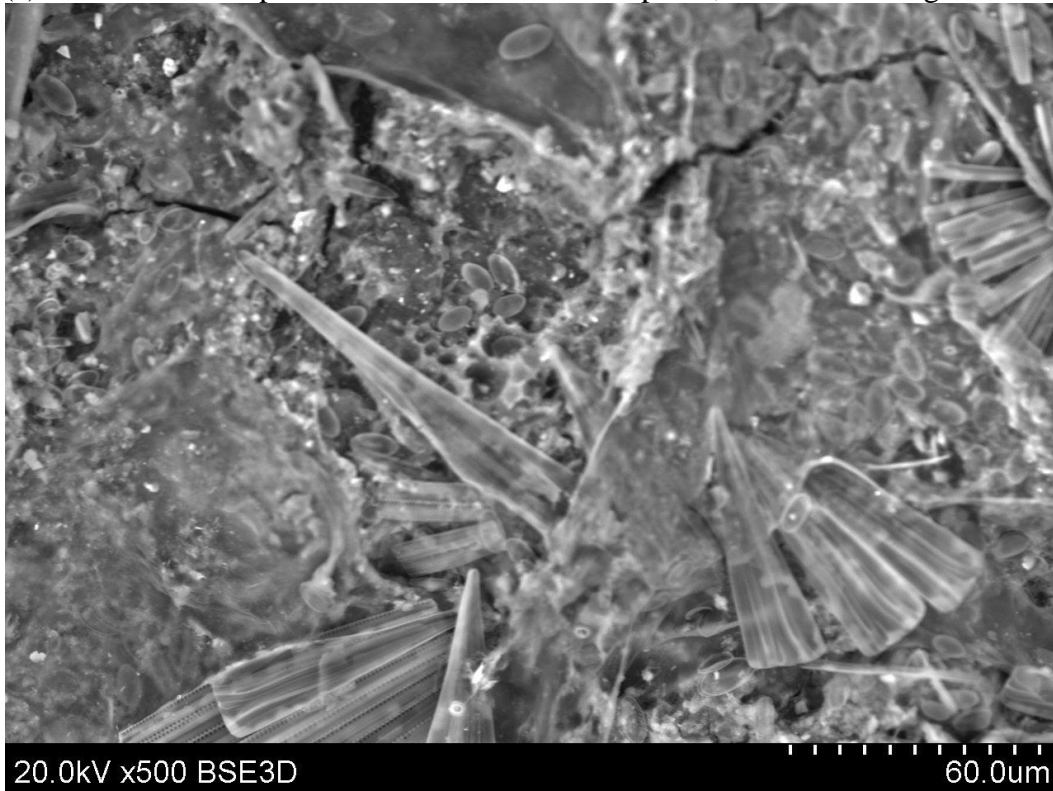
Figure 31 Scanning electron micrographs of duplex 2205 stainless steel with anti-biofouling coating coupon 3 after a 10 month corrosion test, before cleaning.

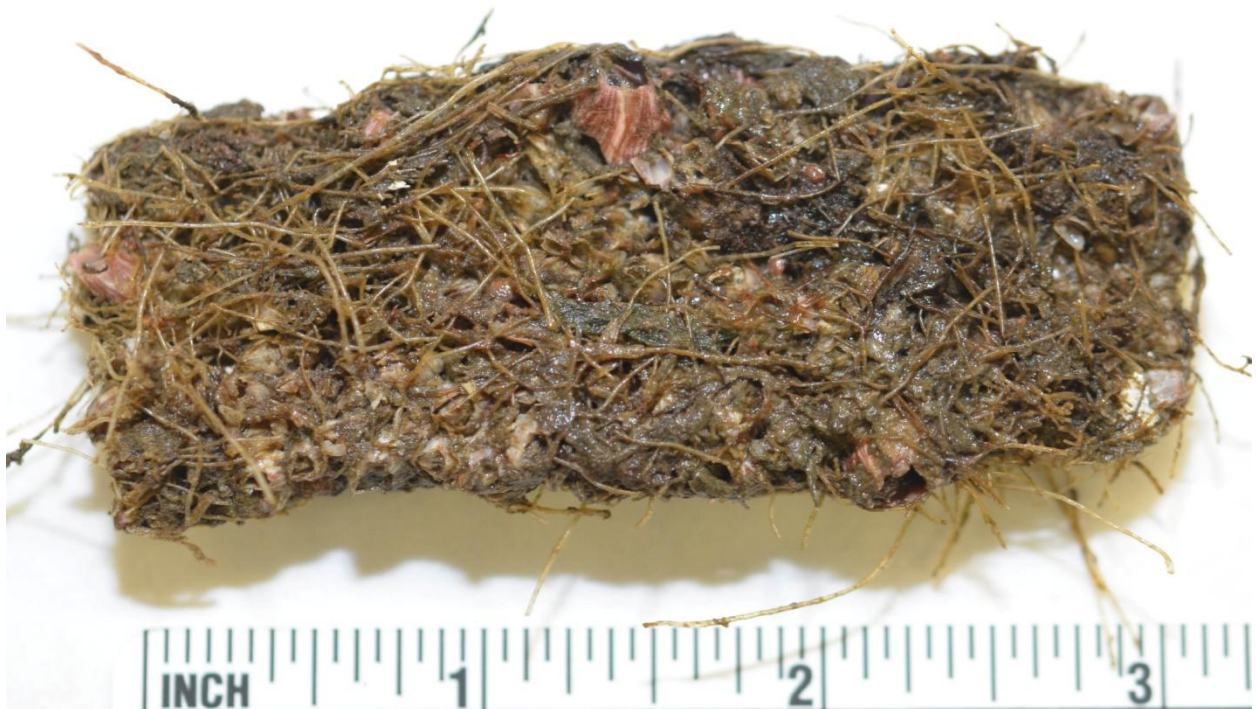
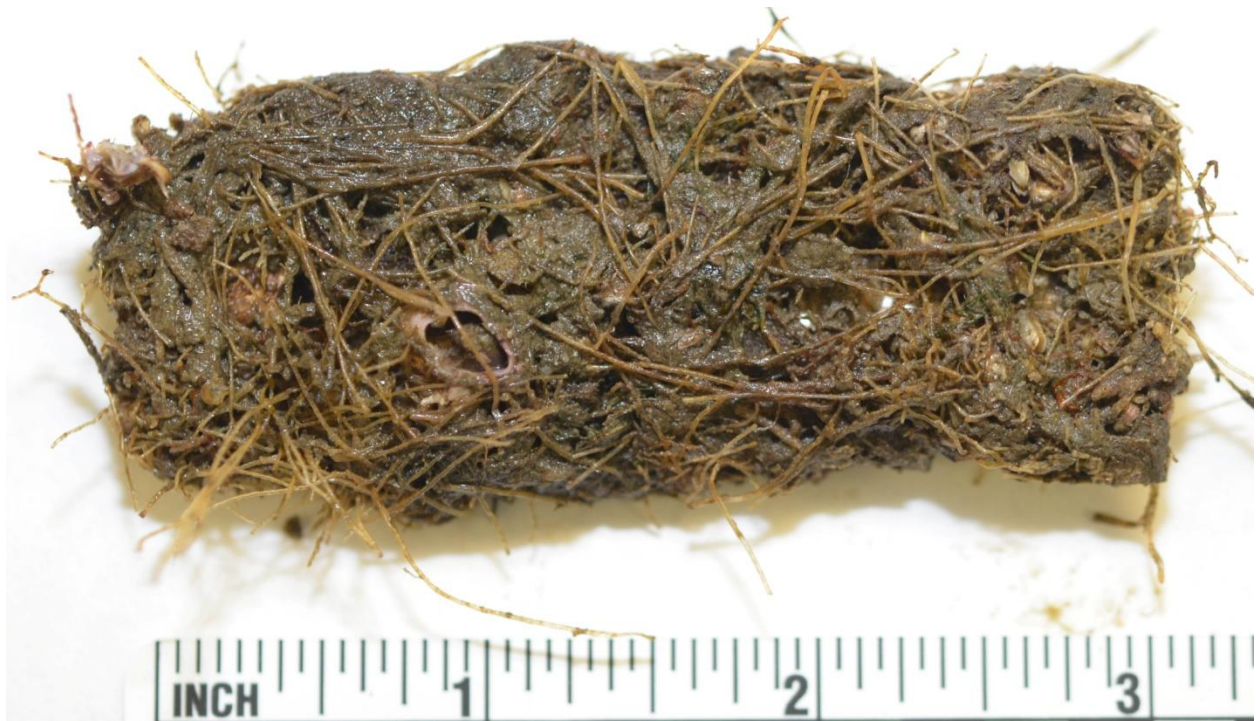
Figure 2 Photographs of duplex 2205 stainless steel coupon 6 (a) front and (b) back side after a 3 month corrosion test.

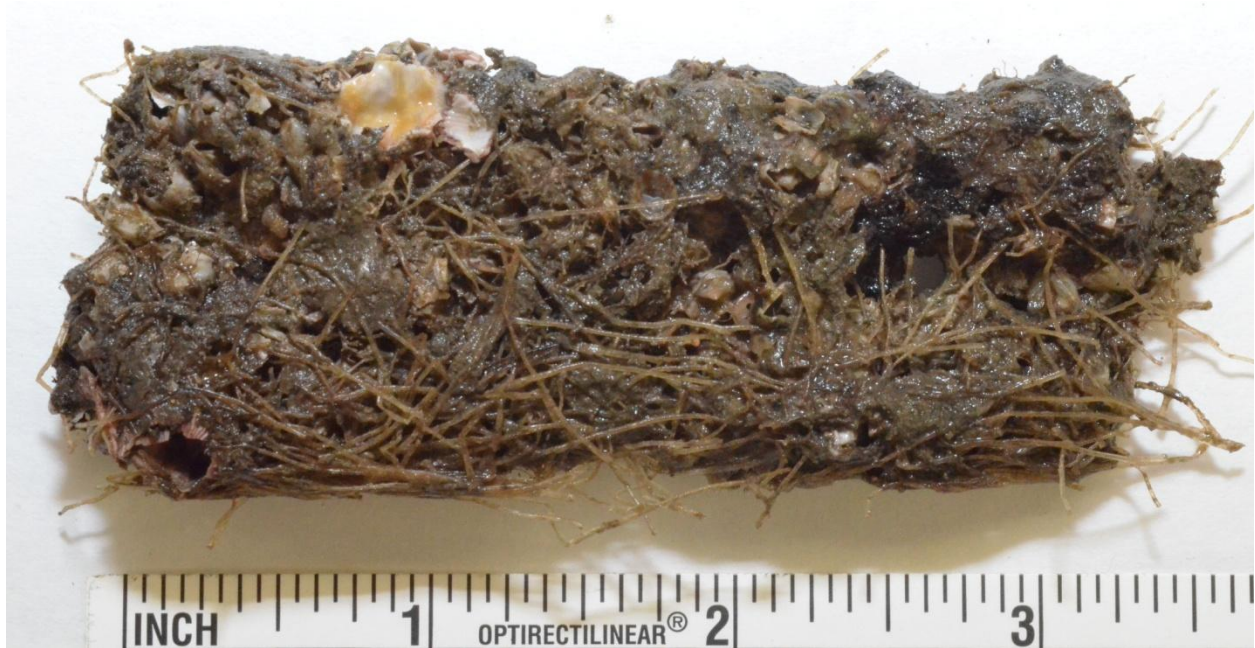
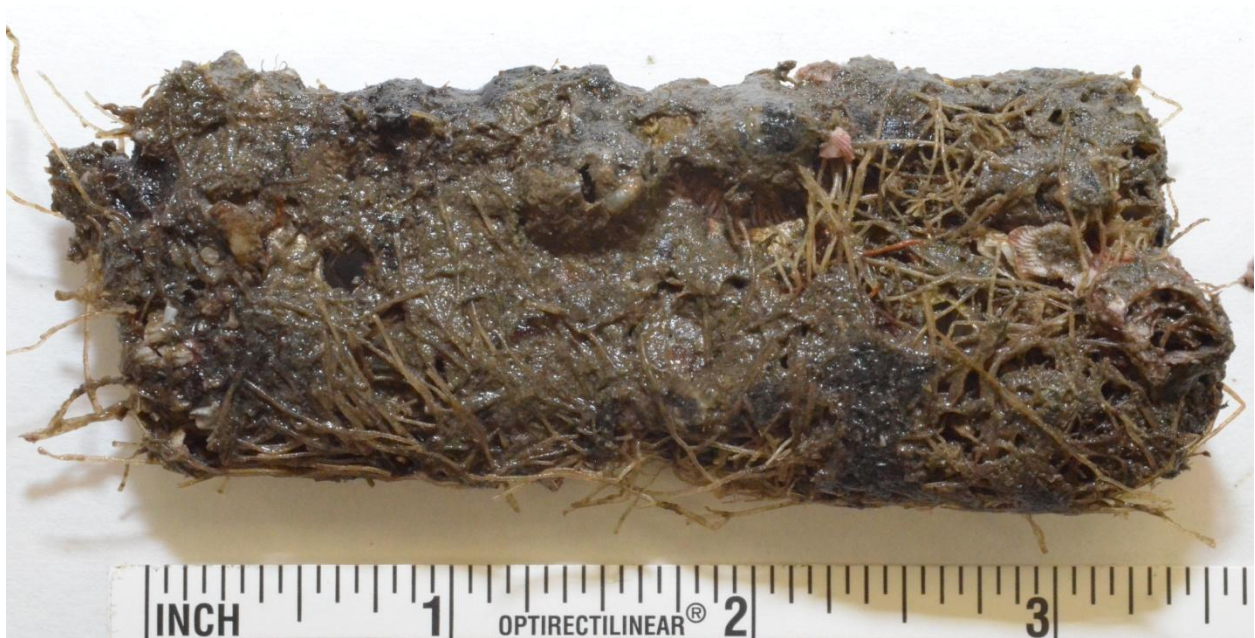
Figure 3 Photographs of duplex 2205 stainless steel coupon 7 (a) front and (b) back side after a 6 month corrosion test.

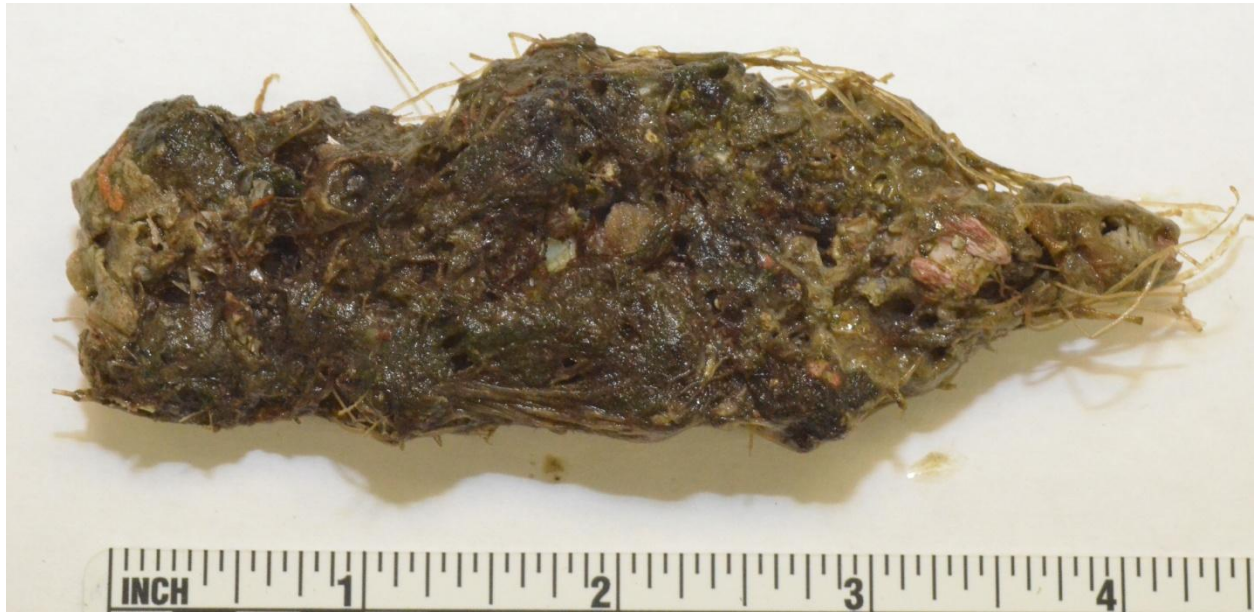
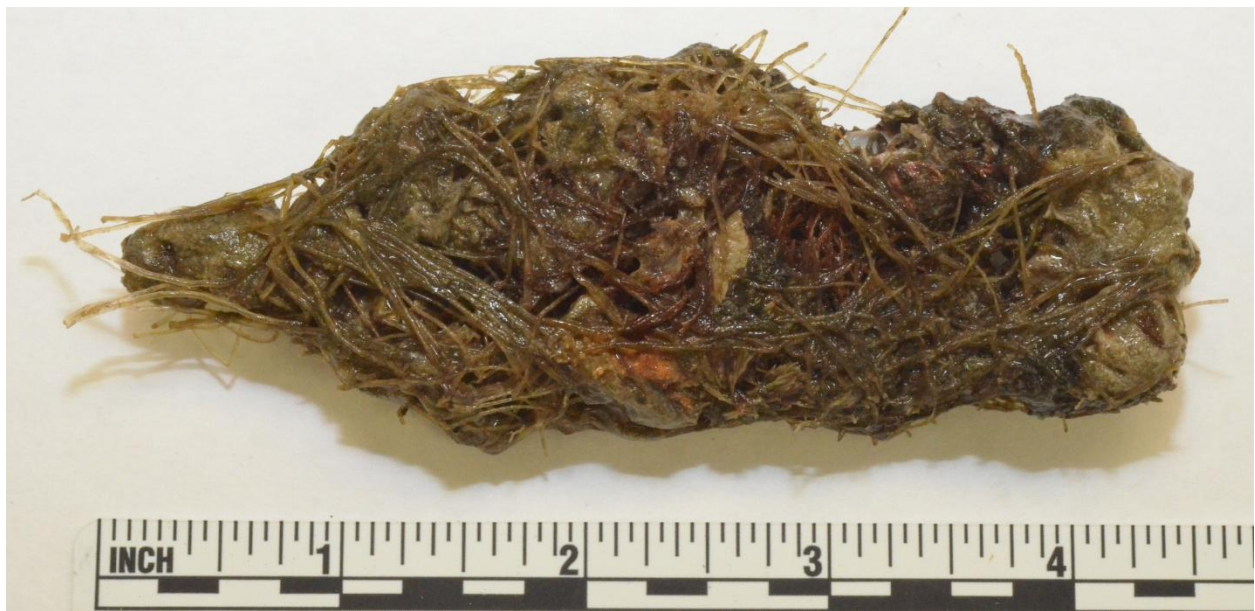
Figure 4 Photographs of duplex 2205 stainless steel coupon 8 (a) front and (b) back side after a 10 month corrosion test.

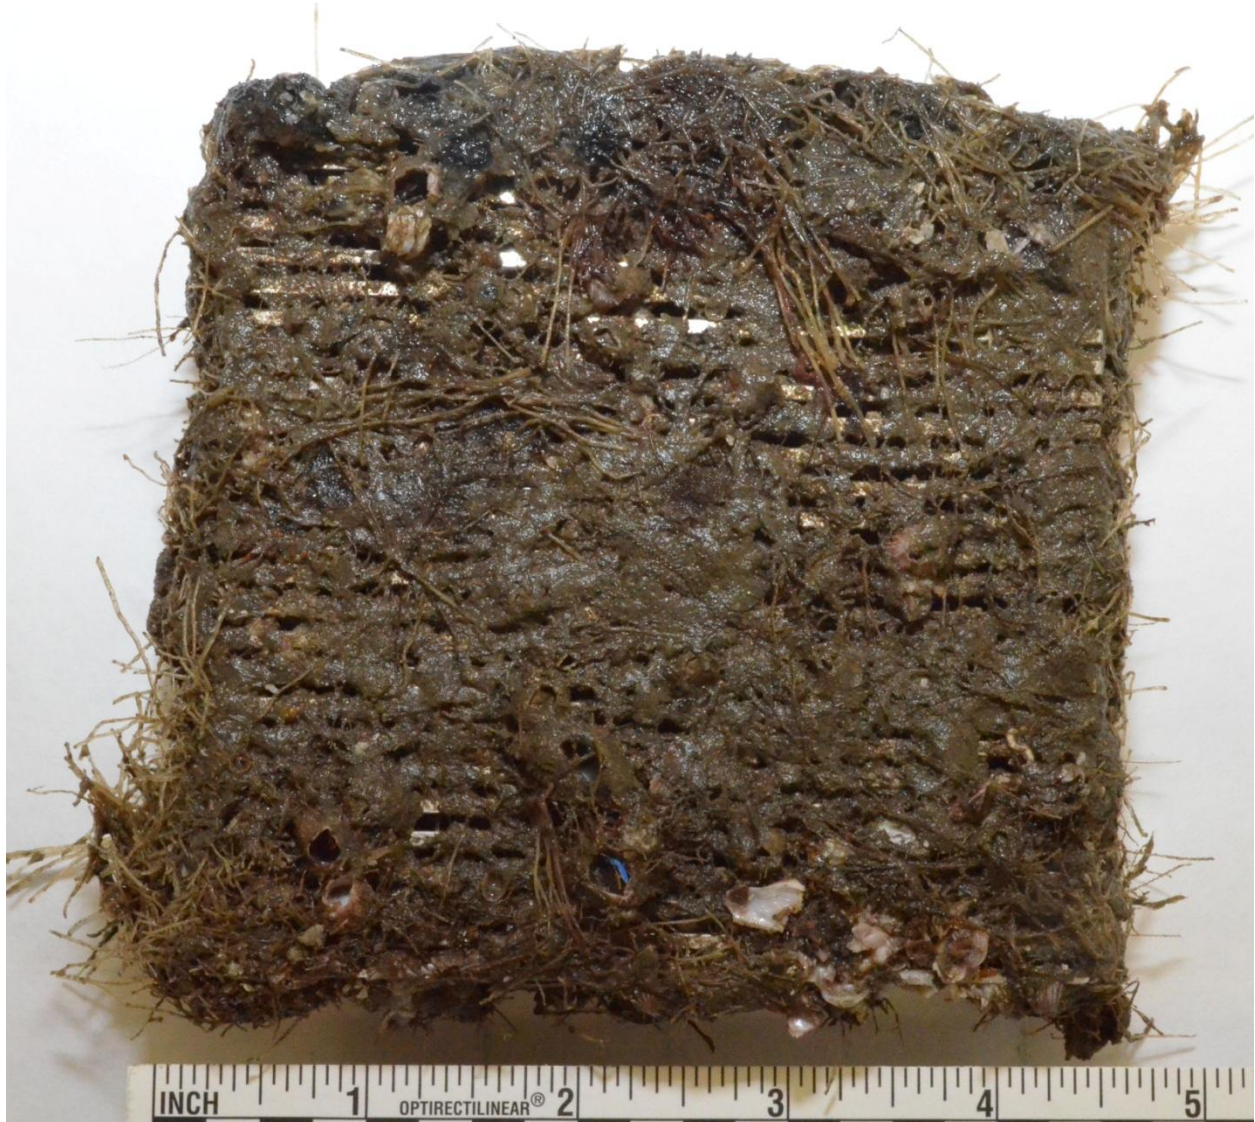
Figure 7 Photograph of duplex 2205 stainless steel screen 2 after a 6 month corrosion test.

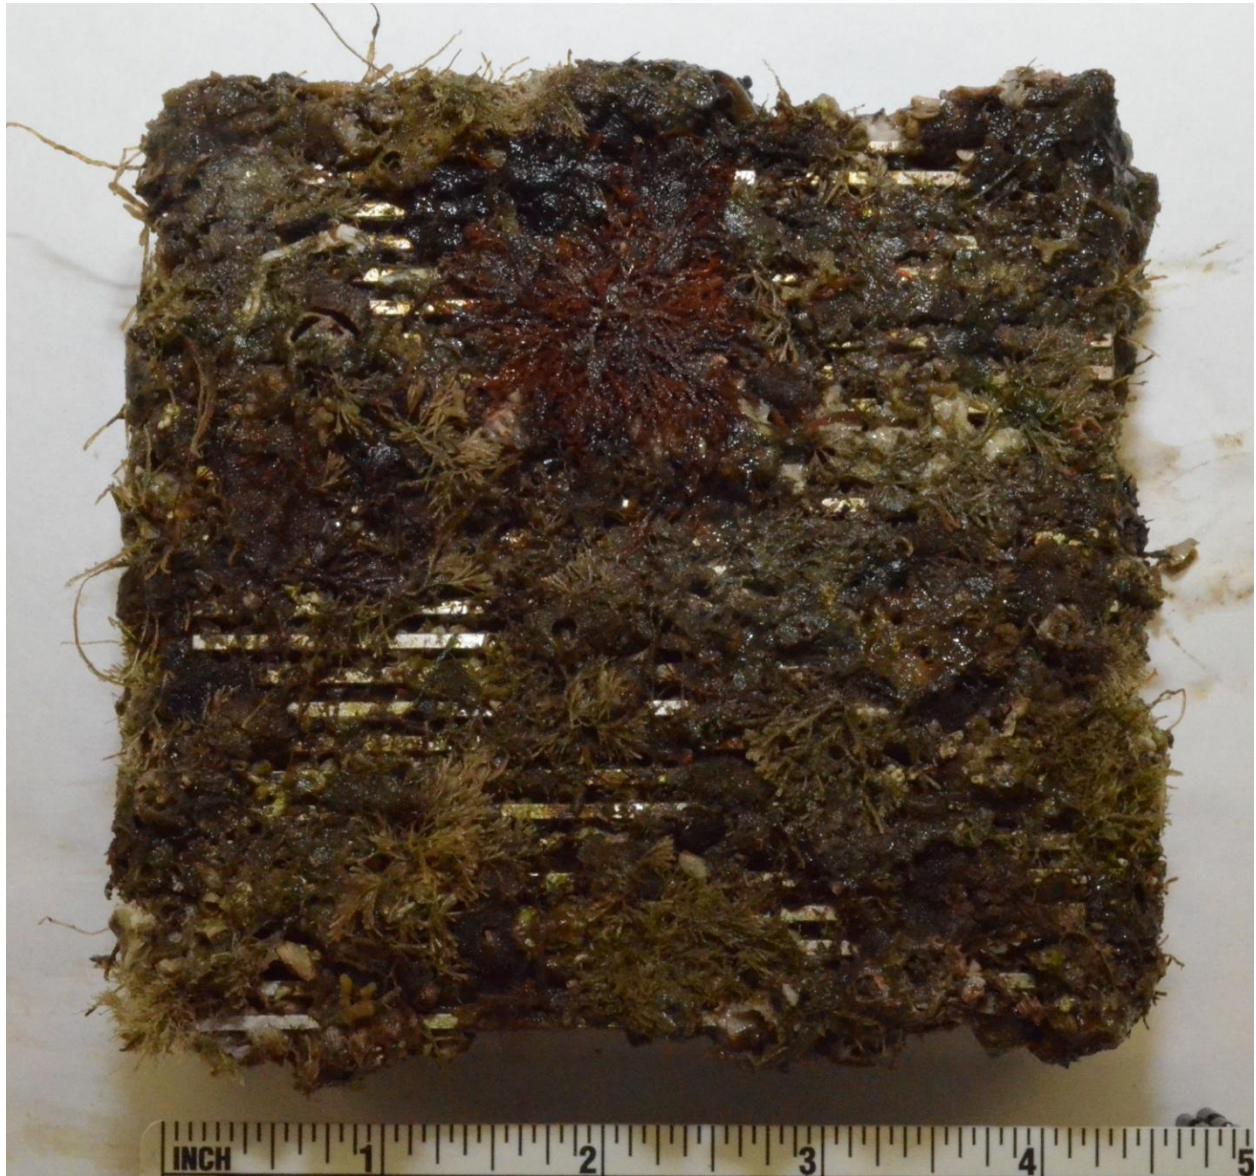
Figure 8 Photograph of duplex 2205 stainless steel screen 3 after a 10 month corrosion test.

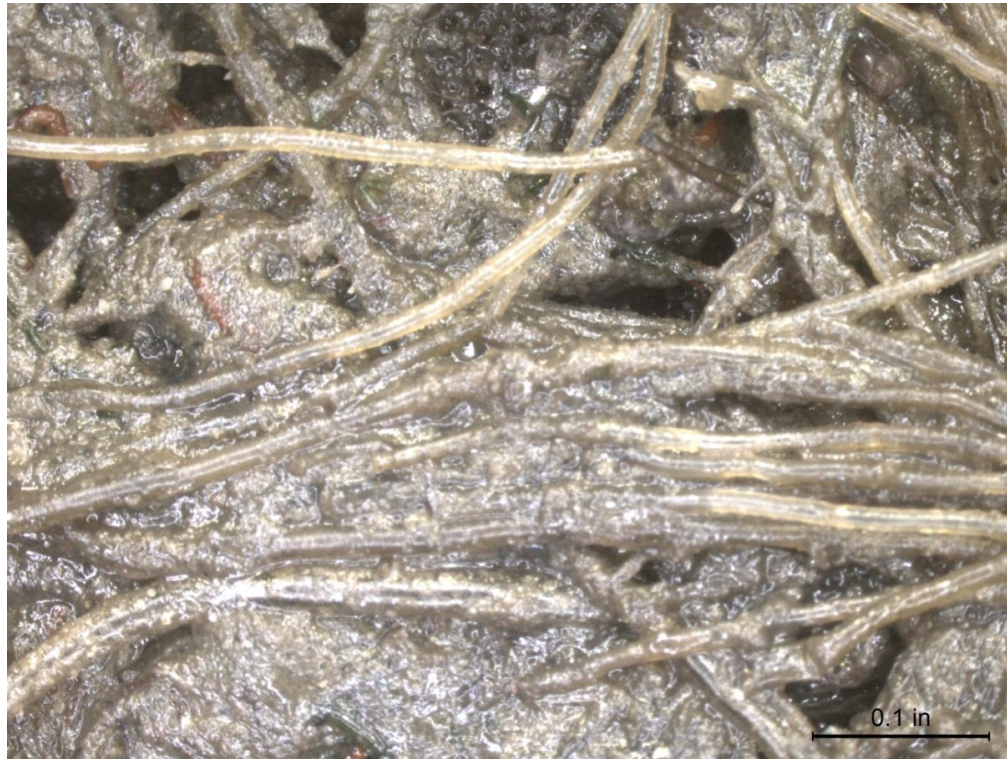
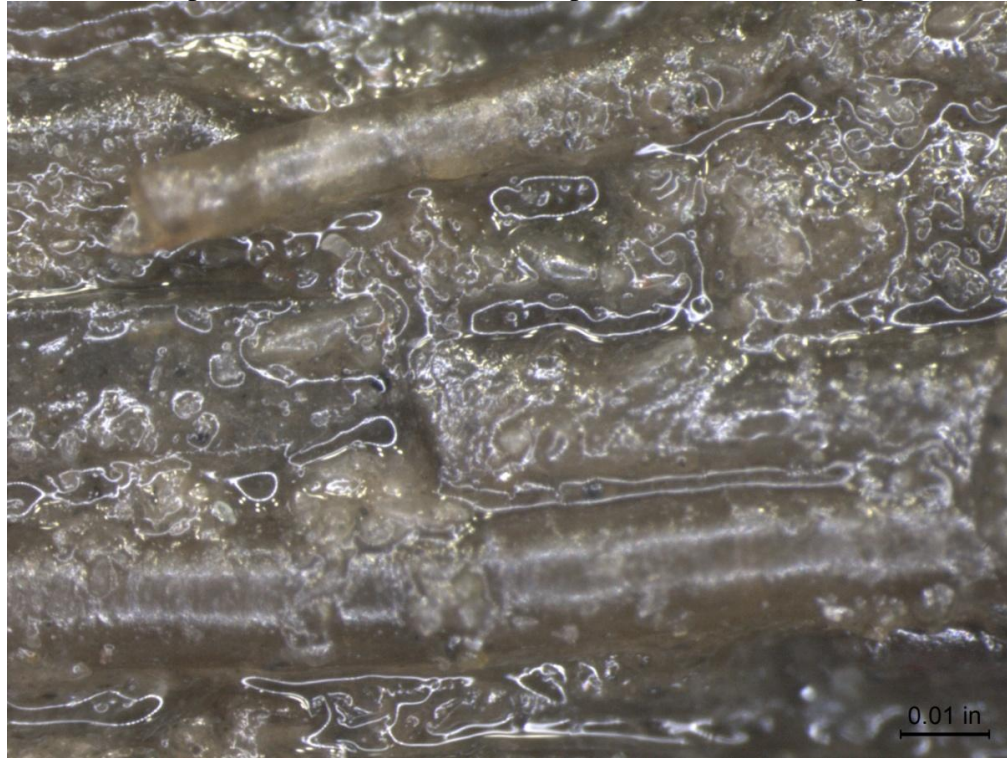
Figure 10 Optical macrographs of duplex 2205 stainless steel coupon 6 after a 3 month corrosion test, before cleaning.

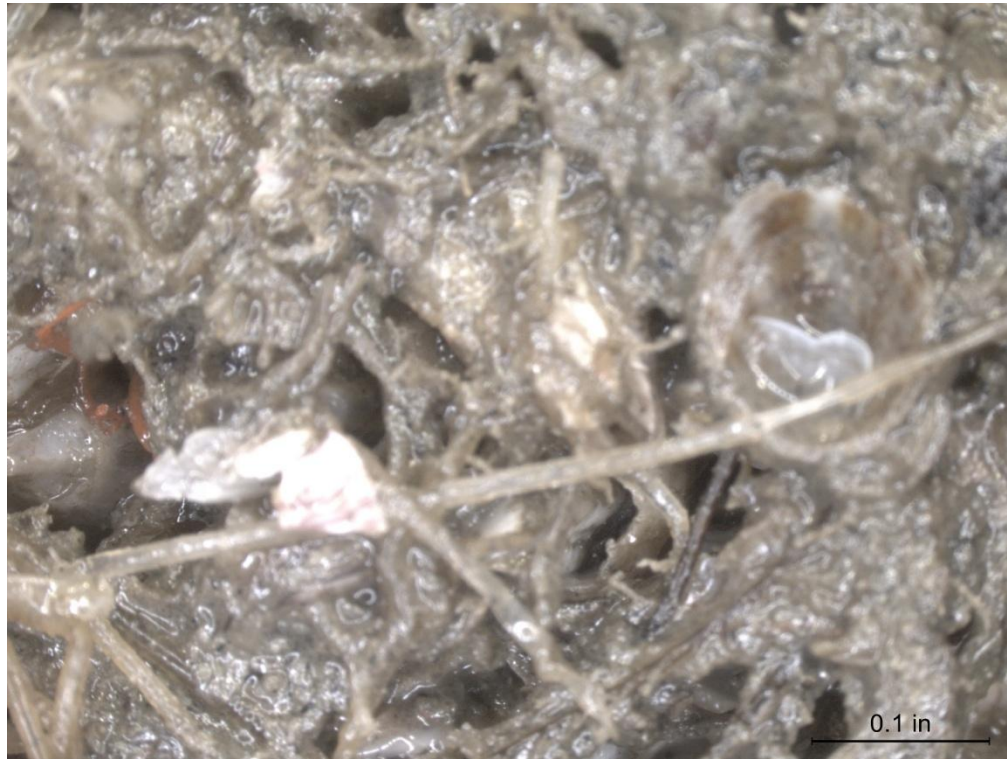
Figure 12 Optical macrographs of duplex 2205 stainless steel coupon 7 after a 6 month corrosion test, before cleaning.

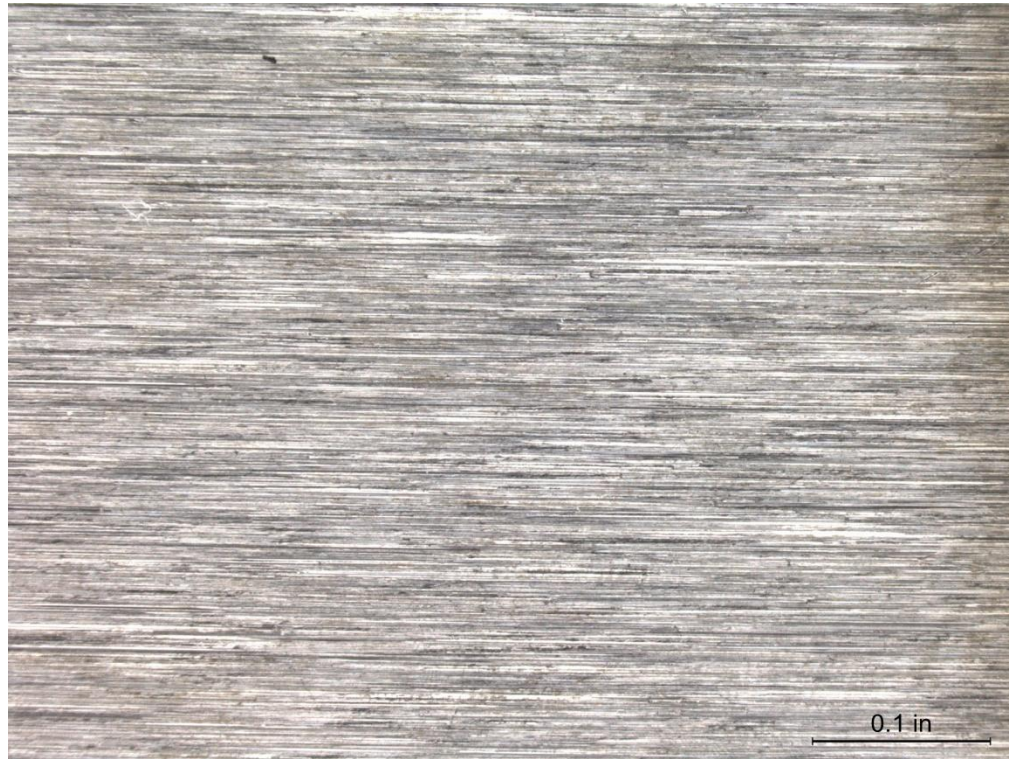
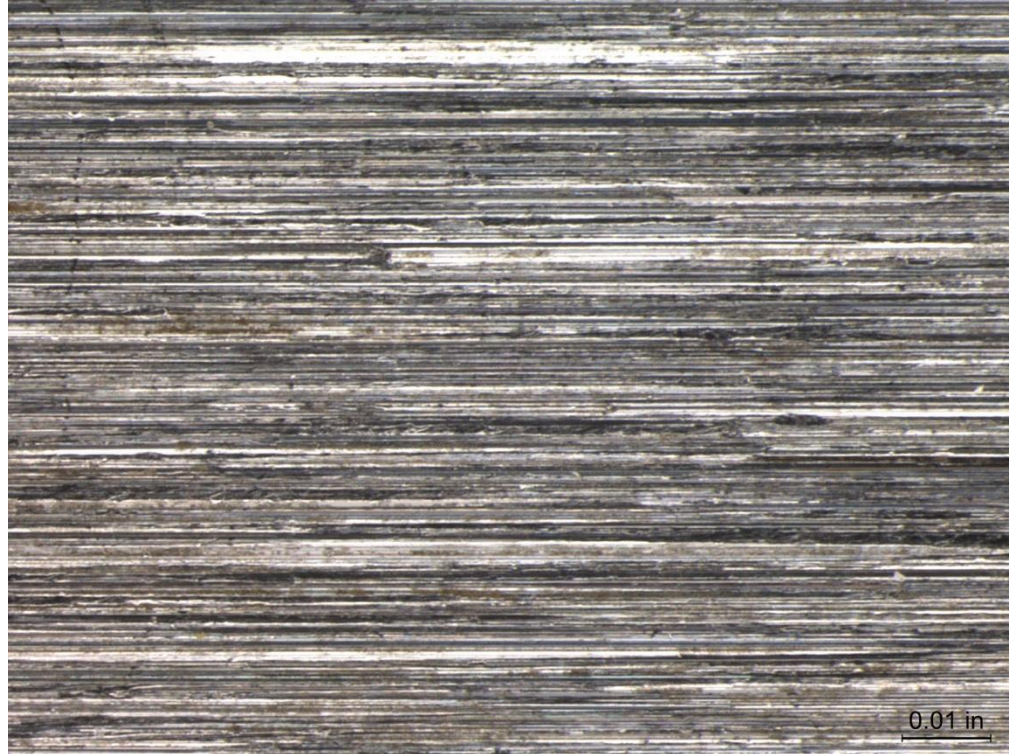
Figure 13 Optical macrographs of duplex 2205 stainless steel coupon 7 after a 6 month corrosion test, after cleaning.

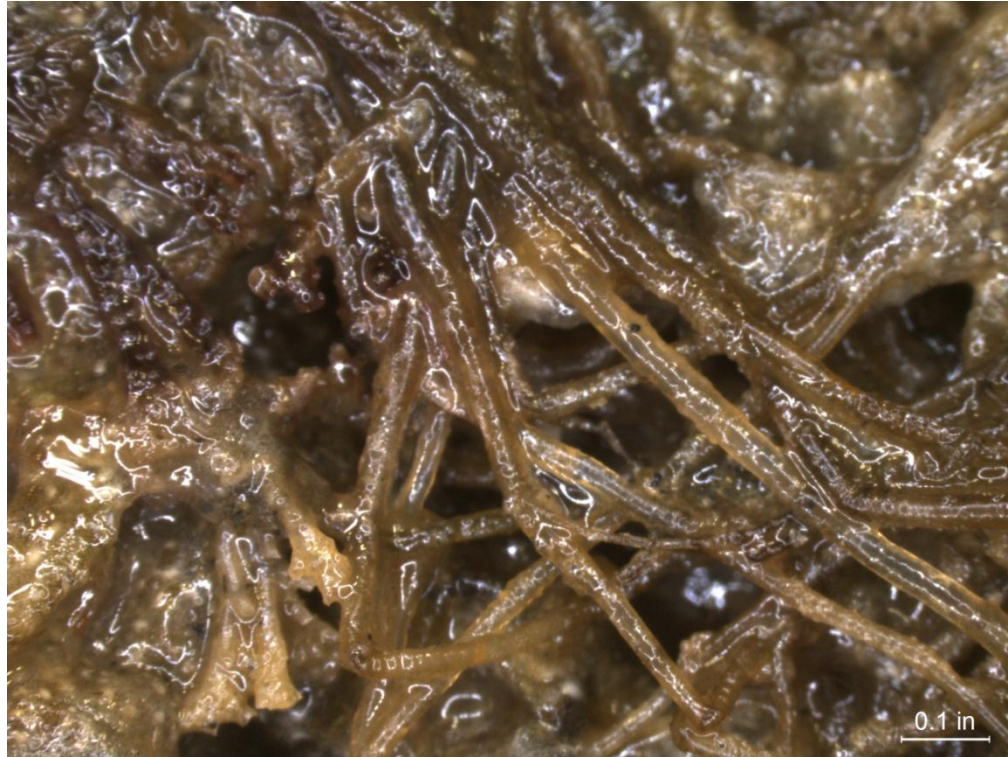
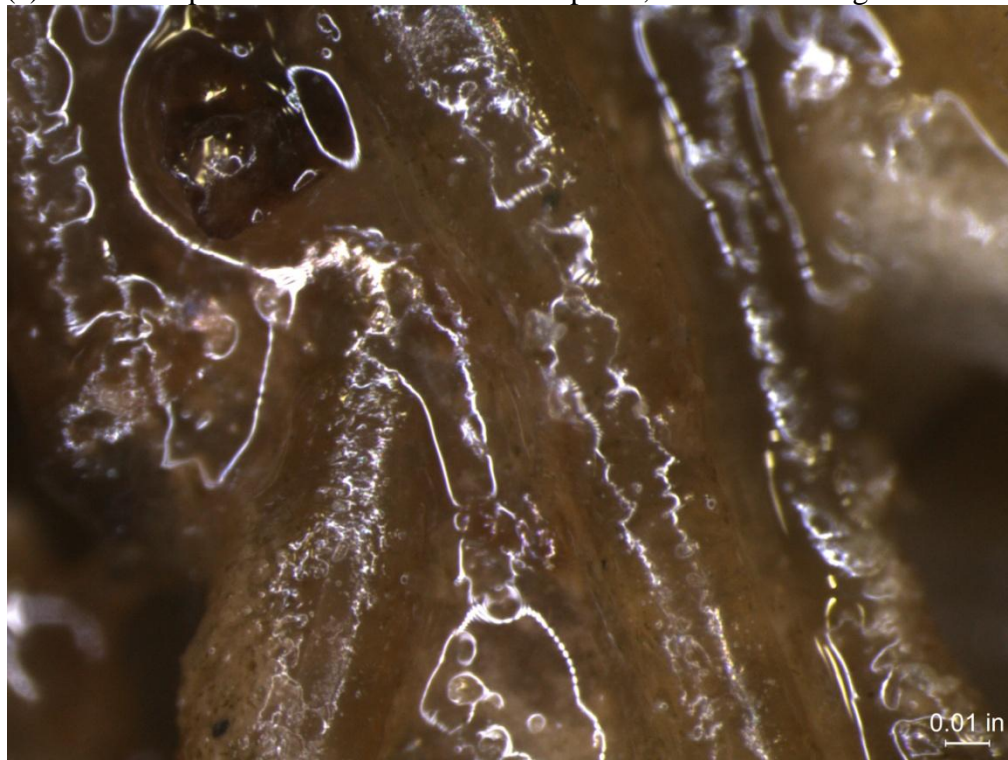
Figure 14 Optical macrographs of duplex 2205 stainless steel coupon 8 after a 10 month corrosion test, before cleaning.

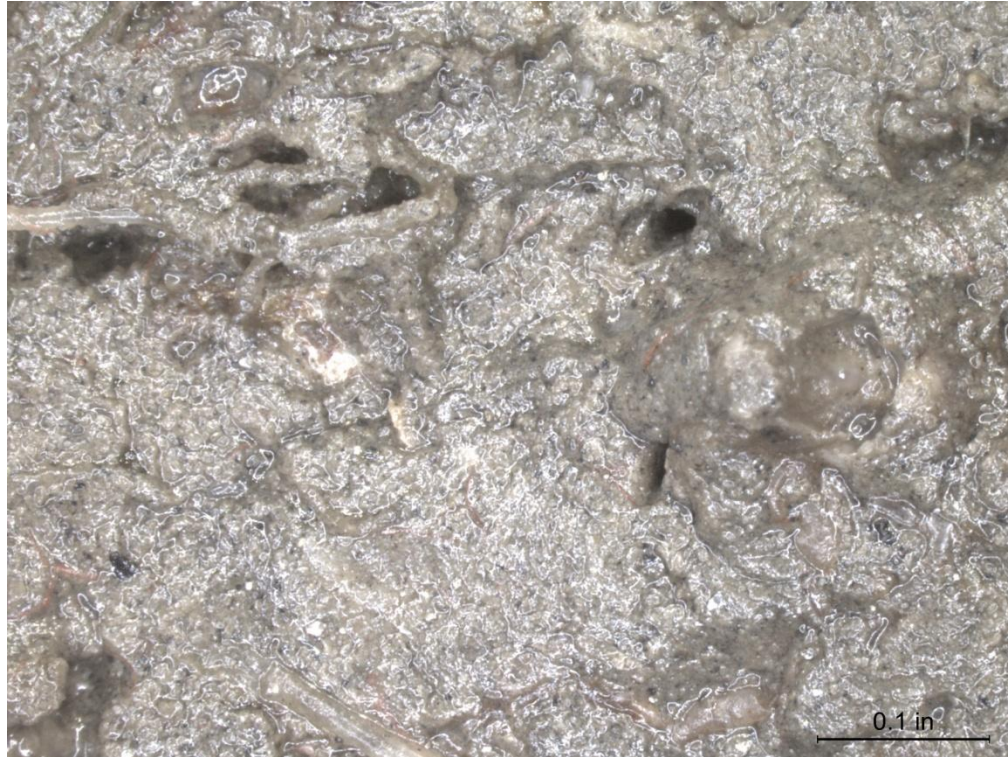
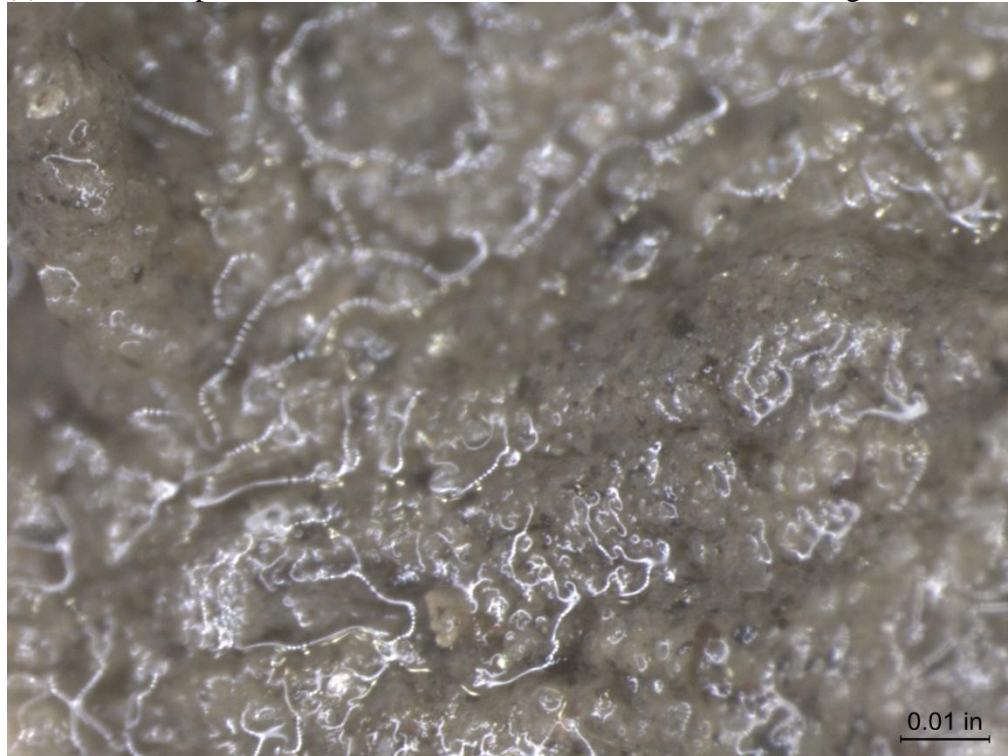
Figure 19 Optical macrographs of duplex 2205 stainless steel screen 2 after a 6 month corrosion test, before cleaning.

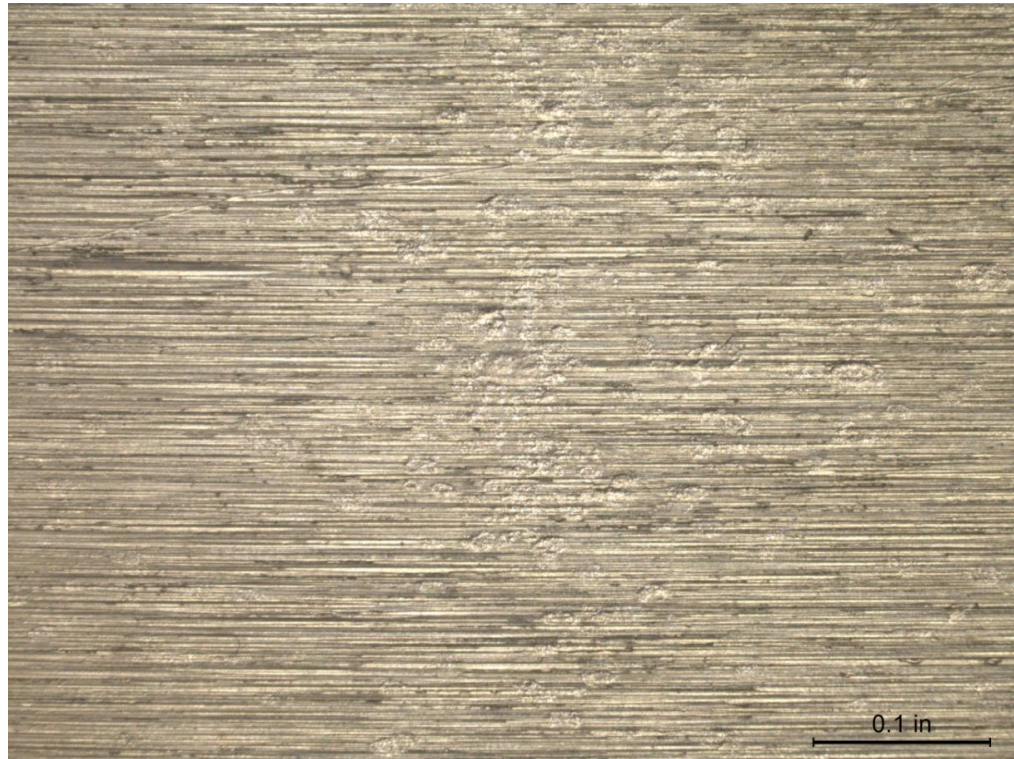
Figure 11 Optical macrographs of CDA 706 coupon 1 after a 3 month corrosion test, after cleaning.

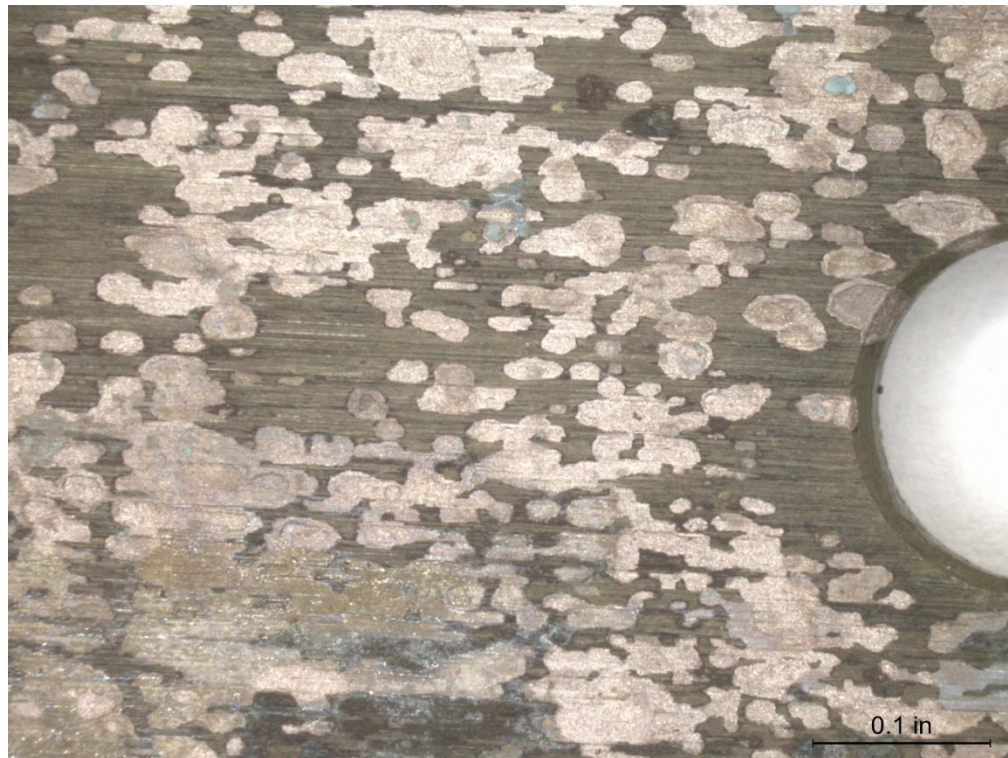
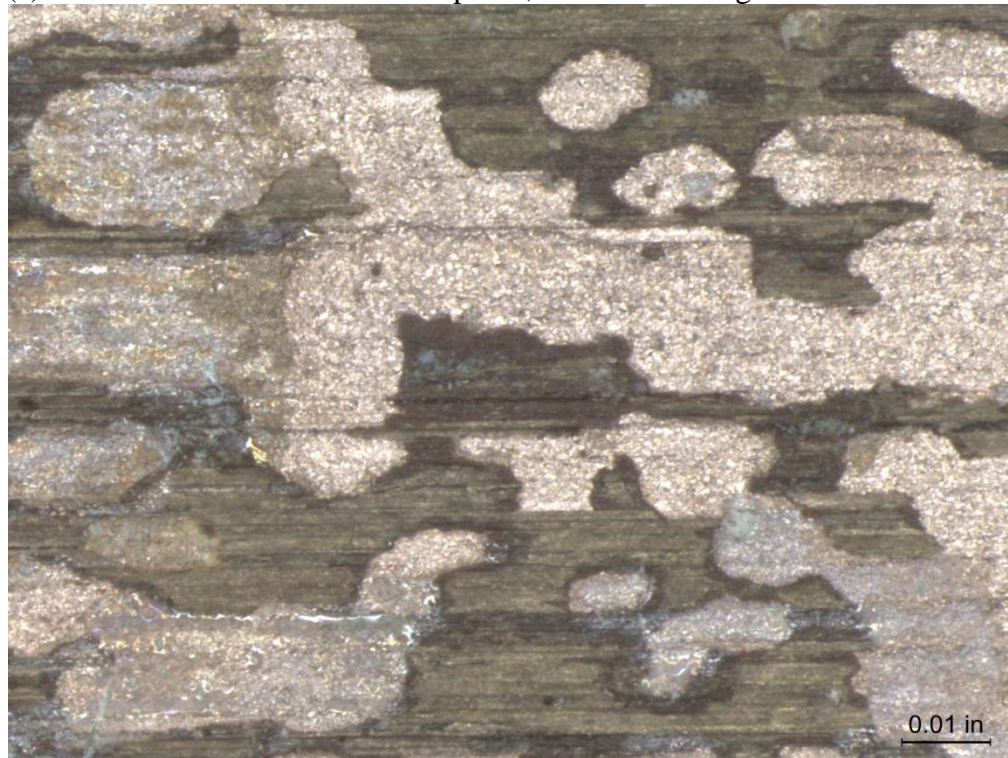
Figure 12 Optical macrographs of CDA 706 coupon 2 after a 6 month corrosion test, before cleaning.

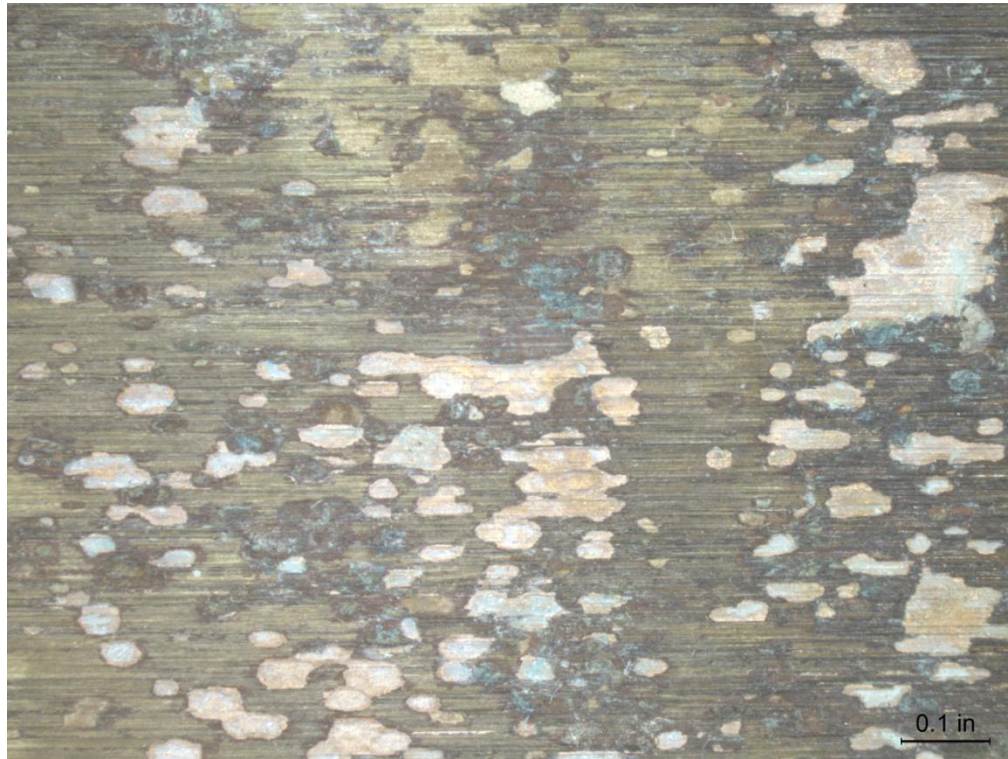
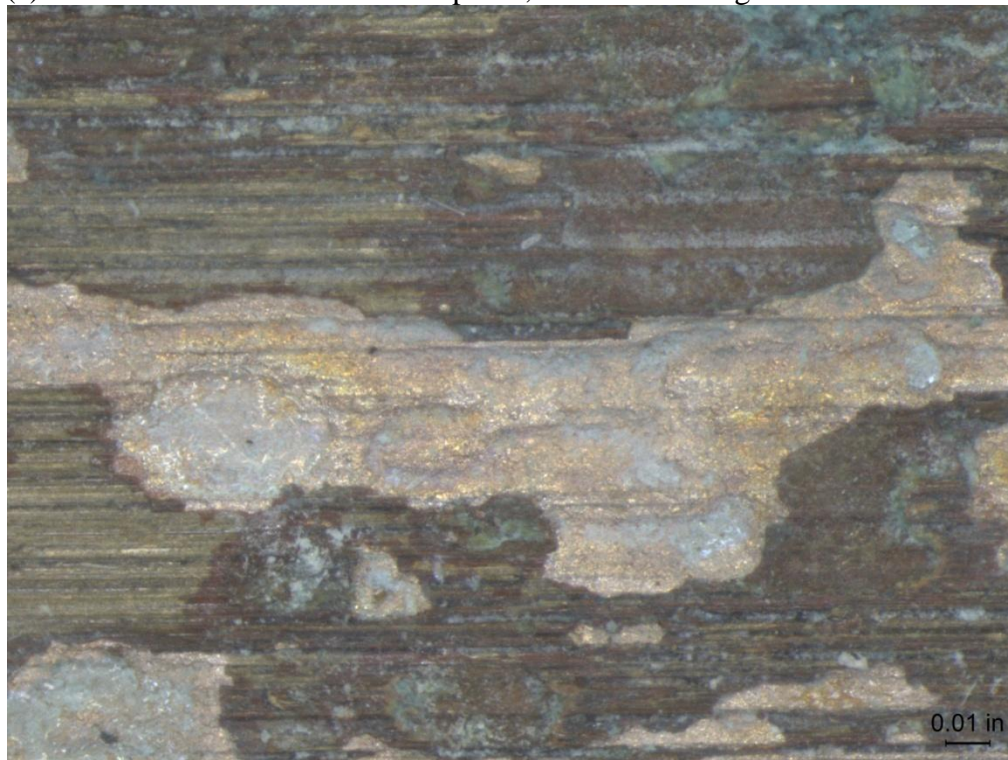
Figure 14 Optical macrographs of CDA 706 coupon 3 after a 10 month corrosion test, before cleaning.

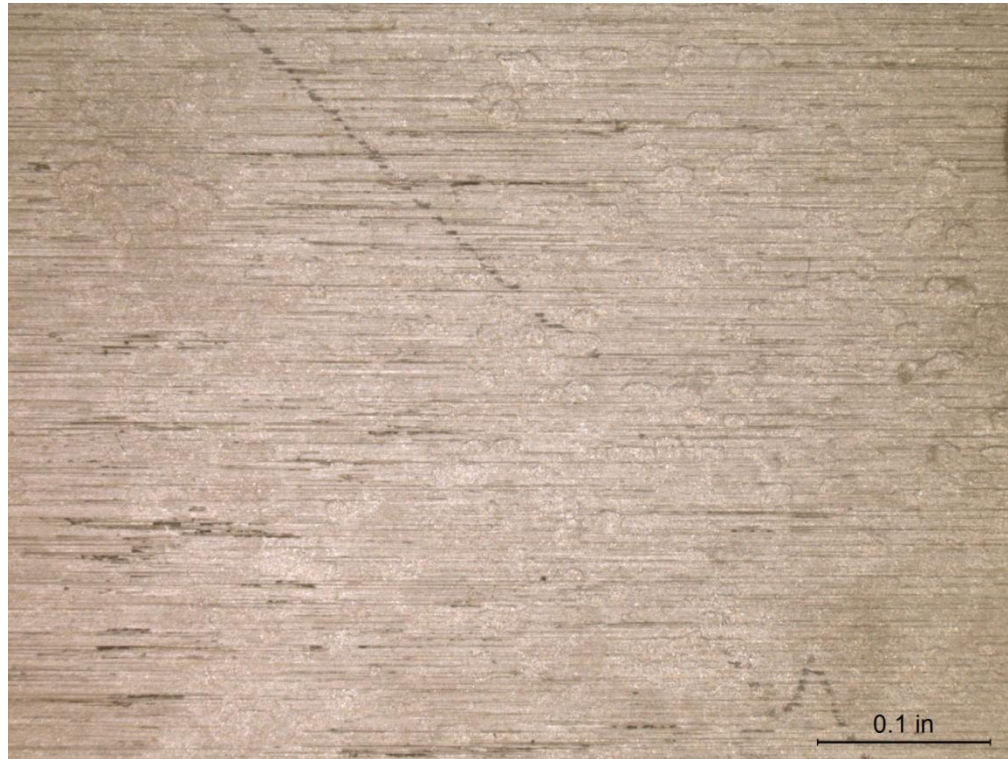
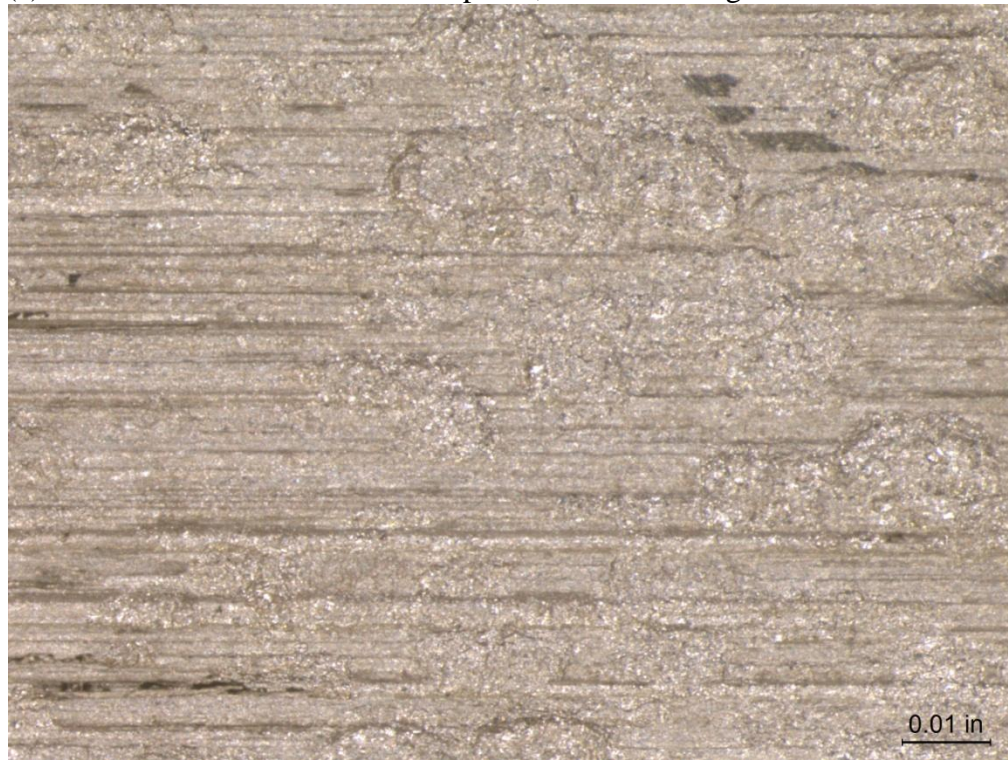
Figure 15 Optical macrographs of CDA 706 coupon 3 after a 10 month corrosion test, after cleaning.
