WEST BASIN MUNICIPAL WATER DISTRICT OCEAN WATER DESALINATION INTAKE CORROSION STUDY

November 2014

V&A Project No.: 13-0376

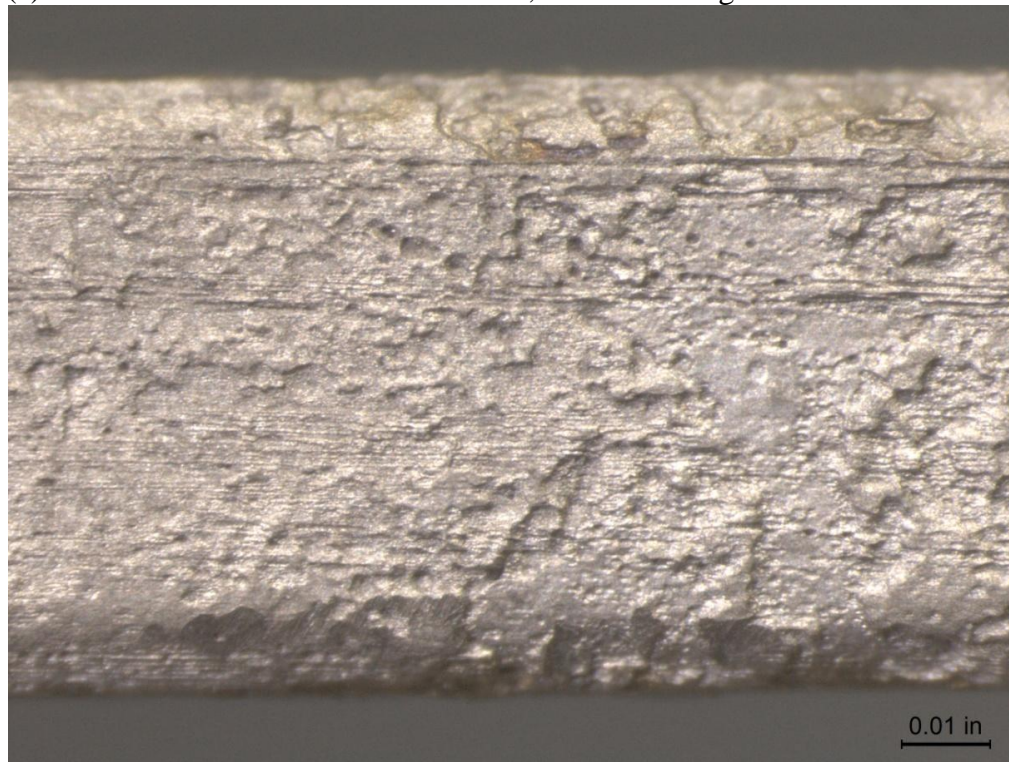
Figure 18 Optical macrographs of CDA 706 screen 1 after a 3 month corrosion test, after cleaning.

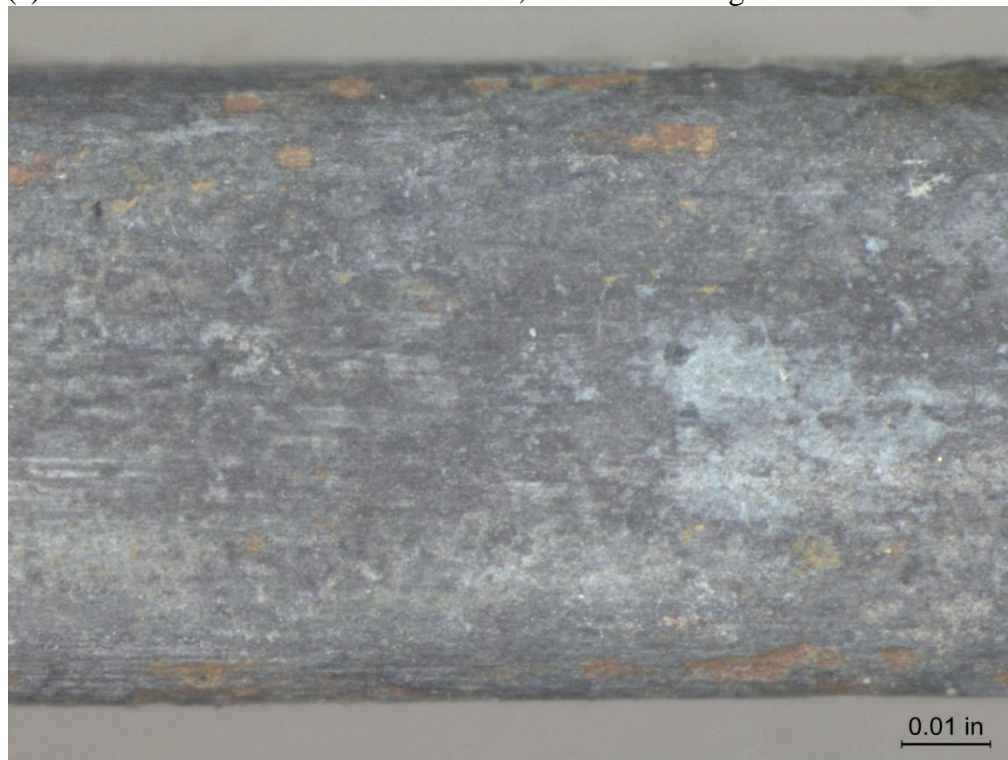
Figure 19 Optical macrographs of CDA 706 screen 2 after a 6 month corrosion test, before cleaning.

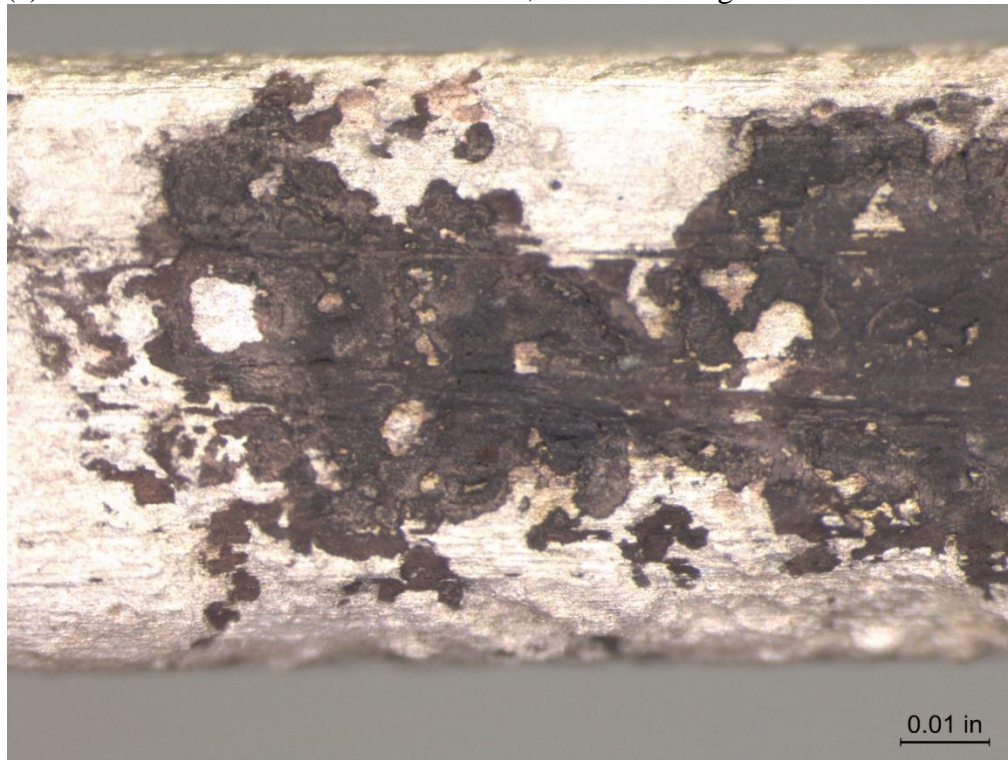
Figure 20 Optical macrographs of CDA 706 screen 2 after a 6 month corrosion test, after cleaning.

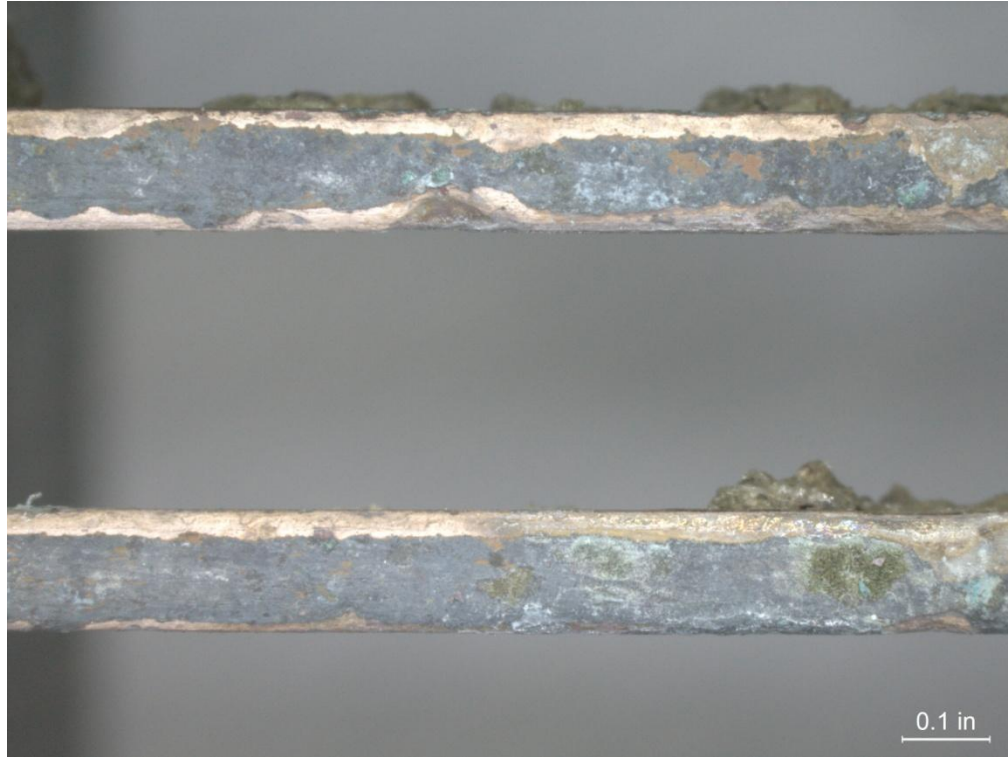
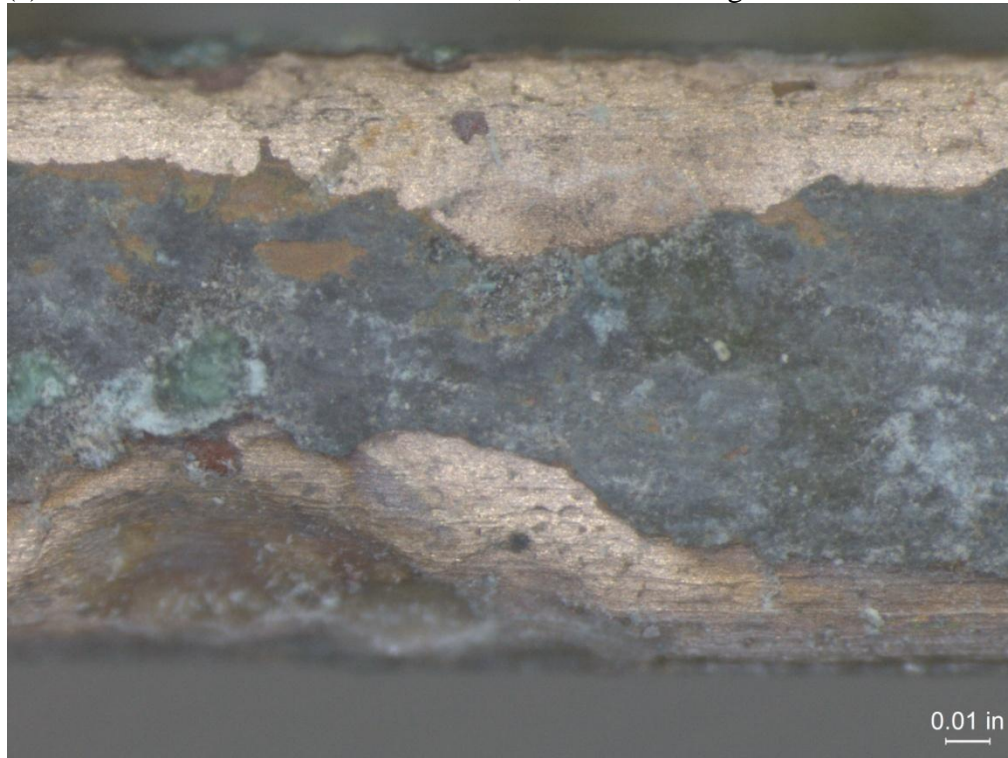
Figure 21 Optical macrographs of CDA 706 screen 3 after a 10 month corrosion test, before cleaning.

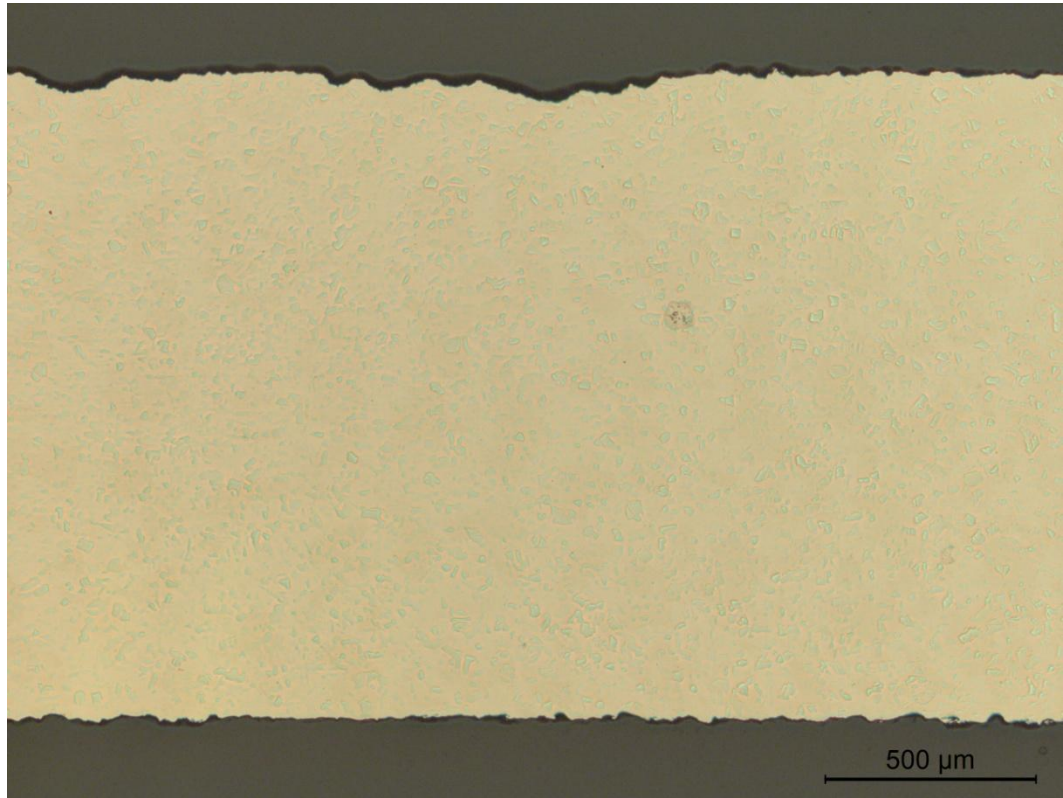
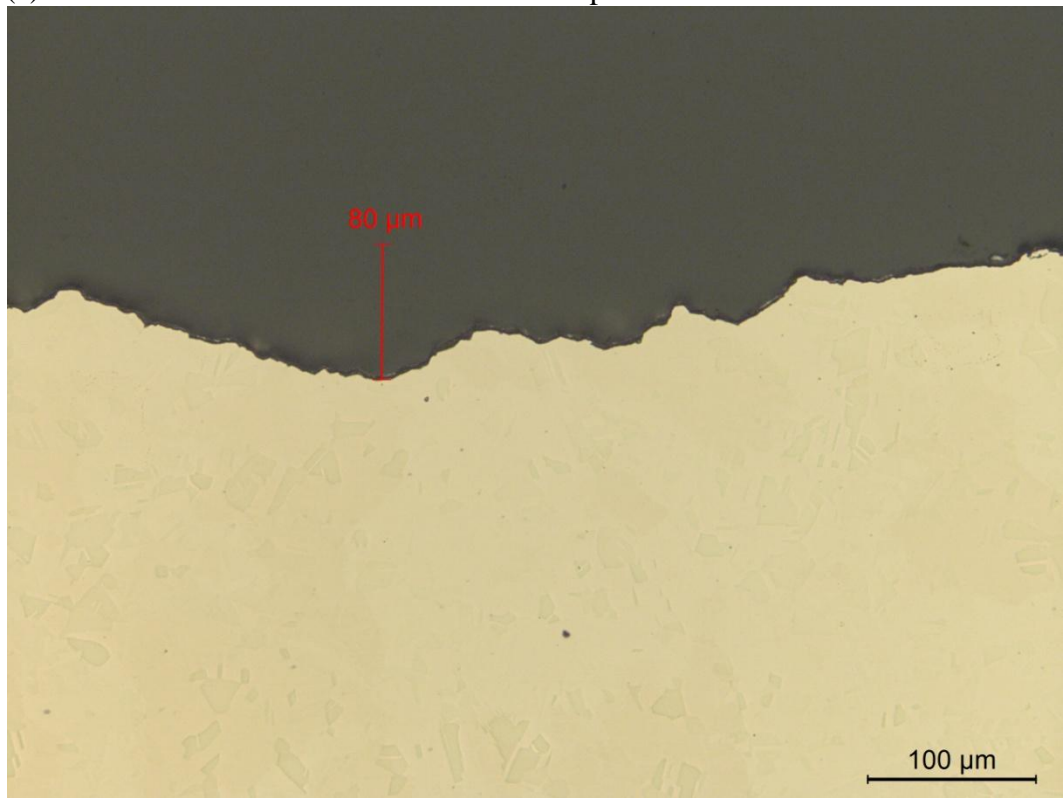
Figure 37 Optical micrographs of CDA 706 coupon 1.

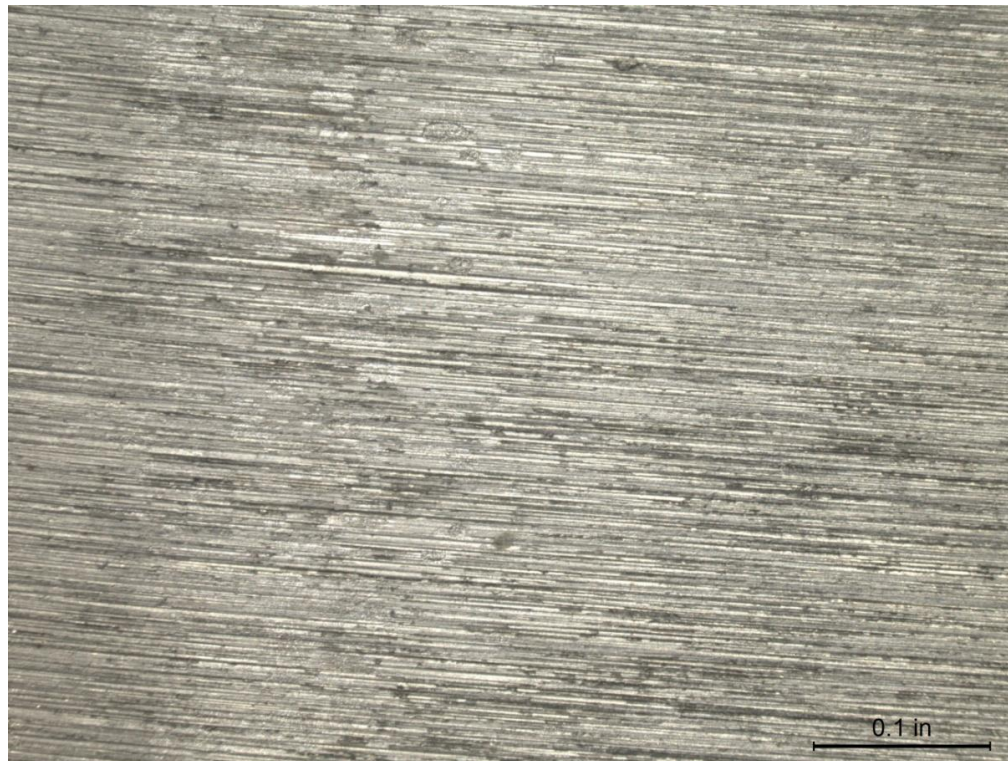
Figure 11 Optical macrographs of CDA 715 coupon 1 after a 3 month corrosion test, after cleaning.

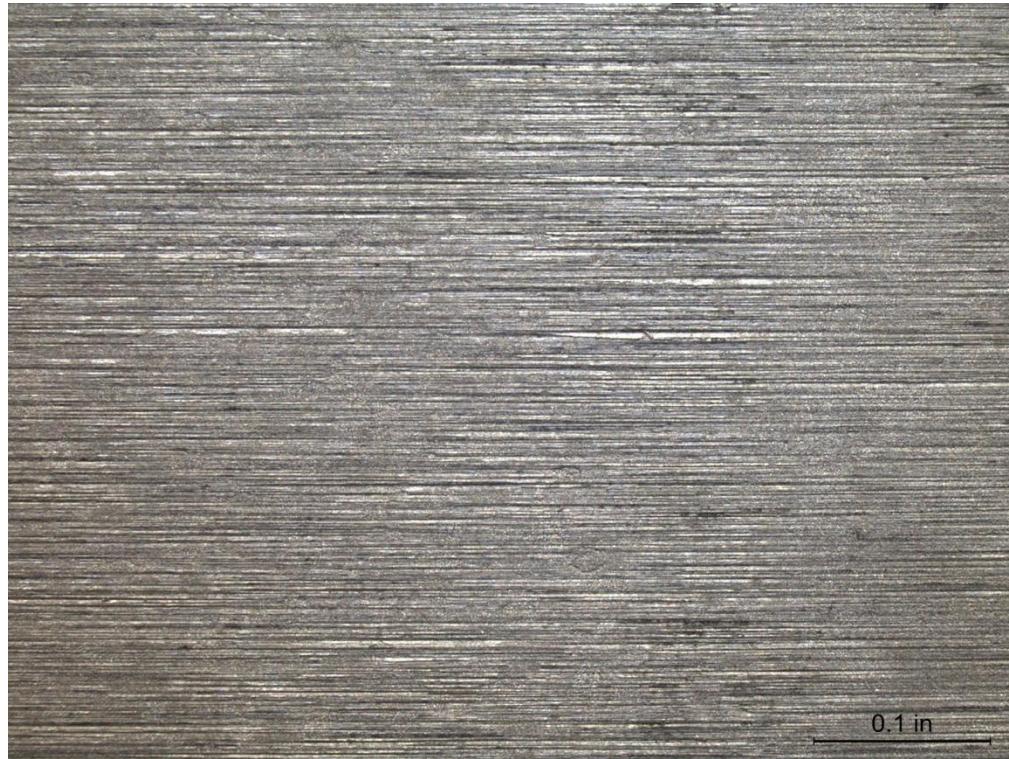
Figure 13 Optical macrographs of CDA 715 coupon 2 after a 6 month corrosion test, after cleaning.

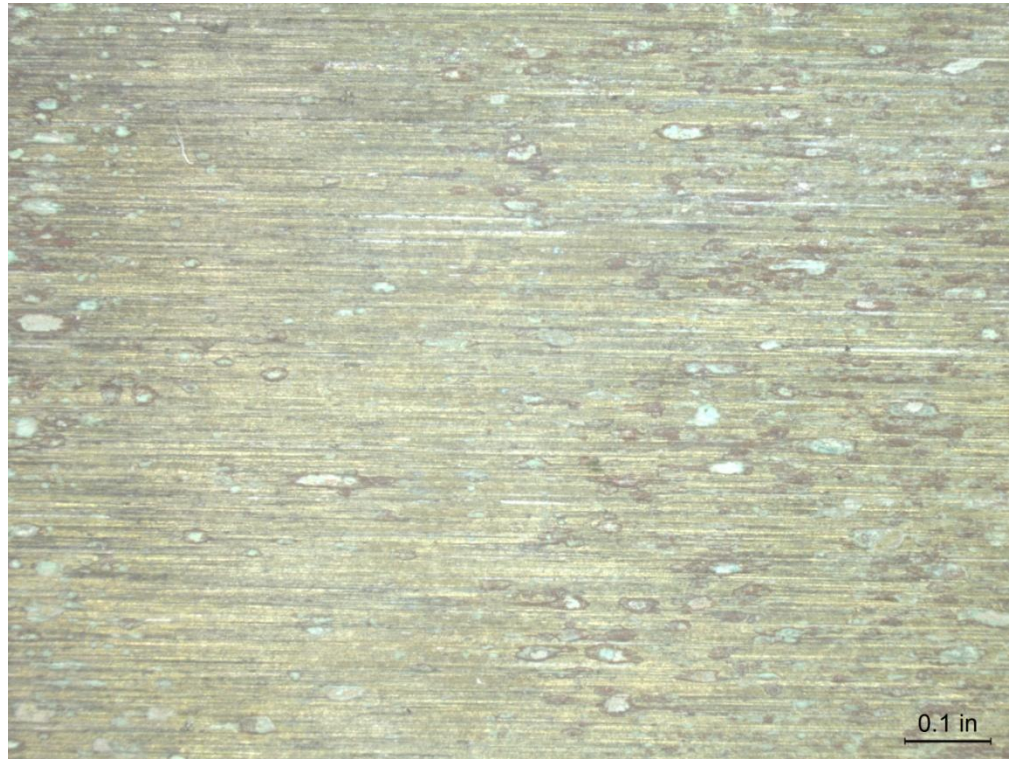
Figure 14 Optical macrographs of CDA 715 coupon 3 after a 10 month corrosion test, before cleaning.

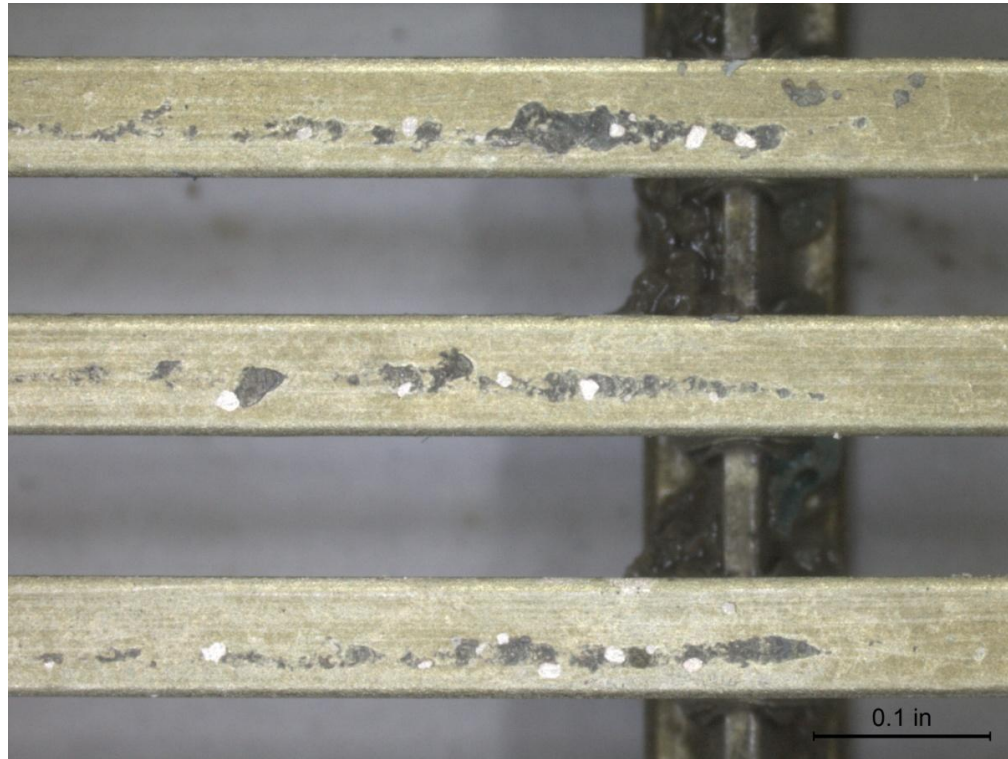
Figure 16 Optical macrographs of the CDA 715 baseline screen.

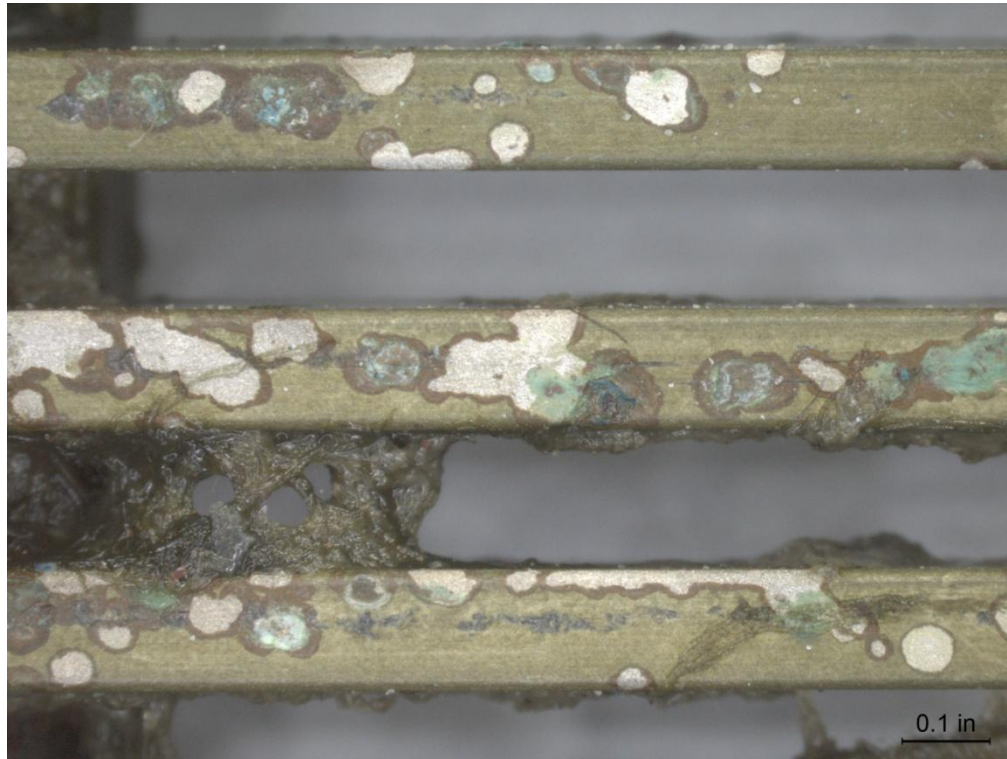
Figure 20 Optical macrographs of CDA 715 screen 2 after a 6 month corrosion test, after cleaning.

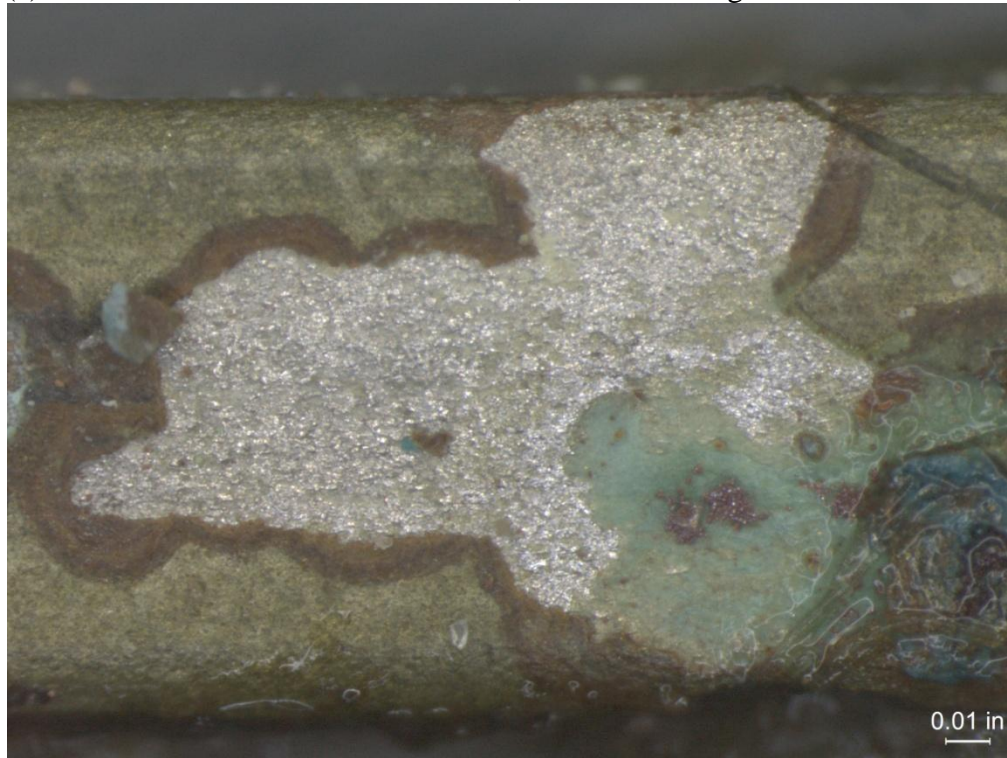
Figure 21 Optical macrographs of CDA 715 screen 3 after a 10 month corrosion test, before cleaning.

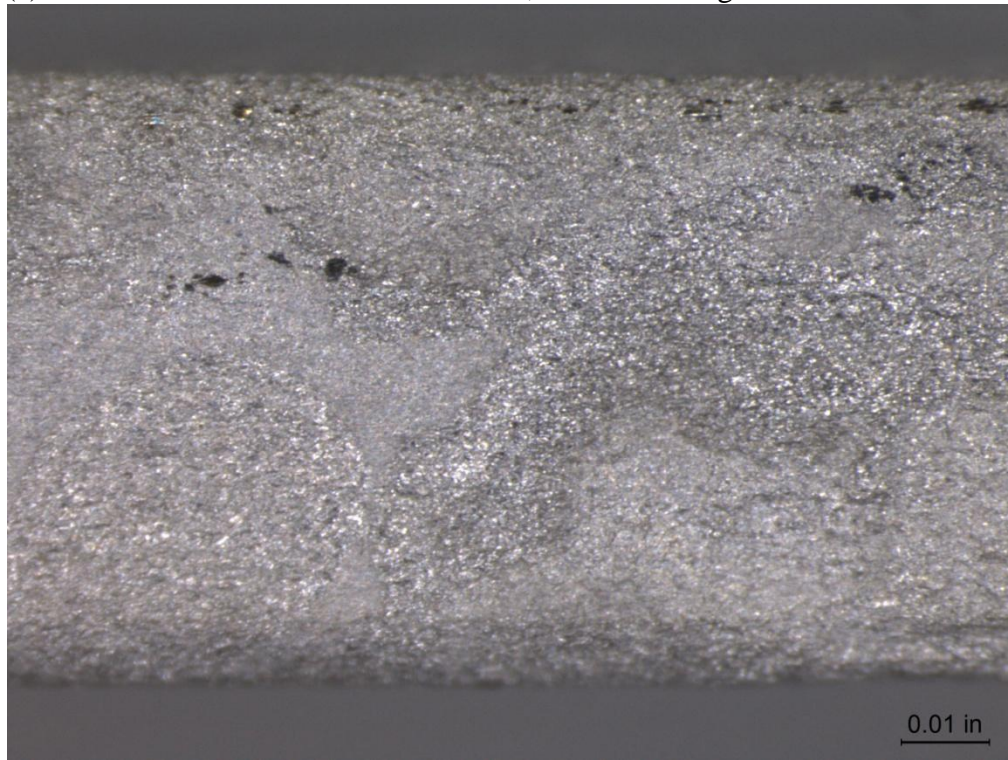
Figure 22 Optical macrographs of CDA 715 screen 3 after a 10 month corrosion test, after cleaning.

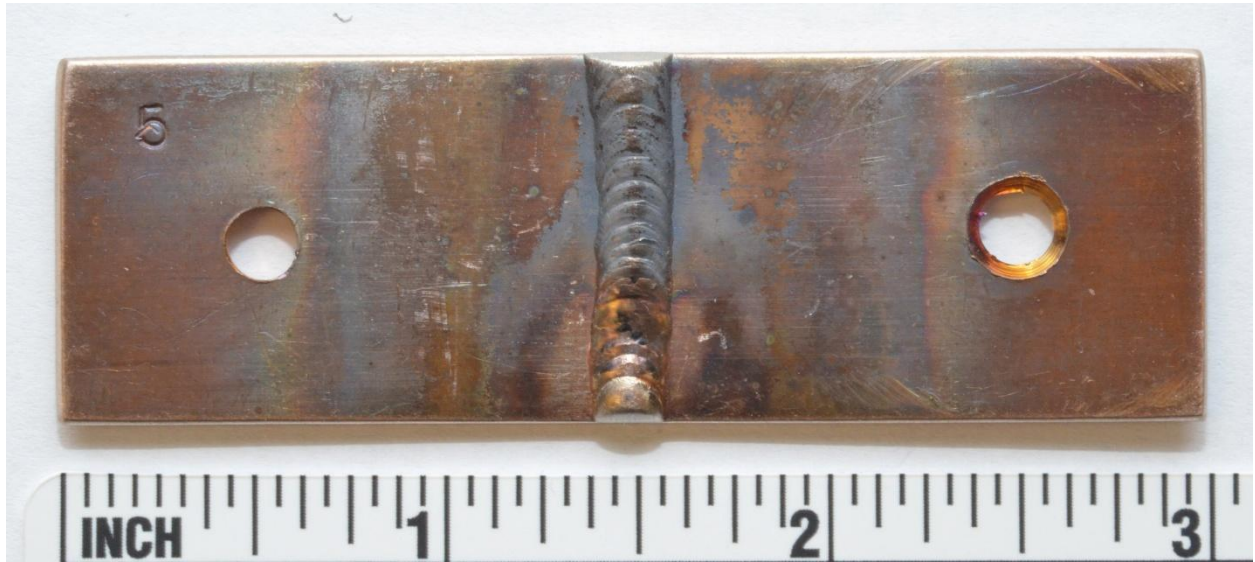
Figure 1 Photographs of the Z-Alloy baseline coupon (a) front and (b) back side.

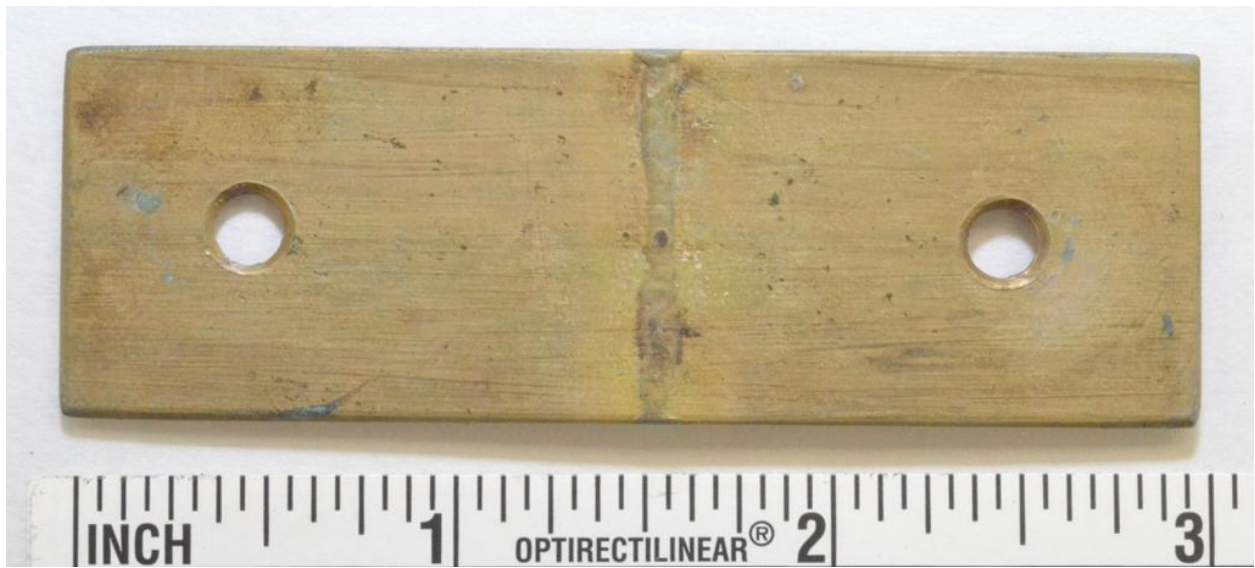
(a) Z-Alloy Coupon 2 Front Side

Figure 3 Photographs of Z-Alloy coupon 2 (a) front and (b) back side after a 6 month corrosion test.

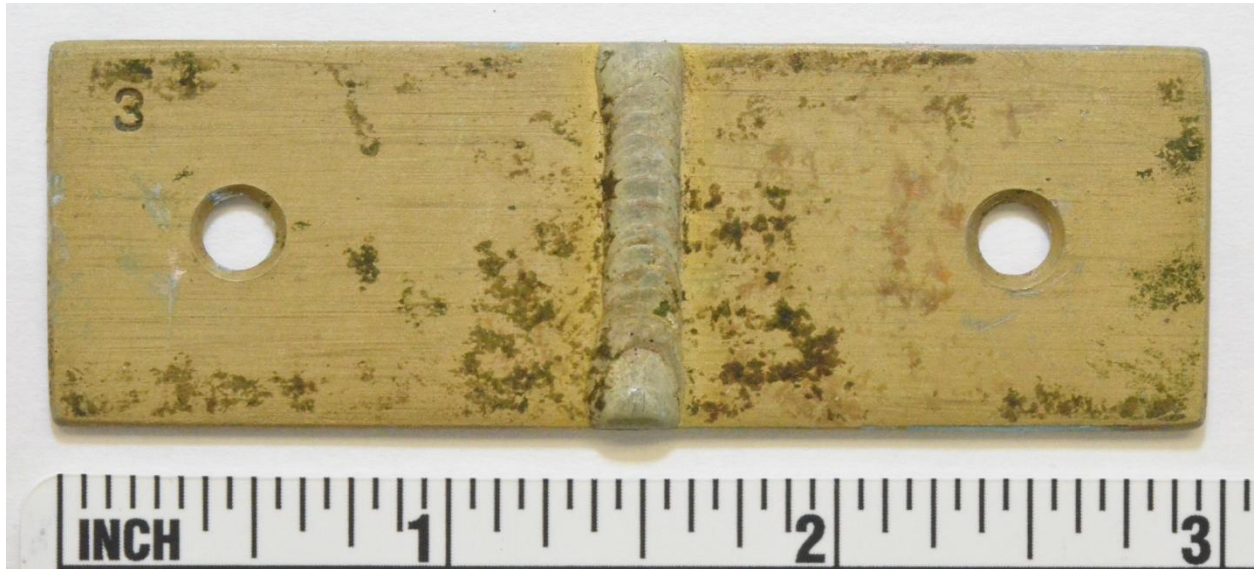
Figure 4 Photographs of Z-Alloy coupon 3 (a) front and (b) back side after a 10 month corrosion test.

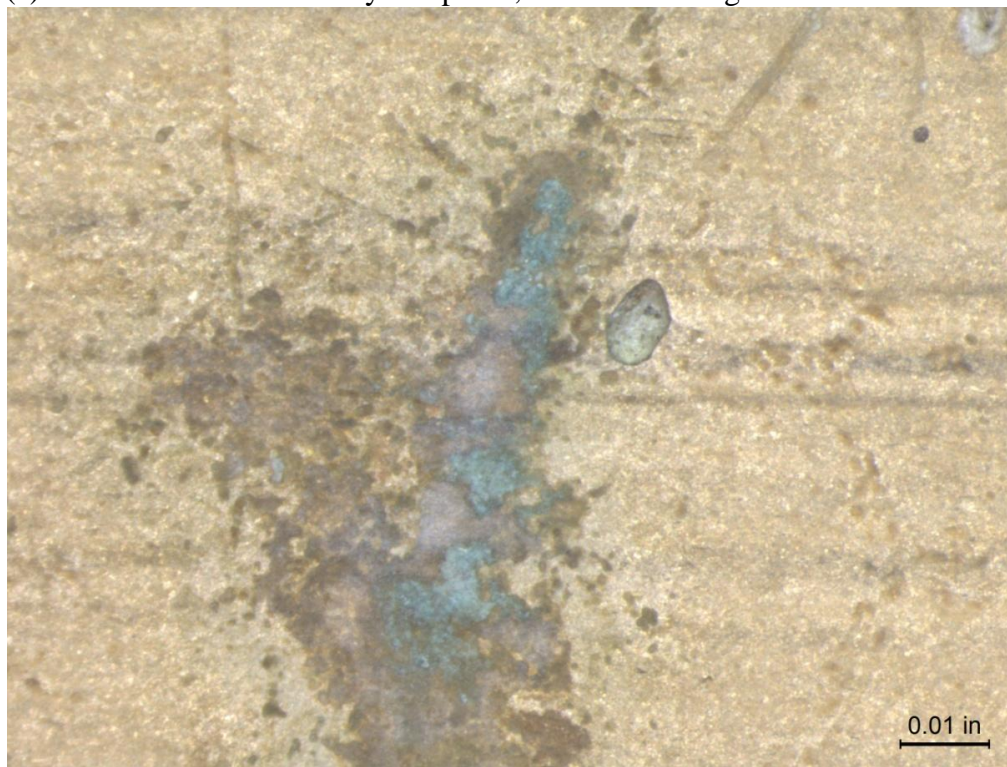
Cross sections were taken from the coupon and prepared for a metallographic examination. Optical micrographs of the surfaces of coupons 1 – 3 are shown in Figures 37 – 39. A wide, shallow pit, measuring 0.2 mm, was observed in coupon 1. Small pits were observed in coupons 2 and 3, the deepest of which measured 15 μm .

Figure 10 Optical macrographs of Z-Alloy coupon 1 after a 3 month corrosion test, before cleaning.

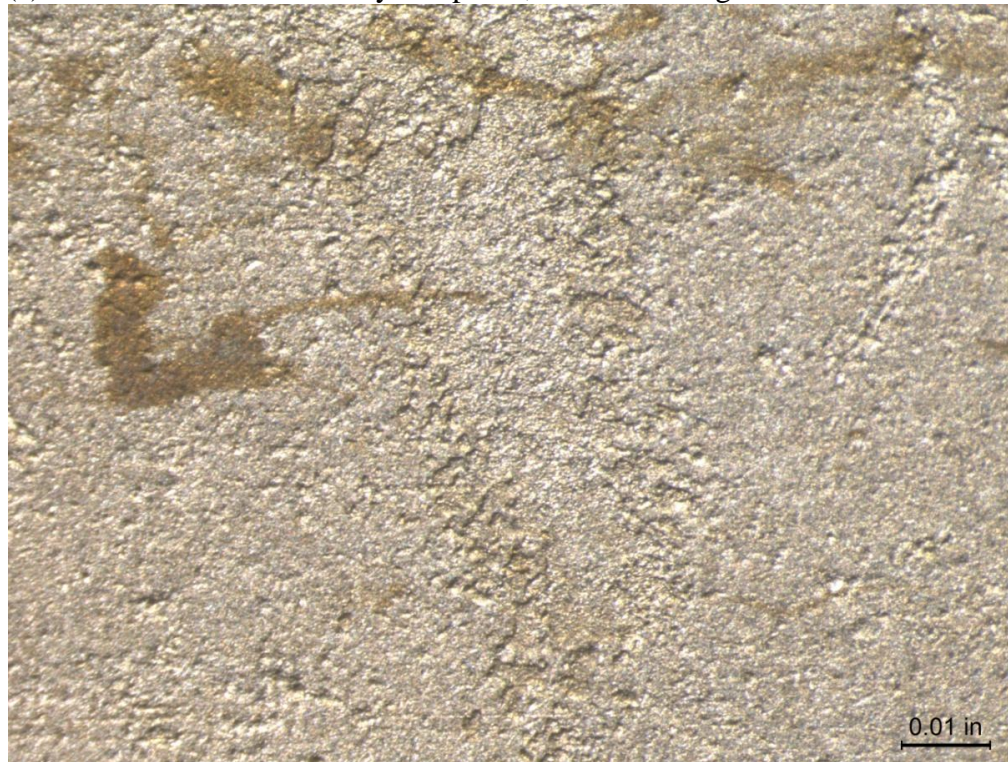
Figure 11 Optical macrographs of Z-Alloy coupon 1 after a 3 month corrosion test, after cleaning.

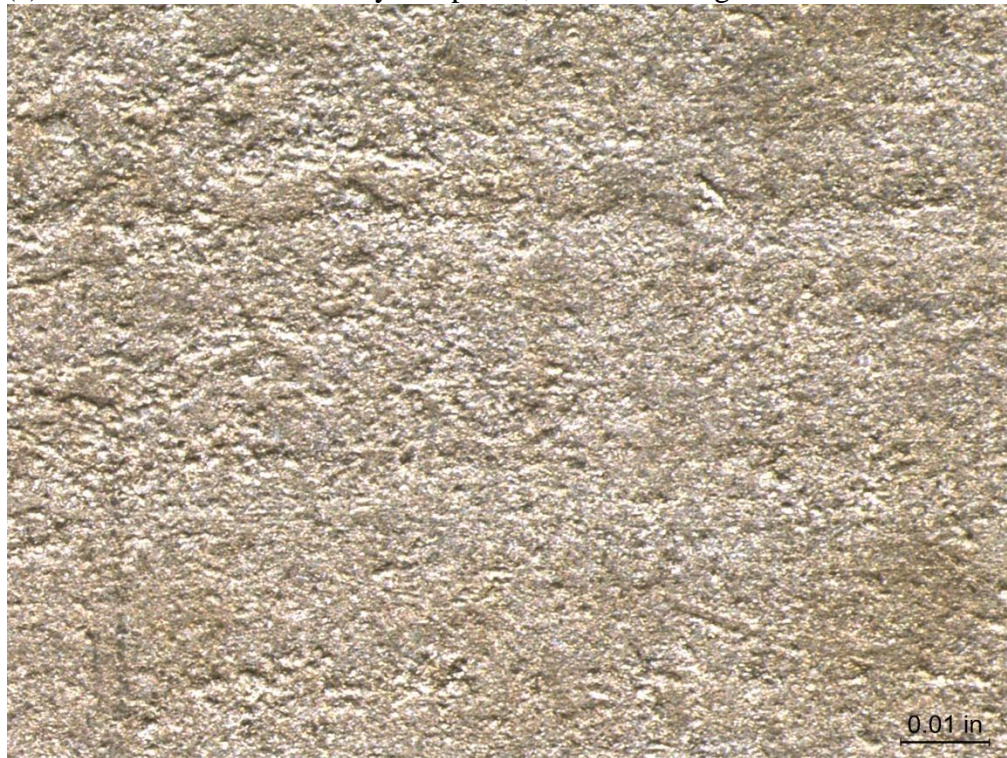
Figure 13 Optical macrographs of Z-Alloy coupon 2 after a 6 month corrosion test, after cleaning.

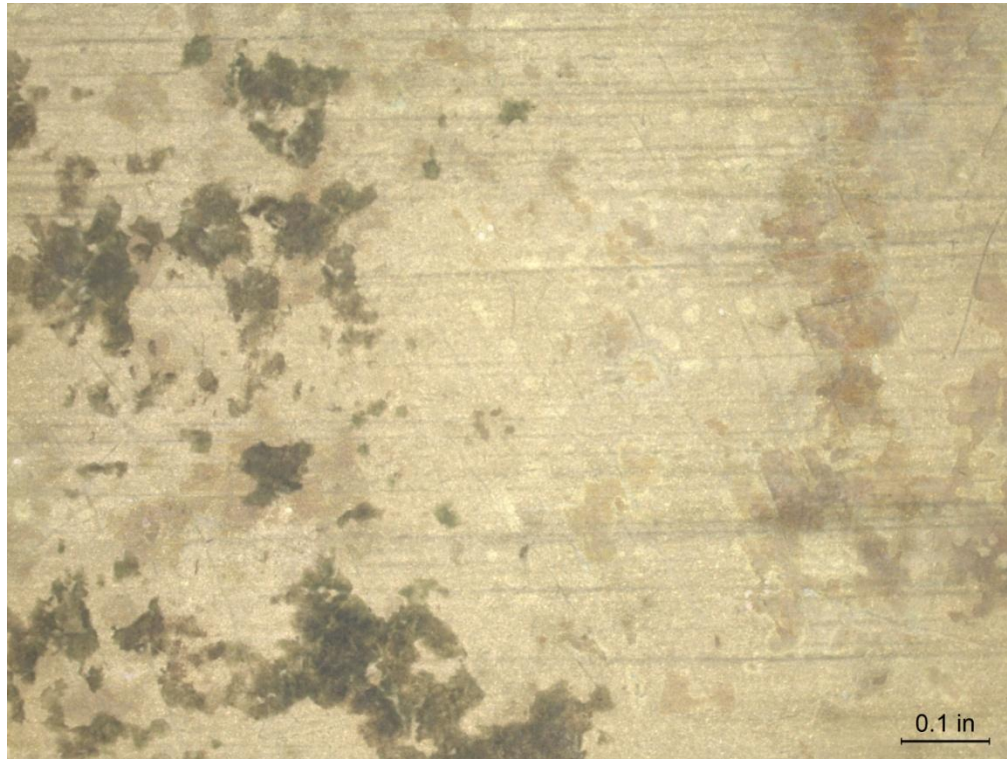
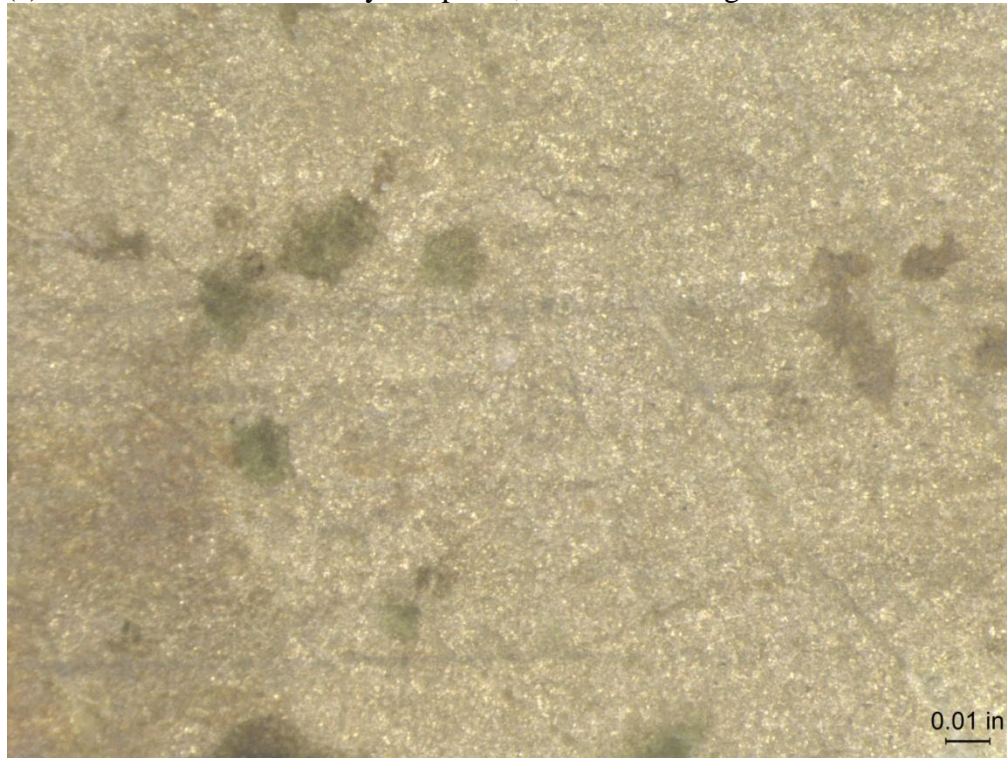
Figure 14 Optical macrographs of Z-Alloy coupon 3 after a 10 month corrosion test, before cleaning.

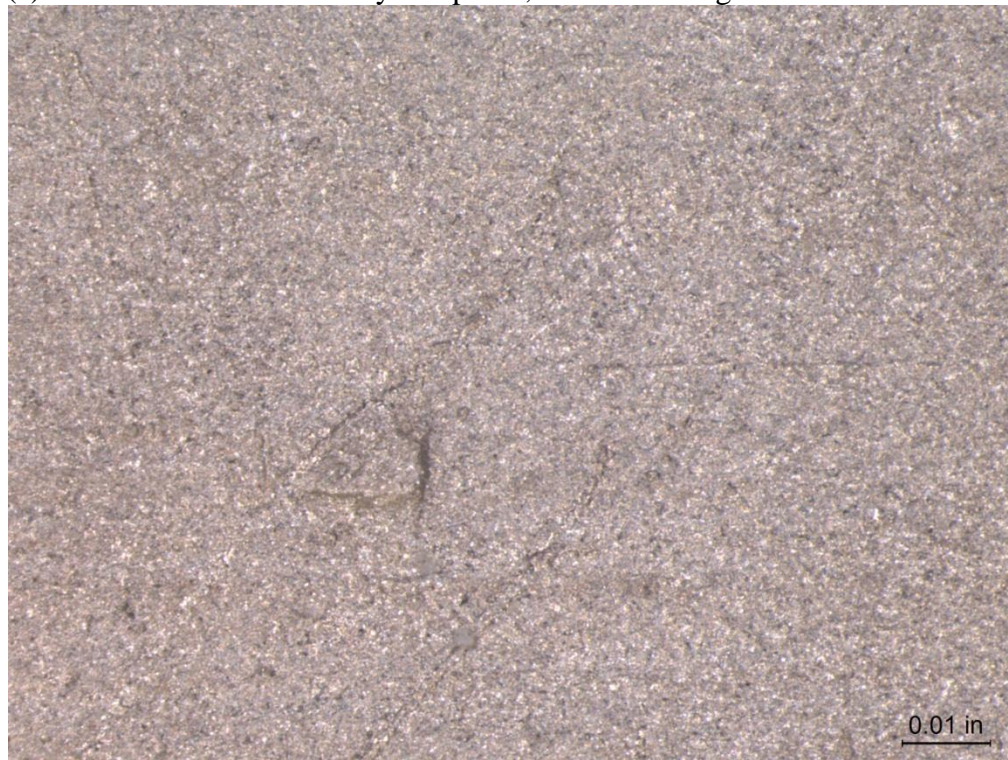
Figure 15 Optical macrographs of Z-Alloy coupon 3 after a 10 month corrosion test, after cleaning.

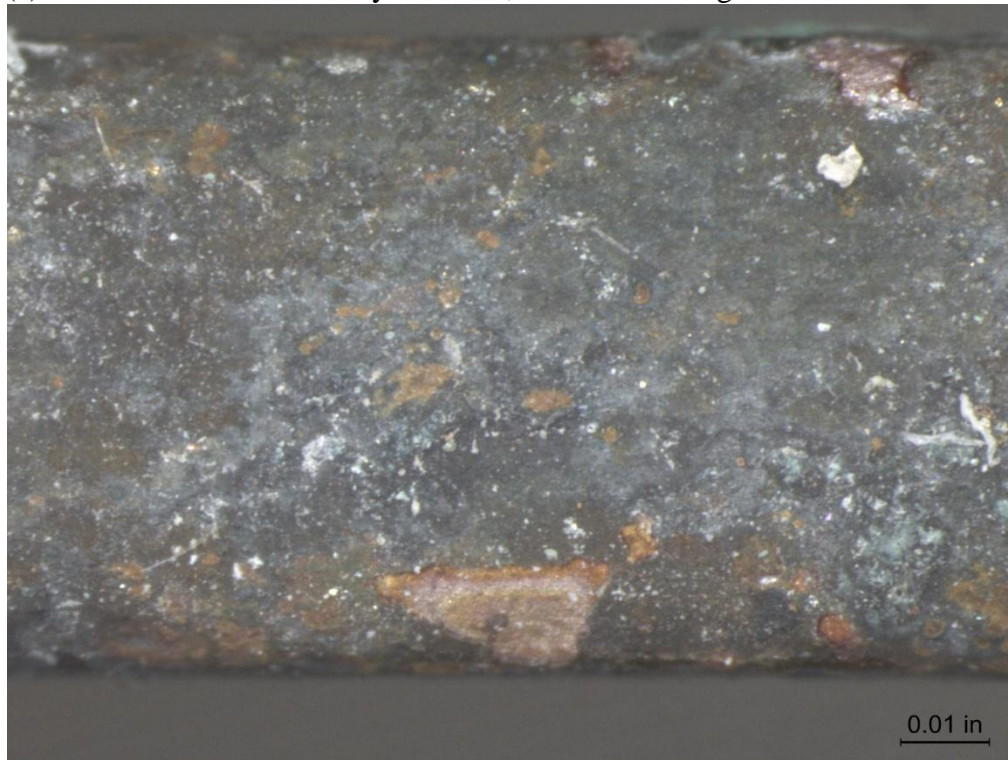
Figure 19 Optical macrographs of Z-Alloy screen 2 after a 6 month corrosion test, before cleaning.

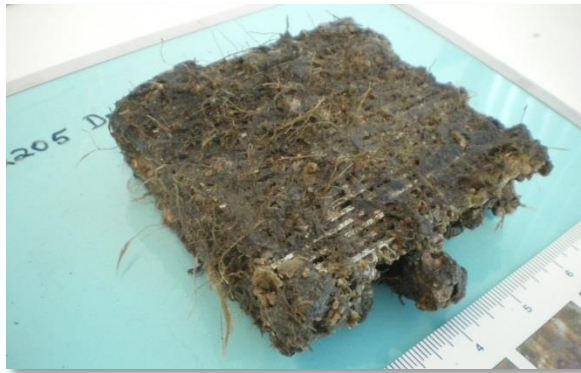
Photo 3-3. Marine life attached to uncoated 2205 Duplex stainless steel wedge wire screen.

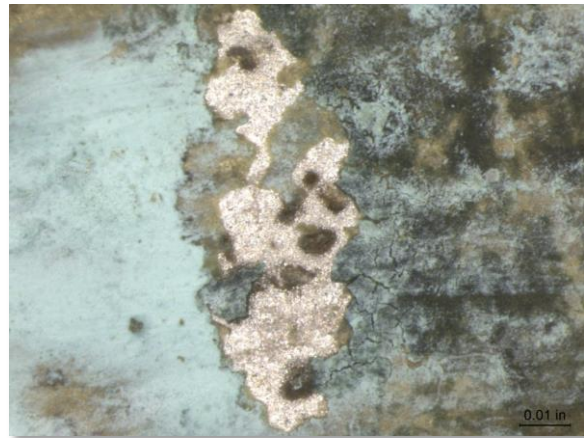
Photo 3-8, Photo 3-11, Photo 3-13, Photo 3-17 and Photo 3-18 show some further oxidation and discoloration of the copper alloy sample surfaces after being exposed to the atmosphere for up to 7 days. These photos are courtesy of Anamet, Inc. and are included in the reports in Appendix A.

Photo 3-18. Surface discoloration of Z alloy coupon, shown at 50x magnification

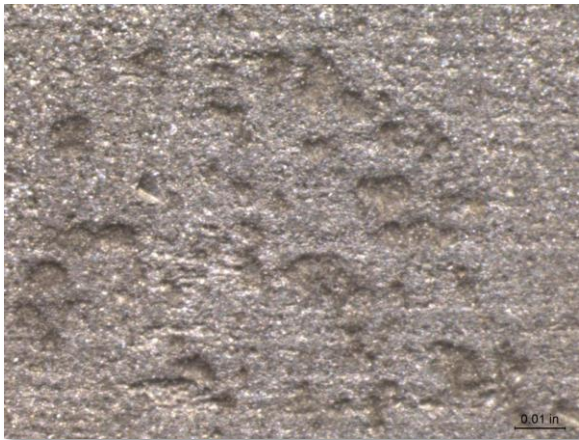
Photo 3-33. Z Alloy coupon at 50X magnification after cleaning.

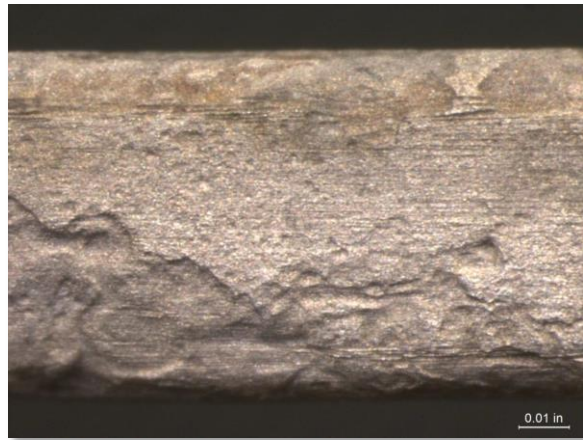
Photo 3-34. Z Alloy Screen at 50X magnification after cleaning.

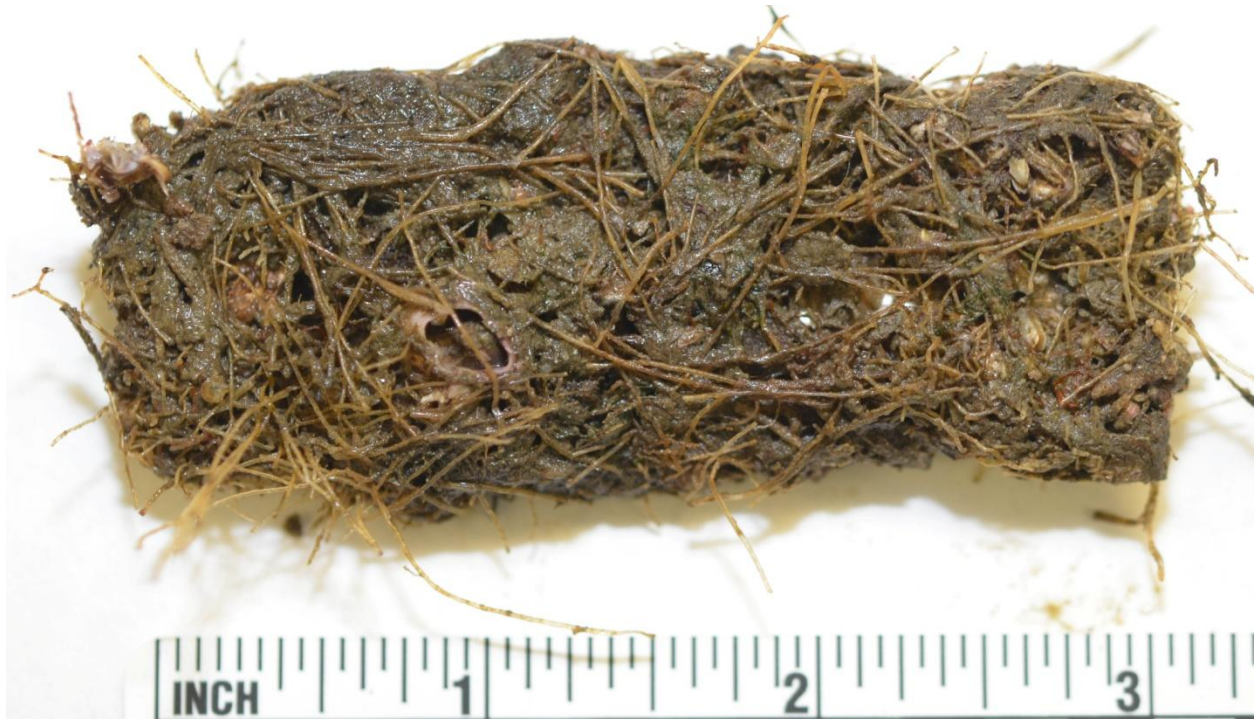
(b) Duplex 2205 Stainless Steel Coupon 6, Back Side

Figure 2 Photographs of duplex 2205 stainless steel coupon 6 (a) front and (b) back side after a 3 month corrosion test.

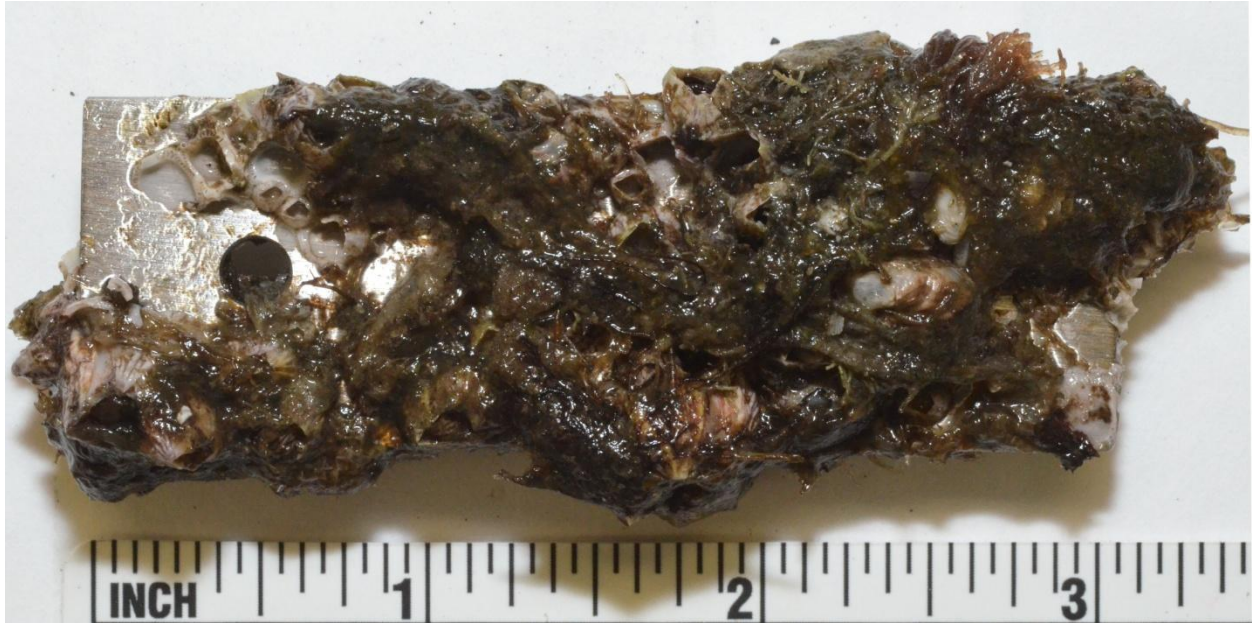
(a) Duplex 2205 Stainless Steel Coupon 9, Front Side

Figure 5 Photographs of duplex 2205 stainless steel coupon 9 (a) front and (b) back side after a 12 month corrosion test.
