WEST BASIN MUNICIPAL WATER DISTRICT OCEAN WATER DESALINATION INTAKE CORROSION STUDY

November 2014

V&A Project No.: 13-0376

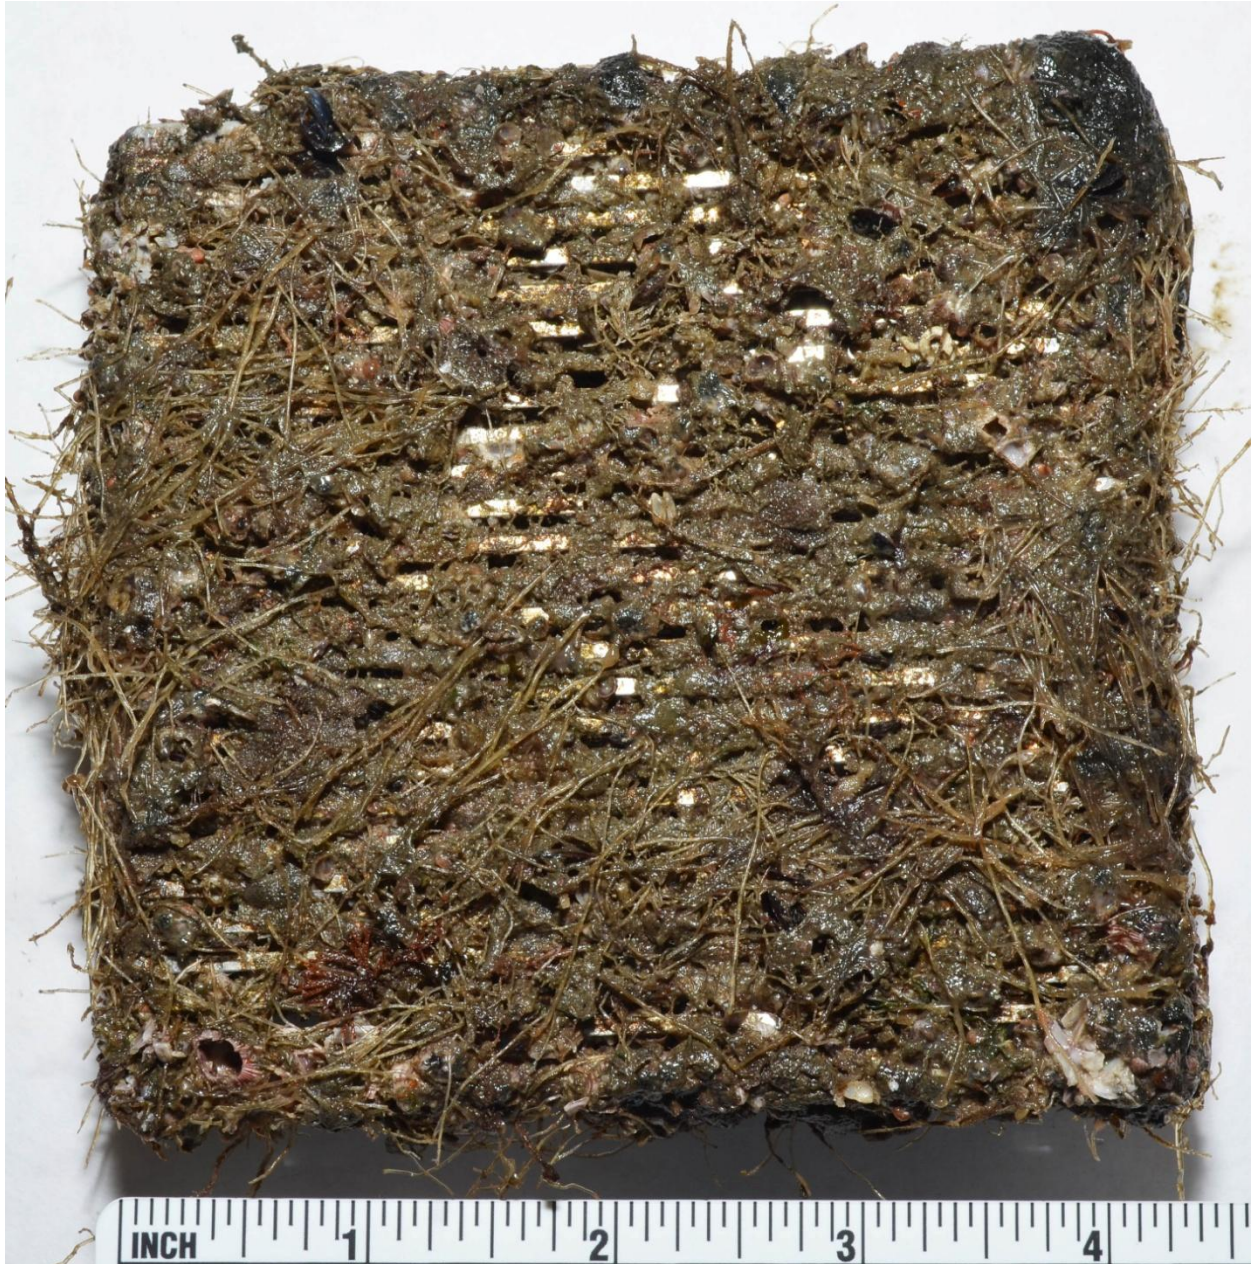
(a) Duplex 2205 Stainless Steel Screen 1

Figure 7 Photograph of duplex 2205 stainless steel screen 1 after a 3 month corrosion test.

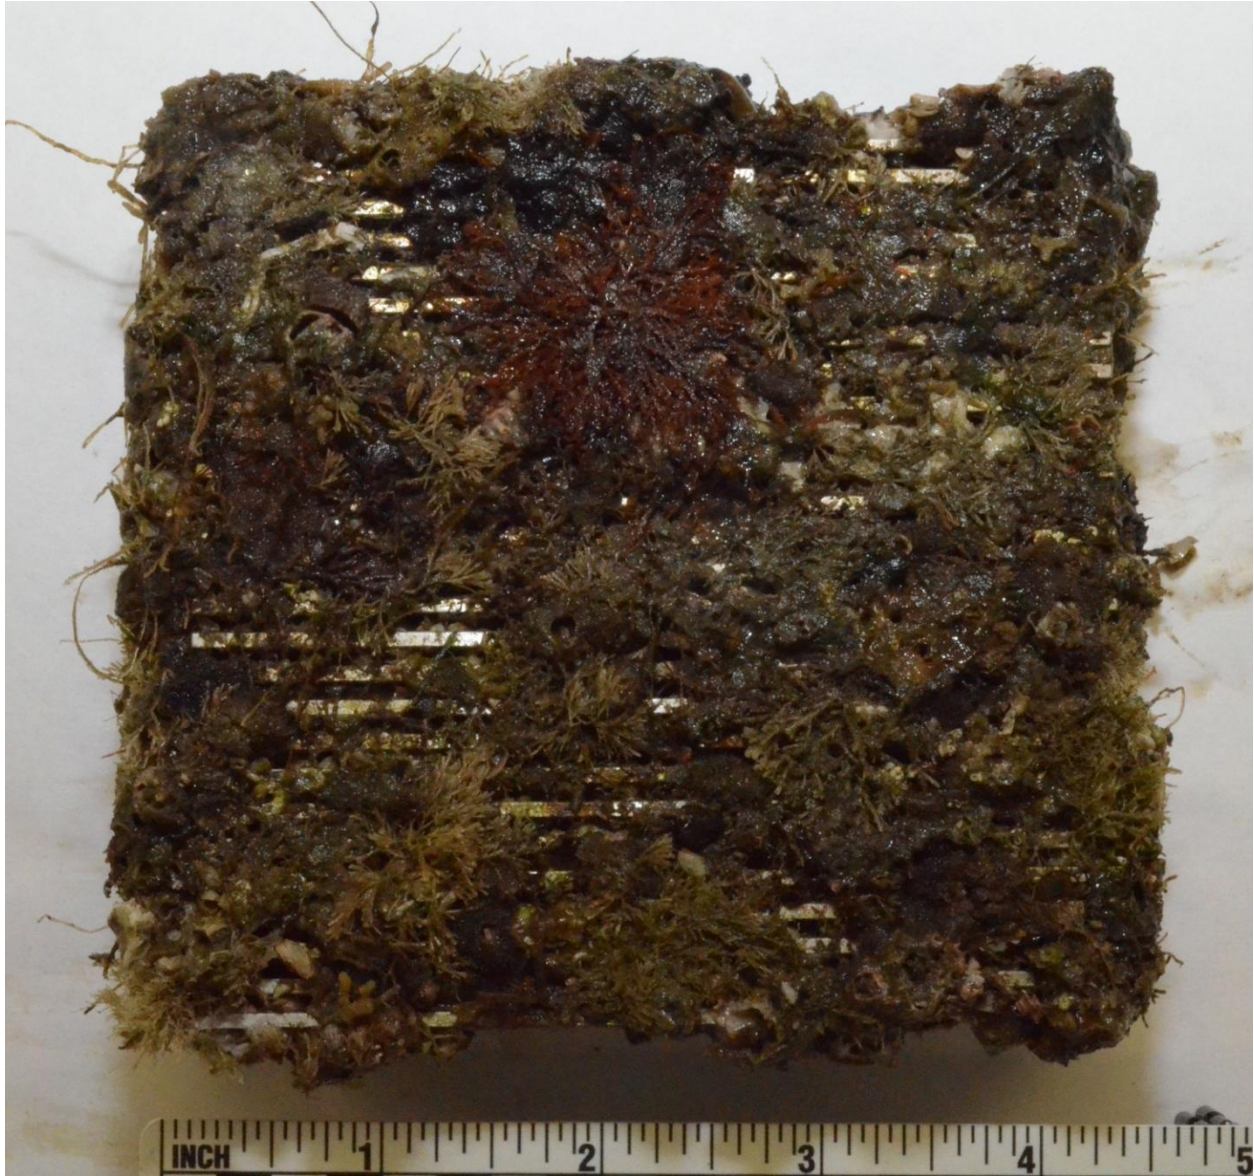
(a) Duplex 2205 Stainless Steel Screen 3

Figure 9 Photograph of duplex 2205 stainless steel screen 3 after a 10 month corrosion test.

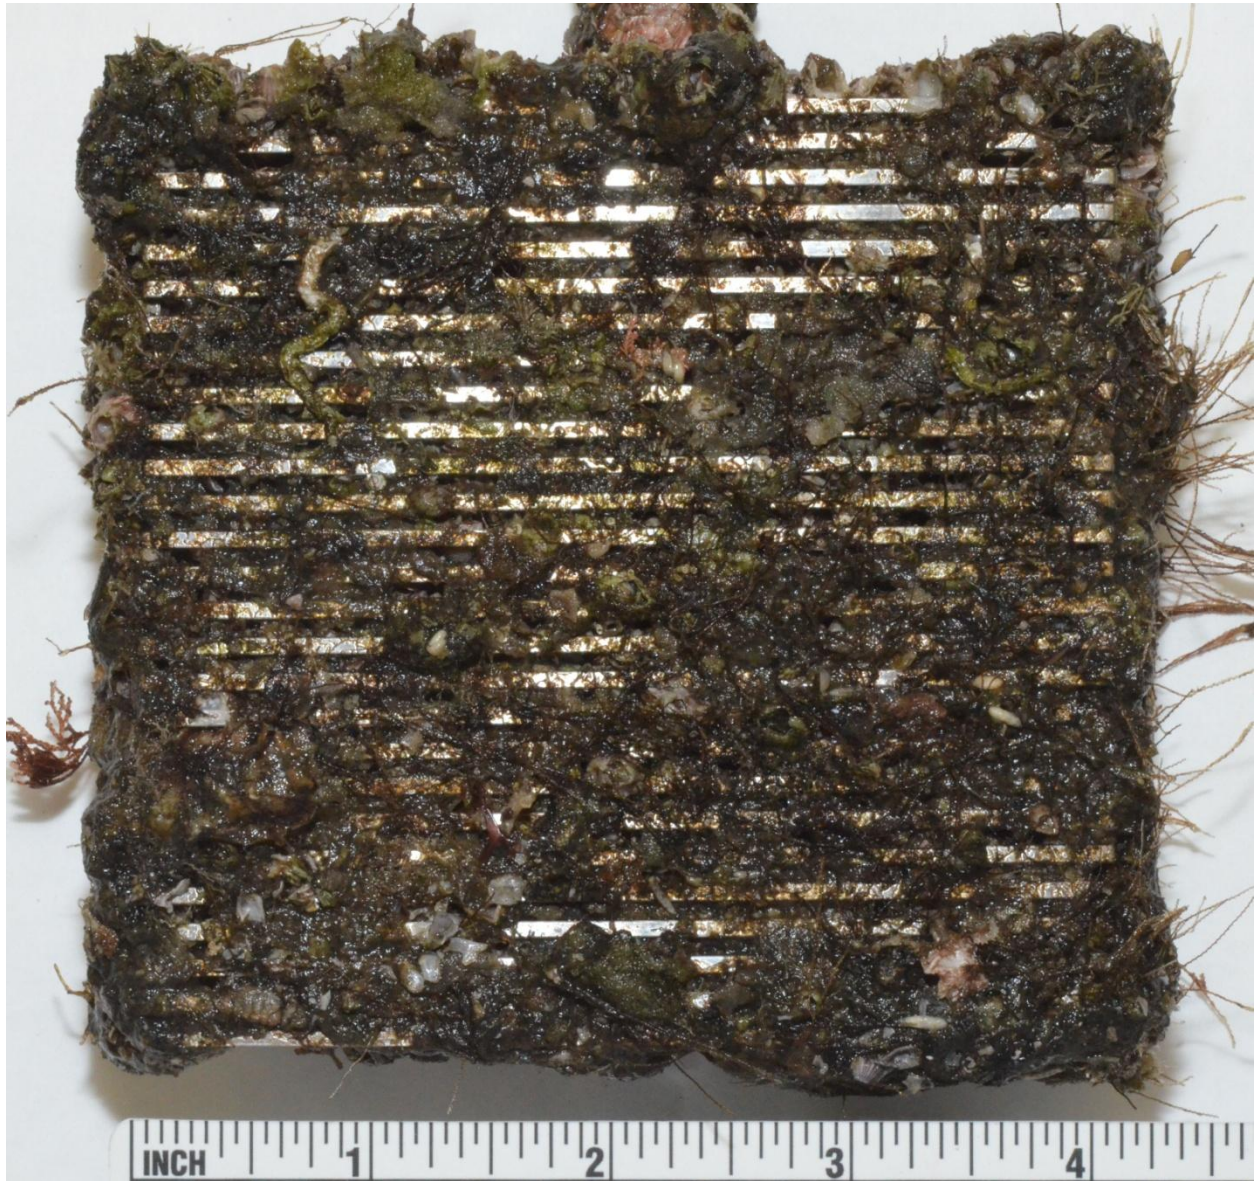
(a) Duplex 2205 Stainless Steel Screen 4

Figure 10 Photograph of duplex 2205 stainless steel screen 4 after a 12 month corrosion test.

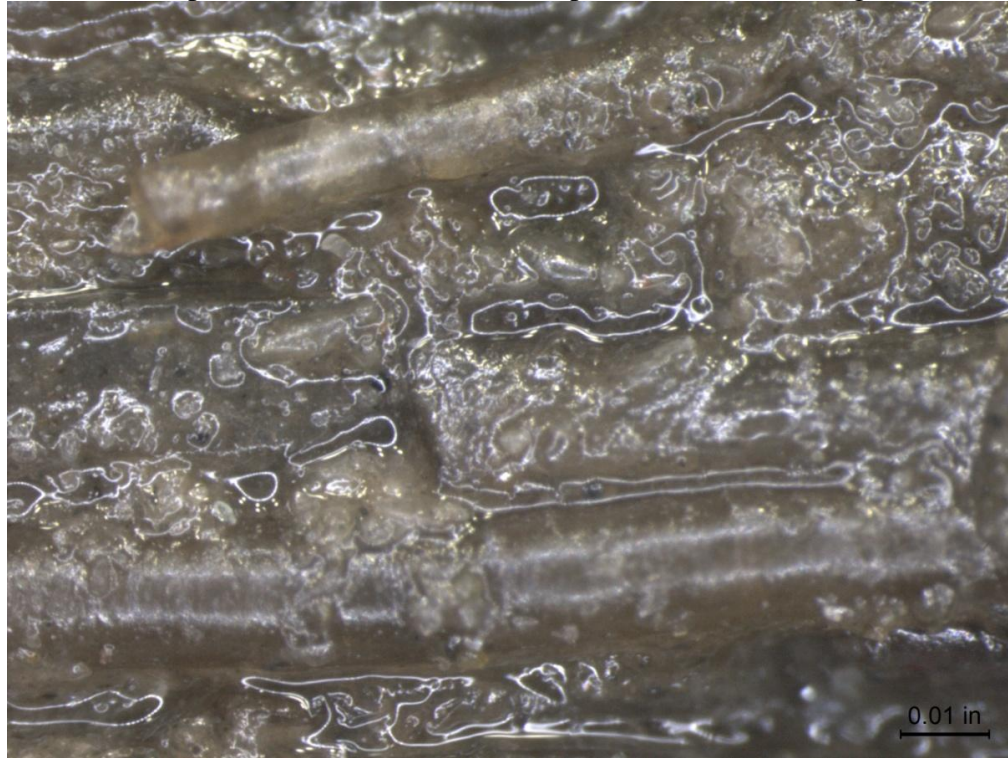
(b) Duplex 2205 Stainless Steel Coupon 6, Before Cleaning 50X

Figure 14 Optical macrographs of duplex 2205 stainless steel coupon 6 after a 3 month corrosion test, before cleaning.

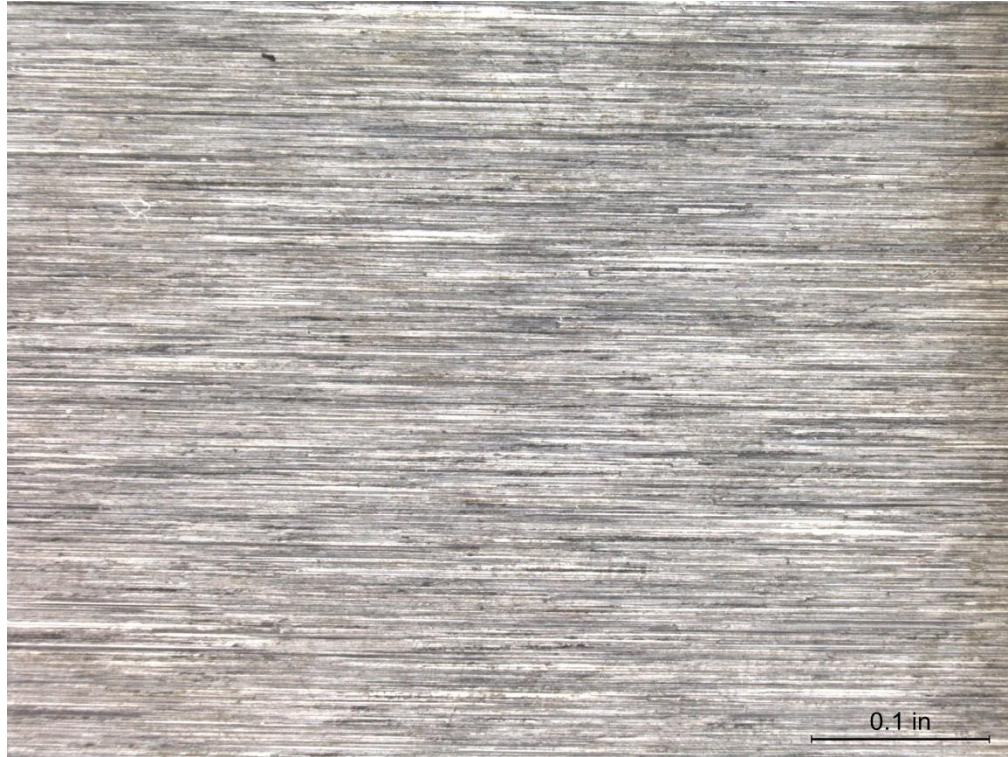
(a) Duplex 2205 Stainless Steel Coupon 7, After Cleaning 10X

Figure 17 Optical macrographs of duplex 2205 stainless steel coupon 7 after a 6 month corrosion test, after cleaning.

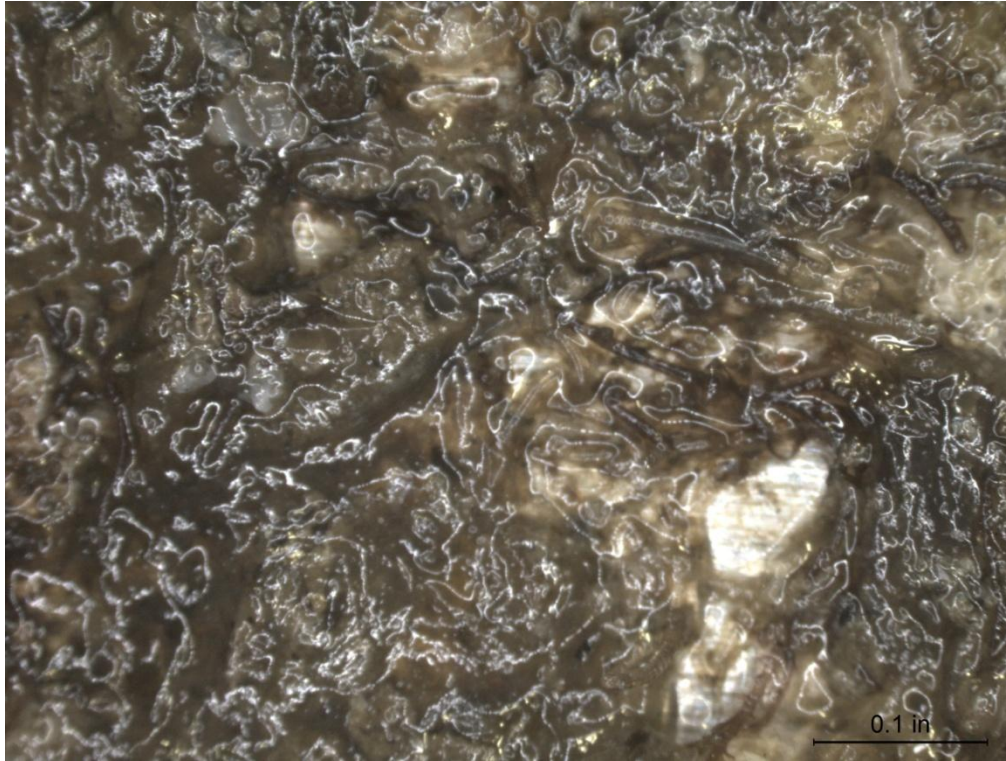
(a) Duplex 2205 Stainless Steel Coupon 9, Before Cleaning 10X

Figure 20 Optical macrographs of duplex 2205 stainless steel coupon 9 after a 12 month corrosion test, before cleaning.

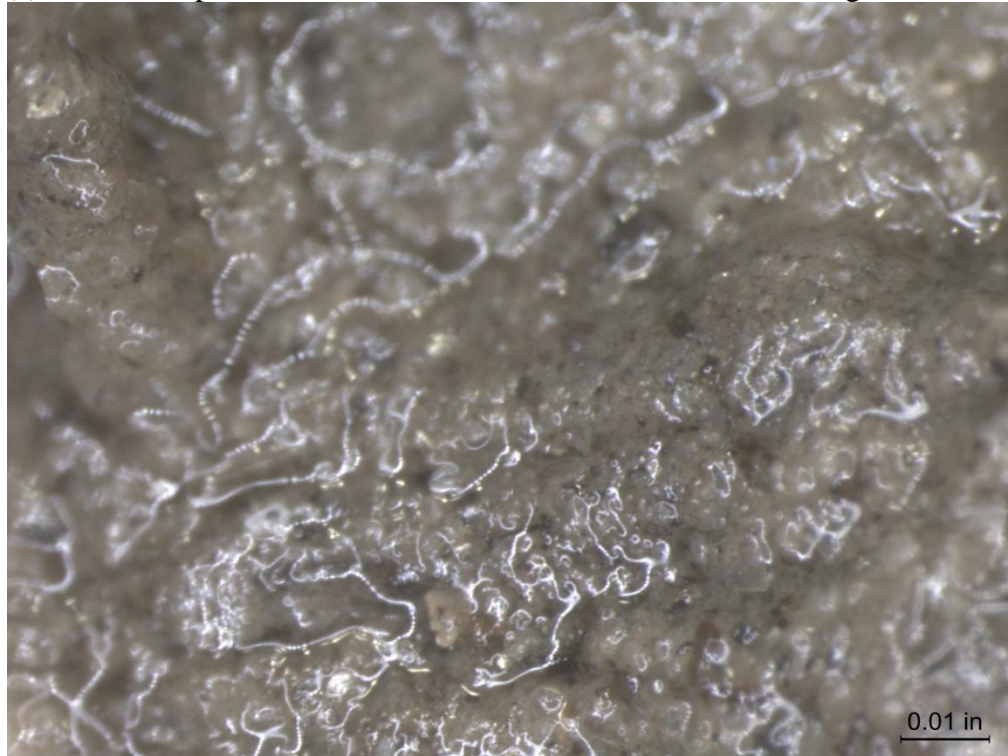
(b) Duplex 2205 Stainless Steel Screen 2, Before Cleaning 50X

Figure 25 Optical macrographs of duplex 2205 stainless steel screen 2 after a 6 month corrosion test, before cleaning.

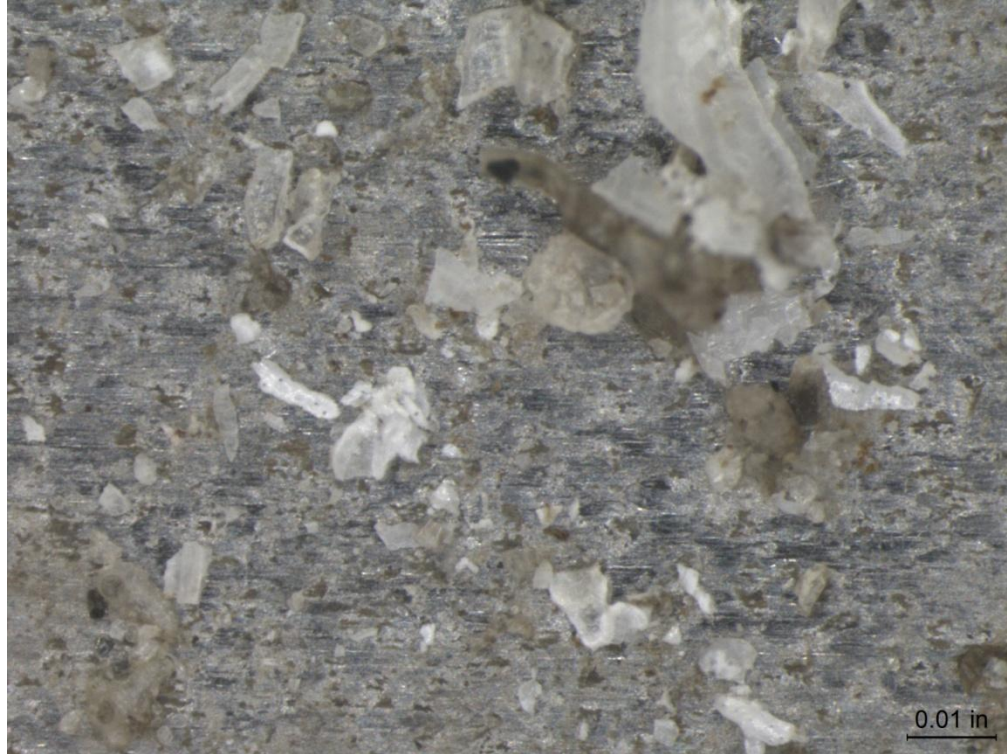
Figure 32 Optical macrographs of duplex 2205 stainless steel plate after a 12 month corrosion test, before cleaning.

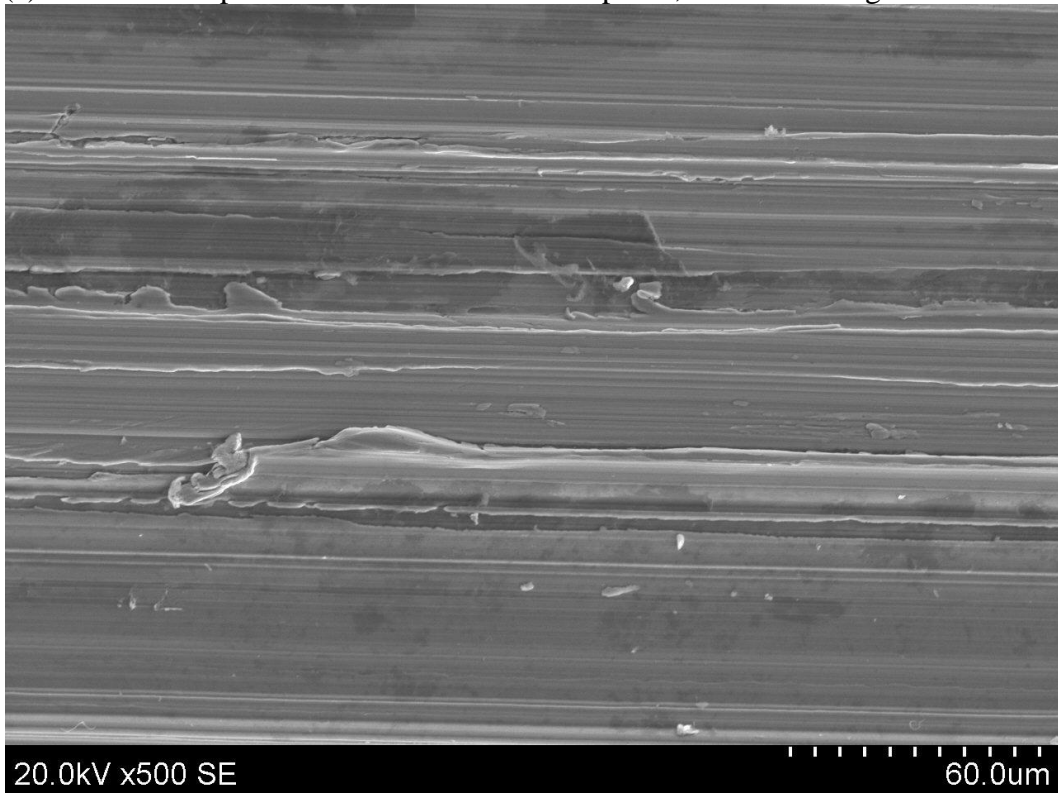
Figure 43 Scanning electron micrographs of duplex stainless steel coupon 9 after a 12 month corrosion test, after cleaning.

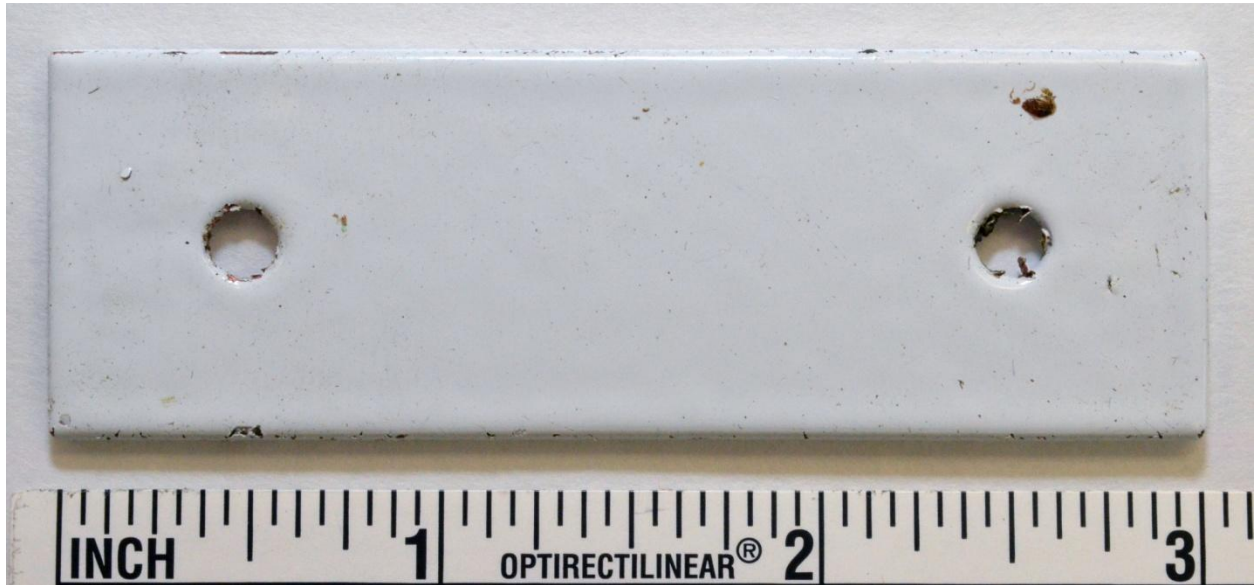
Figure 3 Photographs of duplex 2205 stainless steel with anti-biofouling coating coupon 2 (a) front and (b) back side after a 6 month corrosion test.

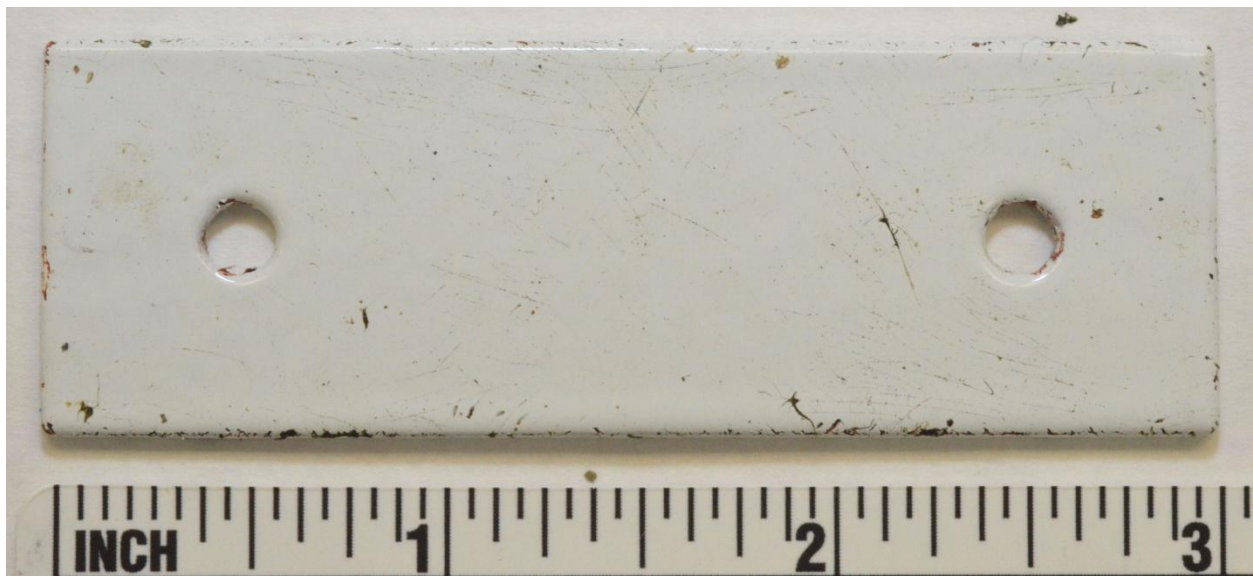
Figure 4 Photographs of duplex 2205 stainless steel with anti-biofouling coating coupon 3 (a) front and (b) back side after a 10 month corrosion test.

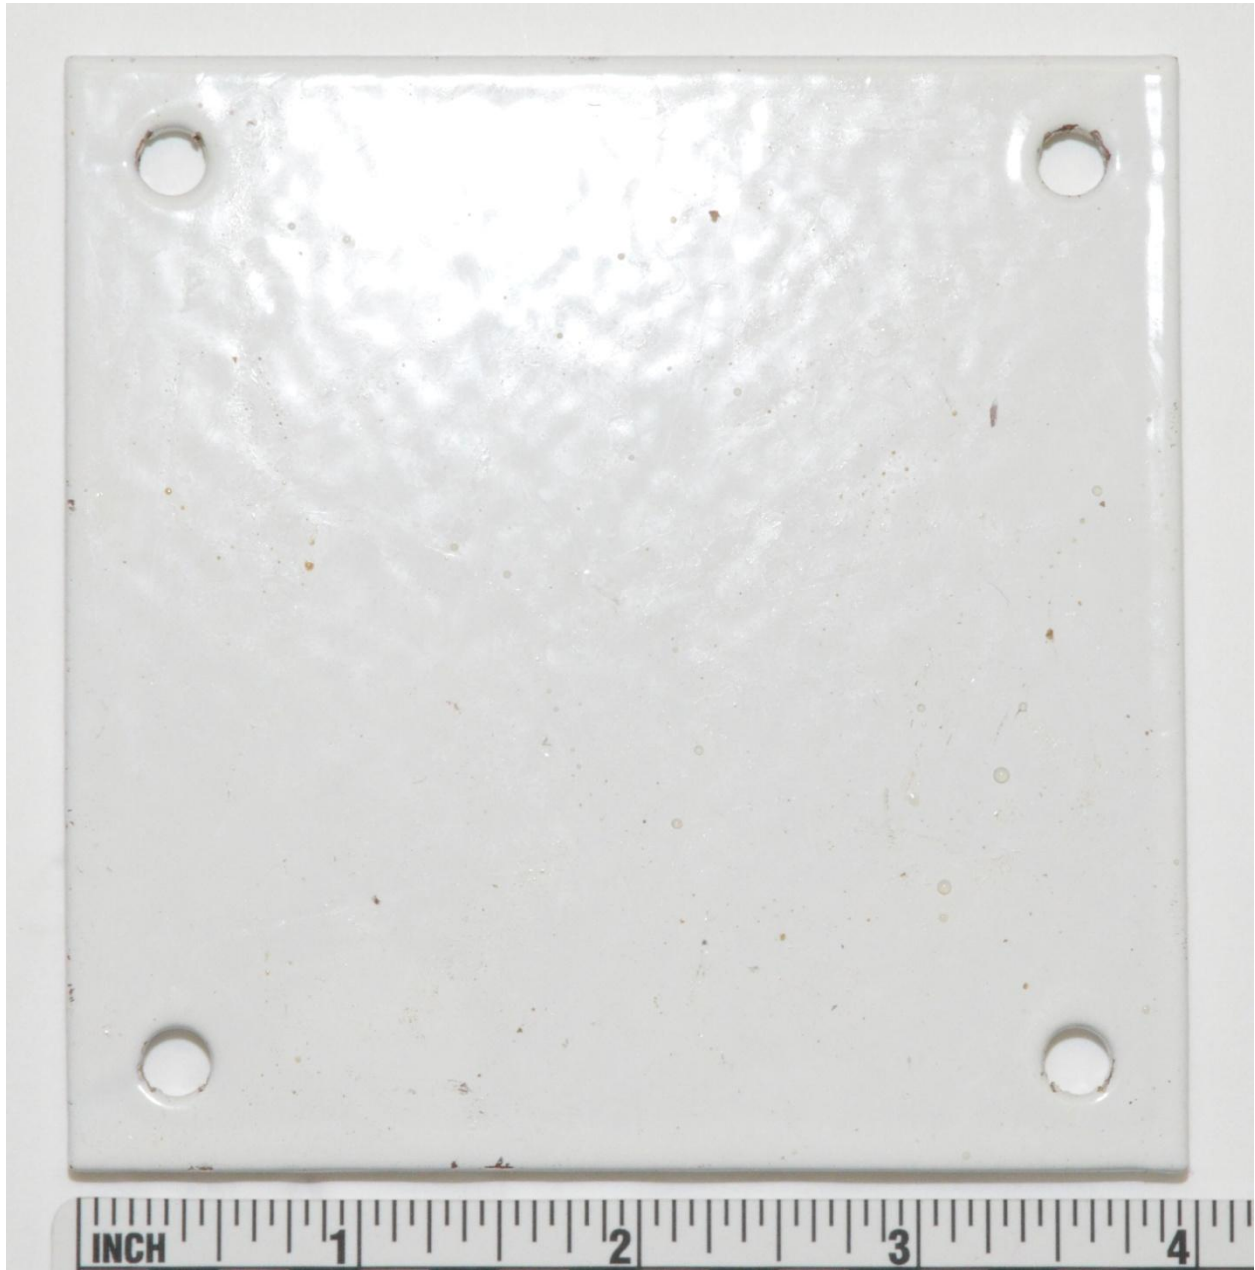
5. The plate, after 12 months of corrosion testing, had a mass loss of 0.21 grams and a corrosion rate of 0.001 mm / year.

Figure 12 Photograph of duplex 2205 stainless steel with anti-biofouling coating plate after a 12 month corrosion test.

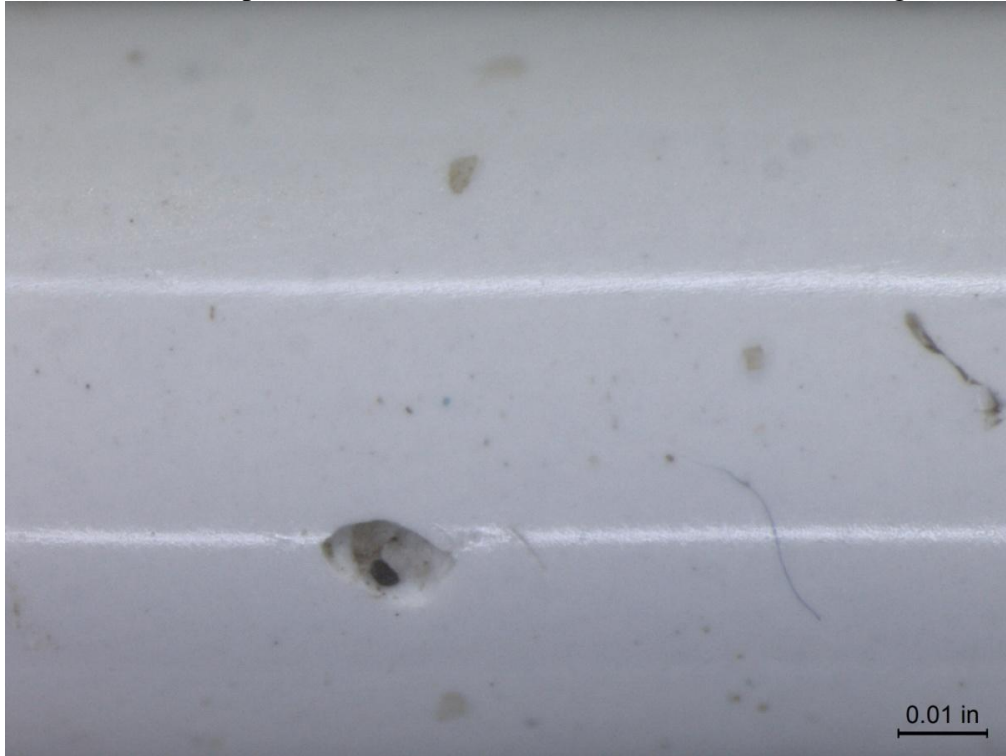
(a) Coated Duplex 2205 Stainless Steel Screen 1, Before Cleaning 10X

(b) Coated Duplex 2205 Stainless Steel Screen 1, Before Cleaning 50X

Figure 23 Optical macrographs of duplex 2205 stainless steel with anti-biofouling coating screen 1 after a 3 month corrosion test, before cleaning.

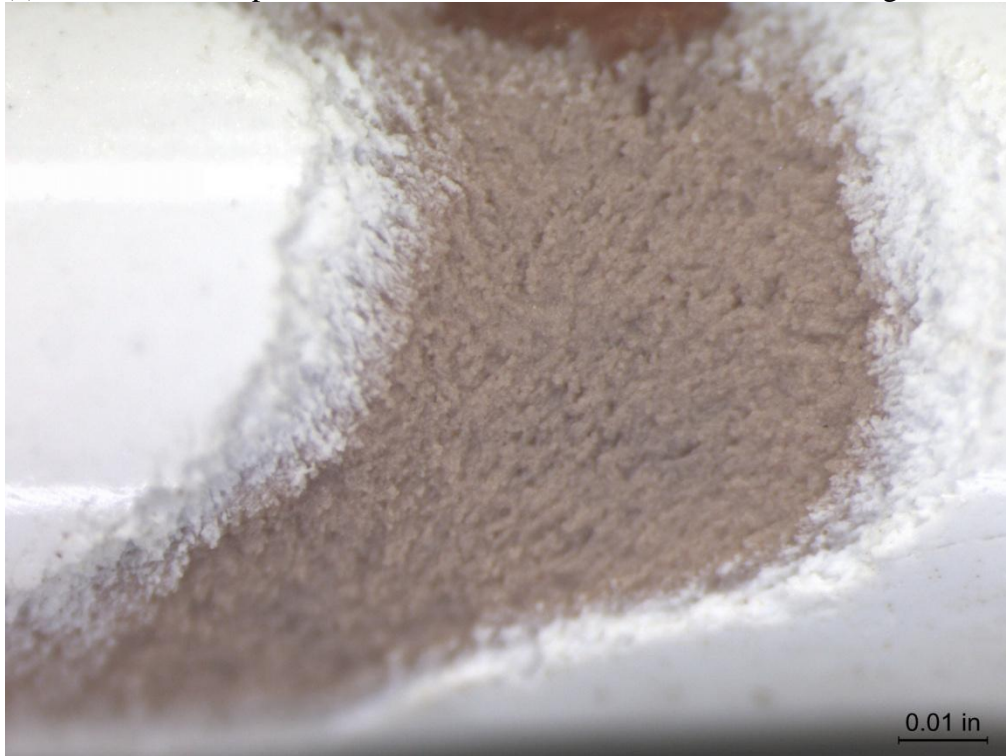
(a) Coated Duplex 2205 Stainless Steel Screen 2, After Cleaning 10X

(b) Coated Duplex 2205 Stainless Steel Screen 2, After Cleaning 50X

Figure 26 Optical macrographs of duplex 2205 stainless steel with anti-biofouling coating screen 2 after a 6 month corrosion test, after cleaning.

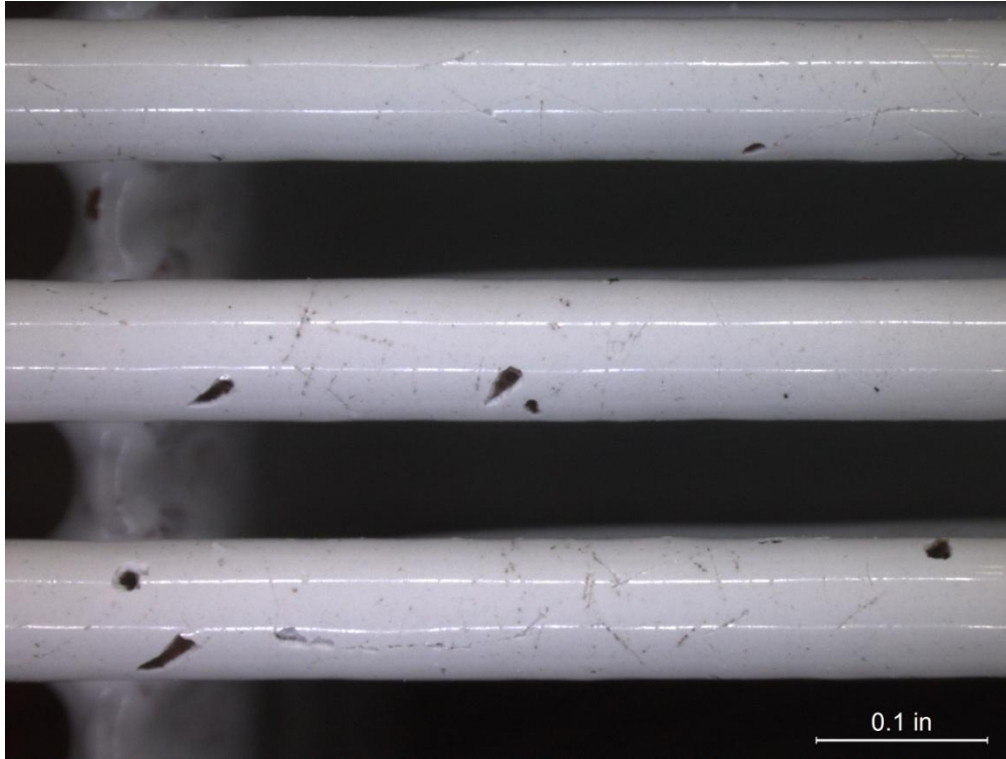
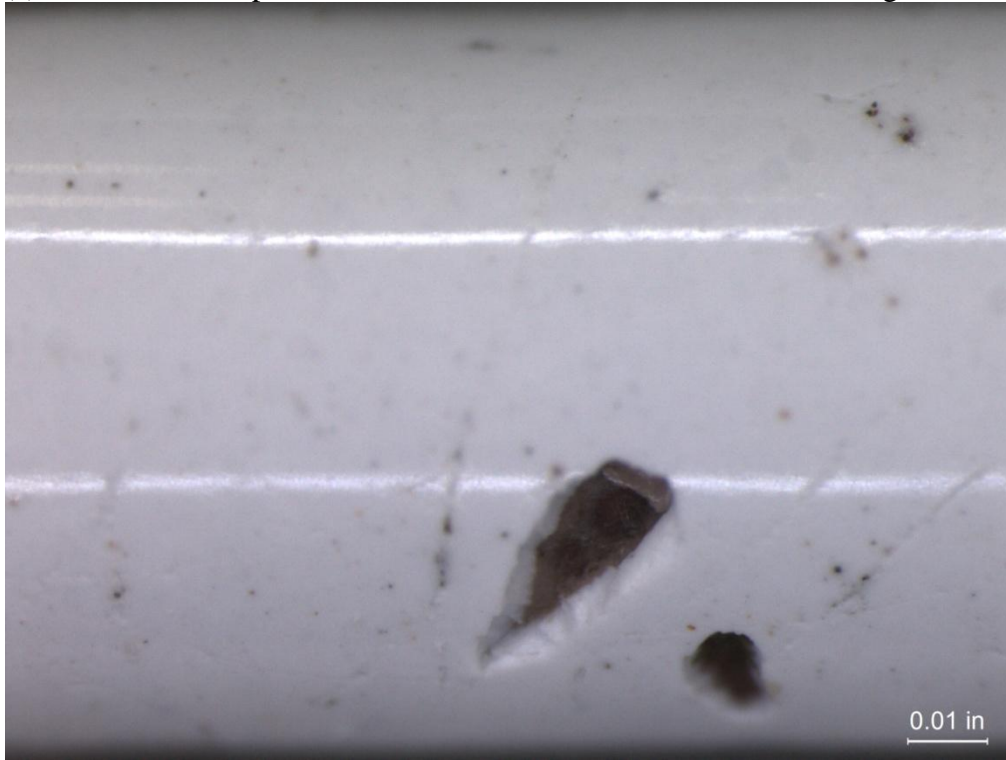
(a) Coated Duplex 2205 Stainless Steel Screen 3, After Cleaning 10X

(b) Coated Duplex 2205 Stainless Steel Screen 3, After Cleaning 50X

Figure 28 Optical macrographs of duplex 2205 stainless steel with anti-biofouling coating screen 3 after a 10 month corrosion test, after cleaning.

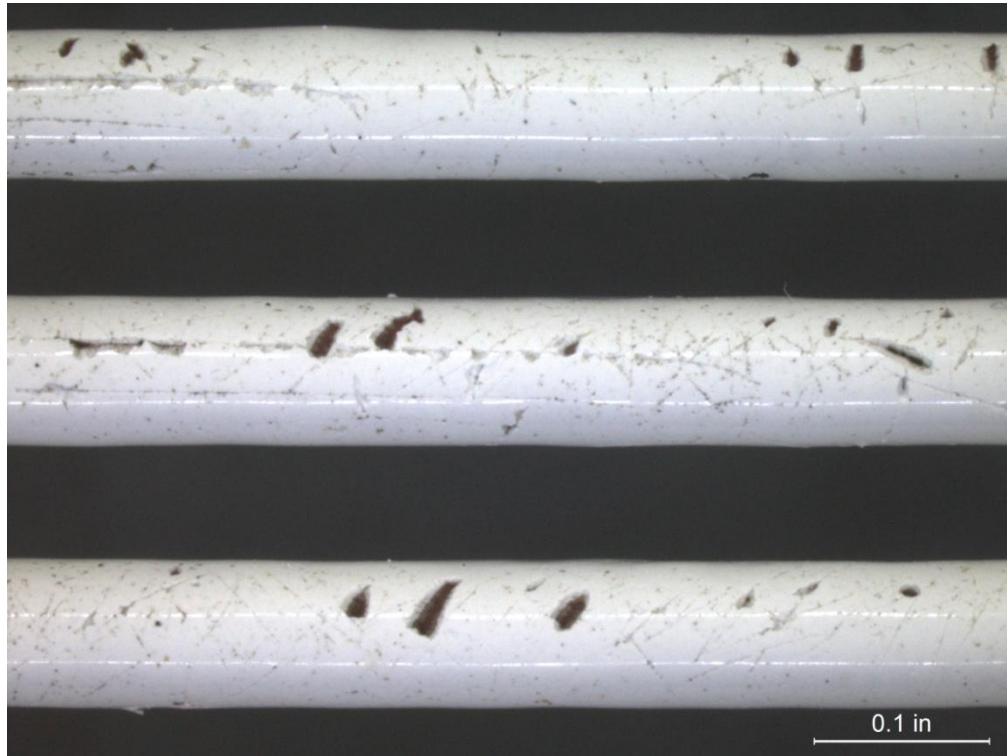
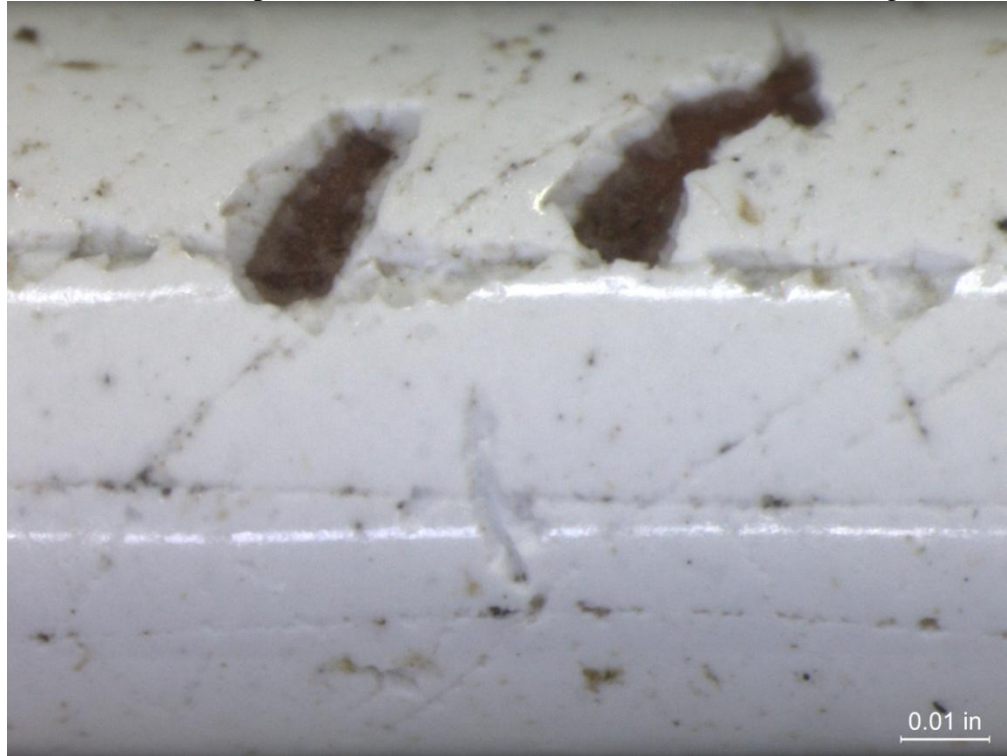
(a) Coated Duplex 2205 Stainless Steel Screen 4, After Cleaning 10X

(b) Coated Duplex 2205 Stainless Steel Screen 4, After Cleaning 50X

Figure 30 Optical macrographs of duplex 2205 stainless steel with anti-biofouling coating screen 4 after a 12 month corrosion test, after cleaning.

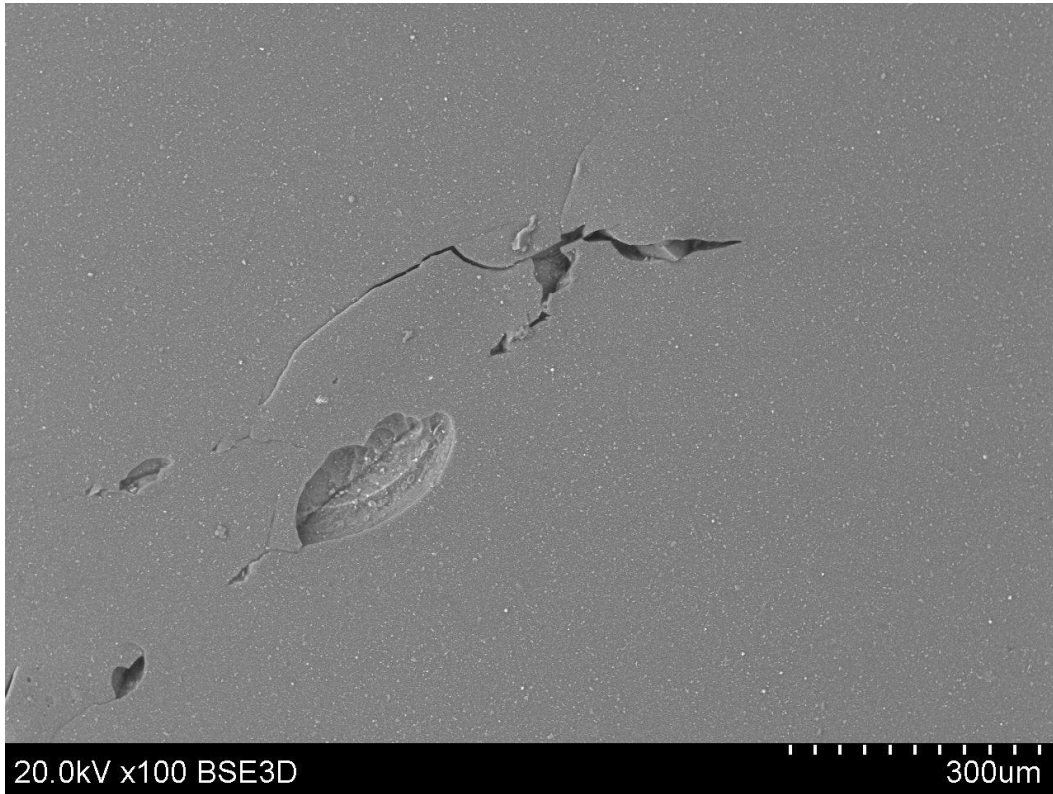
(a) Coated Duplex 2205 Stainless Steel Coupon 4, Before Cleaning 100X

(b) Coated Duplex 2205 Stainless Steel Coupon 4, Before Cleaning 500X

Figure 46 Scanning electron micrographs of duplex 2205 stainless steel with anti-biofouling coating coupon 4 after a 12 month corrosion test, before cleaning.

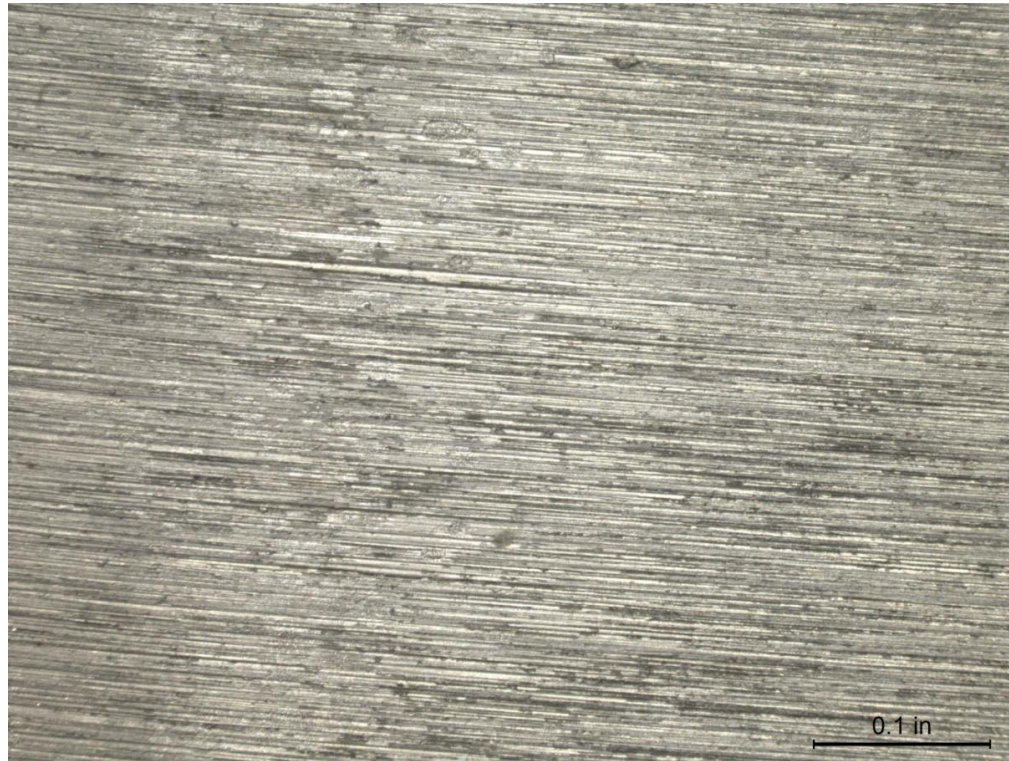
Figure 15 Optical macrographs of CDA 715 coupon 1 after a 3 month corrosion test, after cleaning.

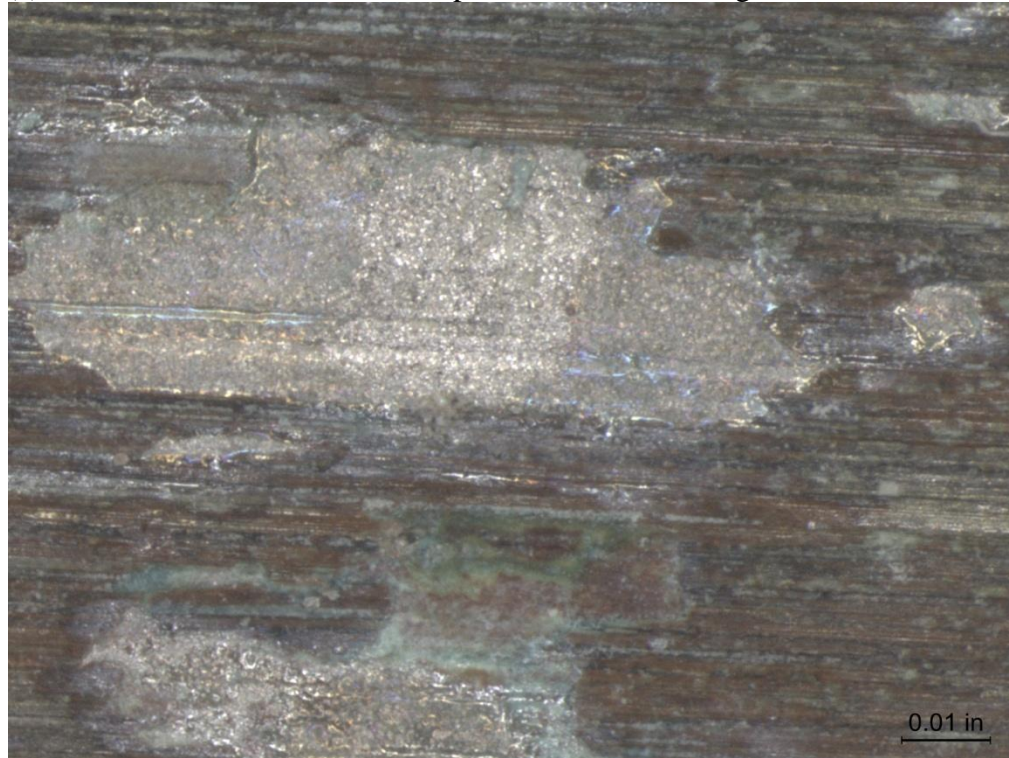
Figure 16 Optical macrographs of CDA 715 coupon 2 after a 6 month corrosion test, before cleaning.

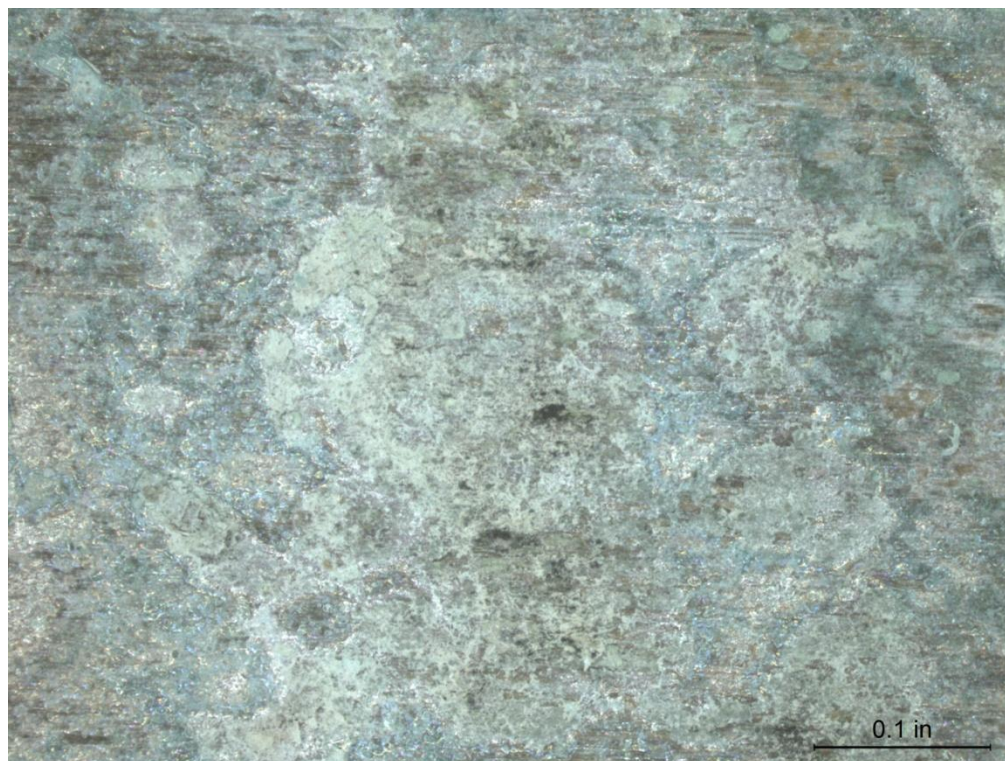
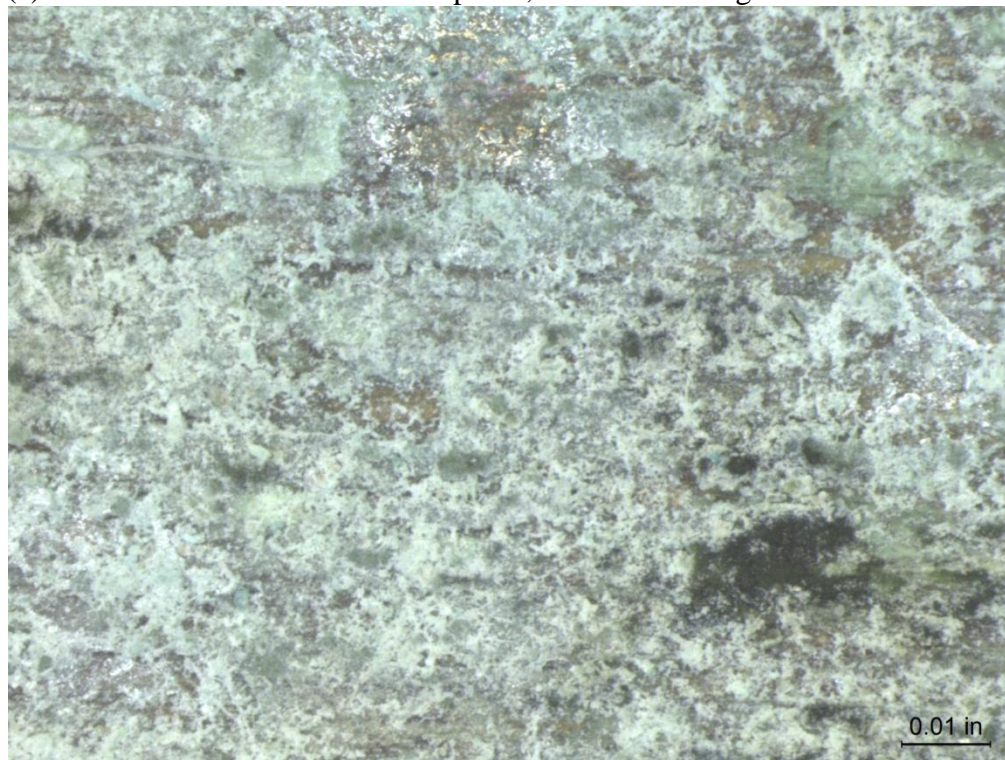
Figure 20 Optical macrographs of CDA 715 coupon 4 after a 12 month corrosion test, before cleaning.

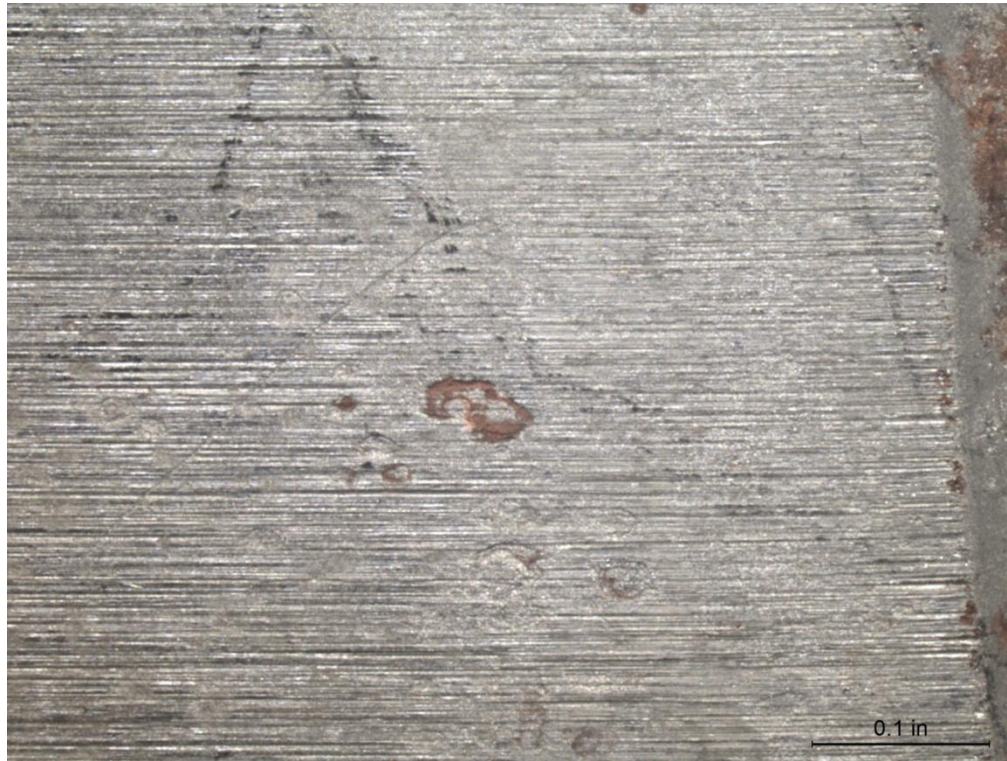
Figure 21 Optical macrographs of CDA 715 coupon 4 after a 12 month corrosion test, after cleaning.

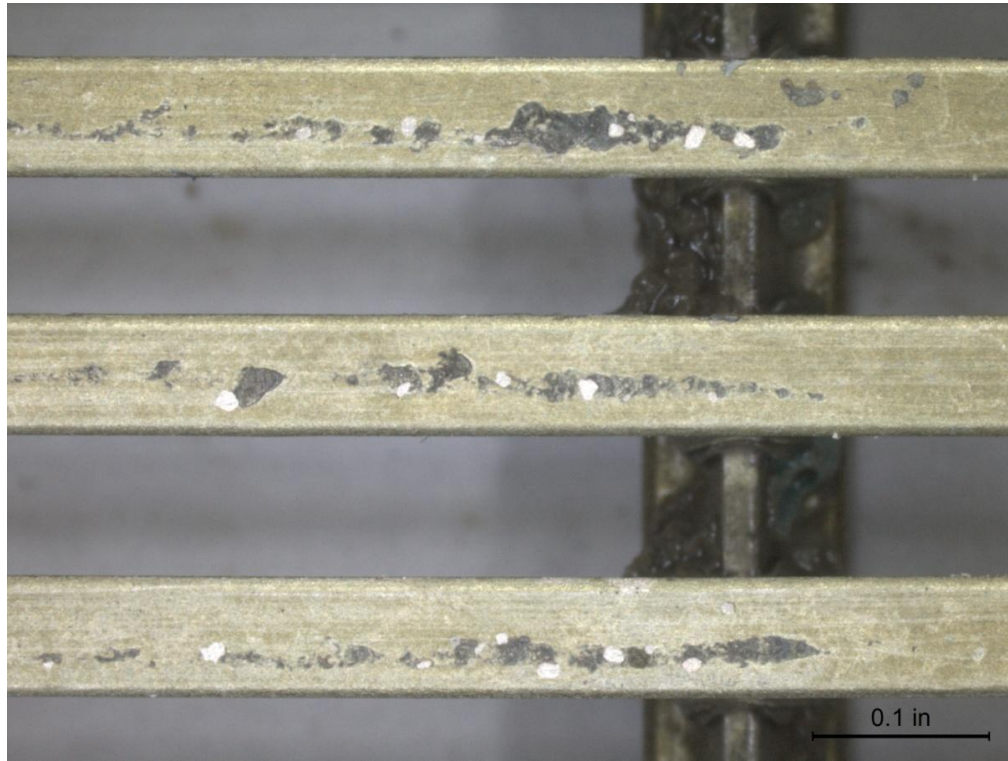
Figure 23 Optical macrographs of CDA 715 screen 1 after a 3 month corrosion test, before cleaning.
