WEST BASIN MUNICIPAL WATER DISTRICT OCEAN WATER DESALINATION INTAKE CORROSION STUDY

November 2014

V&A Project No.: 13-0376

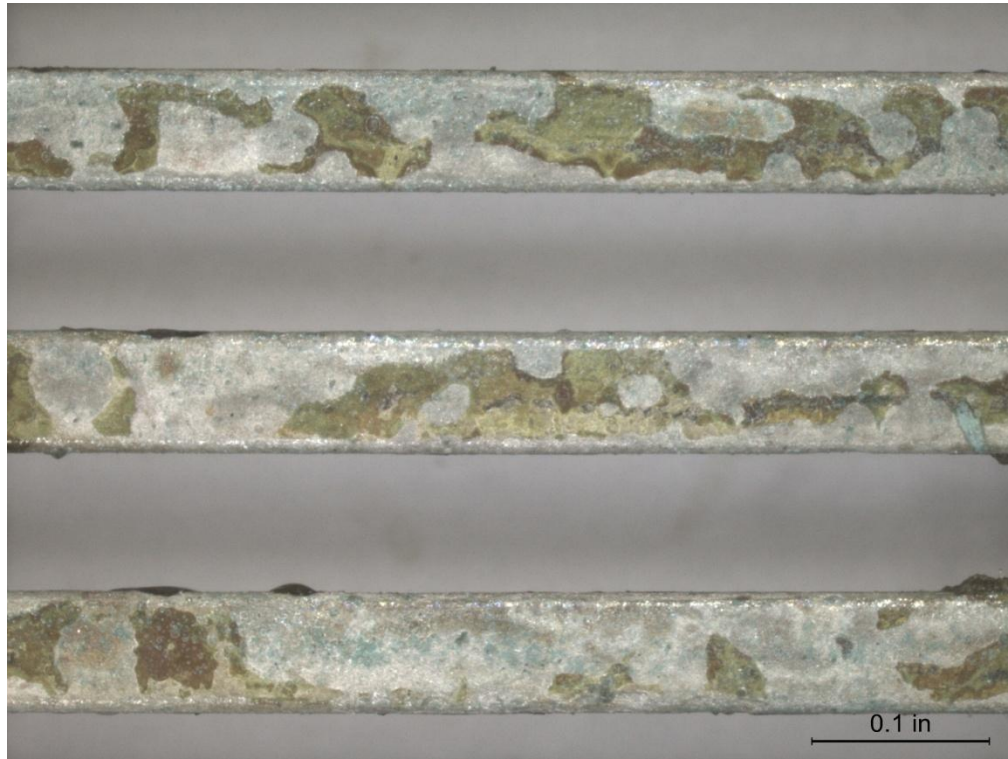
Figure 25 Optical macrographs of CDA 715 screen 2 after a 6 month corrosion test, before cleaning.

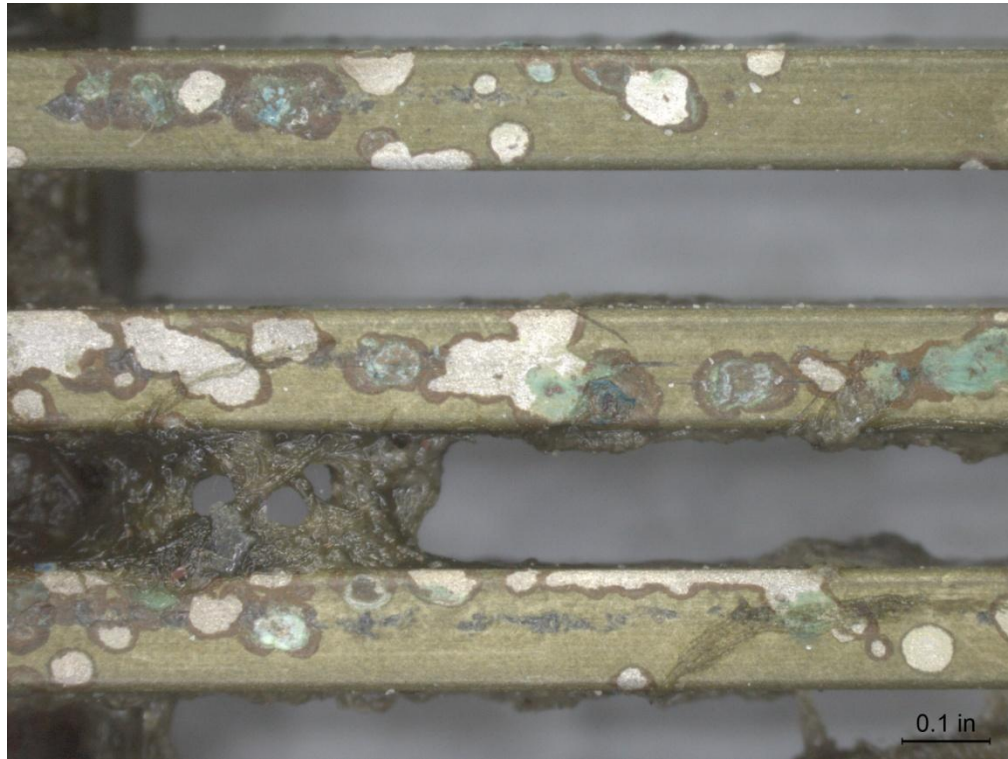
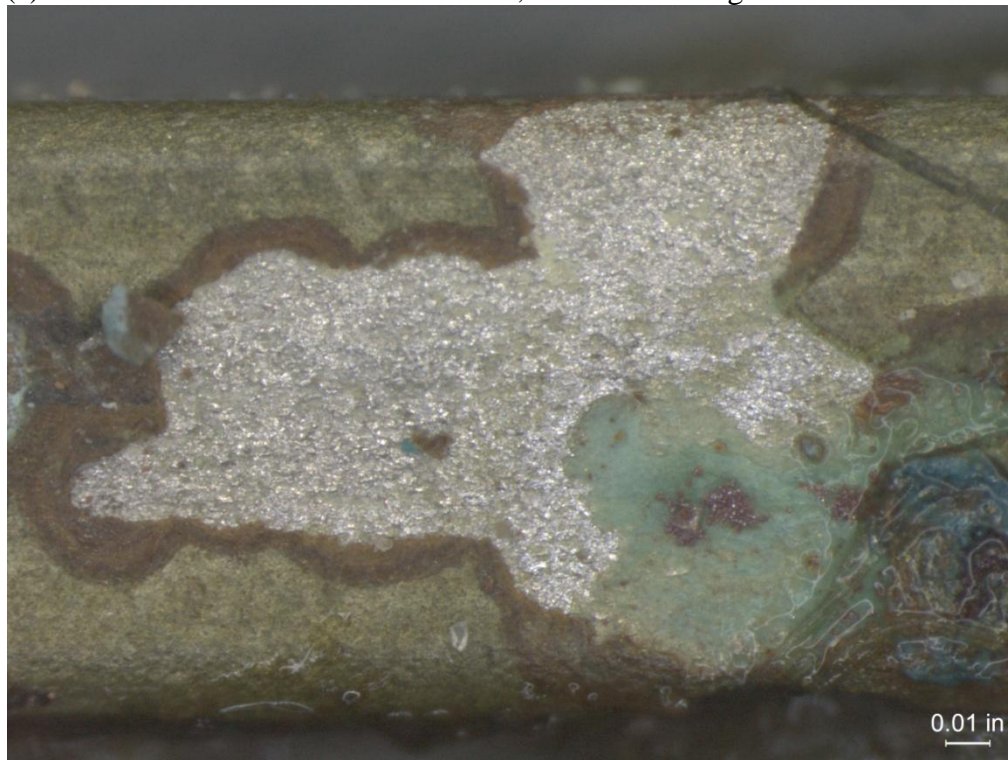
Figure 27 Optical macrographs of CDA 715 screen 3 after a 10 month corrosion test, before cleaning.

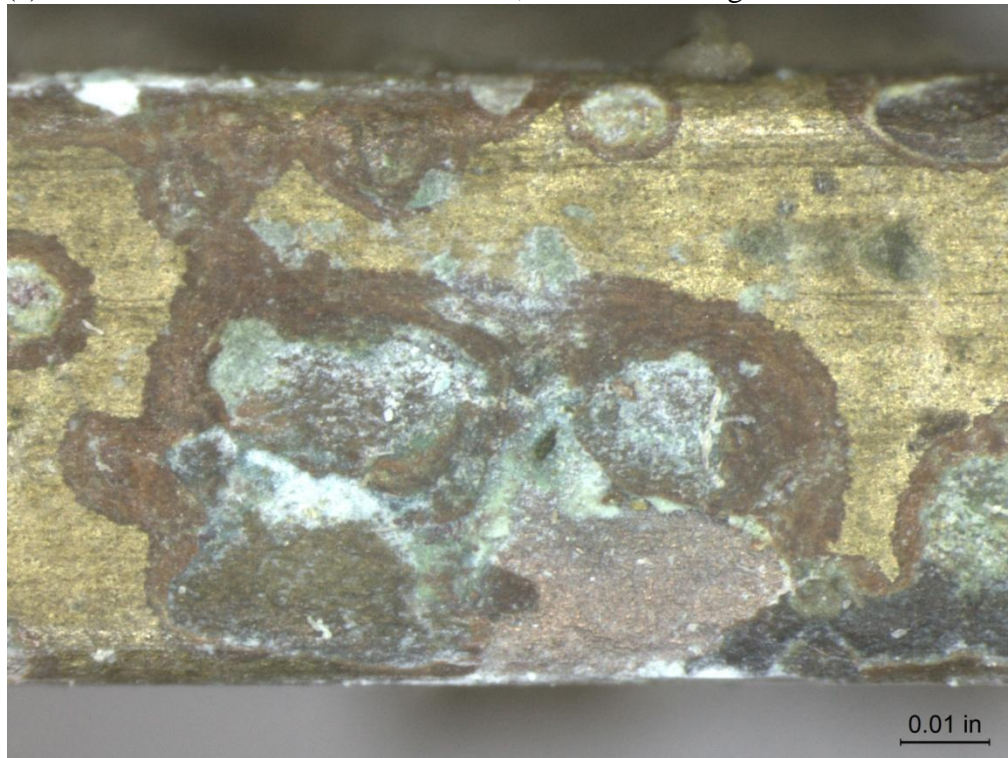
(b) CDA 715 Screen 4, Before Cleaning 50X

Figure 29 Optical macrographs of CDA 715 screen 4 after a 12 month corrosion test, before cleaning.

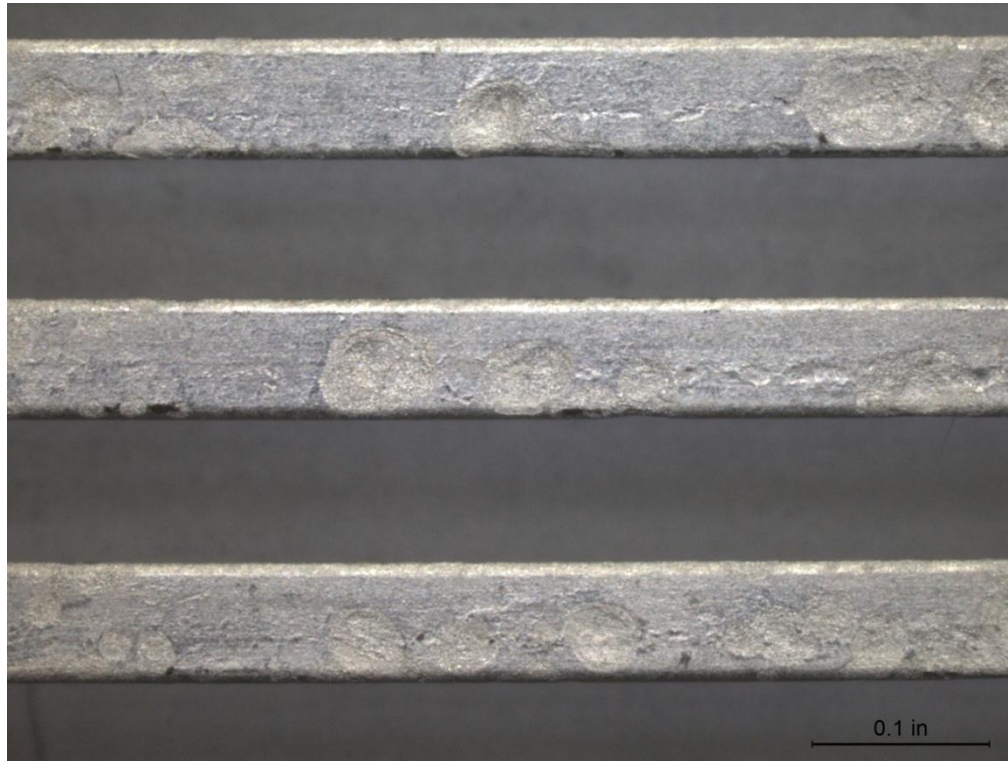
(a) CDA 715 Plate 4, After Cleaning 10X

(b) CDA 715 Screen 4, After Cleaning 50X

Figure 30 Optical macrographs of CDA 715 screen 4 after a 12 month corrosion test, after cleaning.

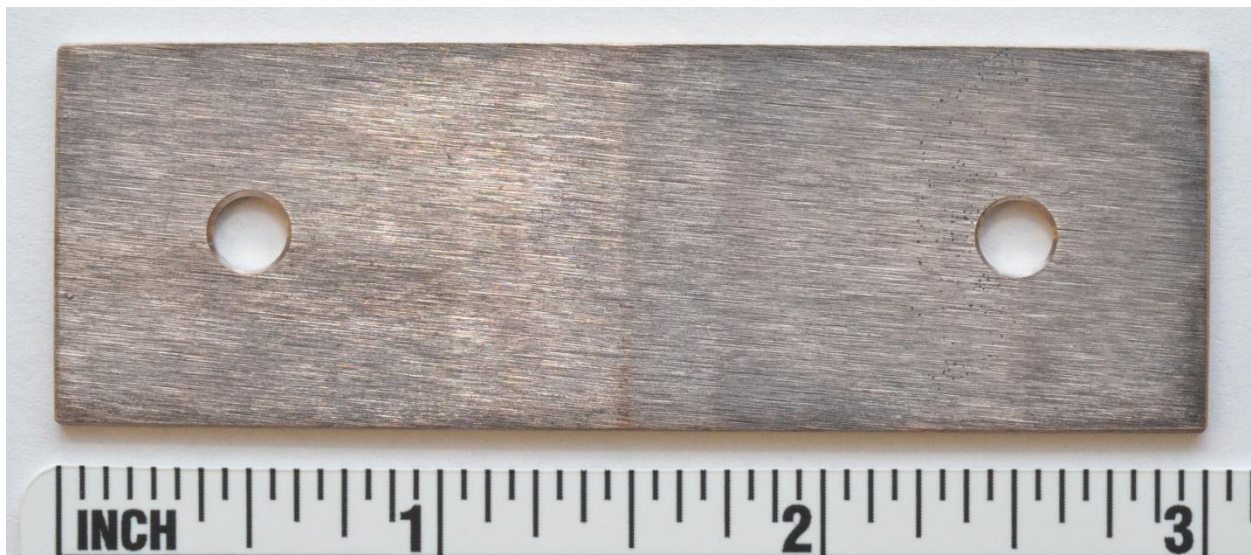
(a) CDA 706 Baseline Coupon, Front Side

(b) CDA 706 Baseline Coupon, Back Side

Figure 1 Photographs of the CDA 706 baseline coupon (a) front and (b) back side.

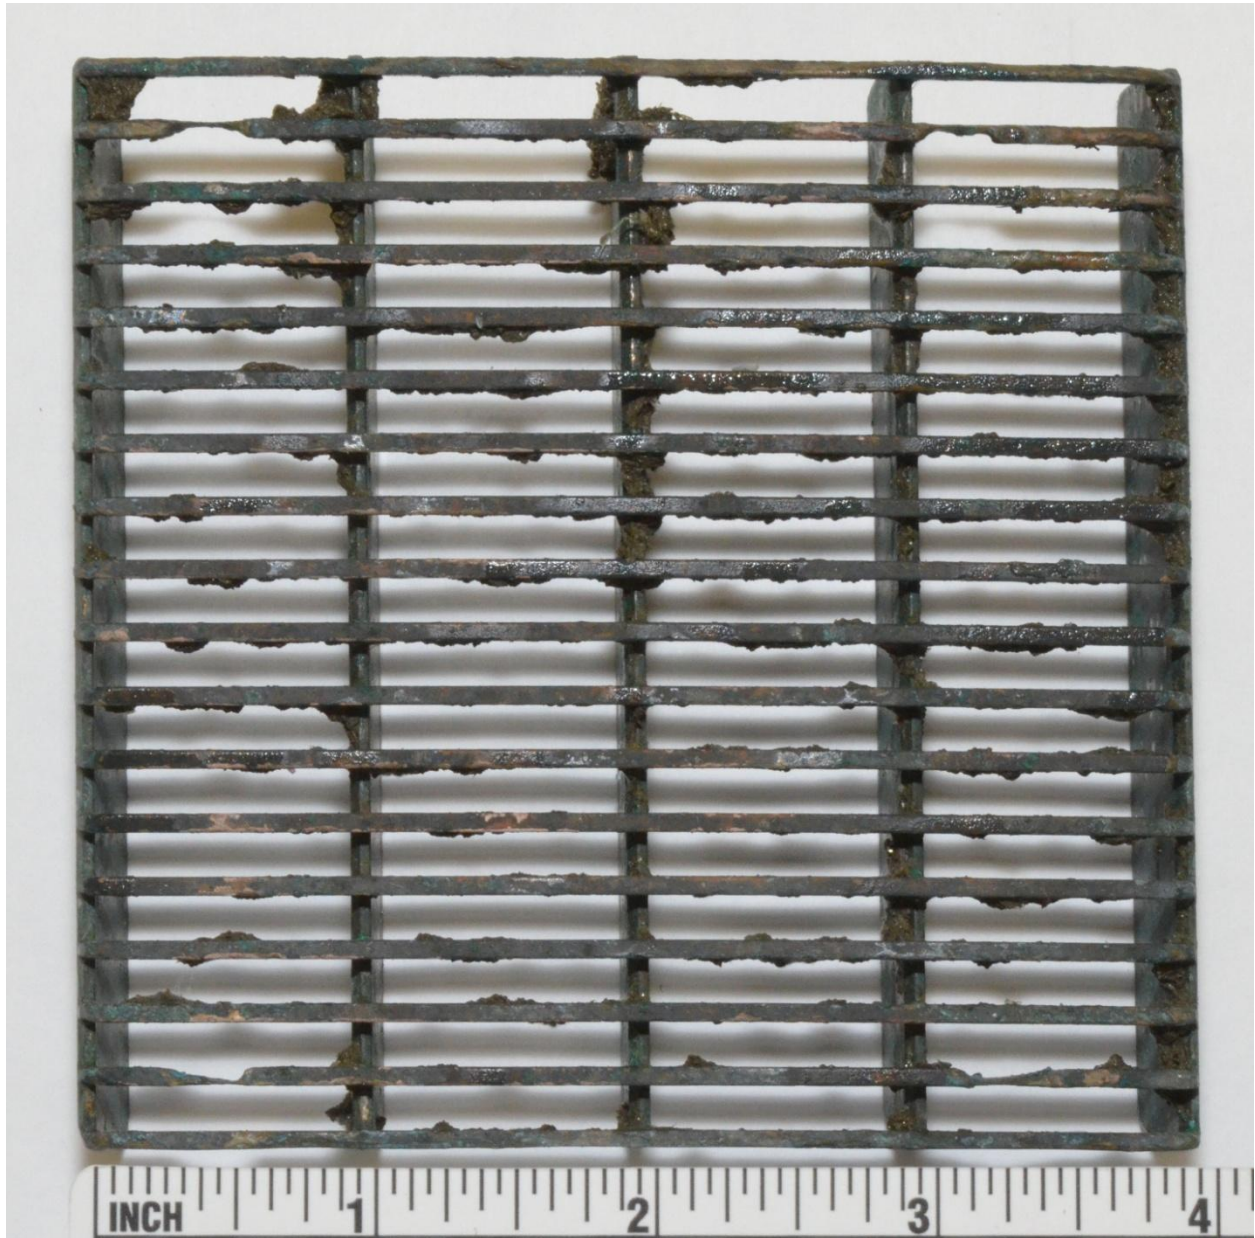
CDA 706 Screen 4

Figure 10 Photograph of CDA 706 screen 4 after a 12 month corrosion test.

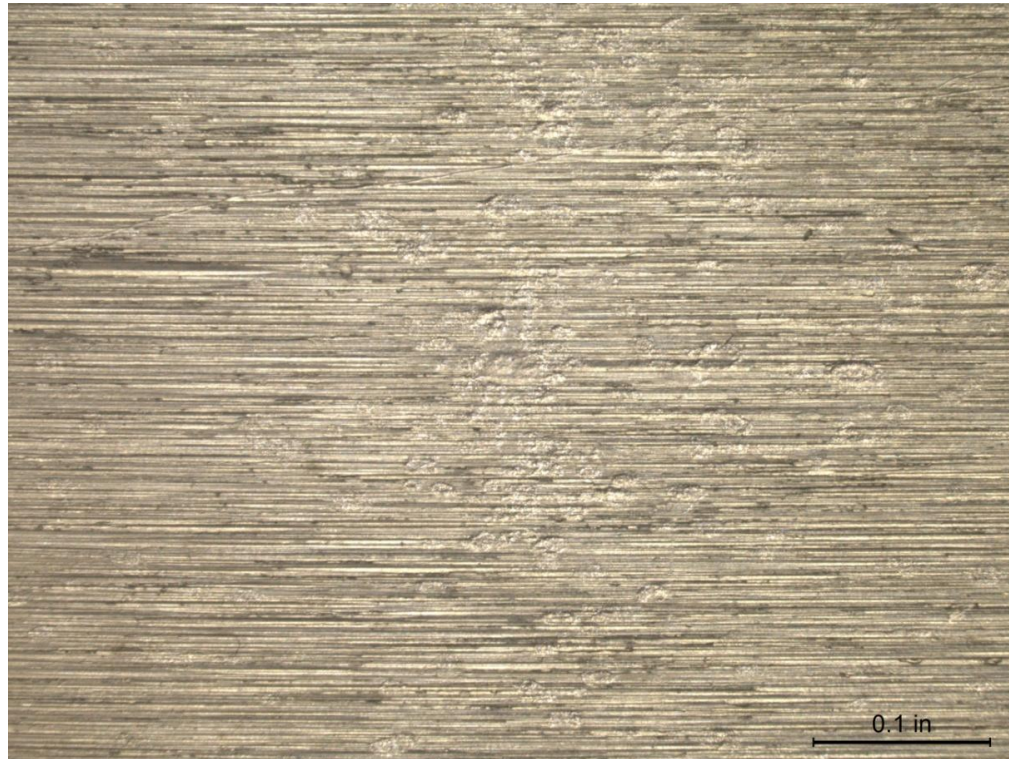
Figure 15 Optical macrographs of CDA 706 coupon 1 after a 3 month corrosion test, after cleaning.

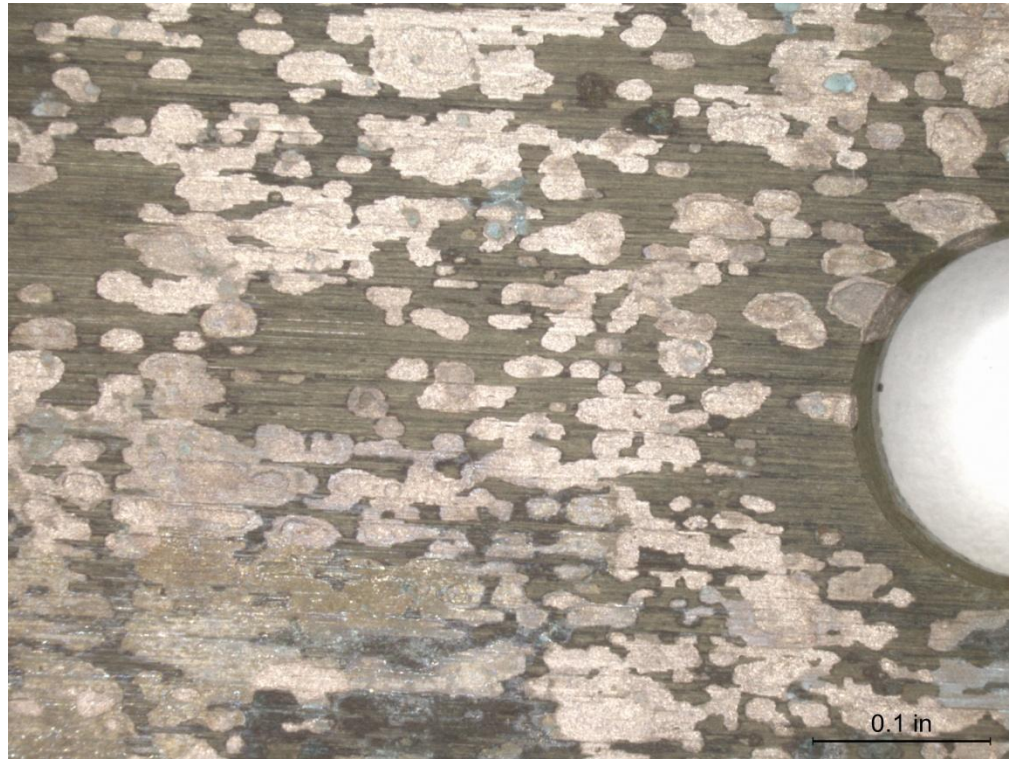
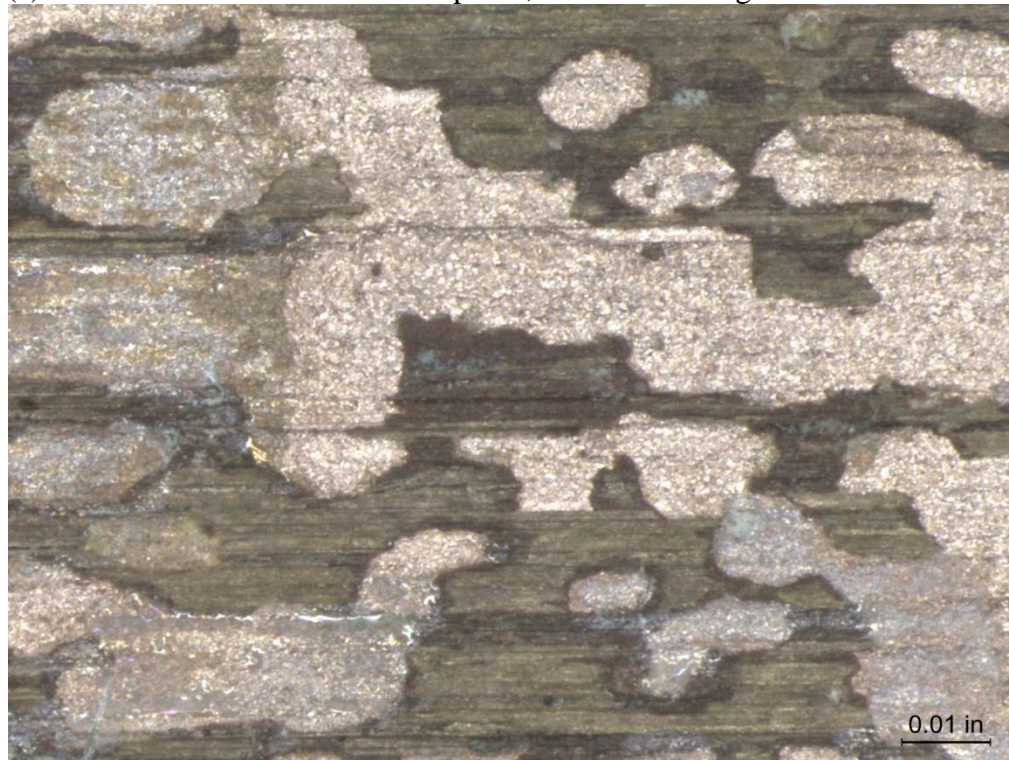
Figure 16 Optical macrographs of CDA 706 coupon 2 after a 6 month corrosion test, before cleaning.

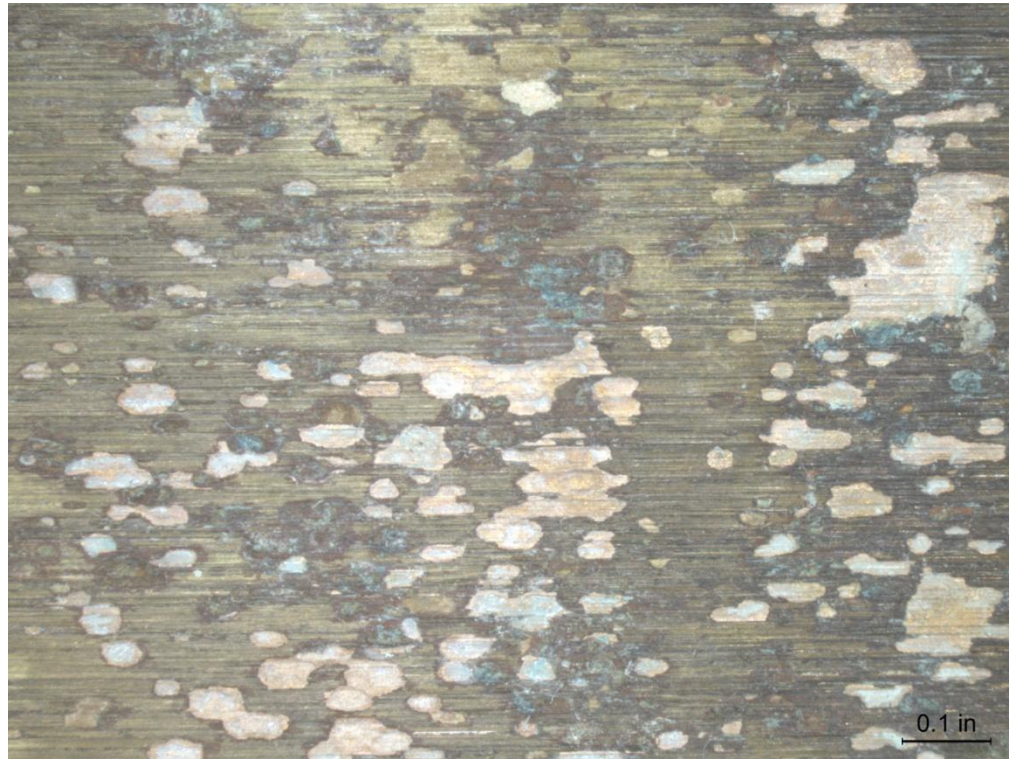
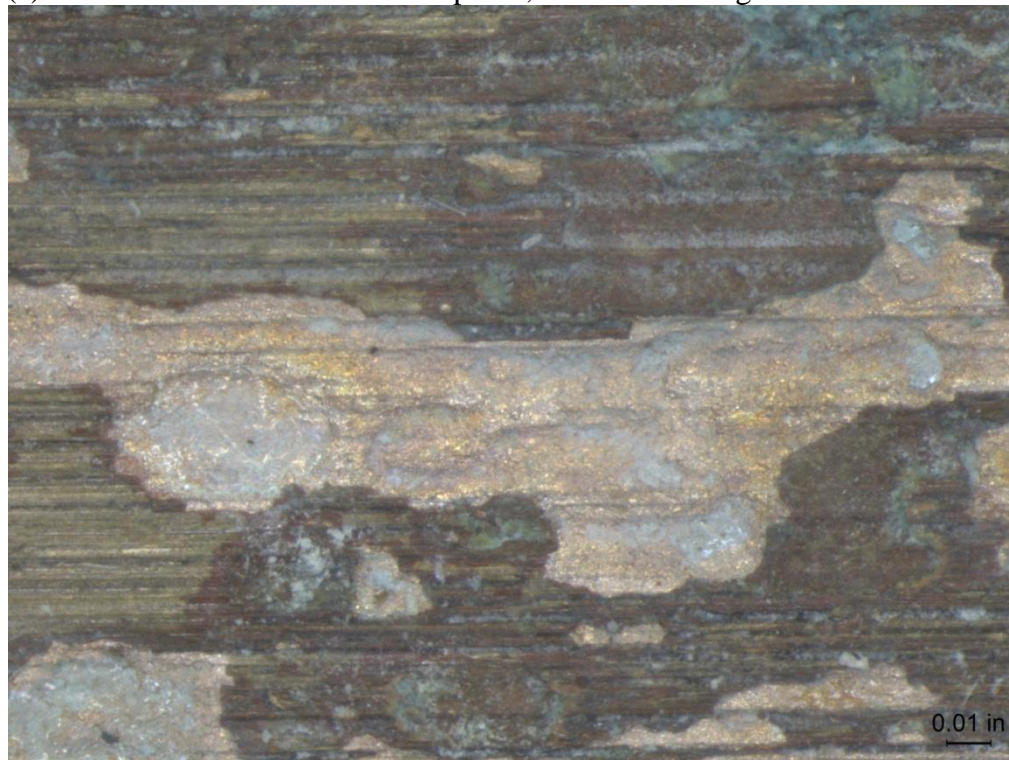
Figure 18 Optical macrographs of CDA 706 coupon 3 after a 10 month corrosion test, before cleaning.

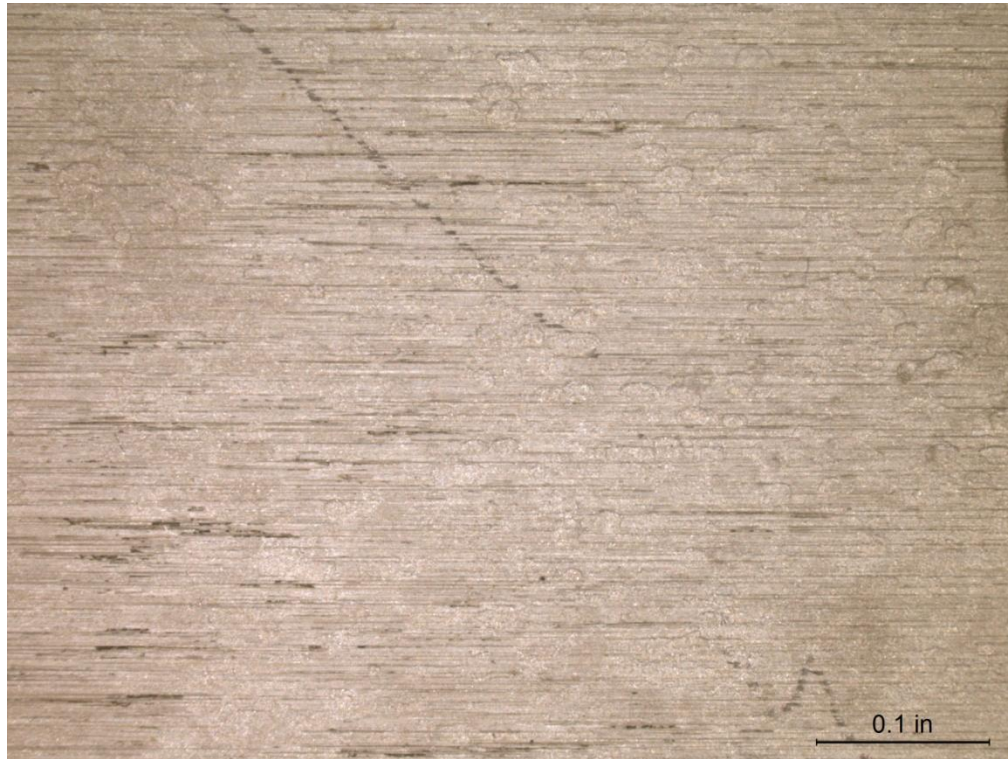
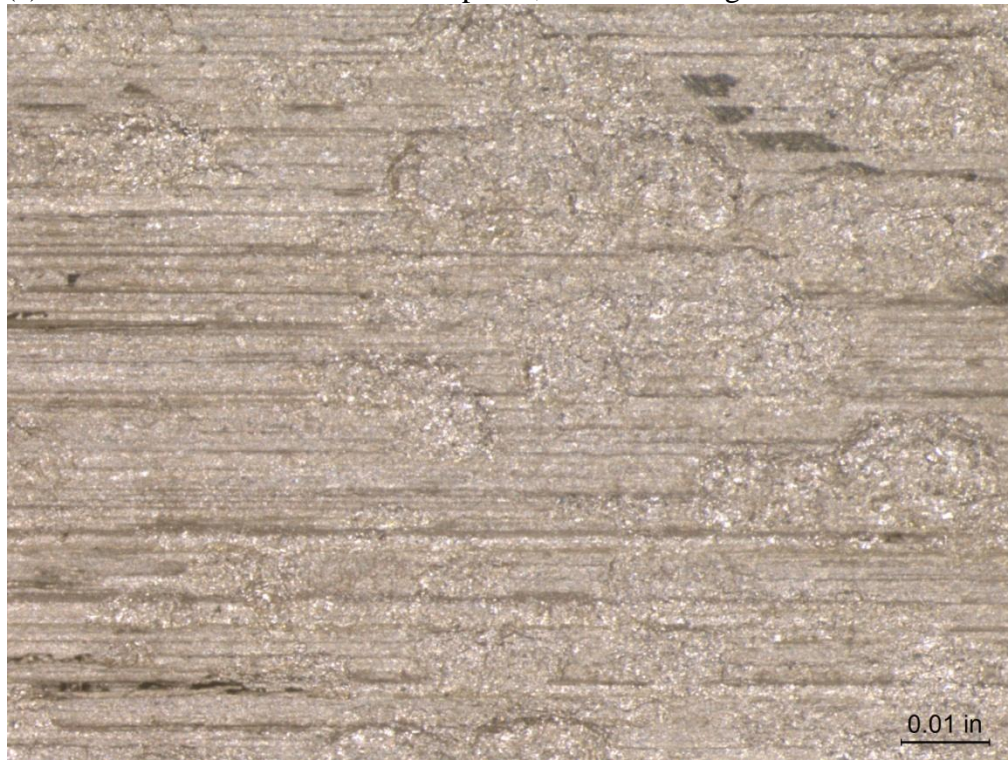
Figure 19 Optical macrographs of CDA 706 coupon 3 after a 10 month corrosion test, after cleaning.

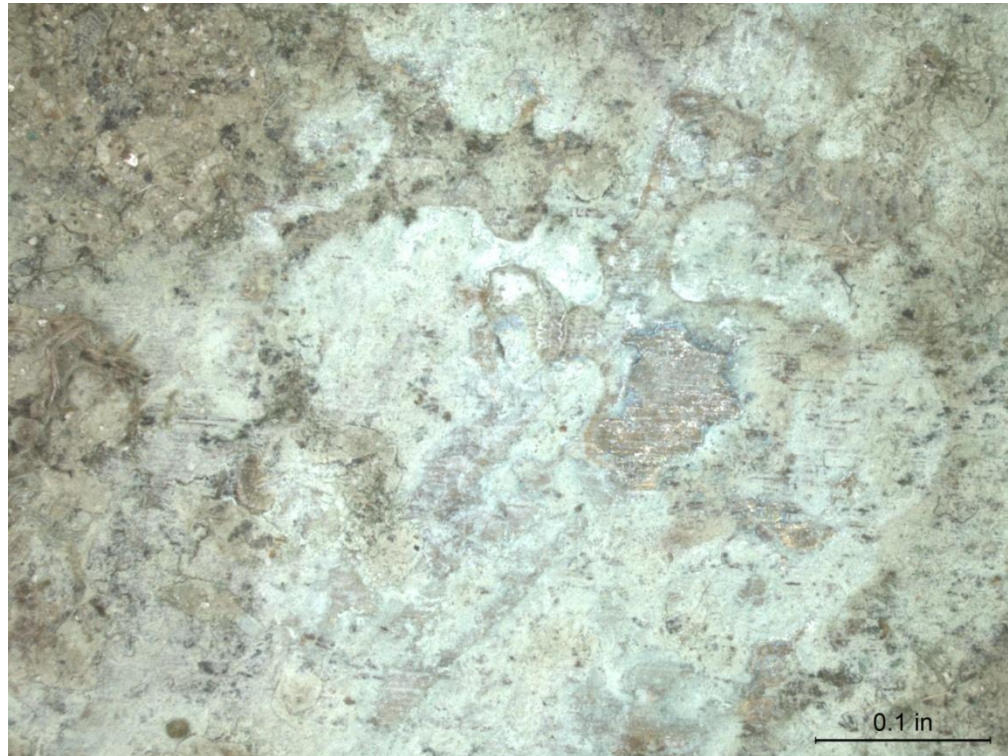
Figure 20 Optical macrographs of CDA 706 coupon 4 after a 12 month corrosion test, before cleaning.

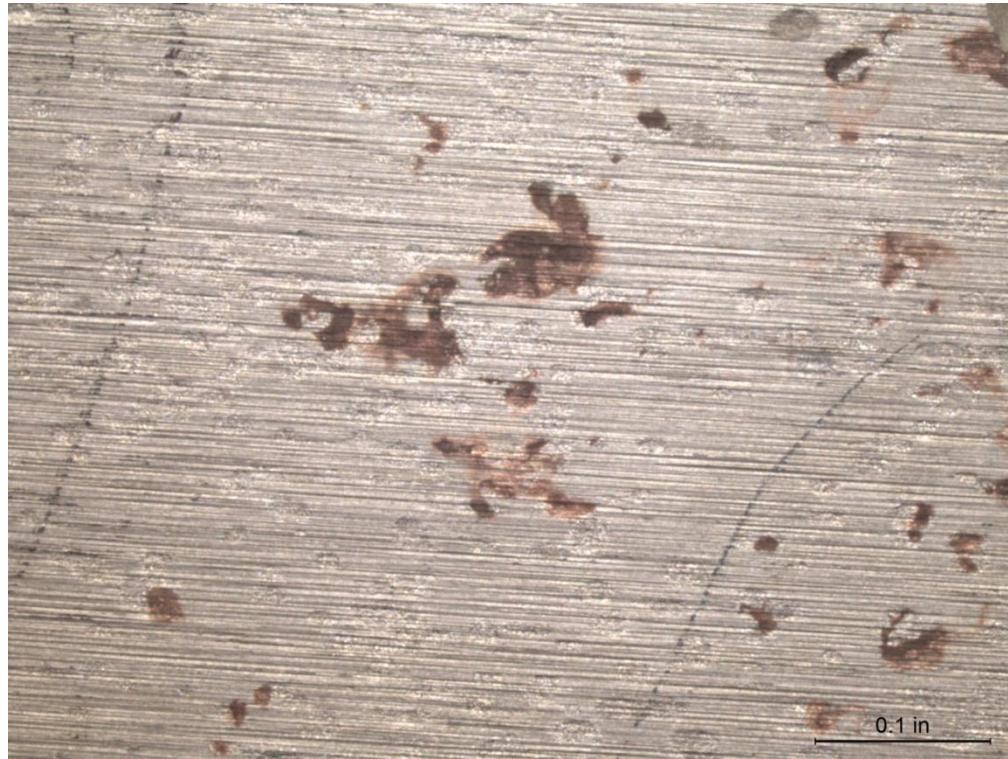
Figure 21 Optical macrographs of CDA 706 coupon 4 after a 12 month corrosion test, after cleaning.

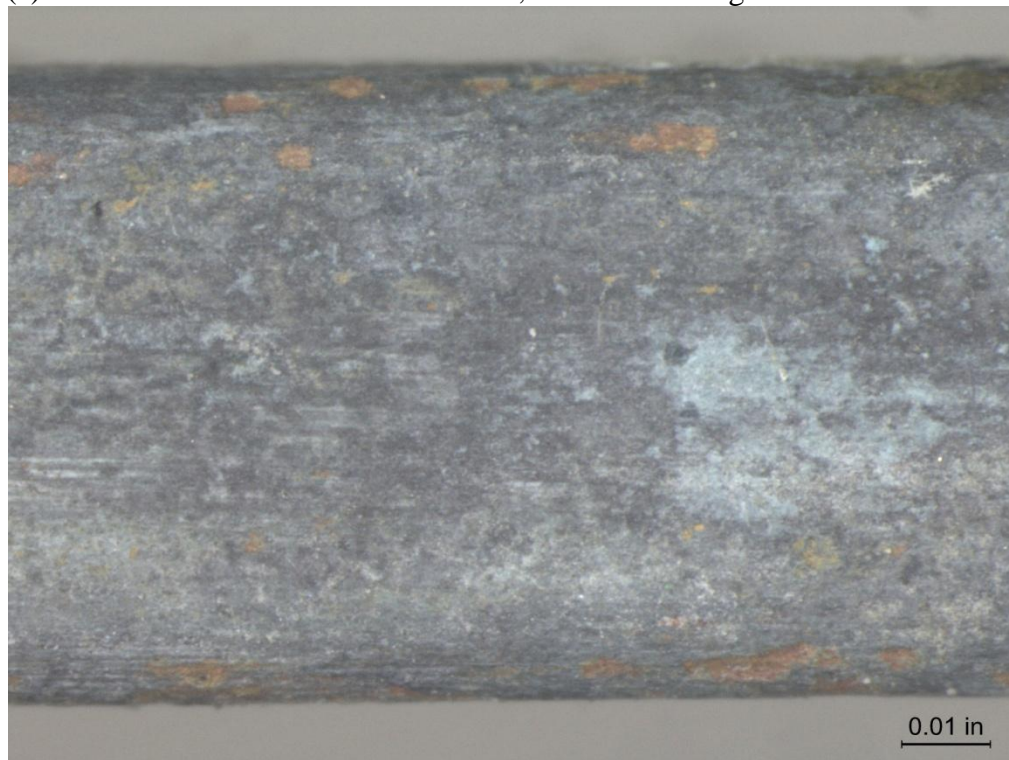
Figure 25 Optical macrographs of CDA 706 screen 2 after a 6 month corrosion test, before cleaning.

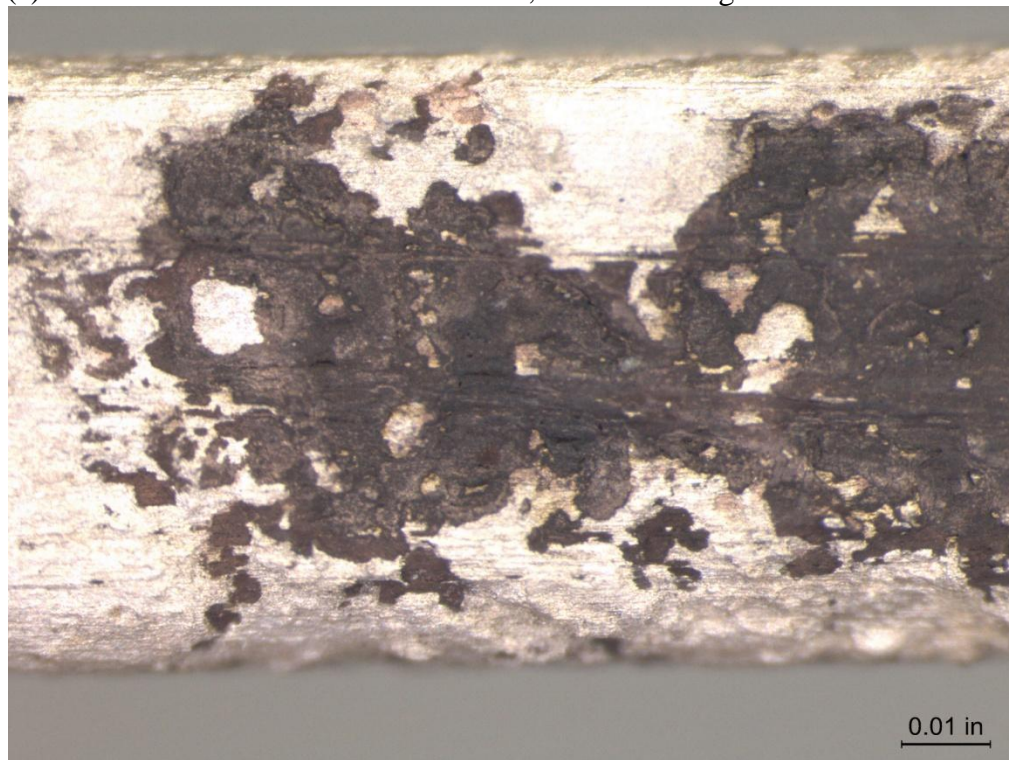
Figure 26 Optical macrographs of CDA 706 screen 2 after a 6 month corrosion test, after cleaning.

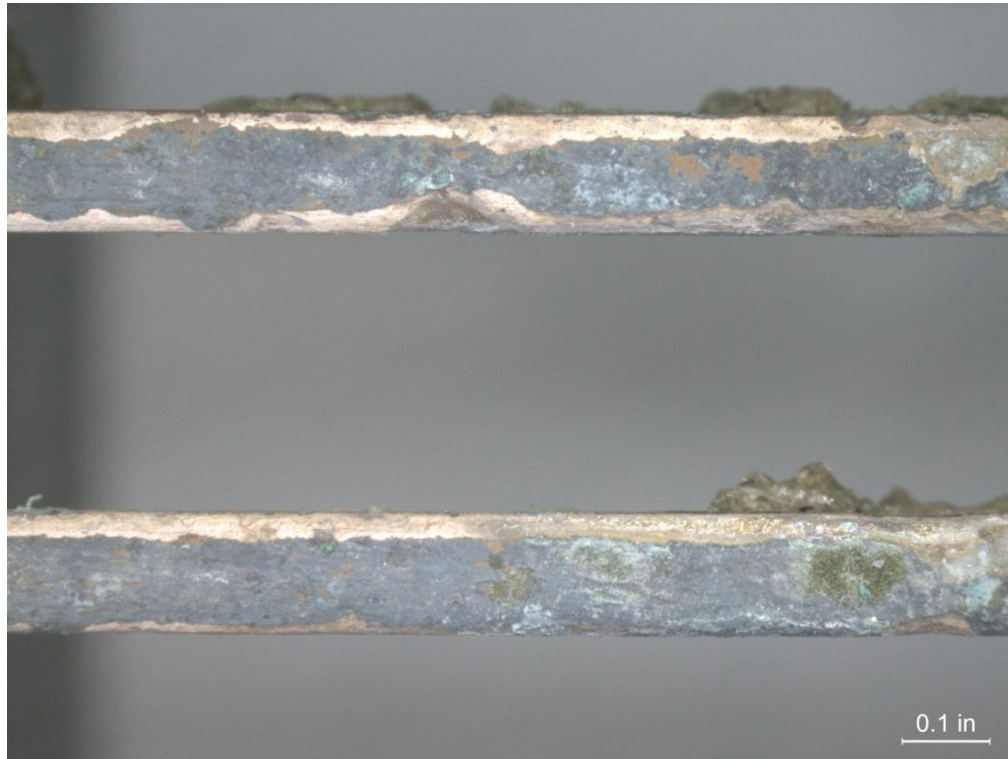
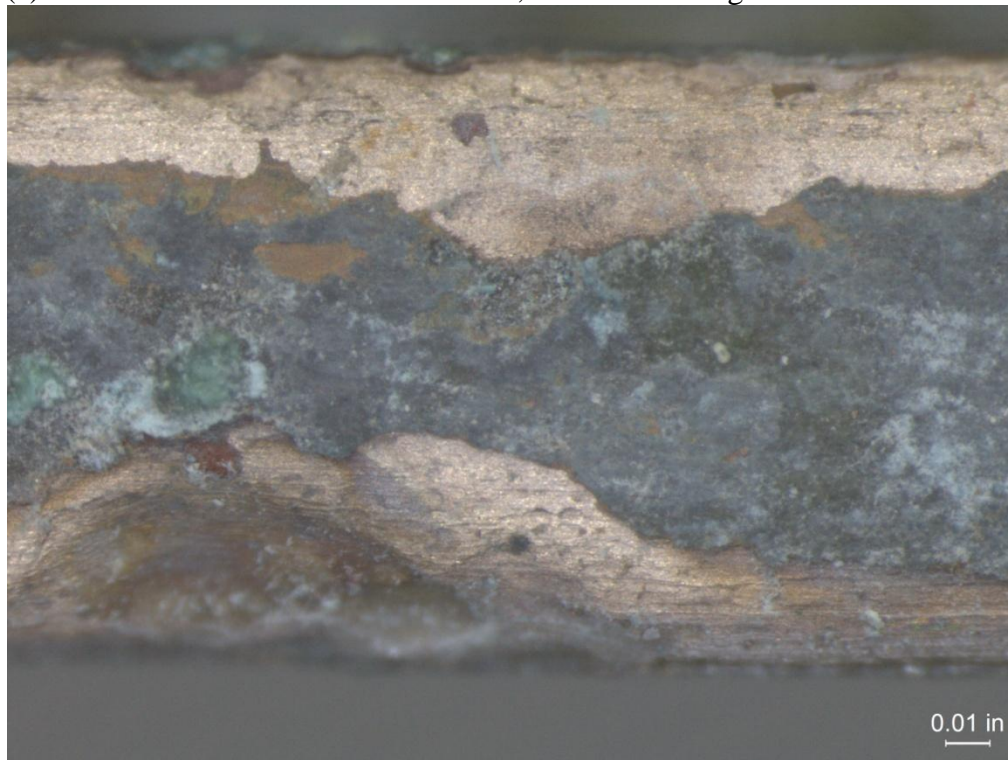
Figure 27 Optical macrographs of CDA 706 screen 3 after a 10 month corrosion test, before cleaning.

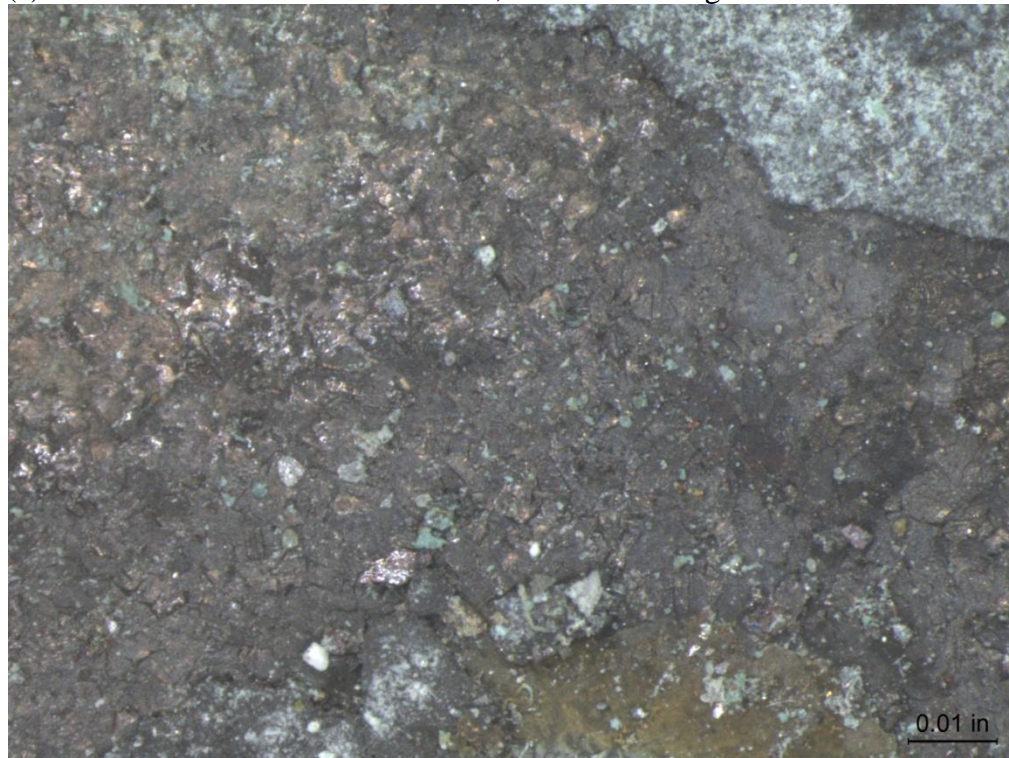
Figure 32 Optical macrographs of CDA 706 plate after a 12 month corrosion test, before cleaning.

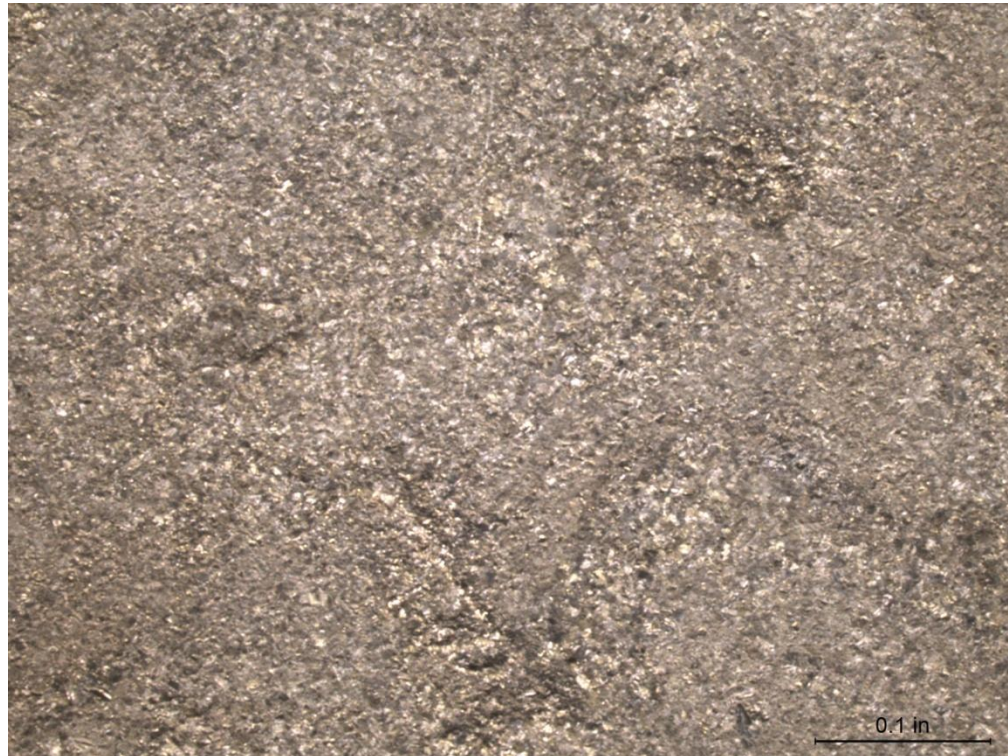
Figure 33 Optical macrographs of CDA 706 plate after a 12 month corrosion test, after cleaning.

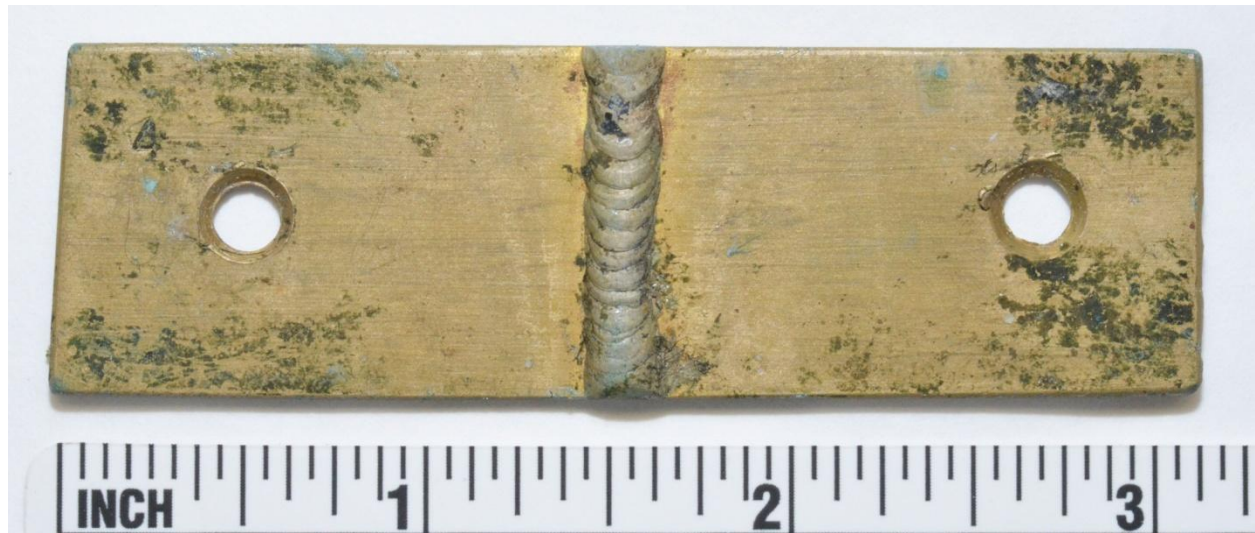
Figure 5 Photographs of Z-Alloy coupon 4 (a) front and (b) back side after a 12 month corrosion test.

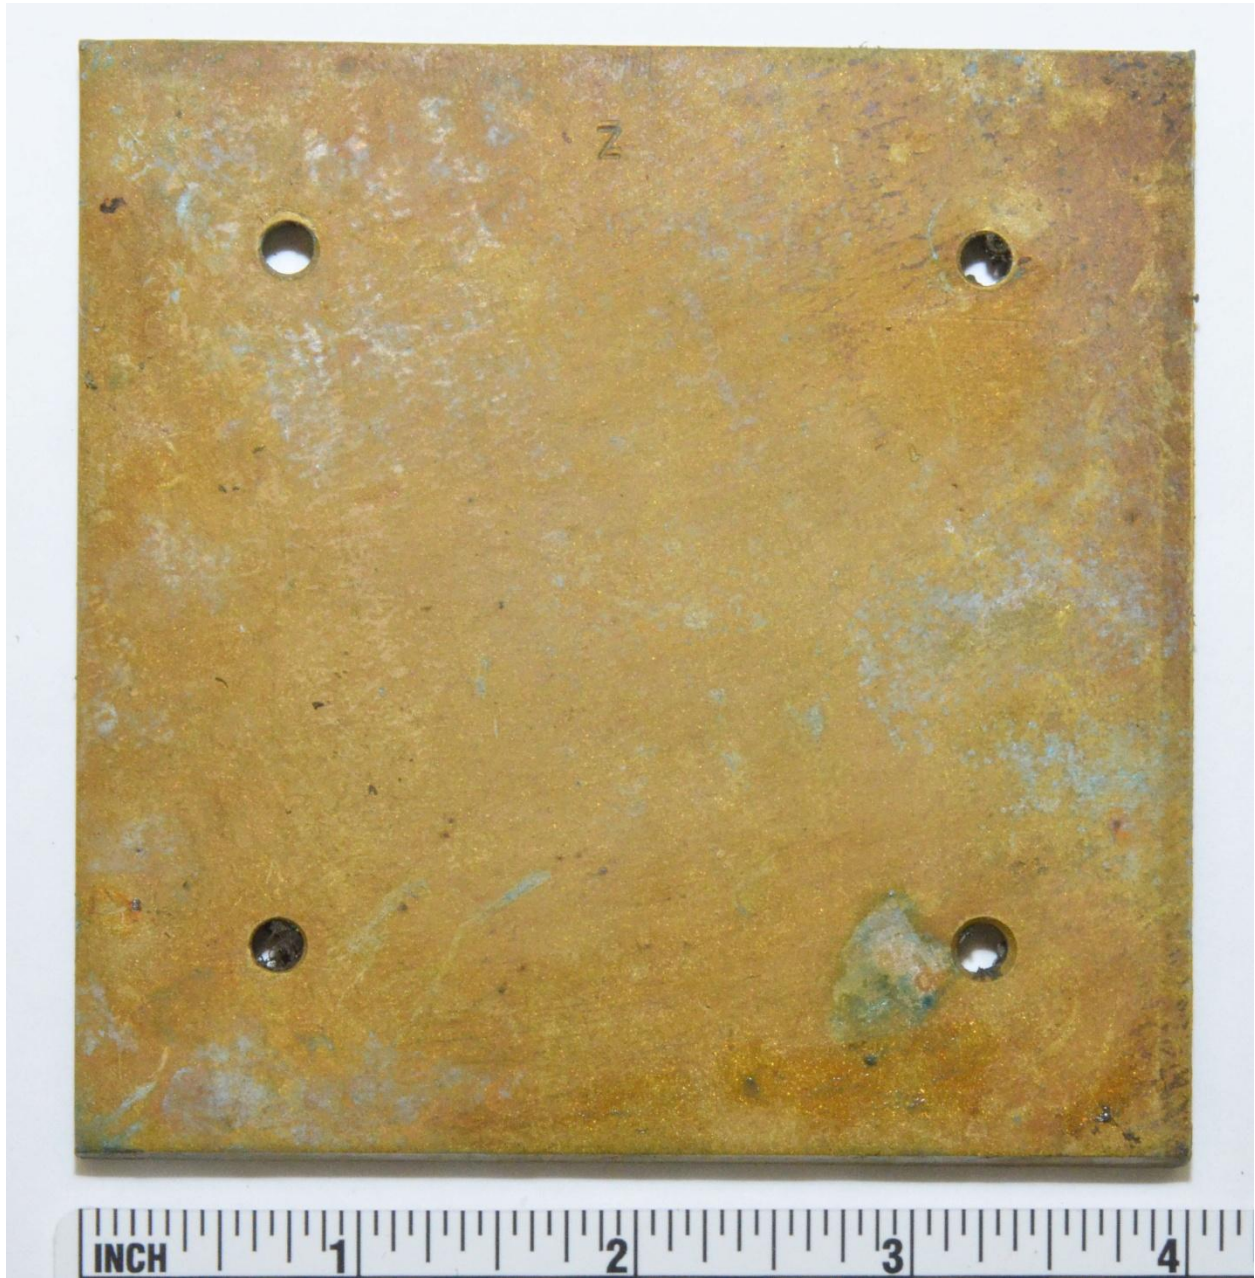
5. The plate, after 12 months of corrosion test, had a mass loss of 1.20 grams and a corrosion rate of 0.006 mm / year.

Figure 12 Photograph of the Z- Alloy plate after a 12 month corrosion test.

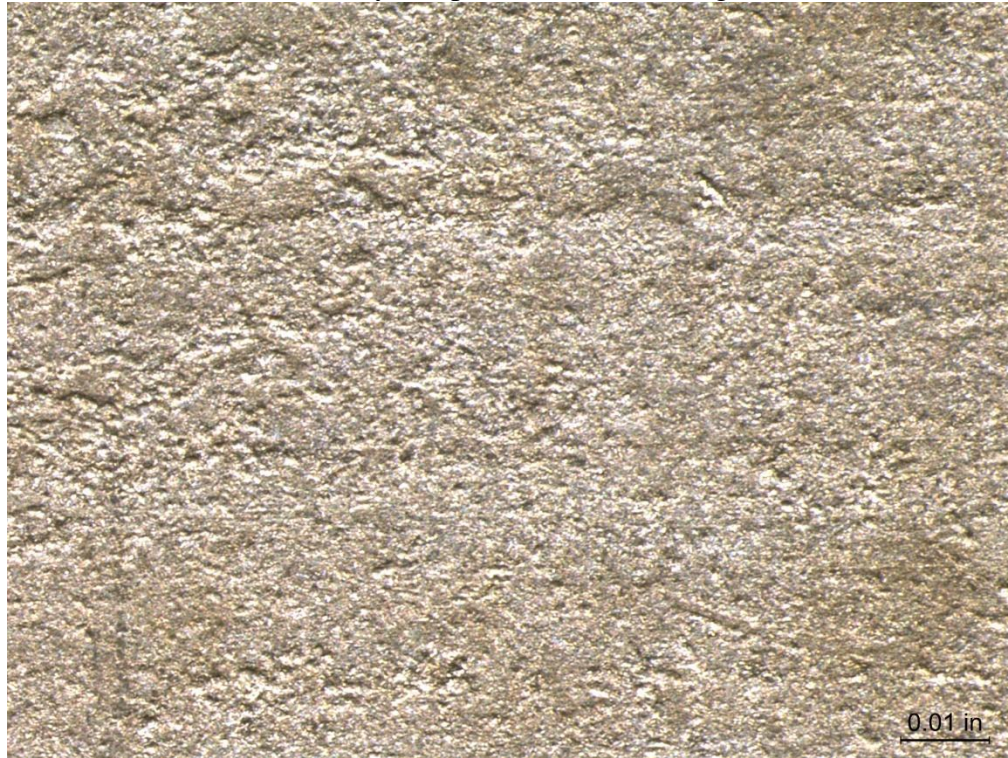
Figure 17 Optical macrographs of Z-Alloy coupon 2 after a 6 month corrosion test, after cleaning.

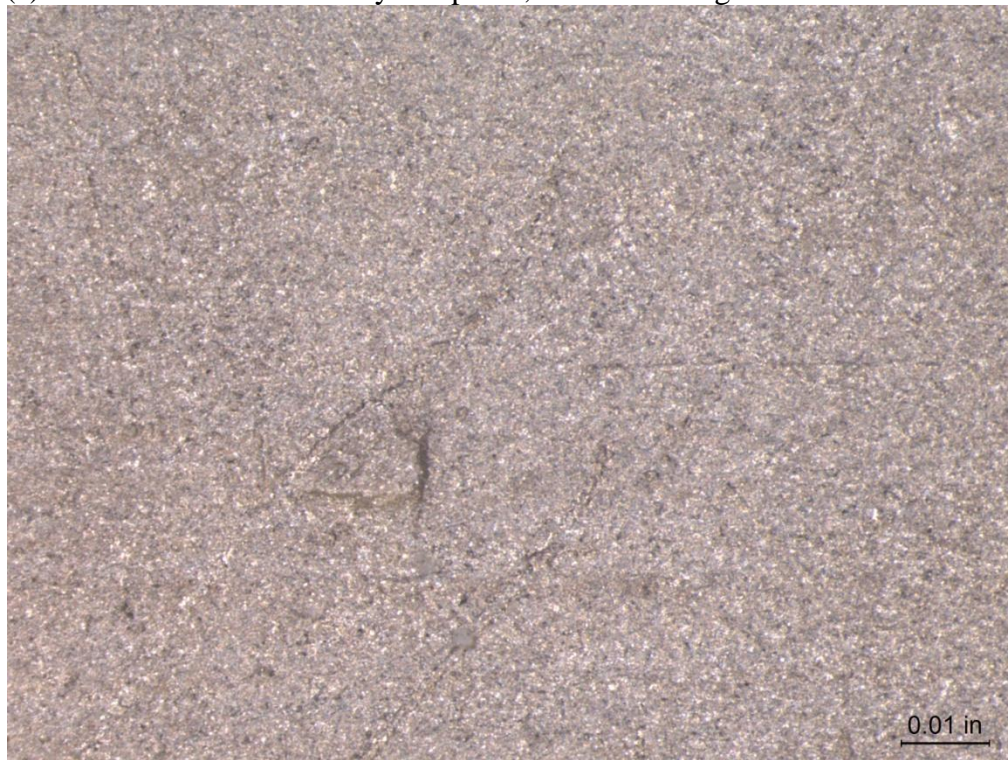
Figure 19 Optical macrographs of Z-Alloy coupon 3 after a 10 month corrosion test, after cleaning.

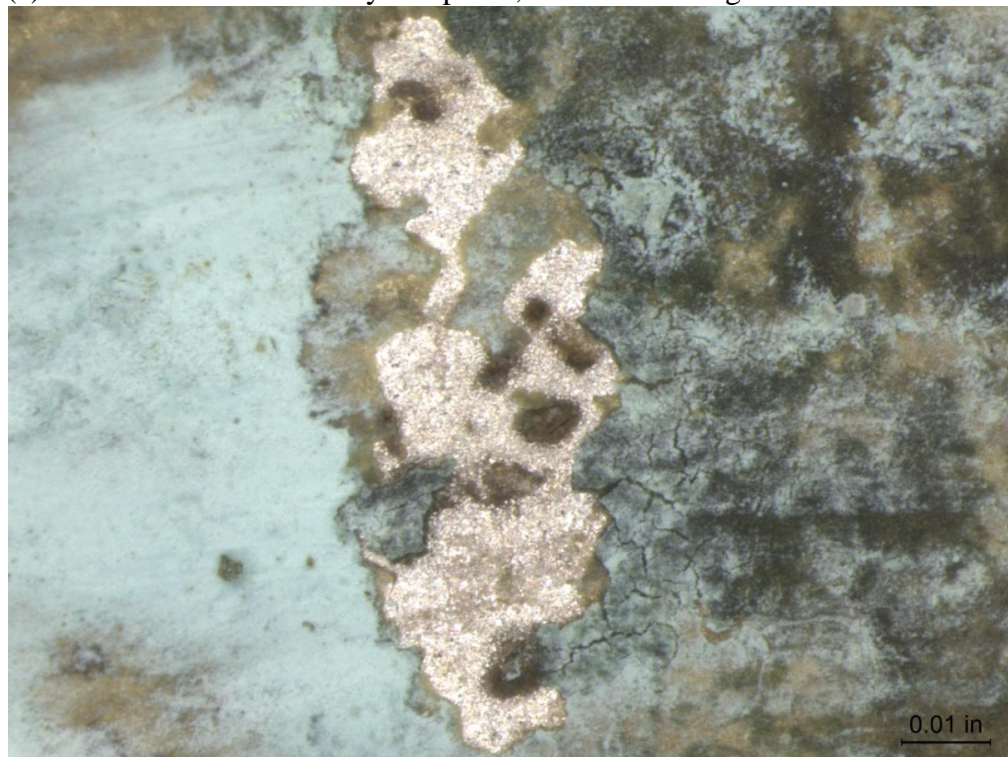
(b) Z-Alloy Coupon 4, Before Cleaning 50X

Figure 20 Optical macrographs of Z-Alloy coupon 4 after a 12 month corrosion test, before cleaning.
