WEST BASIN MUNICIPAL WATER DISTRICT OCEAN WATER DESALINATION INTAKE CORROSION STUDY

November 2014

V&A Project No.: 13-0376

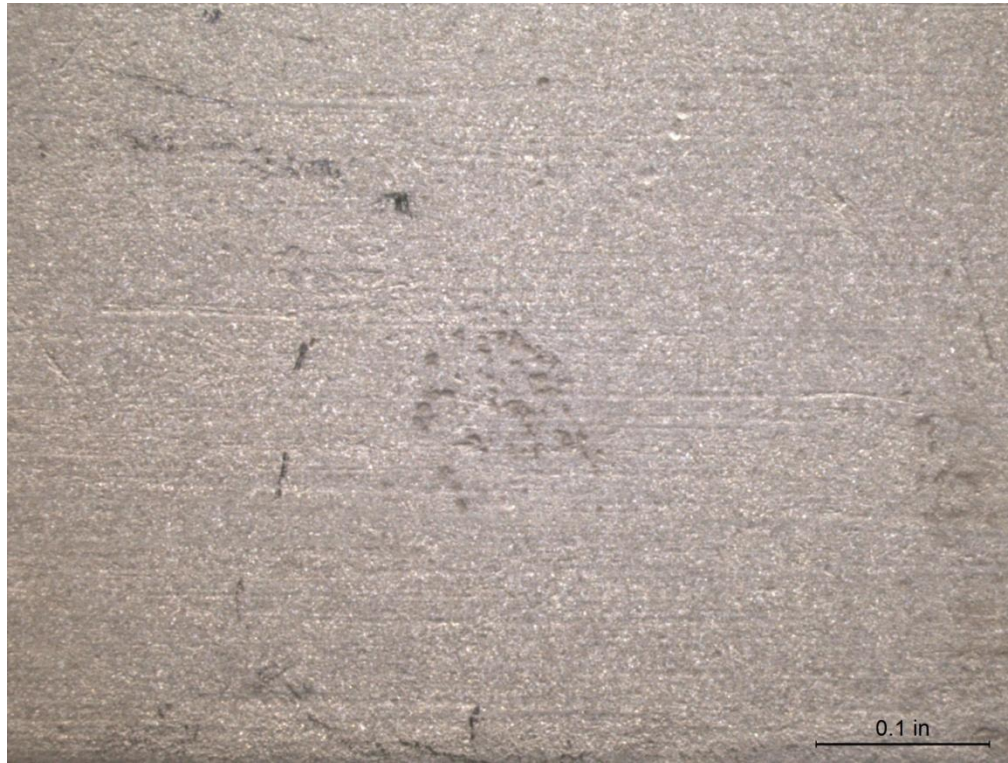
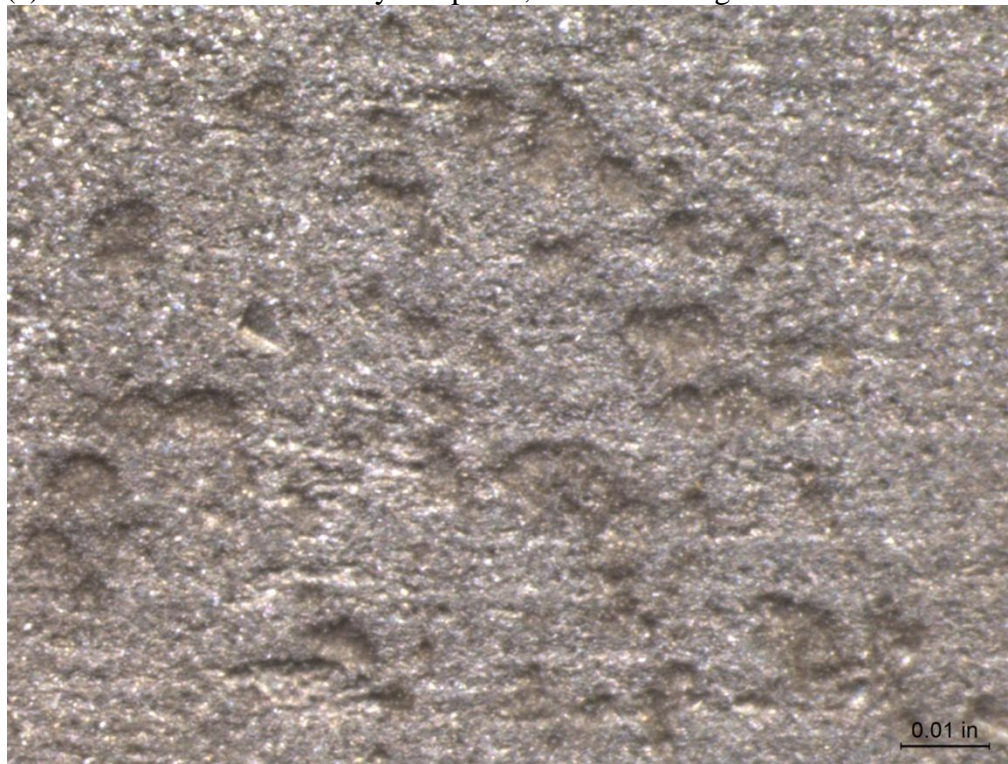
Figure 21 Optical macrographs of Z-Alloy coupon 4 after a 12 month corrosion test, after cleaning.

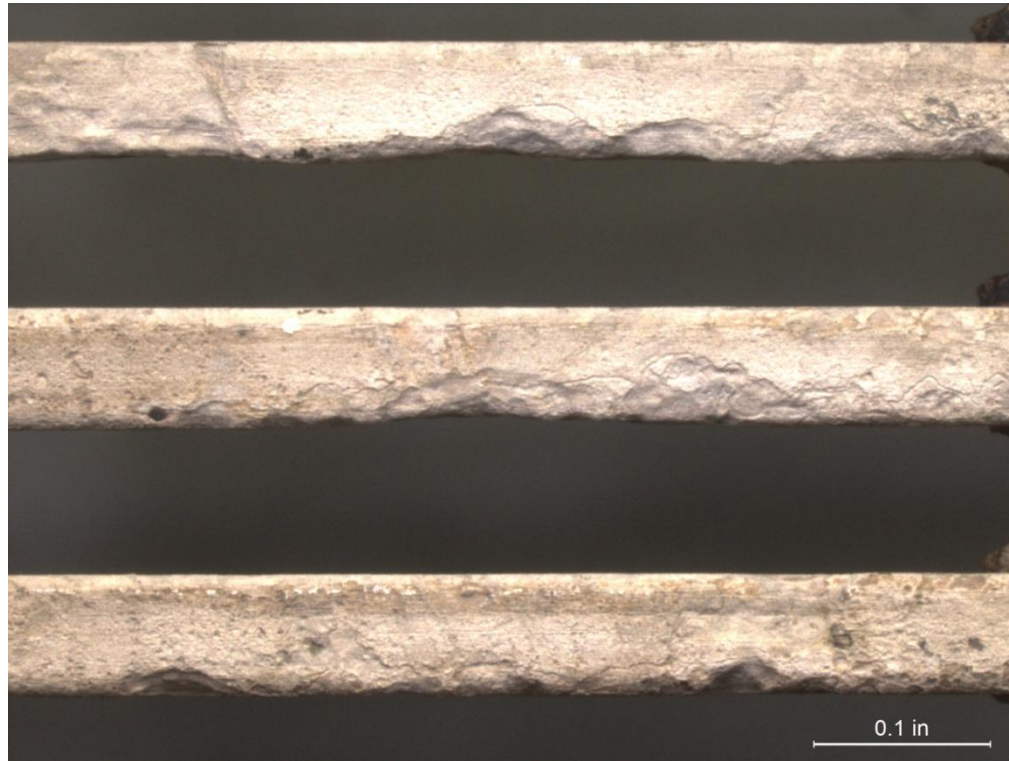
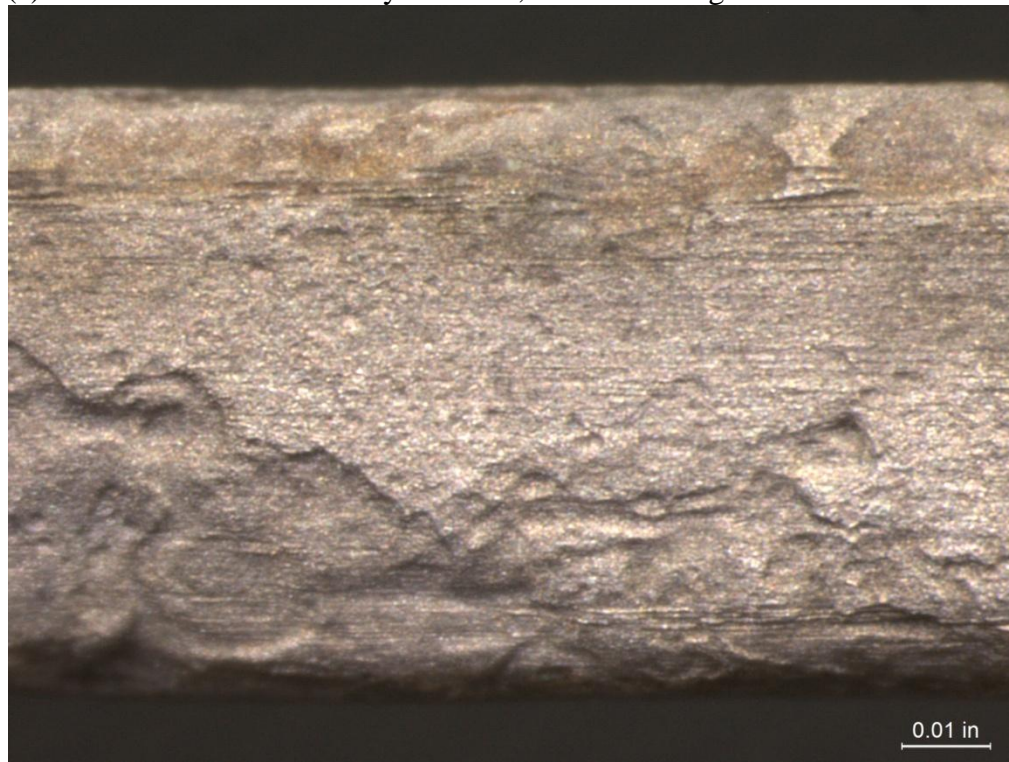
Figure 30 Optical macrographs of Z-Alloy screen 4 after a 12 month corrosion test, after cleaning.

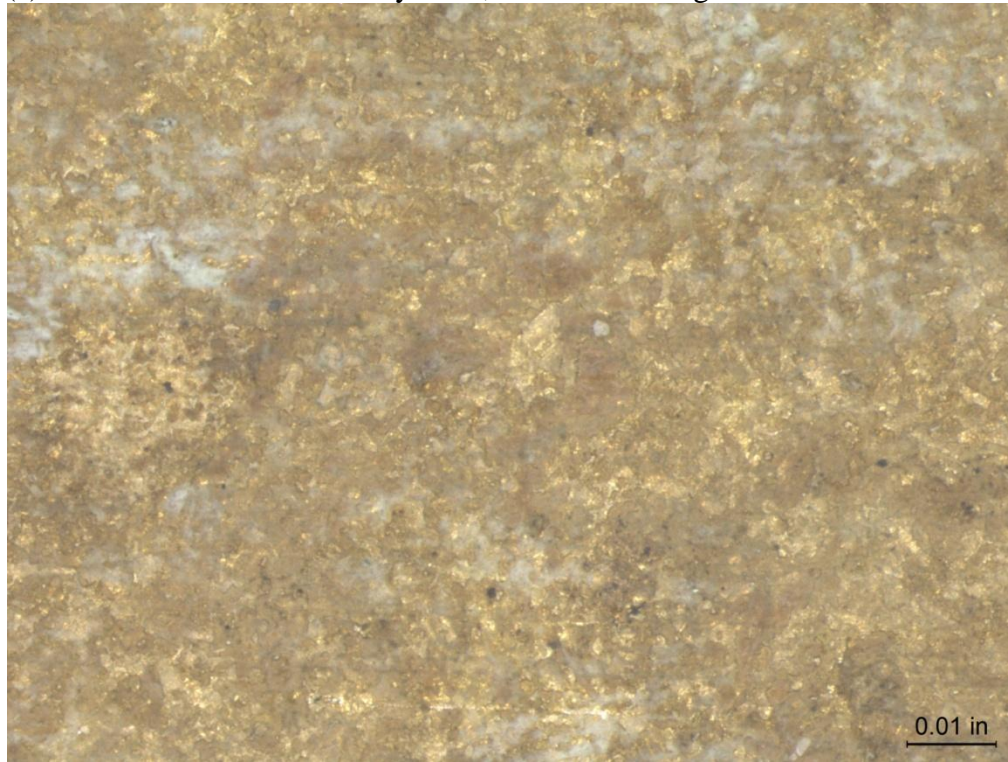
Figure 32 Optical macrographs of Z-Alloy plate after a 12 month corrosion test, before cleaning.

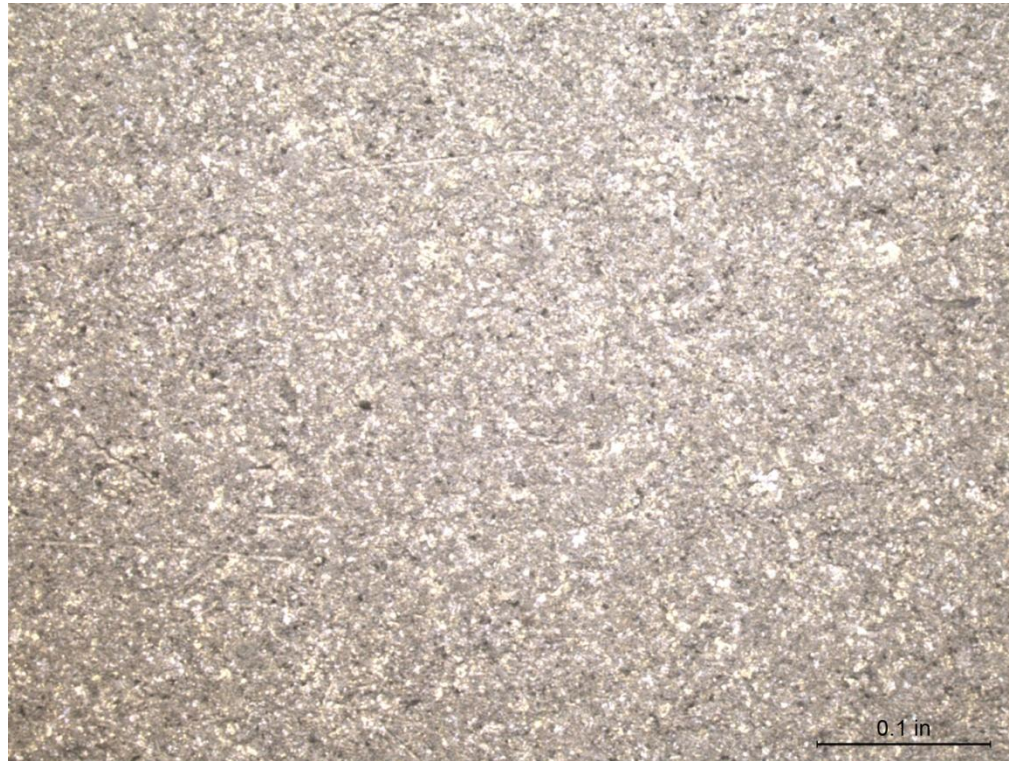
Figure 33 Optical macrographs of Z-Alloy plate after a 12 month corrosion test, after cleaning.

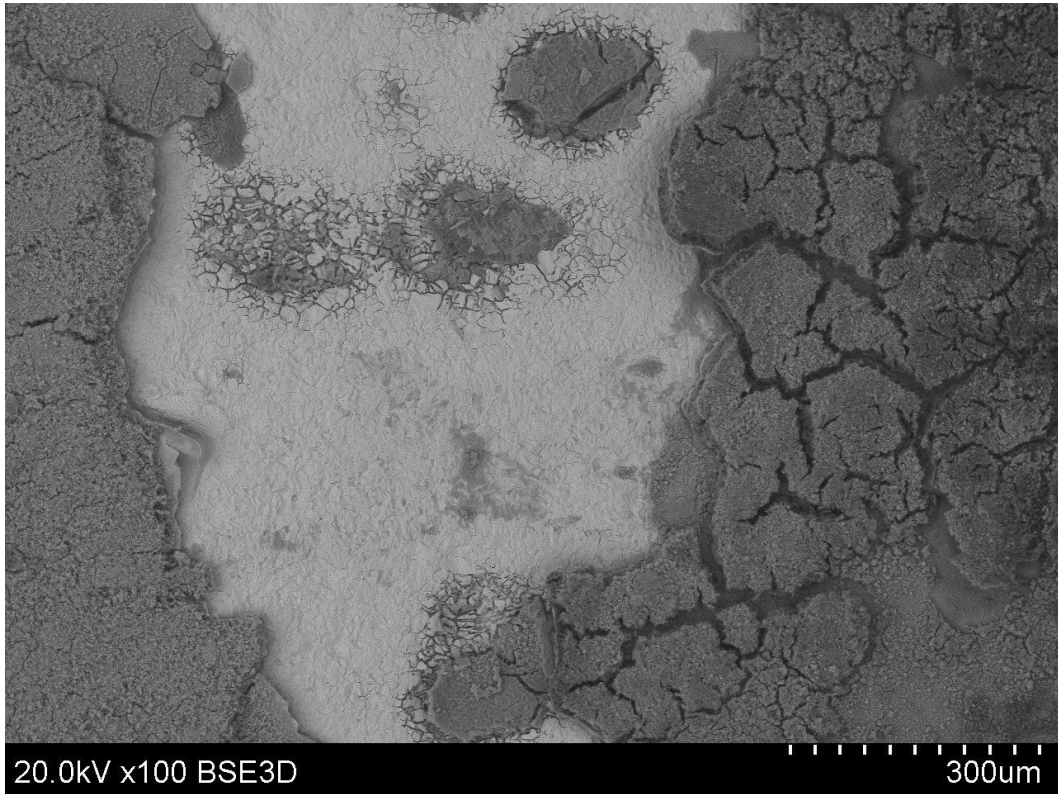
Figure 46 Scanning electron micrographs of Z-Alloy coupon 4 after a 12 month corrosion test, before cleaning.

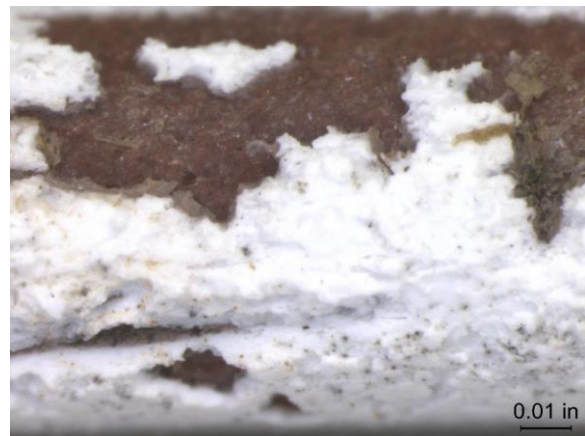
Photo 3-8. Detail view (50x) of coating damage, after cleaning.

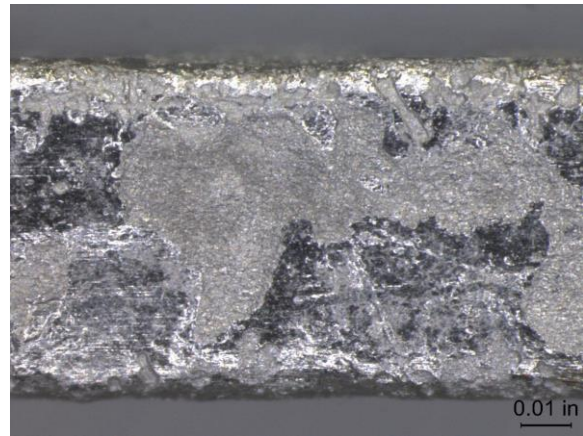
Photo 3-16. Detail view (50x) of 70-30 Cu-Ni wire screen, after cleaning.

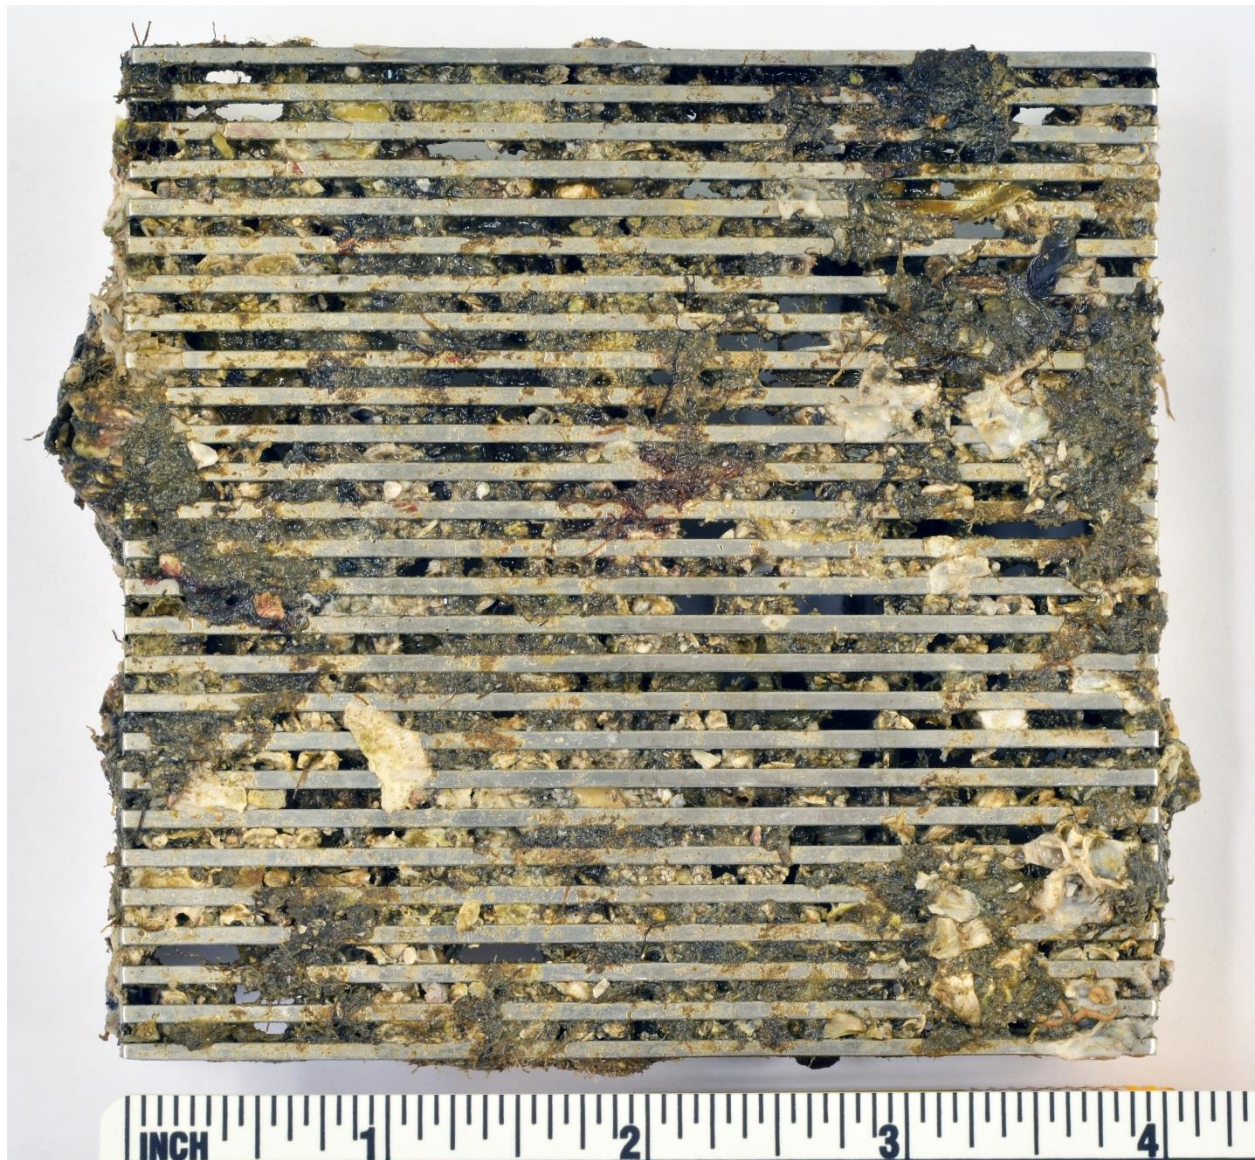
(a) Duplex 2205 Stainless Steel Screen 5

Figure 1 Photograph of duplex 2205 stainless steel screen 5 after a 36 month corrosion test.

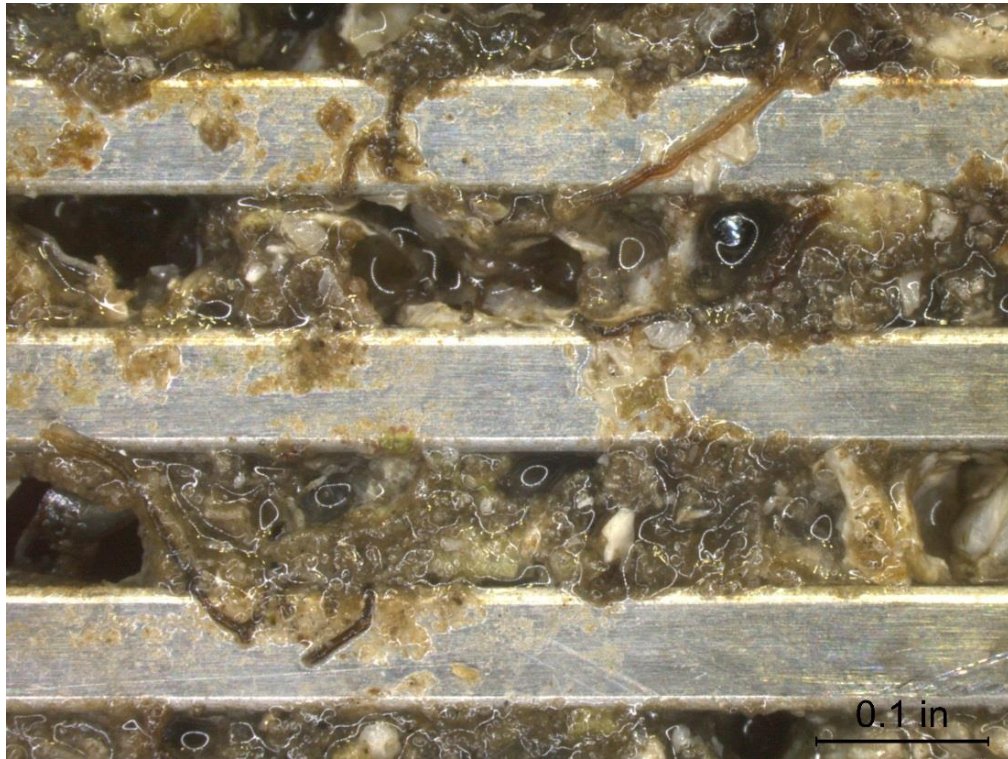
Figure 2 Optical macrographs of duplex 2205 stainless steel screen 5 after a 36 month corrosion test, before cleaning.

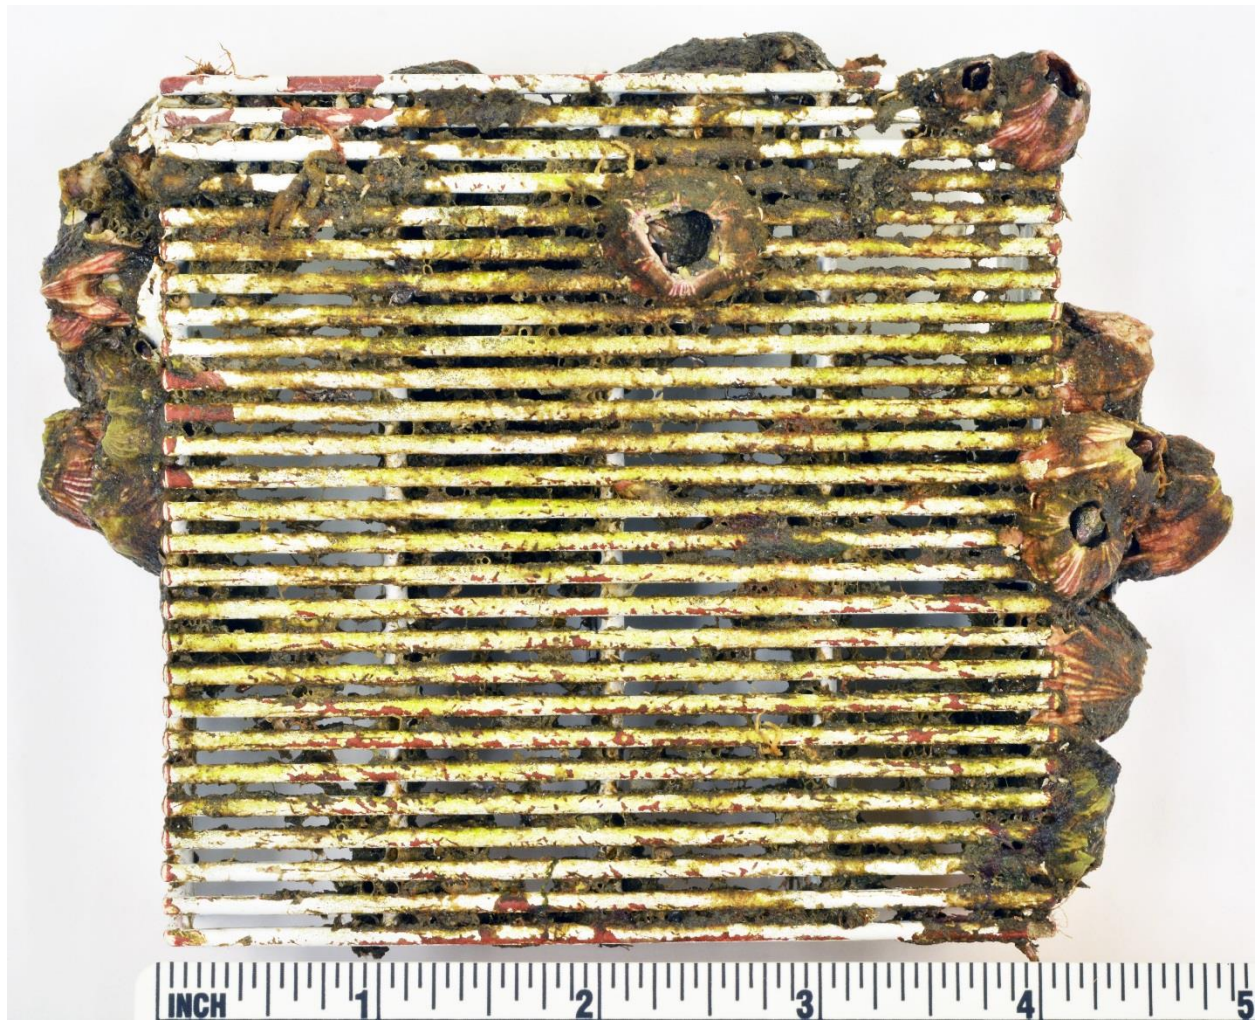
(a) Coated Duplex 2205 Stainless Steel Screen 5

Figure 1 Photograph of duplex 2205 stainless steel with anti-biofouling coating screen 5 after a 36 month corrosion test.

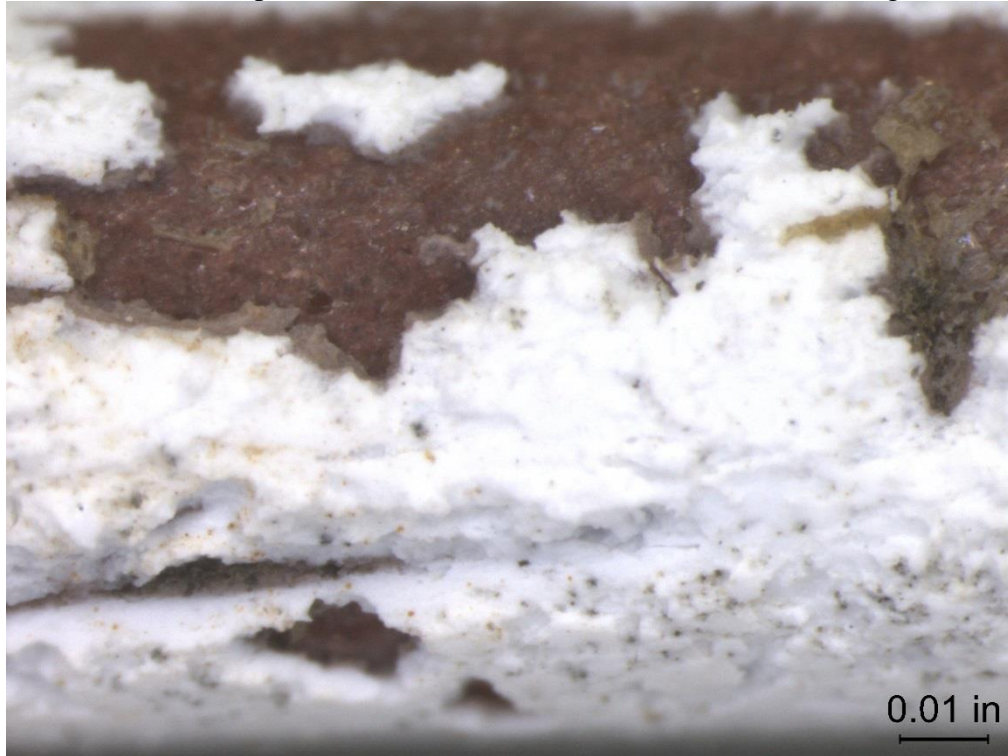
(a) Coated Duplex 2205 Stainless Steel Screen 5, After Cleaning 10X

(b) Coated Duplex 2205 Stainless Steel Screen 5, After Cleaning 50X

Figure 3 Optical macrographs of duplex 2205 stainless steel with anti-biofouling coating screen 5 after a 36 month corrosion test, after cleaning.

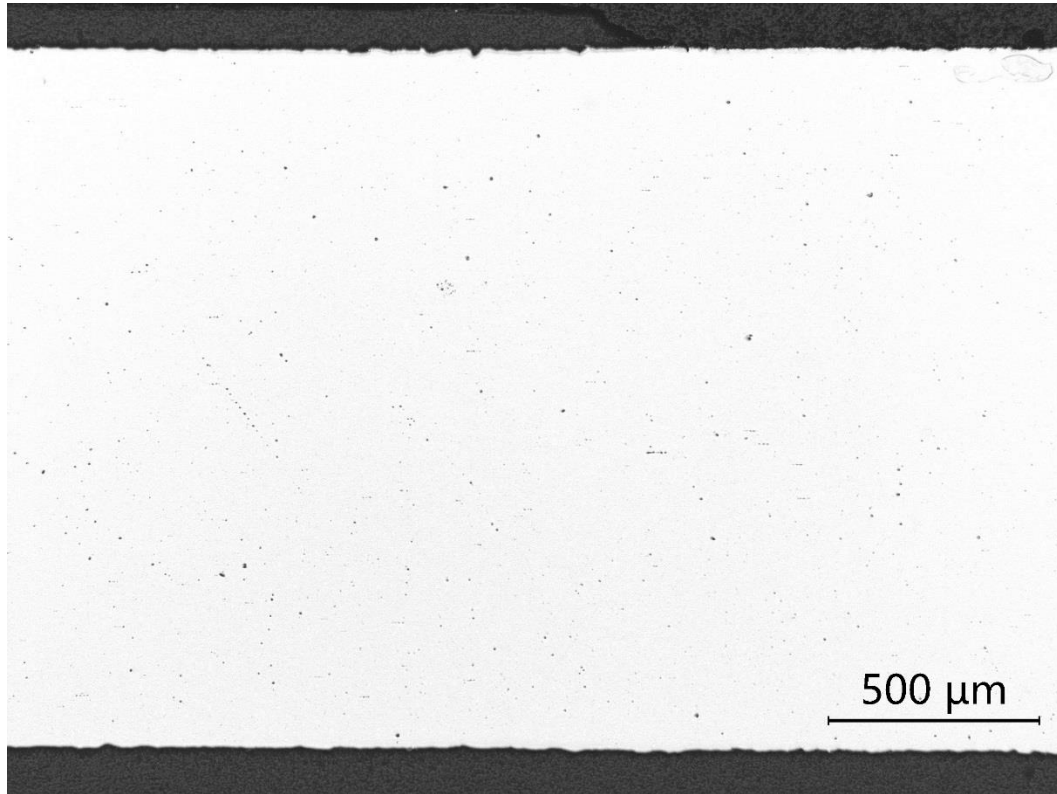
(a) Coated Duplex 2205 Stainless Steel Screen 5 50X

(b) Coated Duplex 2205 Stainless Steel Screen 5 200X

Figure 7 Optical micrographs of duplex 2205 stainless steel with anti-biofouling coating screen 5.

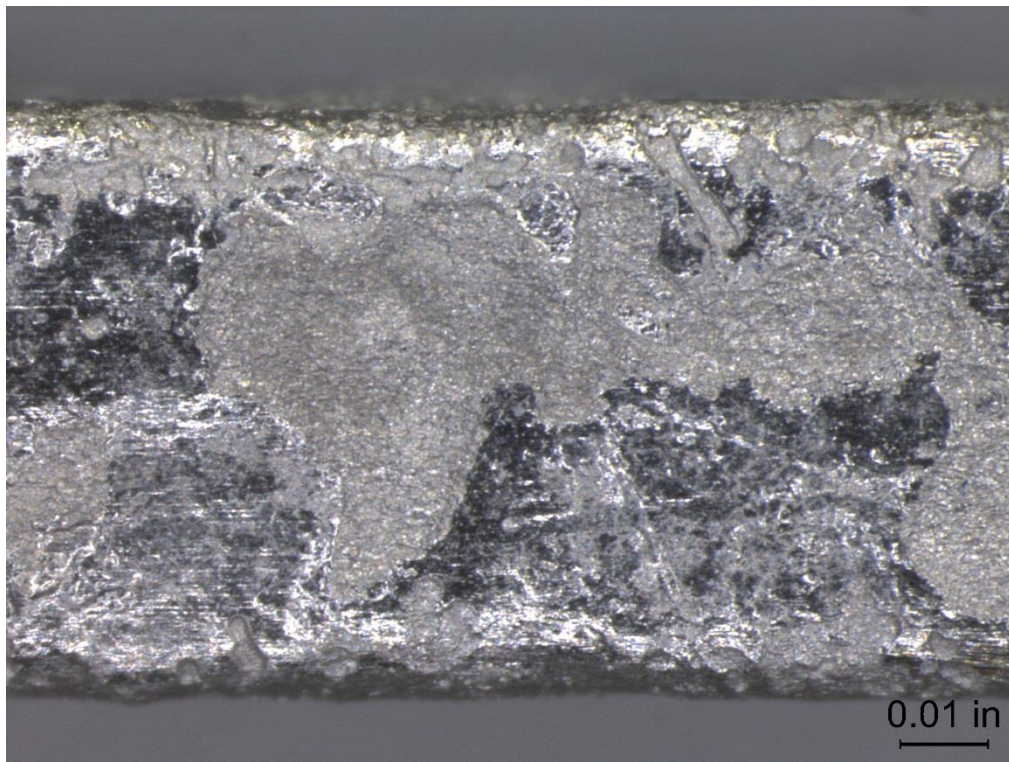
(a) CDA 715 Screen 5, After Cleaning 10X

(b) CDA 715 Screen 5, After Cleaning 50X

Figure 3 Optical macrographs of CDA 715 screen 5 after a 36 month corrosion test, after cleaning.
