FINAL  
INTAKE BIOFOULING  
AND CORROSION STUDY  
(UPDATED)

**West Basin Ocean Water Desalination  
Demonstration Facility Intake  
Biofouling and Corrosion Study**

**April 18, 2018**

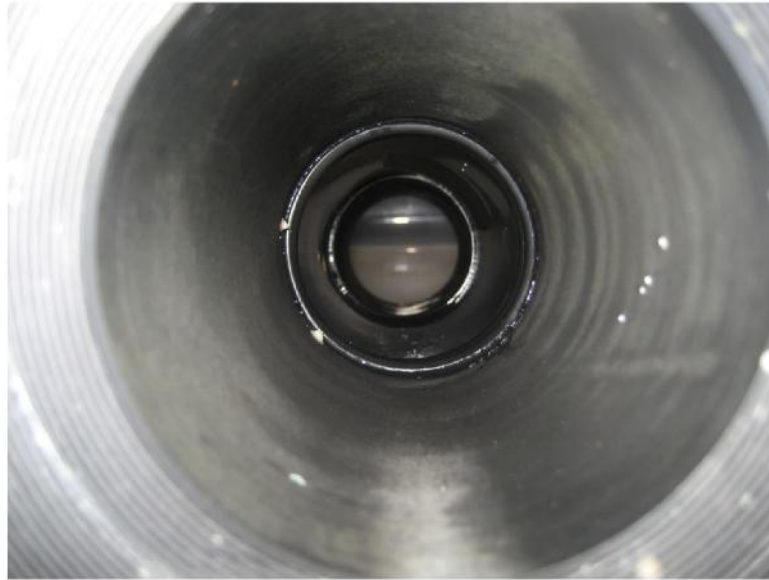
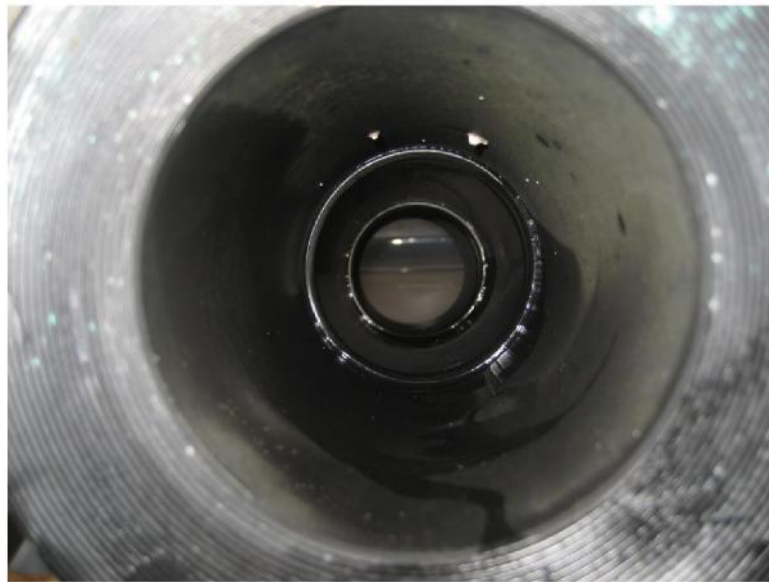
**Figure 3-6. Pipe spool C4 (Shock Chlorination) December 23, 2014. Inlet (top) and Outlet (bottom).**

- This is the fourth pipe spool in spool row C and received a weekly shock treatment with sodium hypochlorite.
- Photos taken from inlet and outlet ends (**Figure 3-6**).
- No slime/diatoms detected by touch or tissue wipe.
- 9 small acorn barnacles (Balanidae) were observed; 5 in the inlet section, 2 in the middle section, and 2 in the outlet section.
  - Size (basal diameter) ranged from about <1 mm to 3 mm.
- No sand or other debris was observed.

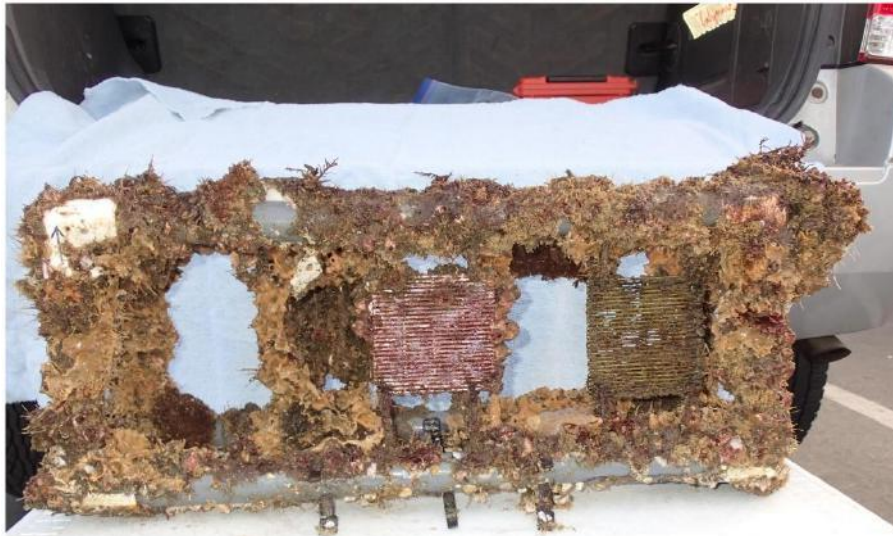
**Figure 4-11: Rack V with three remaining wedgewire samples still attached, photographed 05/23/17.**

Test Material	Biofouling Notes	
PVC test rack	The PVC test rack was heavily fouled to the point where almost none of the PVC was visible. The encrusting biofouling layer exceeded 25mm (1 inch) in thickness on some portions of the rack (See Figure 4-11).	
CDA 706 (90 – 10 Copper Nickel)	Wedgewire sample: Missing from the rack.	Coupon: N/A
Z-Alloy	Wedgewire sample: Missing from the rack.	Coupon: N/A
2205 SS (stainless steel) with antifouling coating	<p>Wedgewire sample: About 80 percent of the sample’s outer surface had a light covering of diatoms and filamentous or encrusting red algae. There were 45 – 50 acorn barnacles (<i>Megabalanus californicus</i>) that ranged in size from 5 – 24 mm. The majority of the barnacles were on the underside of the sample attached to the flat metal sides and reinforcing ribs. About 85% of the outer wedgewire face was not occluded by the barnacles or other fouling.</p> <p>Most of the barnacles were firmly attached, usually at locations where some damage or imperfection in the foul-release coating allowed the barnacle to get a foothold on the bare metal or the primer coat under the foul-release coating. Barnacles that had settled on undamaged portions of the coating could be easily removed with gentle pressure.</p> <p>There were also some hydroids and amphipod tubes on the underside of the sample and attached to the barnacle shells. (See Figure 4-12)</p>	Coupon: N/A

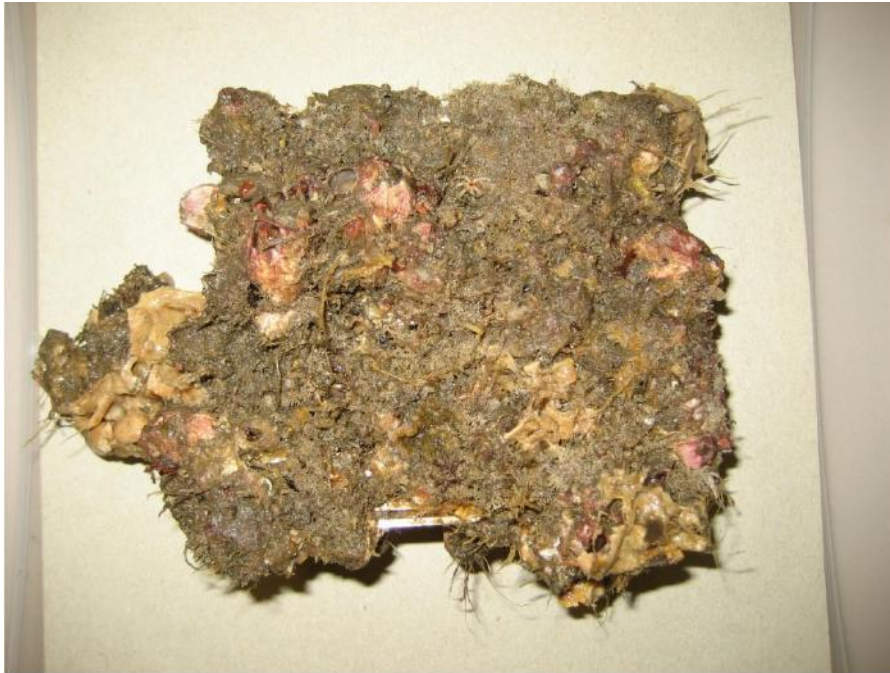
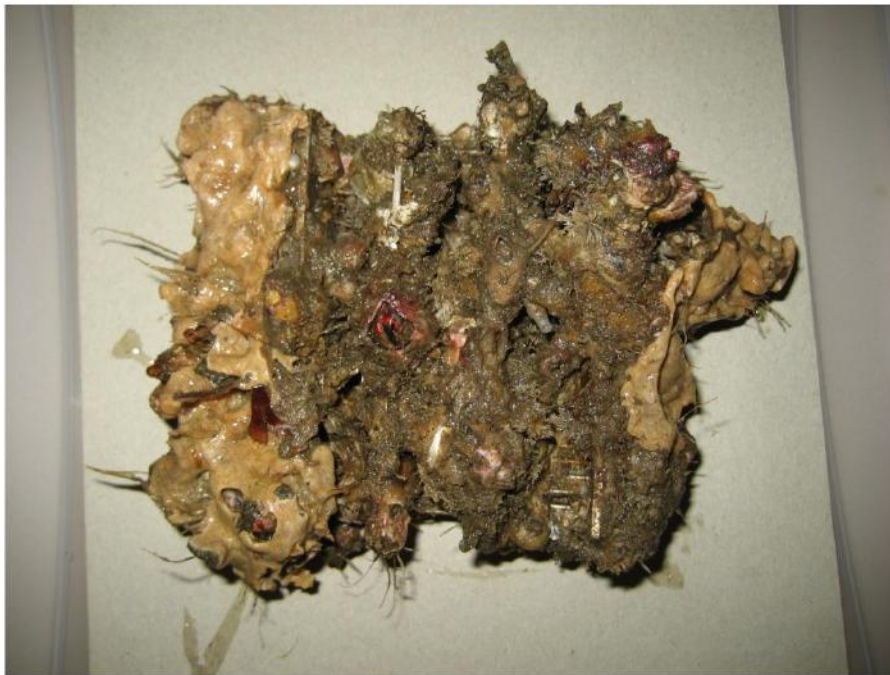
**Figure 4-13: 2205 stainless steel wedgewire sample, photographed 05/24/17.**

Test Material	Biofouling Notes	
	<p>attached and some of the material could not be removed prior to sending the sample to V&amp;A Consulting Engineering due to the potential of damaging the sample prior to metal analyses. (See Figure 4-13)</p>	
<p>CDA 715 (70 – 30 Copper Nickel)</p>	<p>Wedgewire sample: The CDA 715 WW samples from Racks I – IV, were similar to the CDA 706 and Z-Alloy samples, but with more of the surface covered by amphipod tubes and filamentous red algae. There were also more of a diatom and silt film/layer, but less of the green patina than on the other two samples. The sample from Rack V could not be compared with the 90-10 Cu-Ni or the Z-Alloy because those samples were missing. Overall this sample looked very good after being submerged for almost three years. About 70 percent of the outer surface had a light covering of filamentous algae, diatoms, hydroids, and entrapped silt and debris (soft material). The underside had some amphipod tubes, five small (2 – 5 mm diameter) acorn barnacles (<i>M. californicus</i>), and three small white bivalves (2 – 3 mm length). All fouling and debris was easily removed with a soft nylon brush after the sample was photographed and inspected. There was accelerated corrosion/erosion on the wedgewire at the sites of the plastic cable ties, but it was not severe enough to result in the loss of the sample. (See Figures 4-14 and 4-15)</p>

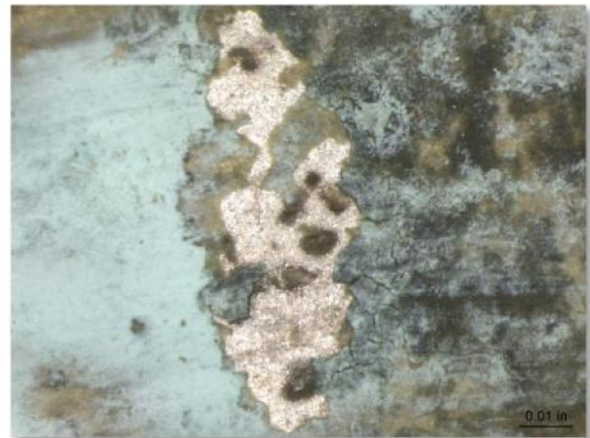
Figures 4-31, 4-34, 4-36, 4-40, and 4-41 show some further oxidation and discoloration of the copper alloy sample surfaces after being exposed to the atmosphere for up to 7 days.

Figure 4-40: Surface discoloration of Z alloy coupon, front (top), back (bottom).

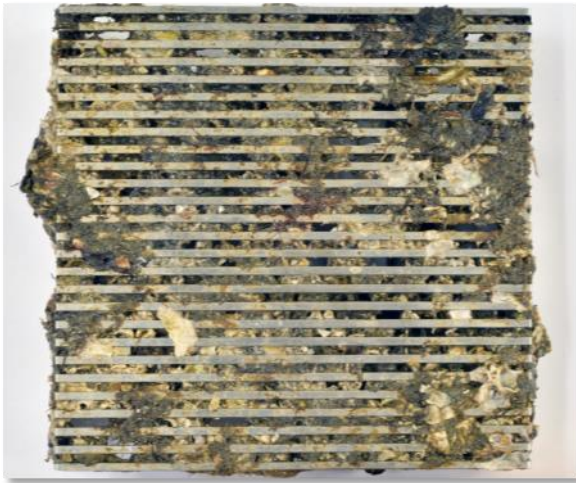
**Photo 4-1: Uncoated 2205 Duplex SS wedgewire screen, before cleaning.**
